# VEHICLE INSPECTION REPORT

**GJ18AXN**

## Skoda Kodiaq 2.0 TDI SE 4x4 5dr

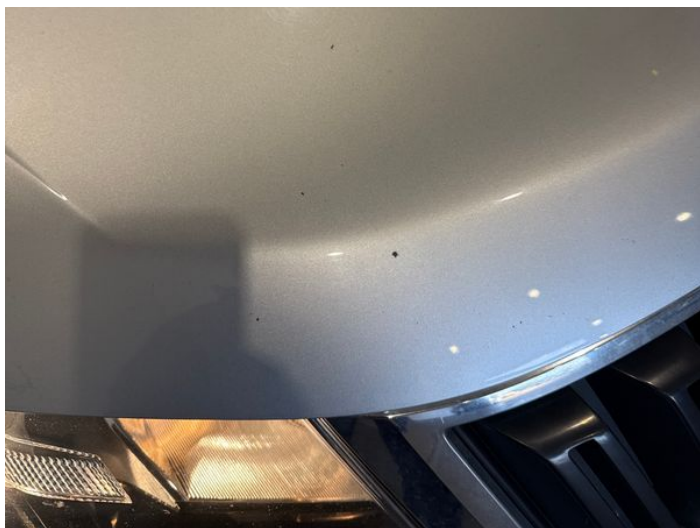
1: Bonnet  
Chipped  
Multiple Chips

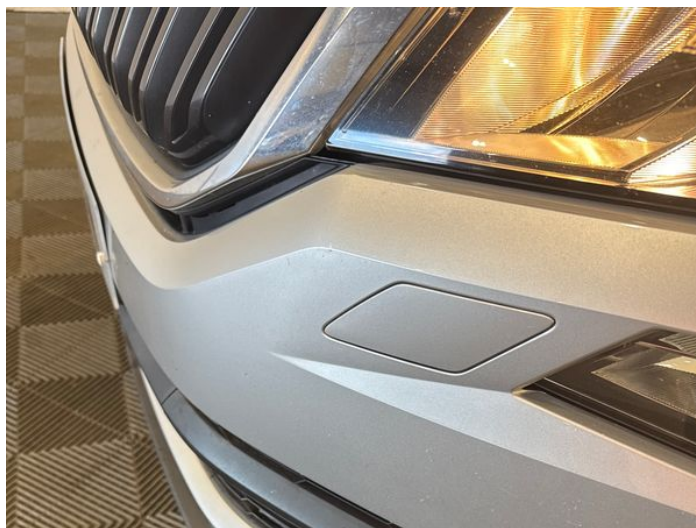
2: Bumper Front  
Chipped  
Multiple Chips

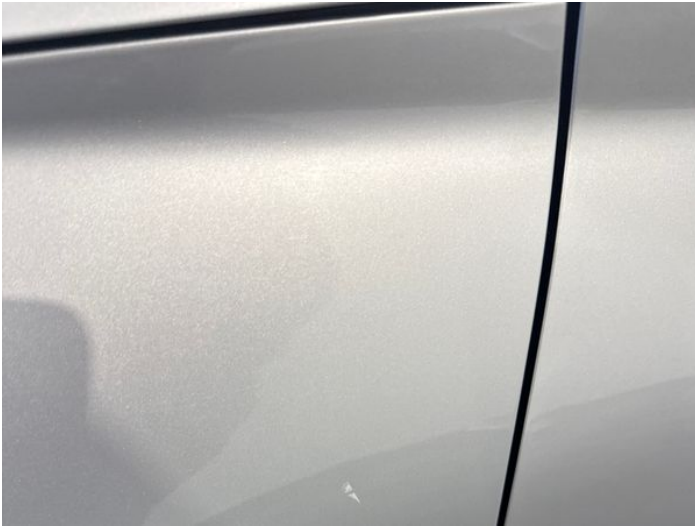
3: Wing nsf  
Chipped  
1 To 5

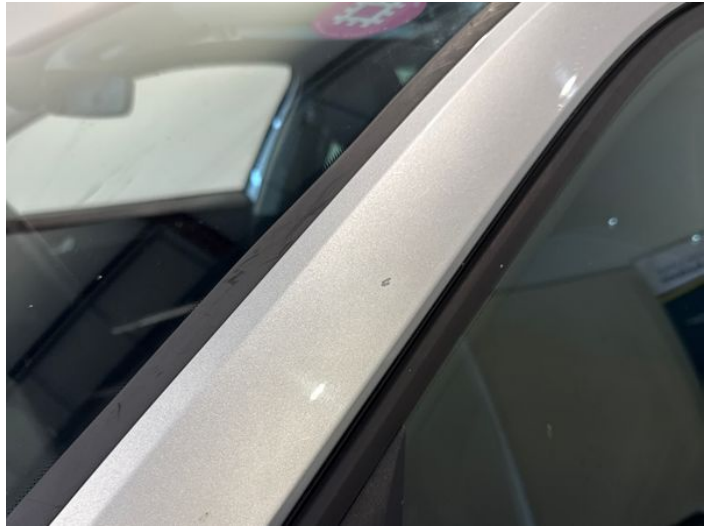
4: A Post ns  
Chipped  
1 To 5

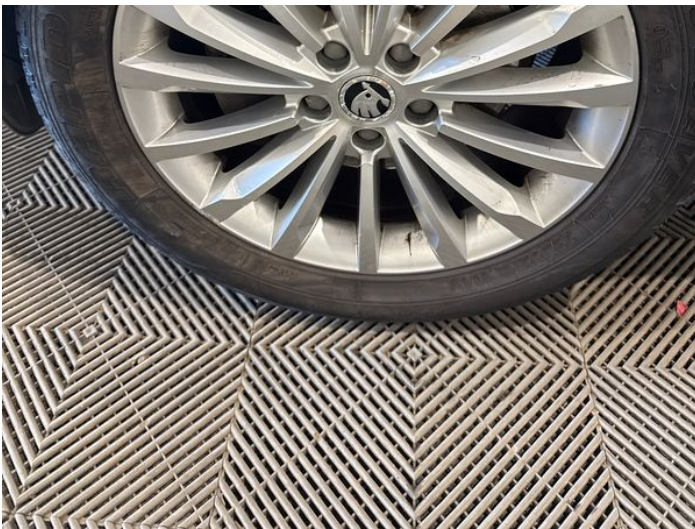
5: Wheel nsf  
Scratched  
Up To 50mm

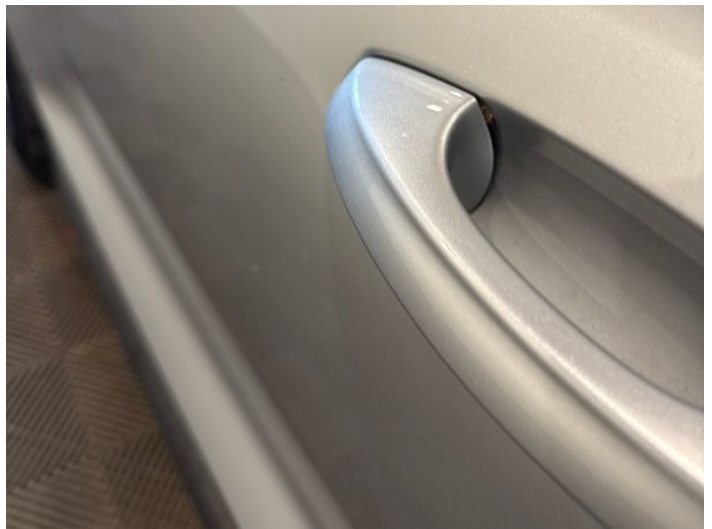
6: Door nsf  
Dented  
Between 10mm + 30mm

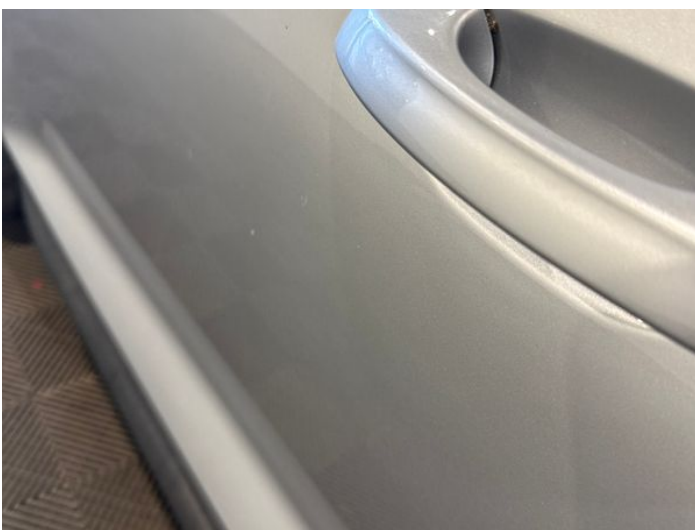
7: Door nsf  
Chipped  
1 To 5

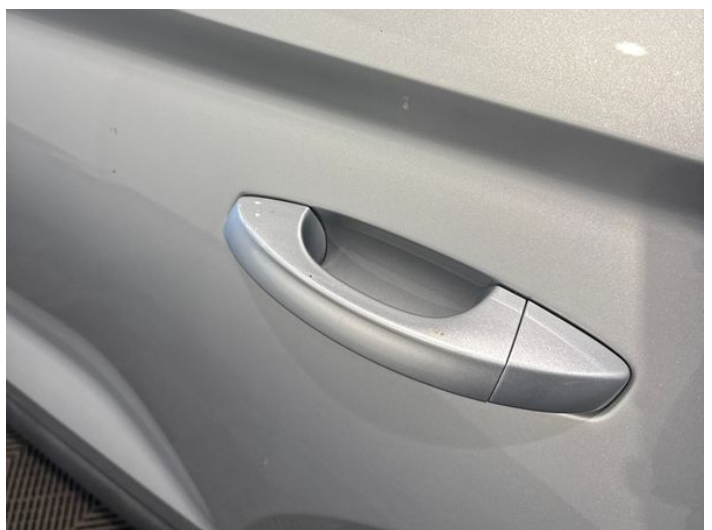
8: Door nsr  
Poor Previous Repair  
Rippled UpTo 30%

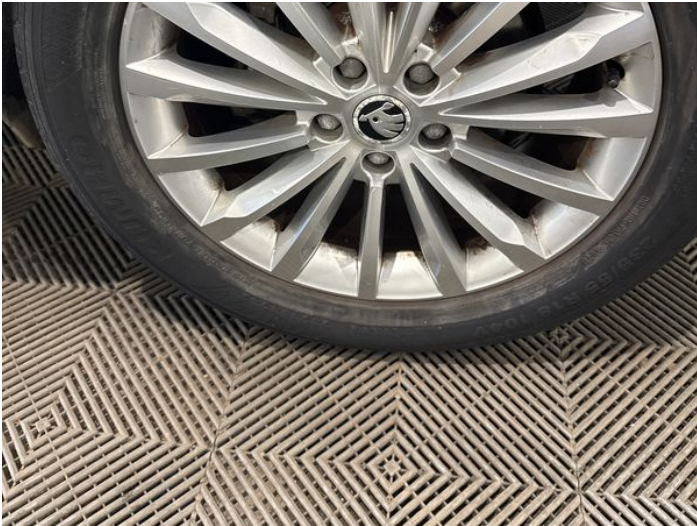
9: Wheel nsr  
Scratched  
Up To 50mm

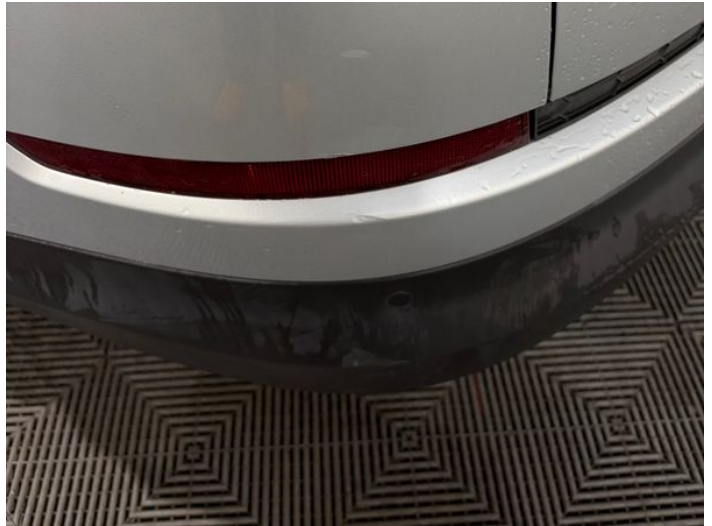
10: Bumper Rear  
Scratched  
Up To 25mm Thru Paint

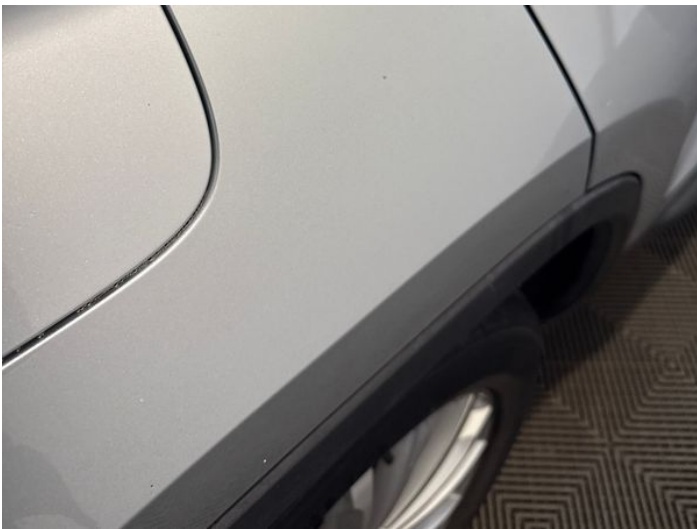
11: Qtr Panel nsr  
Chipped  
1 To 5

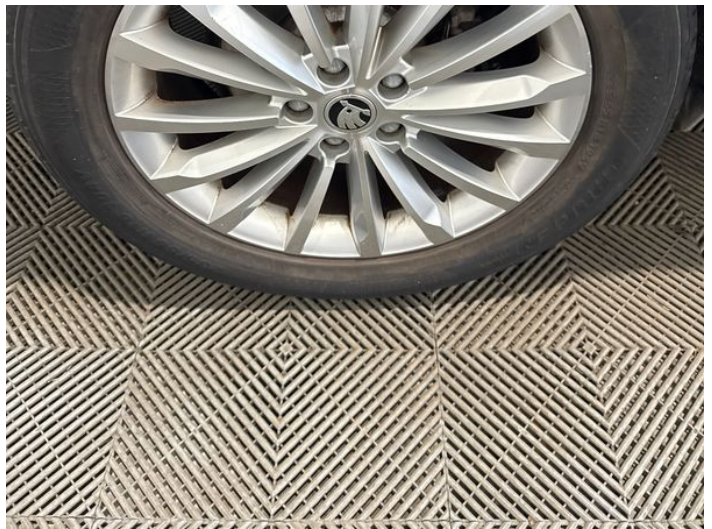
12: Wheel osr  
Scratched  
Up To 50mm

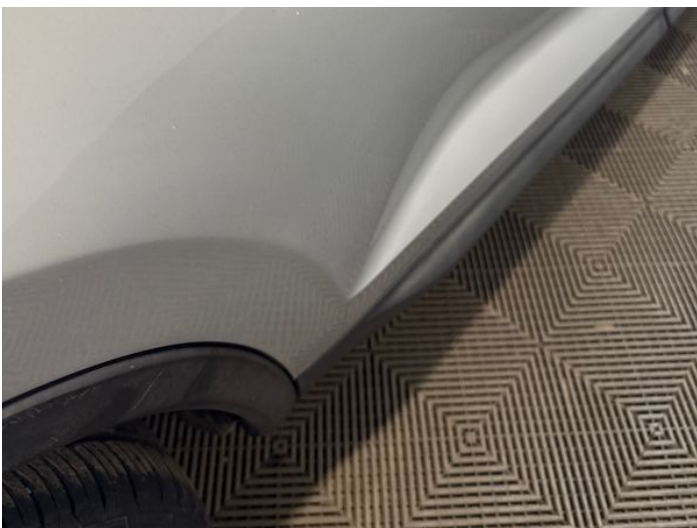
13: Door osr  
Dented  
Between 10mm + 30mm

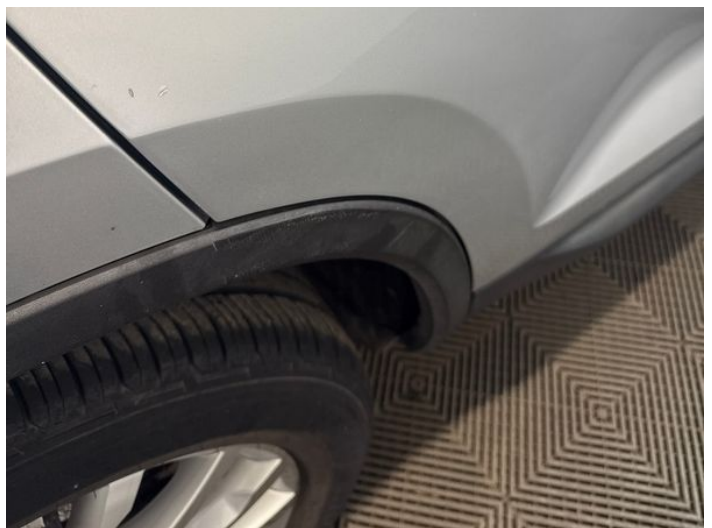
14: Door osr  
Chipped  
1 To 5

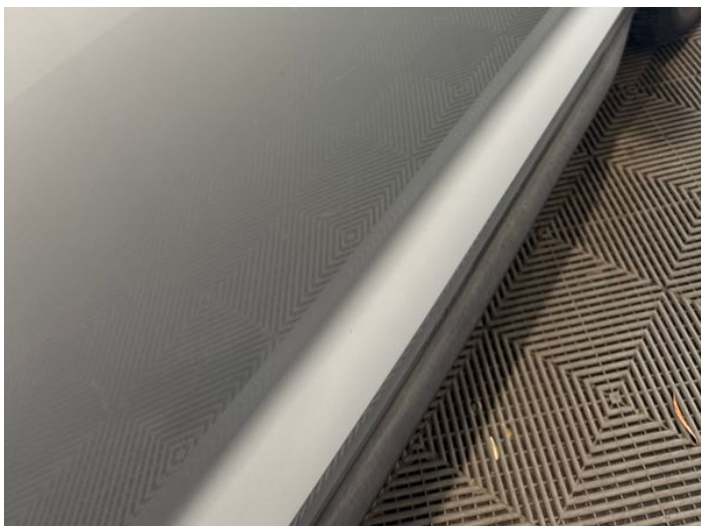
15: Door osf  
Scratched  
Over 25mm Thru Paint

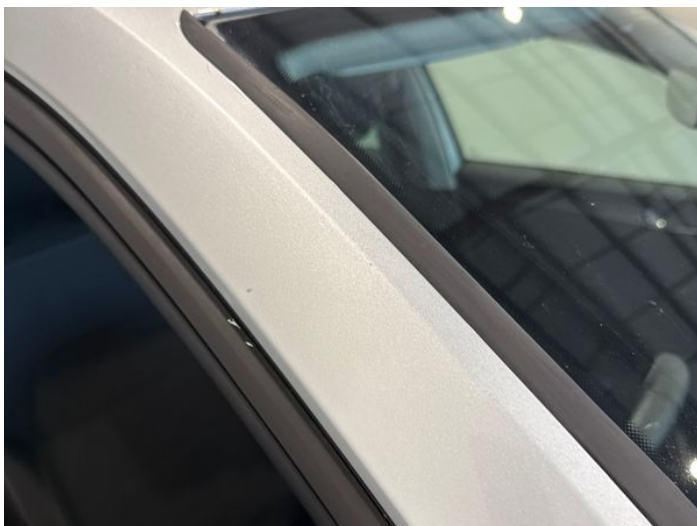
16: A Post os  
Chipped  
1 To 5

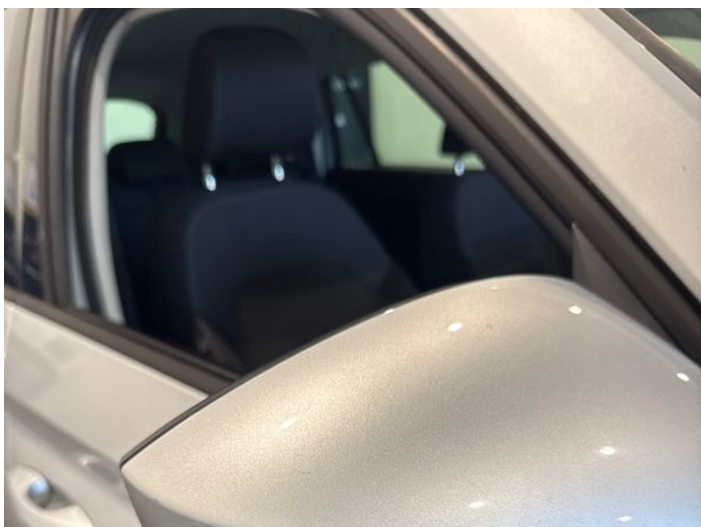
17: Door Mirror Assy osf  
Scratched (Painted)  
UpTo 25mm Thru Paint

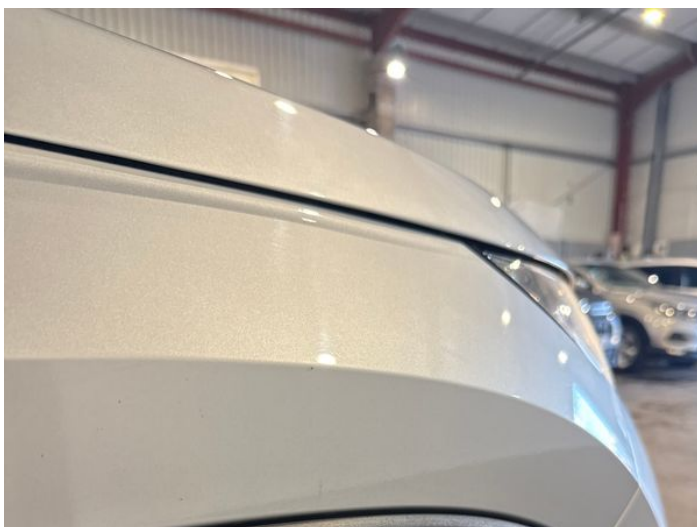
18: Wing osf  
Chipped  
1 To 5

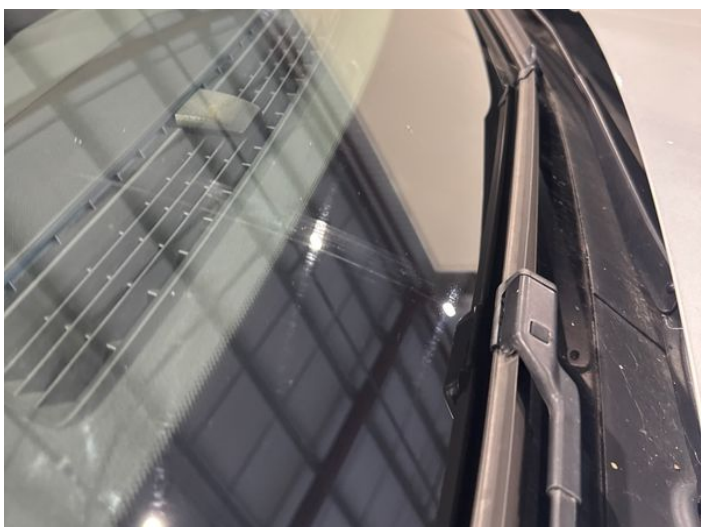
19: Screen Front  
Scratched  
Over 30mm

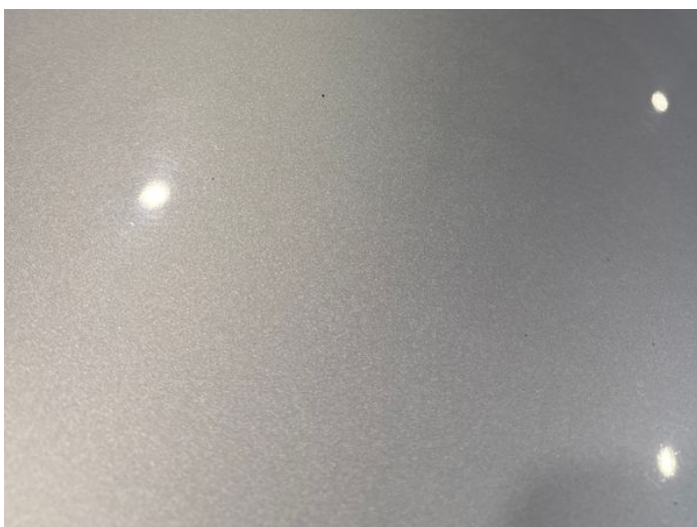
20: Roof  
Chipped  
1 To 5

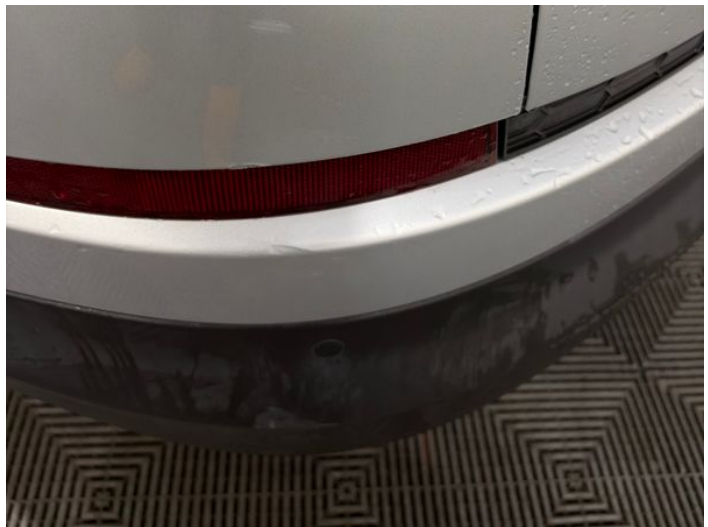
22: Bumper Rear  
Dented  
Between 10mm + 30mm
