# VEHICLE INSPECTION REPORT

**FV14UHK**

## Nissan Note 1.2 DiG-S Tekna 5dr [Style Pack]

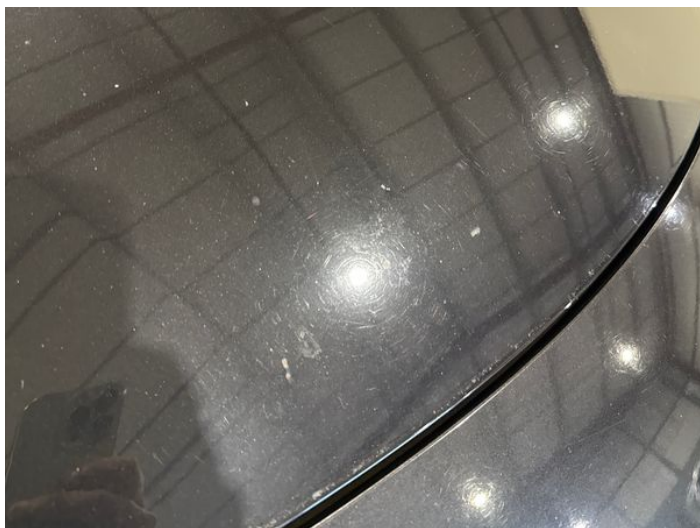
1: Bonnet  
Chipped  
Multiple Chips

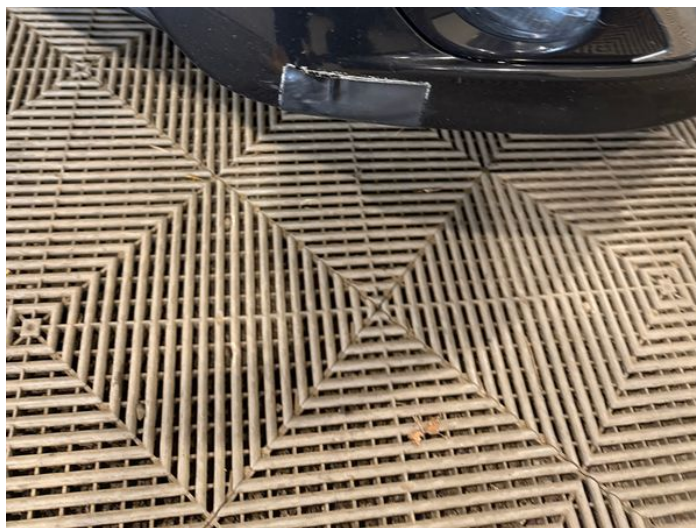
2: Bumper Front  
Cracked  
Over 25mm

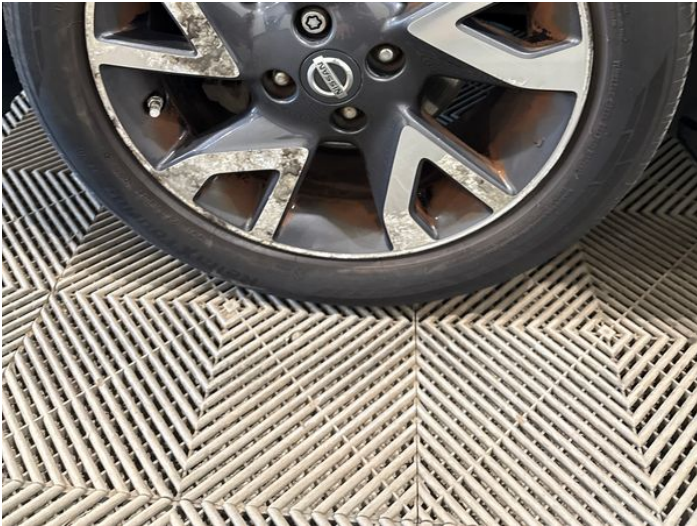
3: Wheel nsf  
Scratched  
Over 50mm

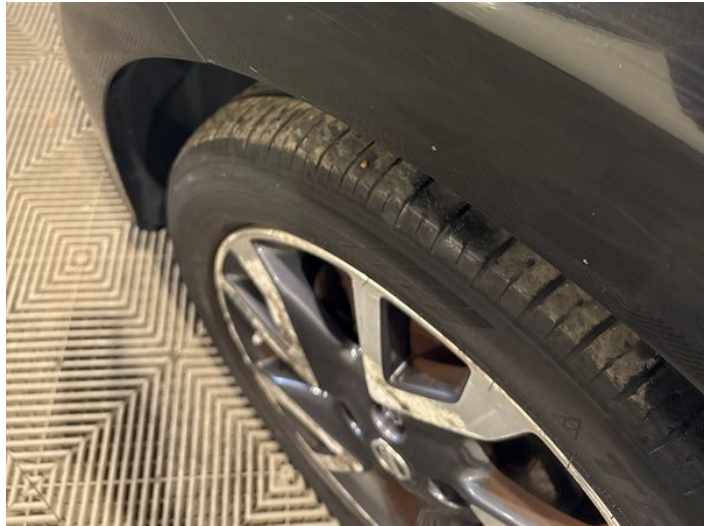
4: Wing nsf  
Scratched  
Over 25mm Thru Paint

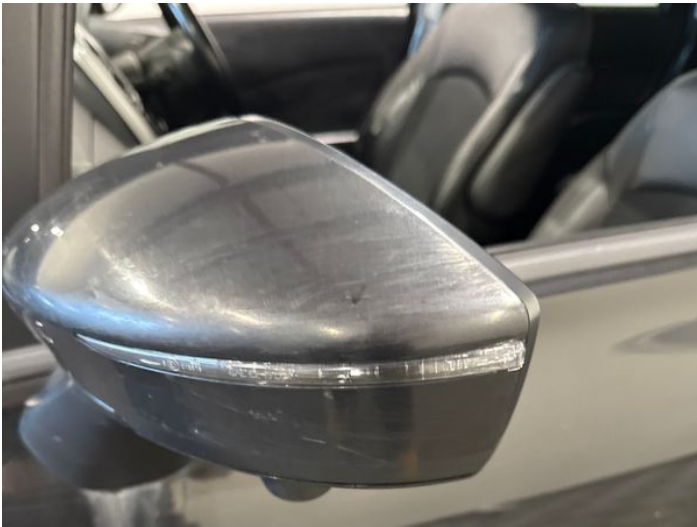
5: Door Mirror Assy nsf  
Scuffed (Unpainted)  
UpTo 100mm

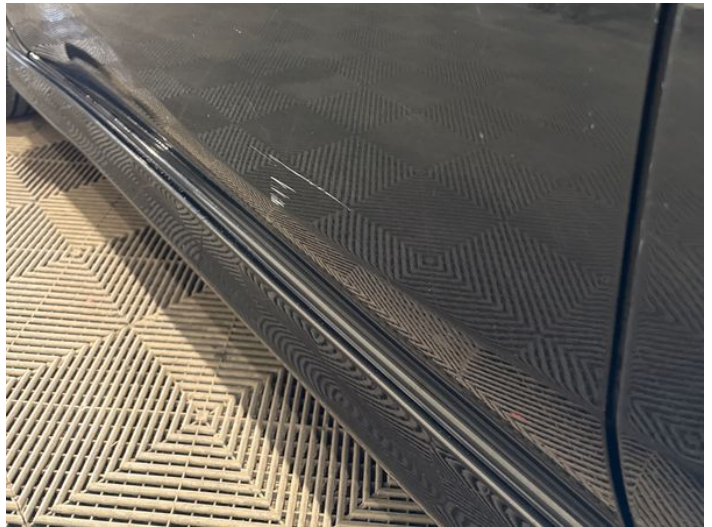
6: Door nsf  
Scratched  
Over 25mm Thru Paint

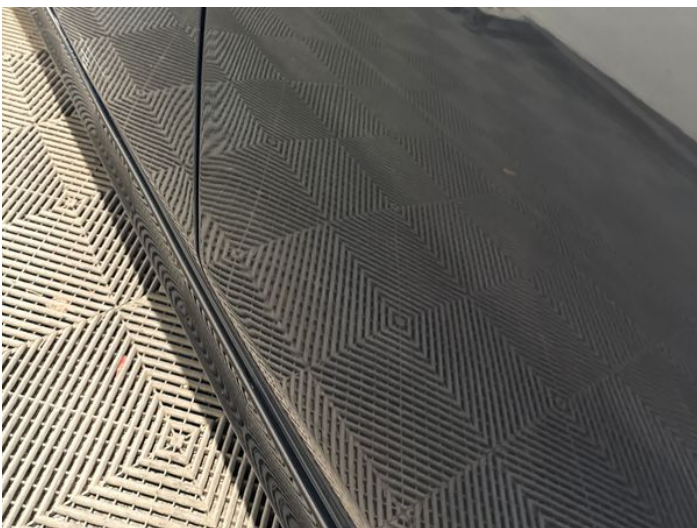
7: Door nsr  
Dented  
With Paint Damage

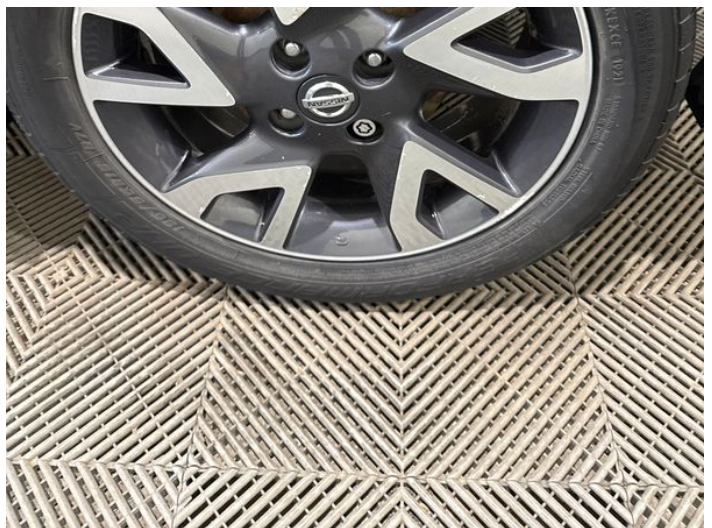
8: Wheel nsr  
Scratched  
Over 50mm

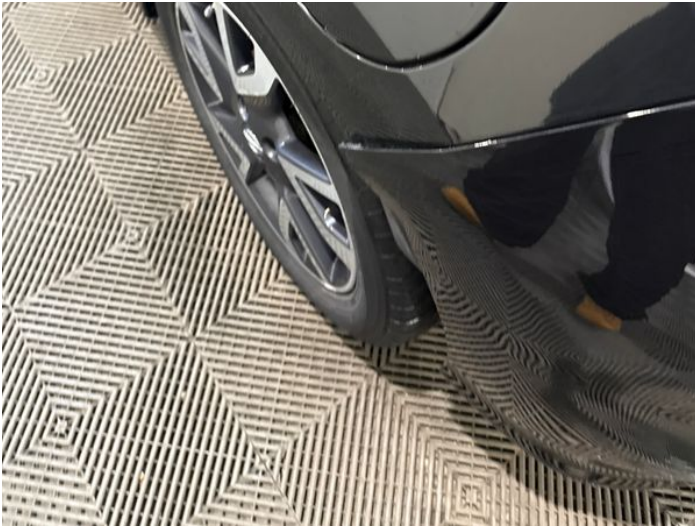
9: Qtr Panel osr  
Scratched  
Over 25mm Thru Paint

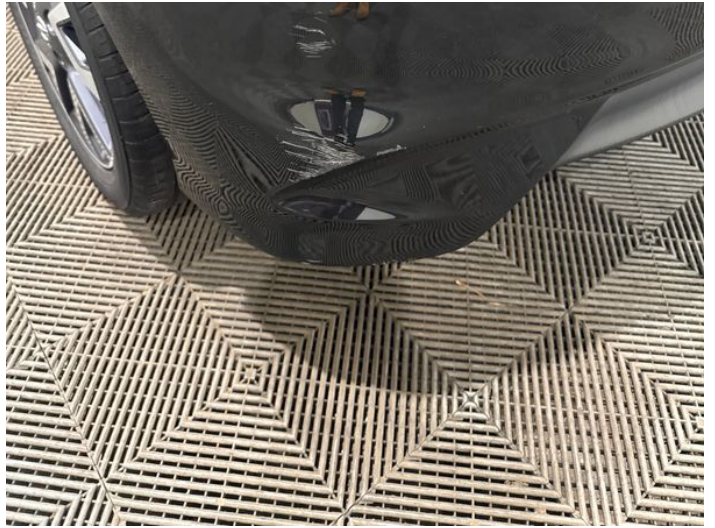
10: Bumper Rear  
Dented  
With Paint Damage

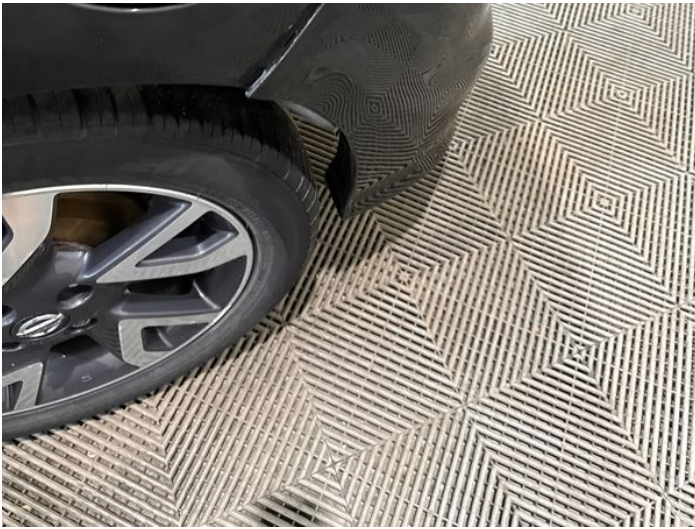
11: Bumper Rear  
Insecure  
Action Required

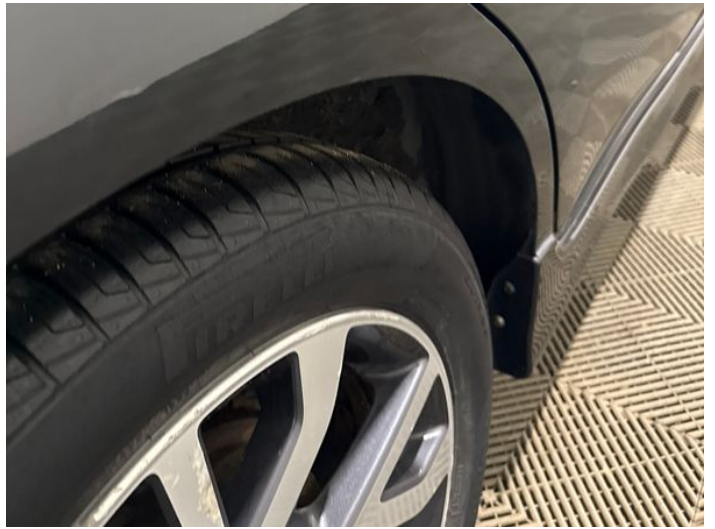
12: Qtr Panel osr  
Dented  
2 Or Less UpTo 10mm

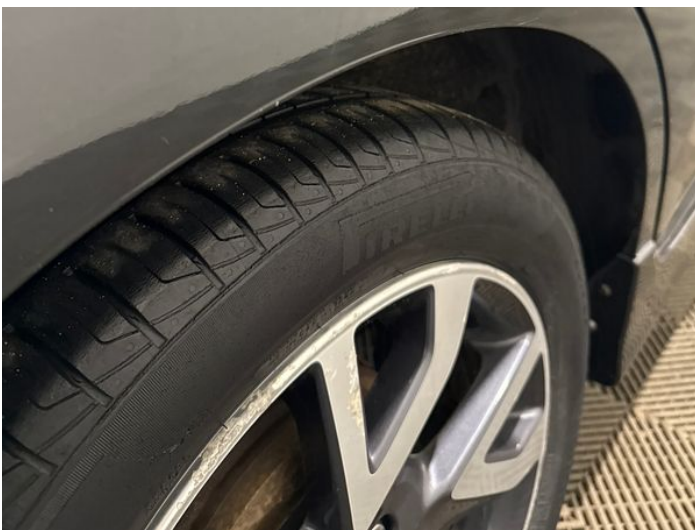
13: Qtr Panel osr  
Scratched  
UpTo 25mm Thru Paint

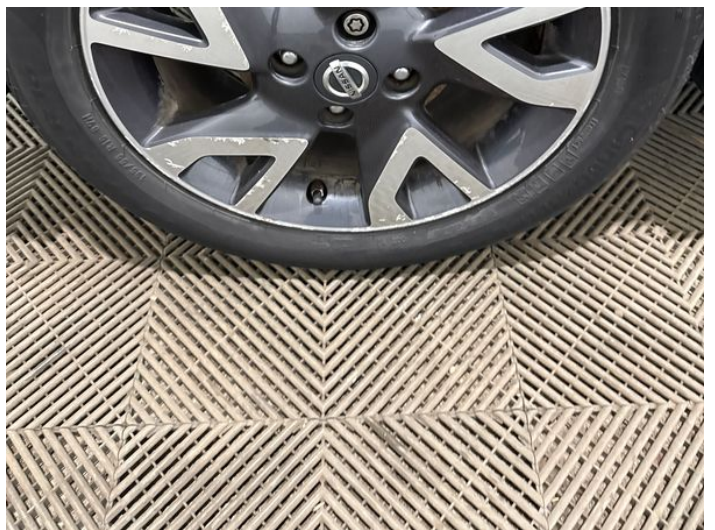
14: Wheel osr  
Scratched  
Over 50mm

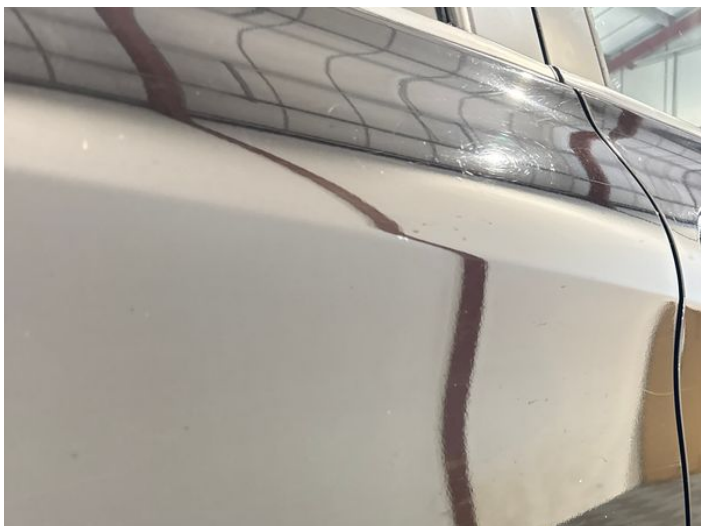
15: Door osr  
Scratched  
Over 25mm Thru Paint

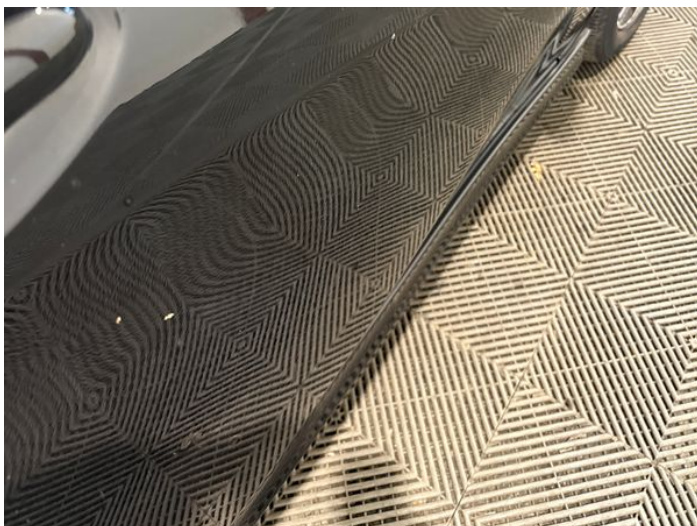
16: Door osf  
Dented  
With Paint Damage

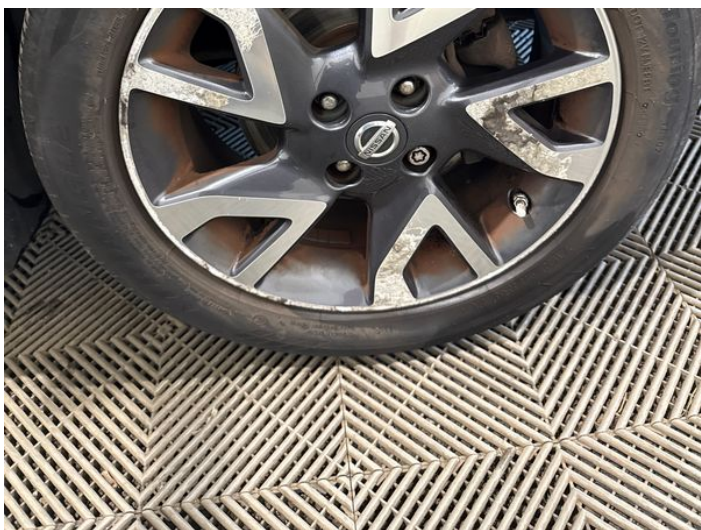
17: Wheel osf  
Scratched  
Over 50mm

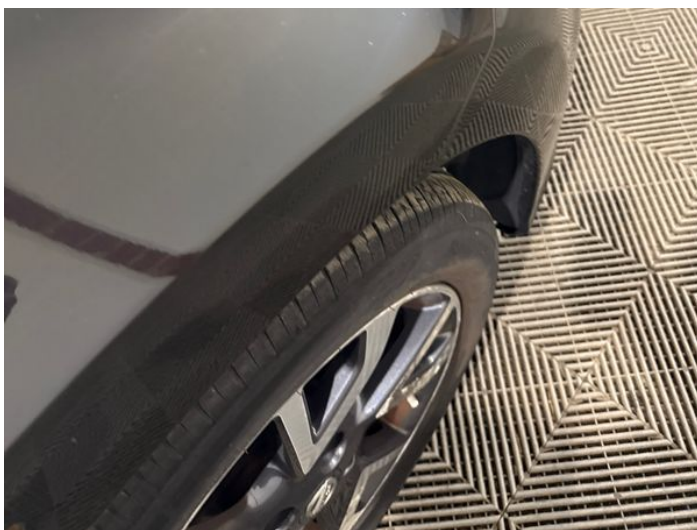
18: Wing osf  
Chipped  
1 To 5

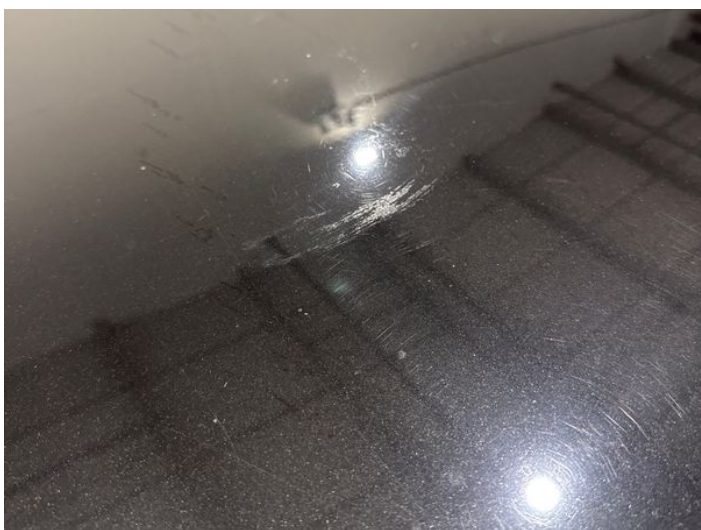
19: Roof  
Scratched  
Over 25mm Thru Paint

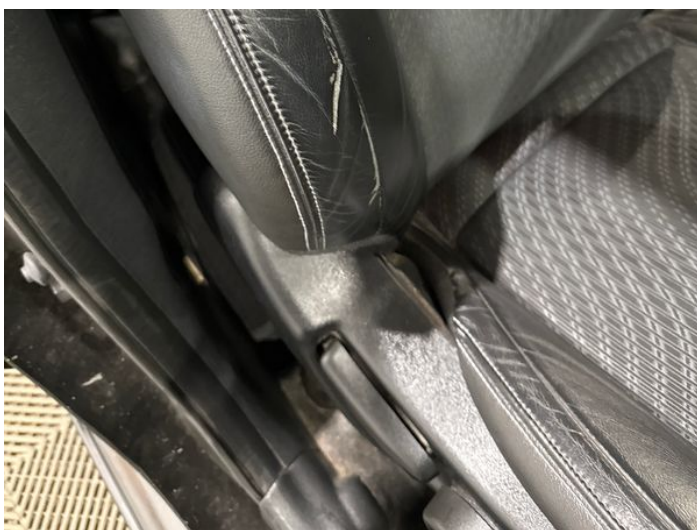
20: Seat Back Cover osf  
Scuffed  
Over 25mm
