# VEHICLE INSPECTION REPORT

**GU14XEN**

## Kia Venga 1.4 EcoDynamics 1 5dr

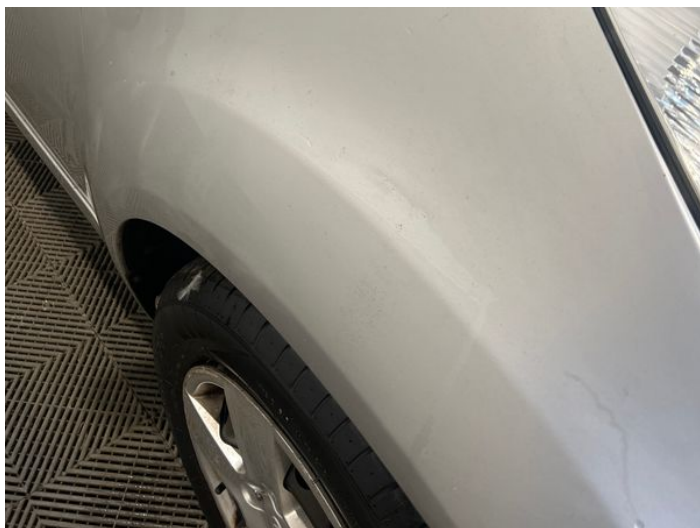
1: Wing osf  
Poor Previous Repair  
Poor Paint

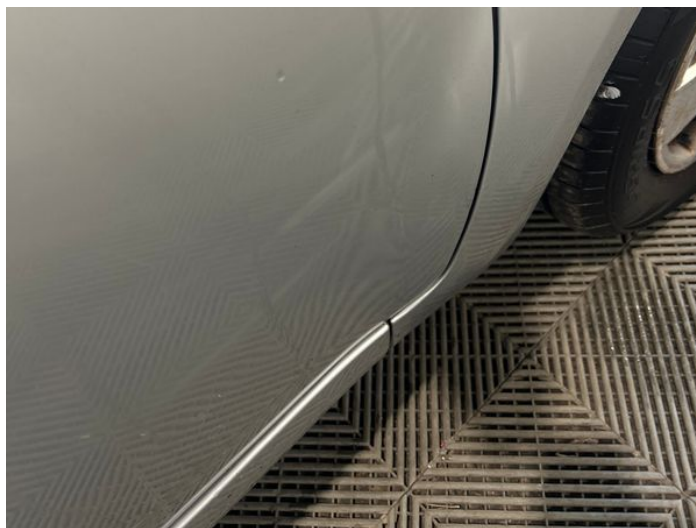
2: Door osf  
Poor Previous Repair  
Poor Paint

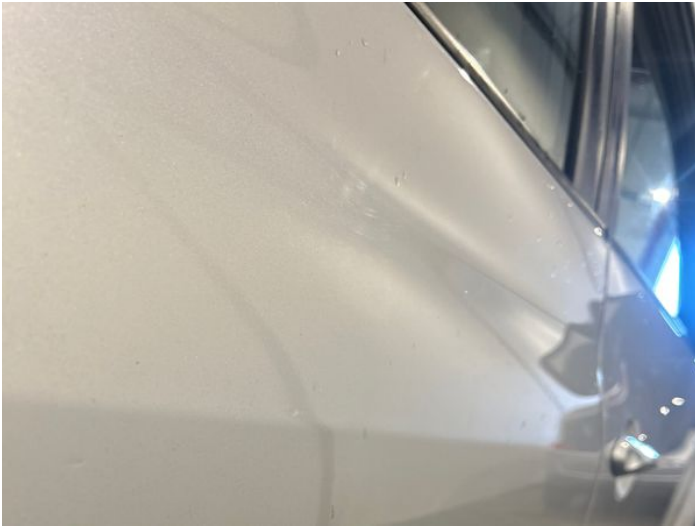
3: Door osr  
Dented  
Over 30mm

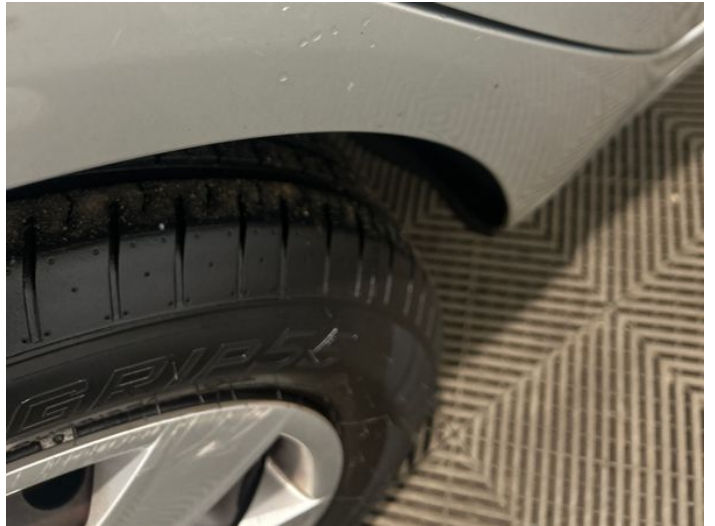
4: Qtr Panel osr  
Chipped  
1 To 5

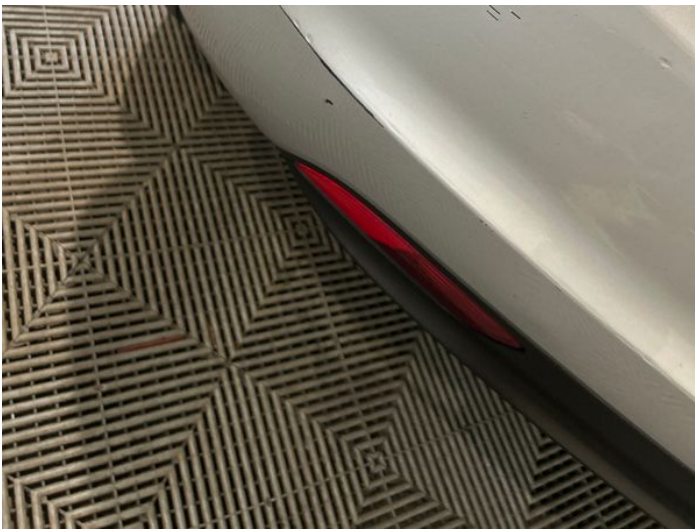
5: Bumper Rear  
Scratched  
Over 100mm Thru Paint

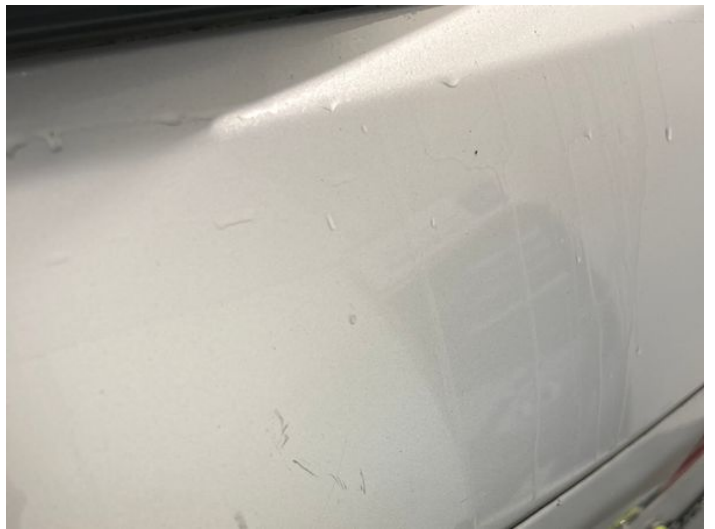
6: Tailgate  
Scratched  
UpTo 25mm Thru Paint

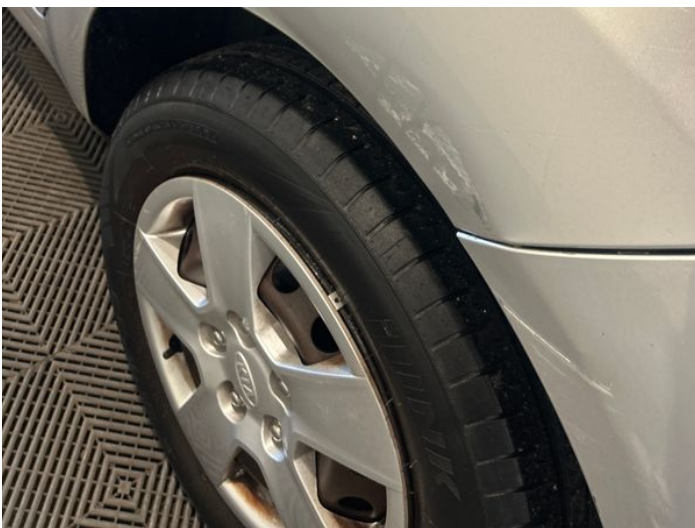
7: Qtr Panel nsr  
Dented  
With Paint Damage

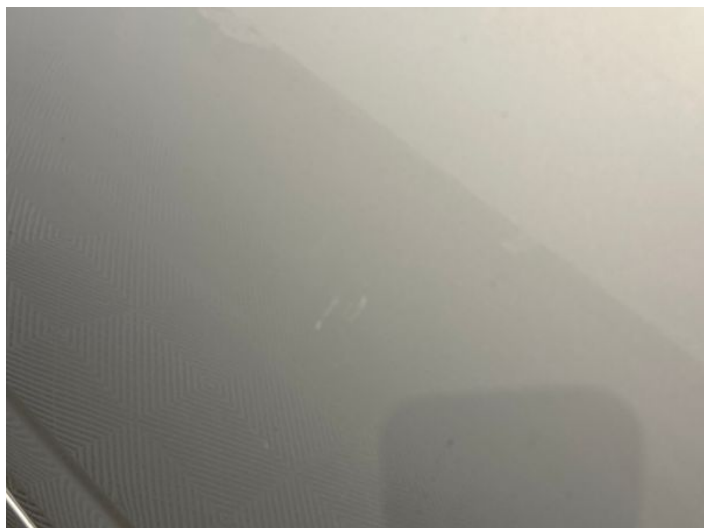
8: Door nsr  
Scratched  
UpTo 25mm Thru Paint

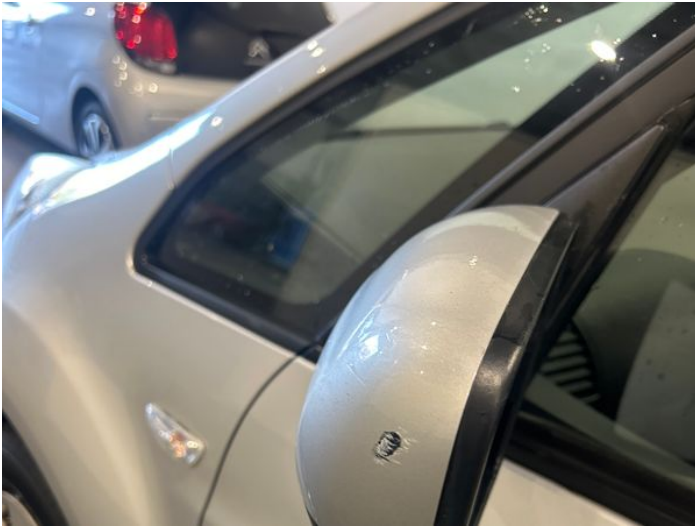
9: Door Mirror Assy nsf  
Scratched (Painted)  
UpTo 25mm Thru Paint

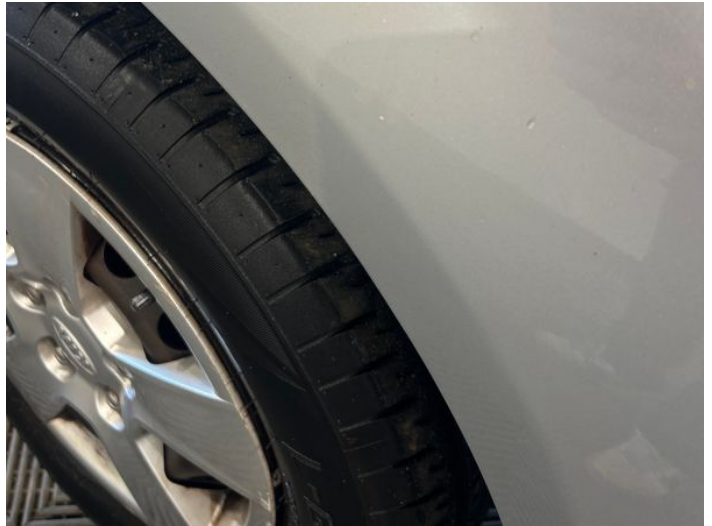
10: Wing nsf  
Chipped  
1 To 5

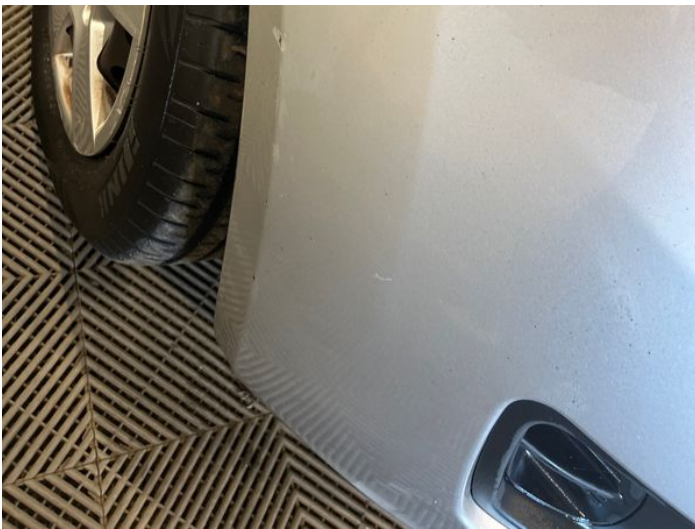
11: Bumper Front  
Scratched  
Over 100mm Thru Paint

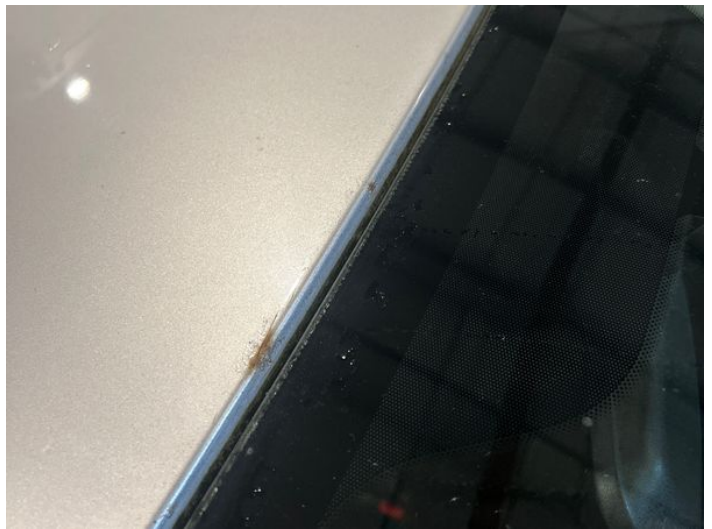
12: Roof  
Rusted  
Over 5mm
