## VEHICLE INSPECTION REPORT

**NU59MXY**

### Jaguar XF 3.0d V6 Premium Luxury 4dr Auto

**Cat: C**  
**Inspection**

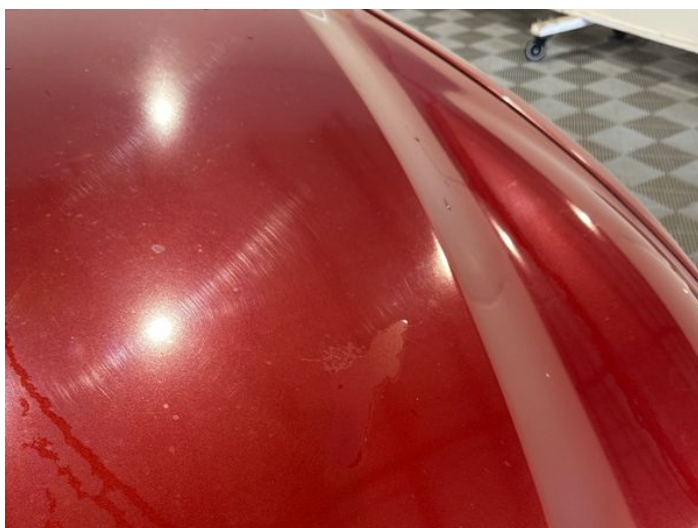
1: Bonnet  
Poor Previous Repair  
Paint Flake

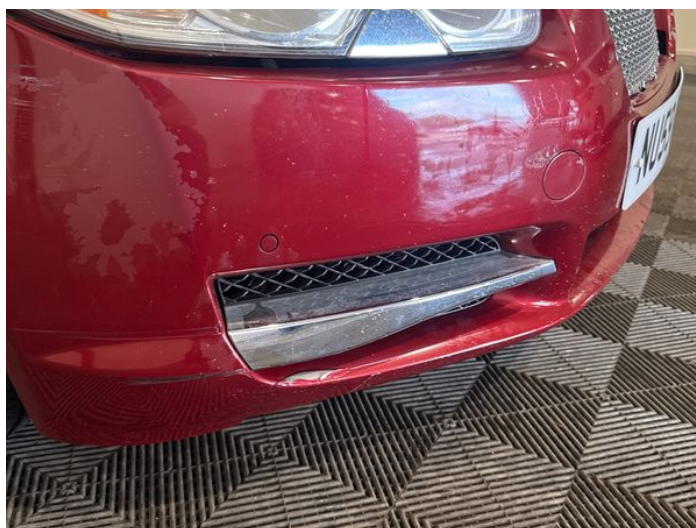
2: Bumper Front  
Dented  
With Paint Damage

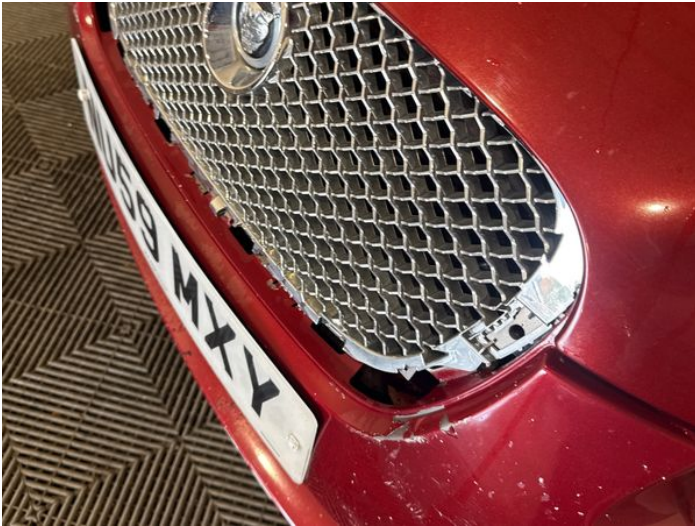
3: Bumper Front Grill  
Broken  
Replace

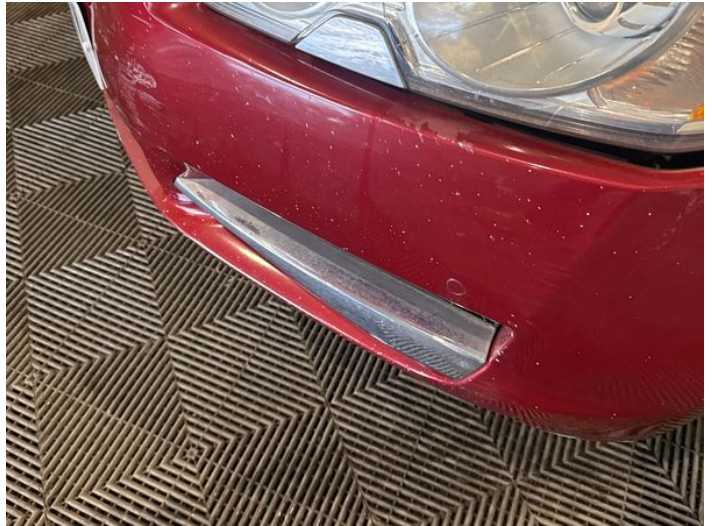
4: Bumper Front  
Poor Previous Repair  
Paint Flake

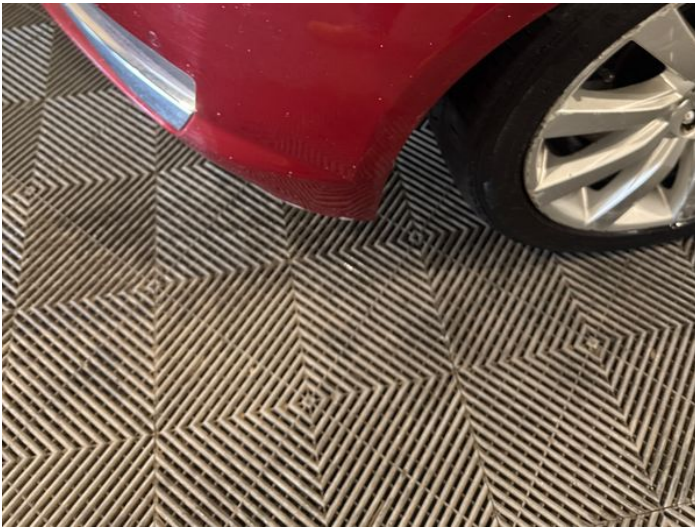
5: Bumper Front  
Insecure  
Action Required

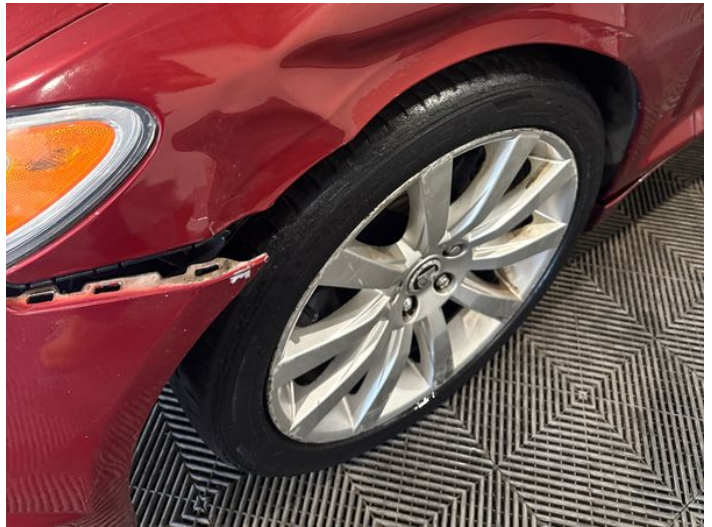
6: Wing nsf  
Dented  
Over 30% Of Panel

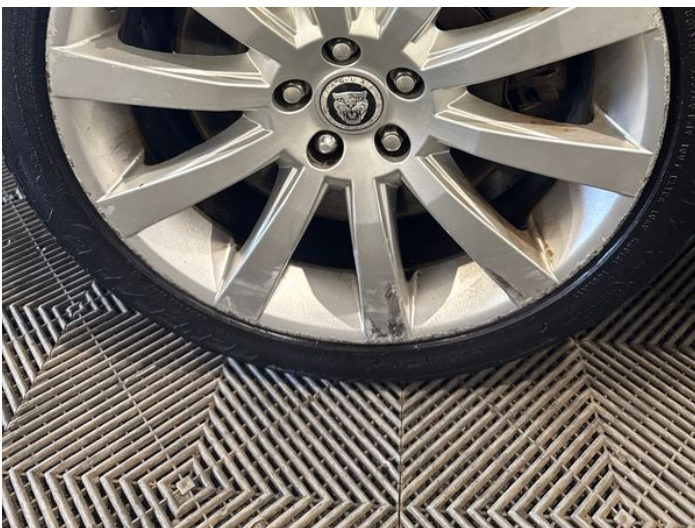
7: Wheel nsf  
Scratched  
Over 50mm

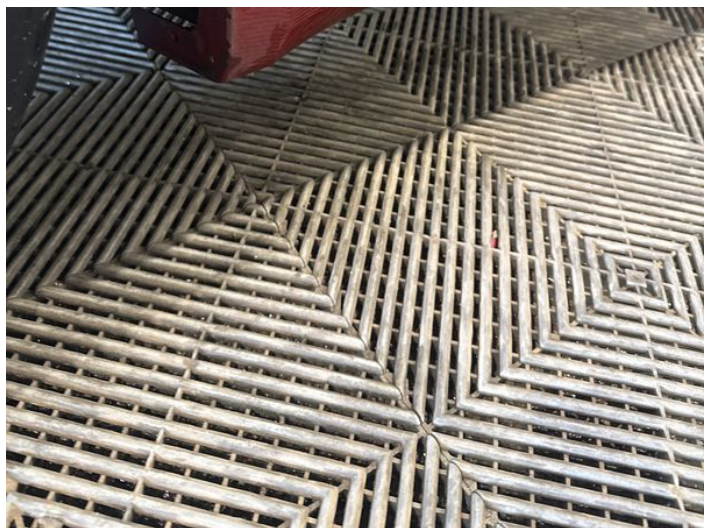
8: Sill Panel Trim ns  
Broken  
Replace

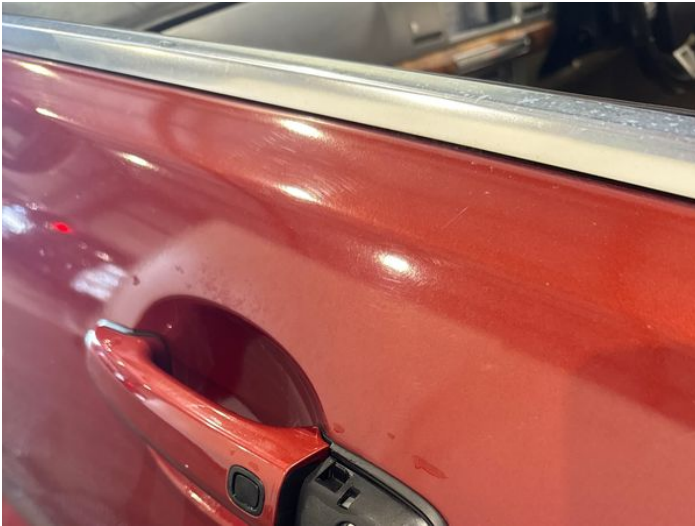
9: Handle Outer nsf  
Broken  
Replace

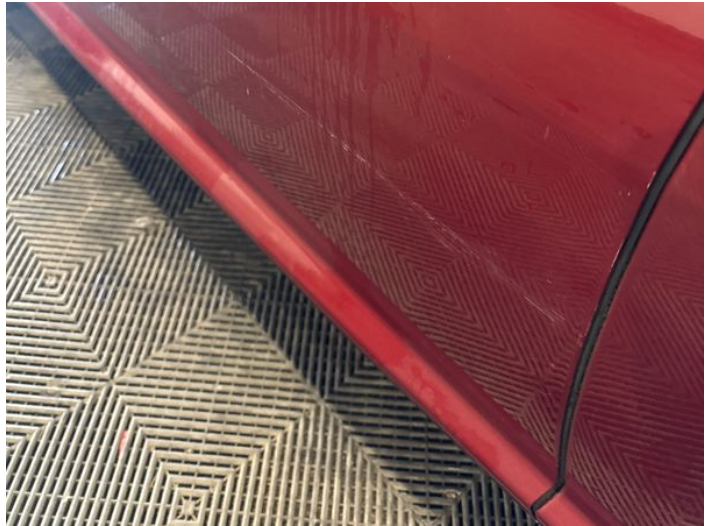
10: Door nsf  
Dented  
With Paint Damage

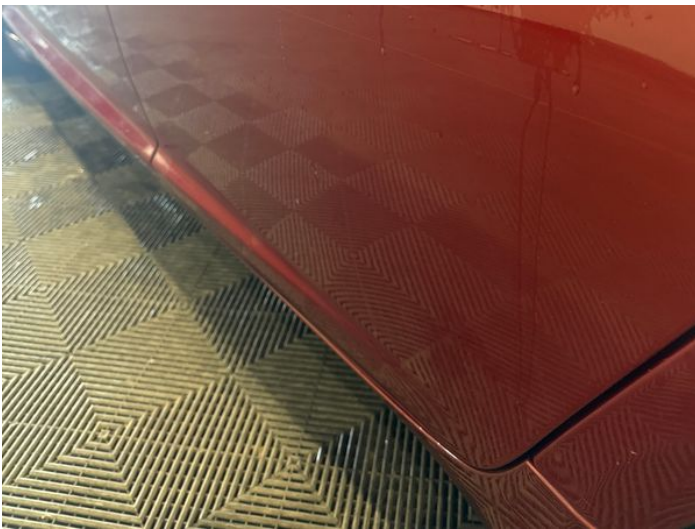
11: Door nsr  
Dented  
With Paint Damage

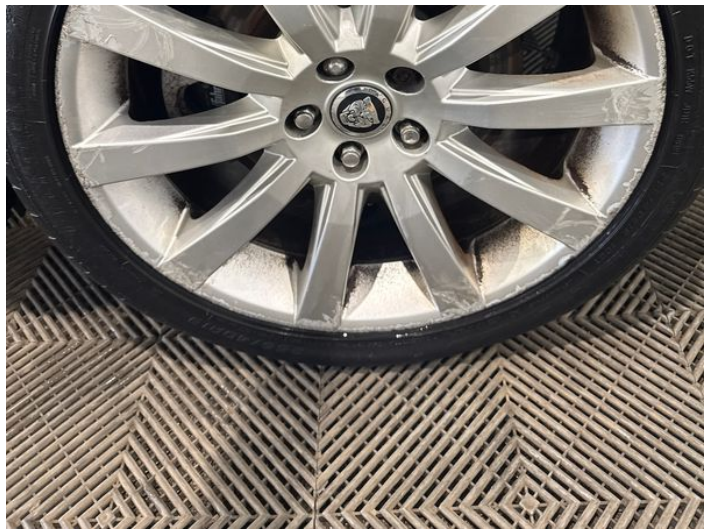
12: Wheel nsr  
Scratched  
Over 50mm

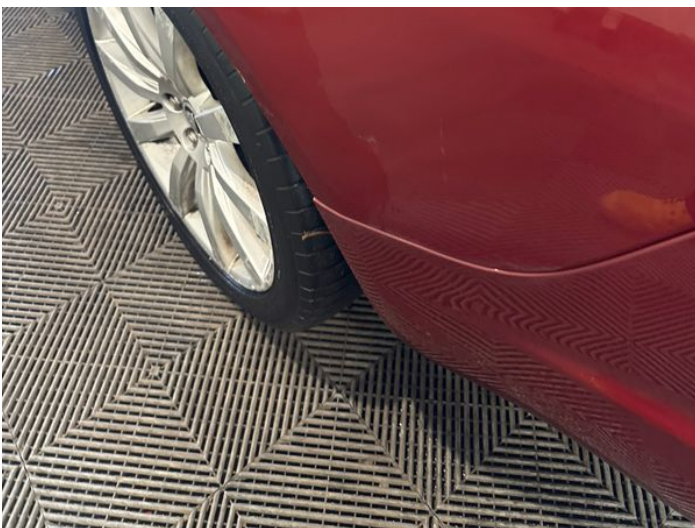
13: Qtr Panel nsr  
Dented  
With Paint Damage

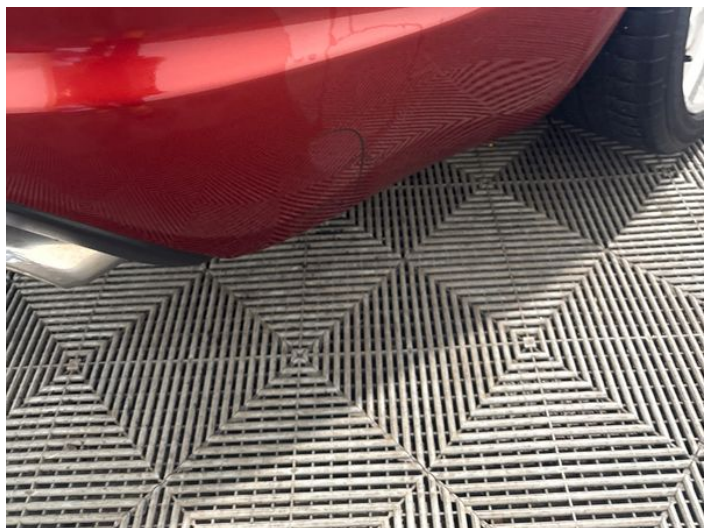
14: Bumper Rear  
Scratched  
25 to 100mm Thru Paint

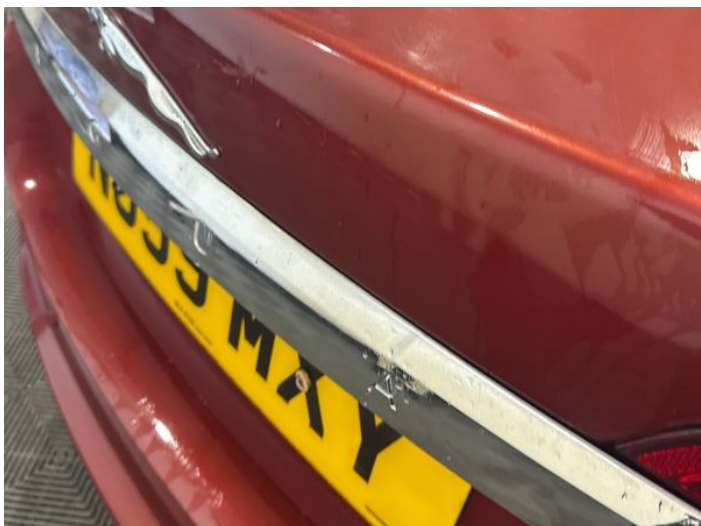
15: Boot Lid  
Scratched  
Over 25mm Thru Paint

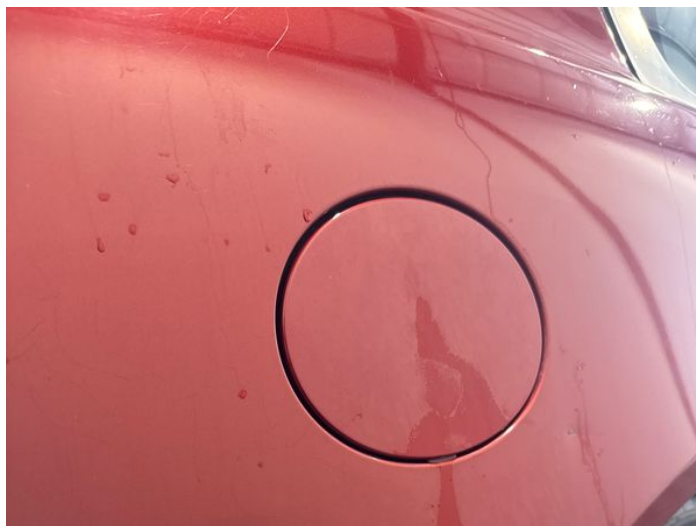
16: Qtr Panel osr  
Dented  
With Paint Damage

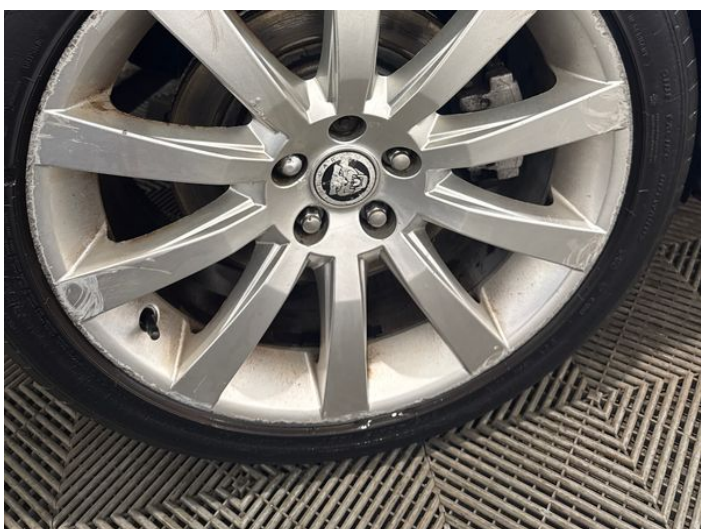
17: Wheel osr  
Scratched  
Over 50mm

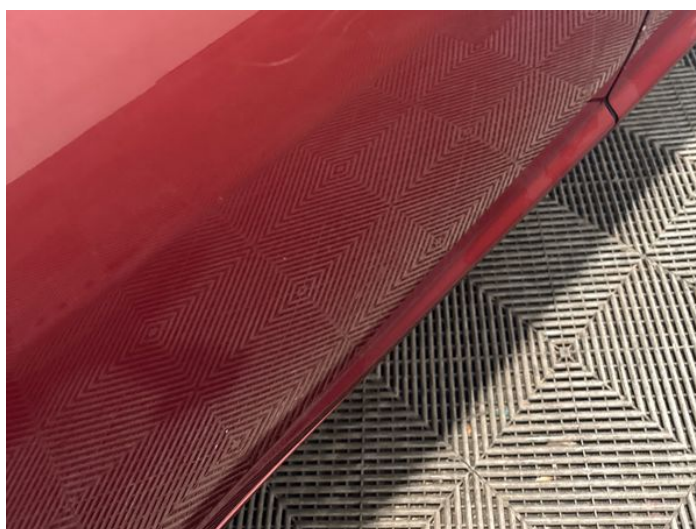
18: Door osr  
Scratched  
Over 25mm Thru Paint

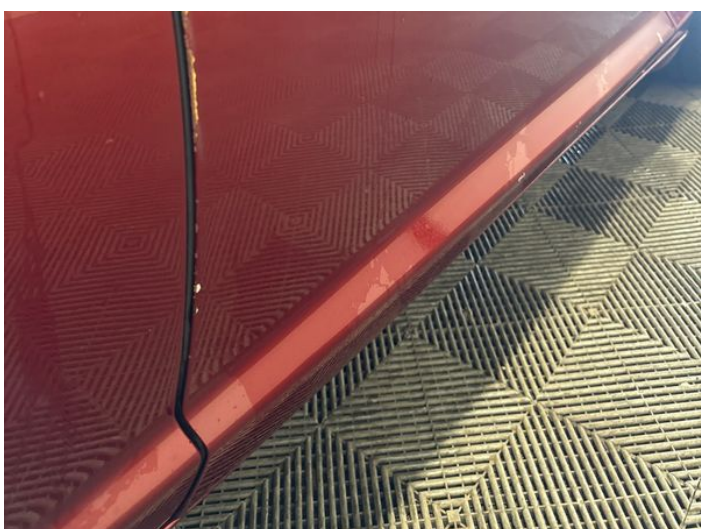
19: Door osf  
Dented  
With Paint Damage

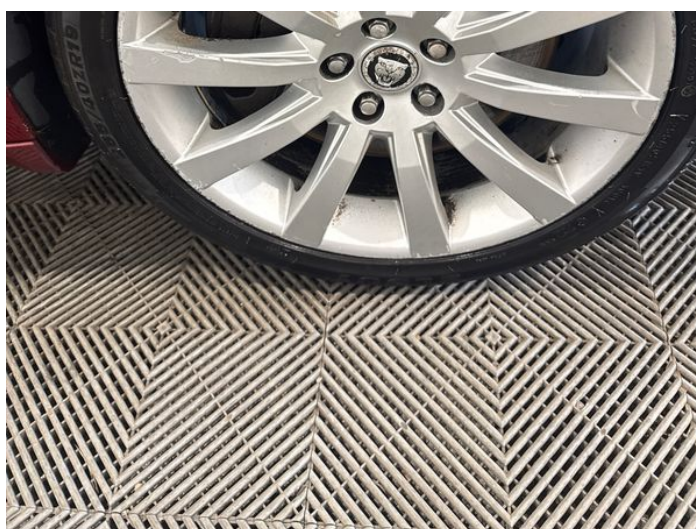
20: Wheel osf  
Scratched  
Over 50mm

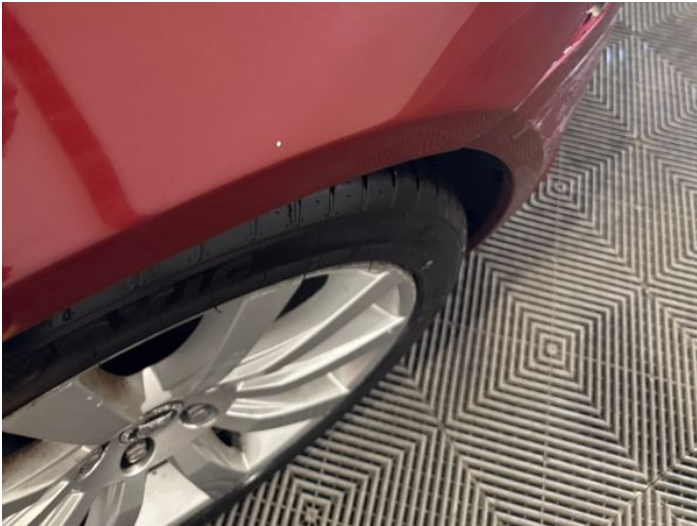
21: Wing osf  
Chipped  
1 To 5

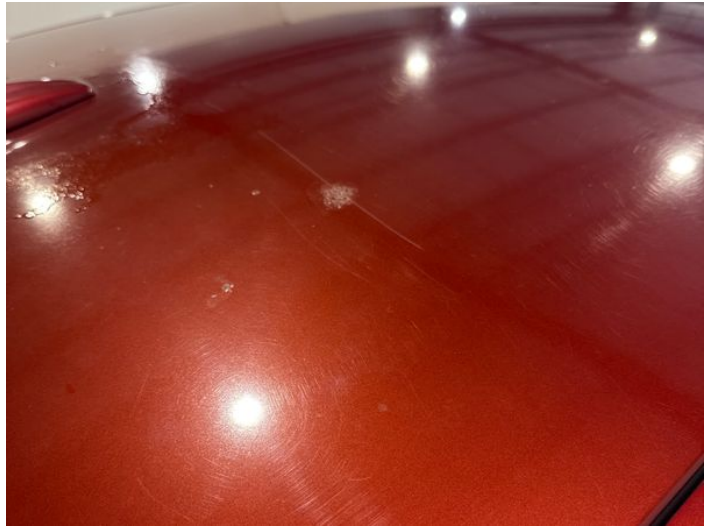
22: Roof  
Scratched  
Over 25mm Thru Paint

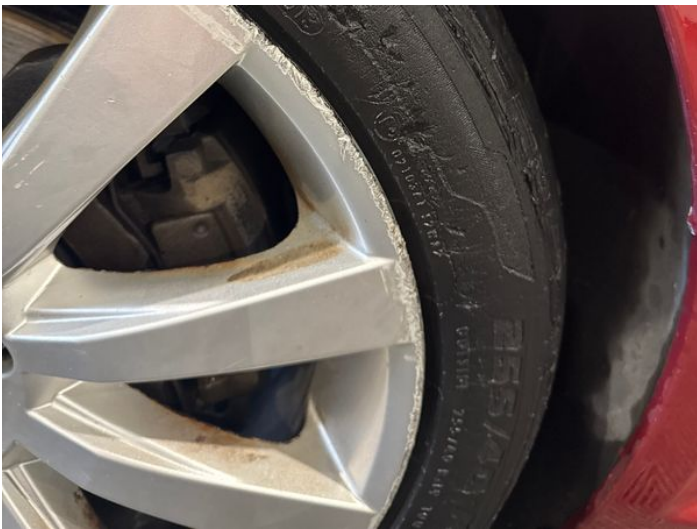
**NSF** GENERAL TIRE Damaged

23: Tyre nsf  
Damaged  
Replace

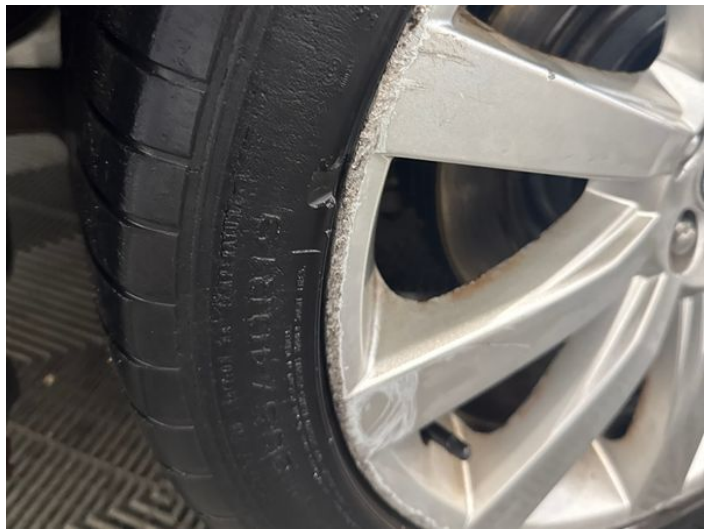
**OSR** GOODYEAR Damaged

24: Tyre osr  
Damaged  
Replace

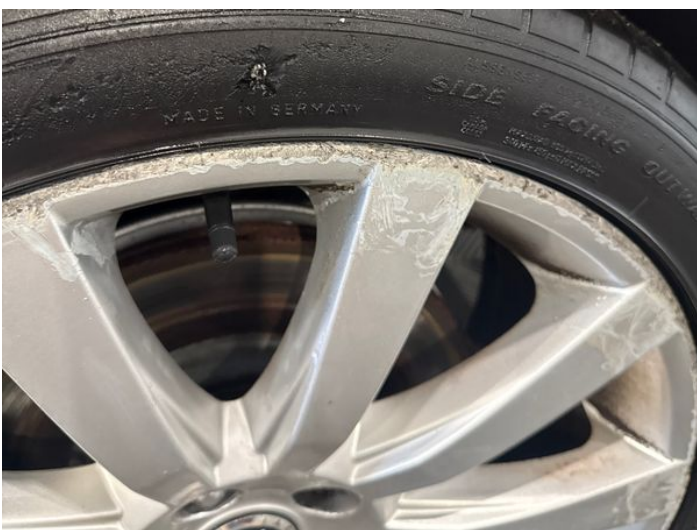
**NSR** GOODYEAR Damaged

25: Tyre nsr  
Damaged  
Replace
