# VEHICLE INSPECTION REPORT

**MM22SWY**

## Peugeot 2008 1.2 PureTech 130 GT 5dr

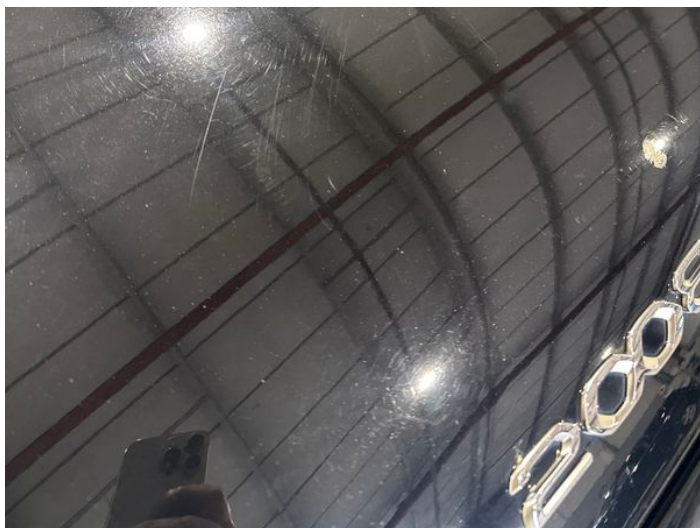
1: Bonnet  
Scratched  
Over 25mm Thru Paint

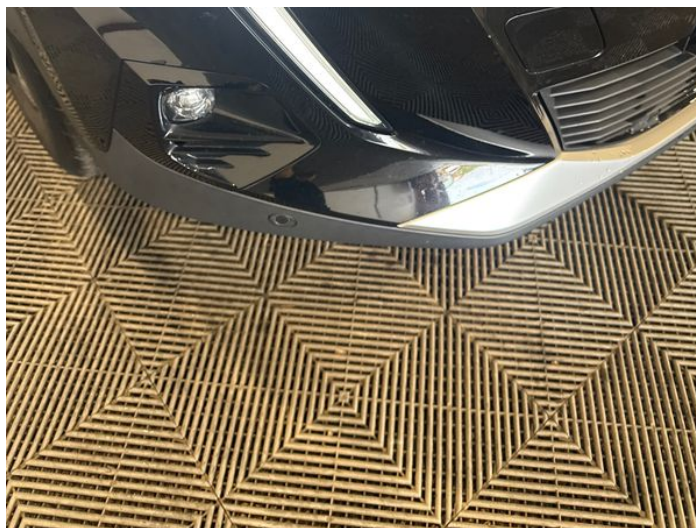
2: Bumper Front  
Chipped  
1 To 5

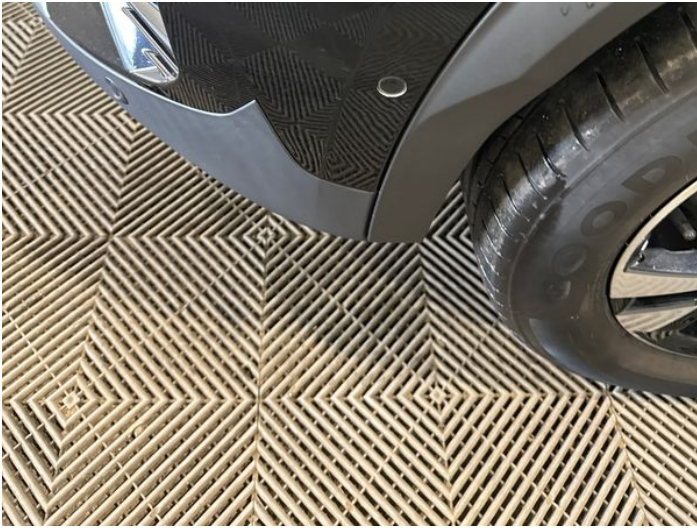
3: Bumper Front  
Scratched  
UpTo 25mm Thru Paint

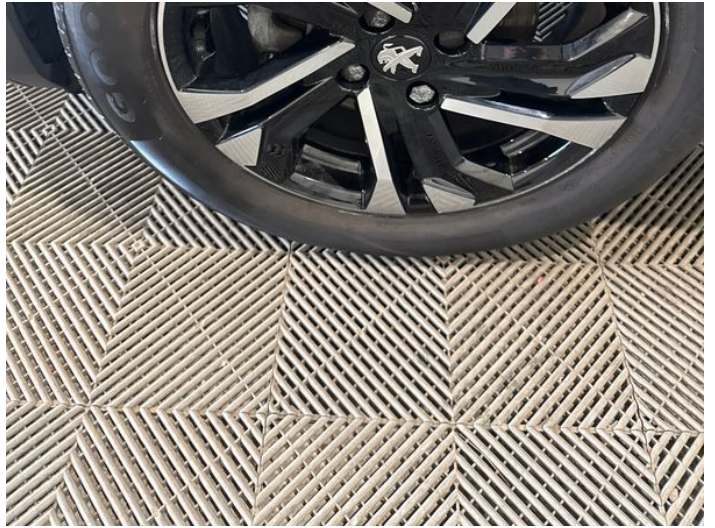
4: Wheel nsf  
Scratched  
Over 50mm

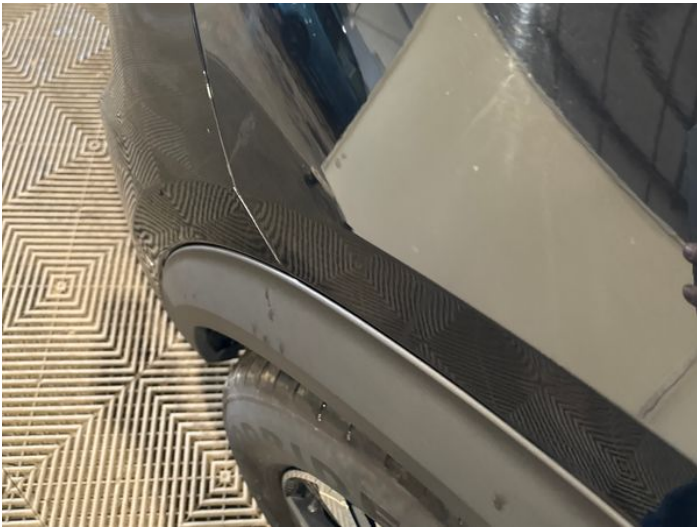
5: Wing nsf  
Chipped  
1 To 5

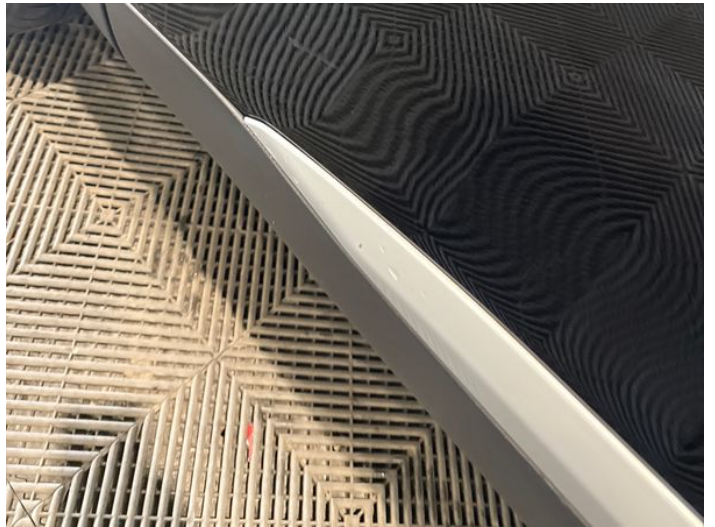
6: Door nsf  
Scratched  
Over 25mm Thru Paint

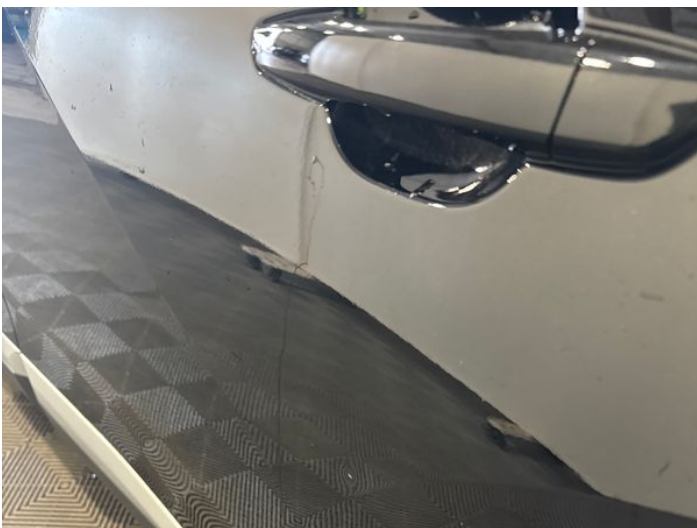
7: Door nsr  
Chipped  
1 To 5

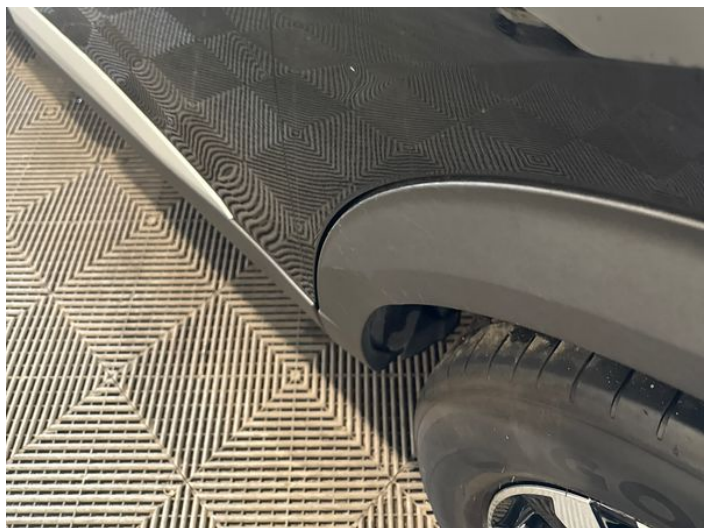
8: Door nsr  
Dented  
2 Or Less UpTo 10mm

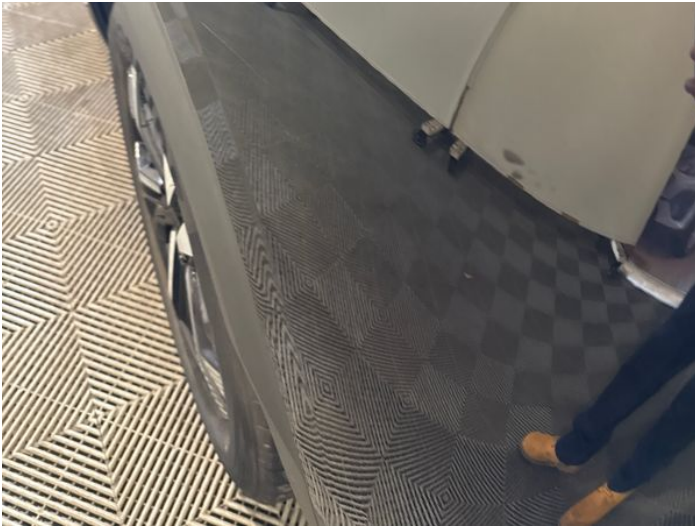
9: Bumper Rear  
Scratched  
25 to 100mm Thru Paint

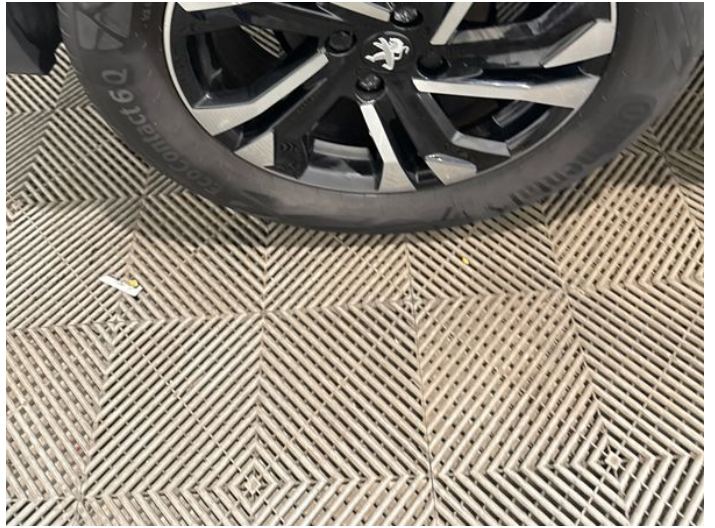
10: Wheel osr  
Scratched  
Up To 50mm

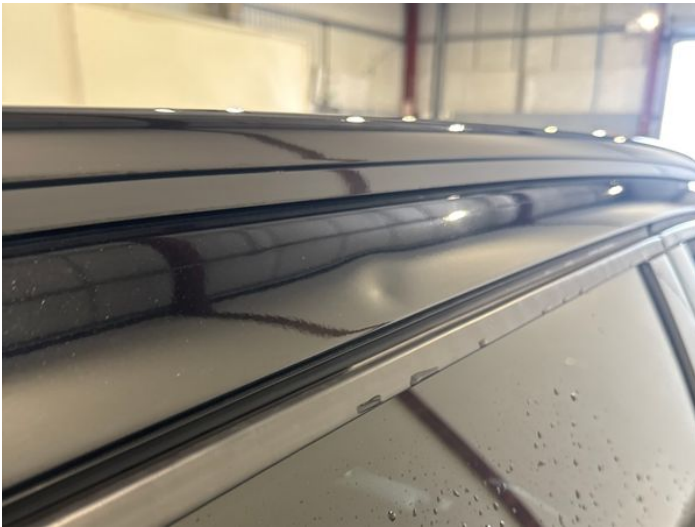
11: B Post os  
Dented  
Between 10mm + 30mm

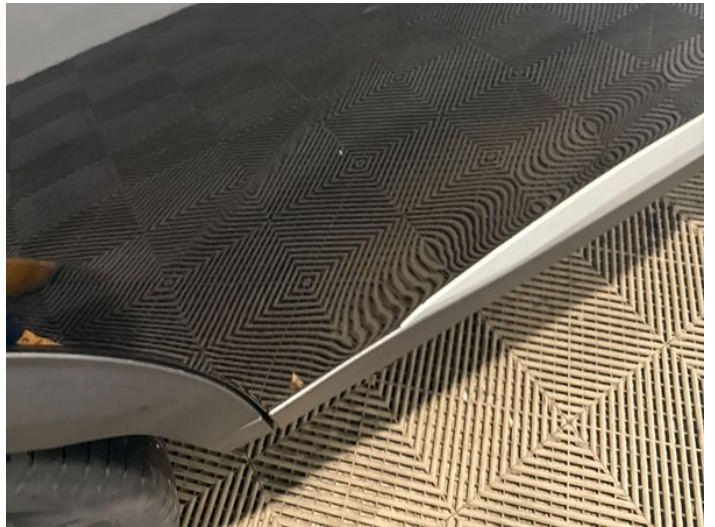
12: Door osr  
Scratched  
Up To 25mm Thru Paint

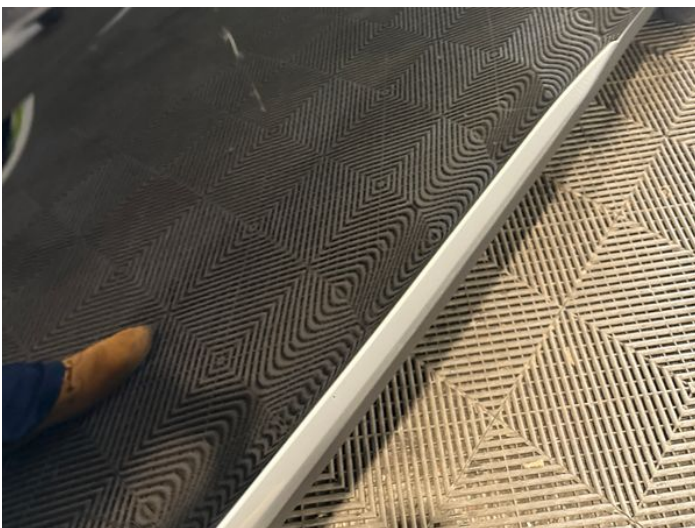
13: Door osf  
Scratched  
Over 25mm Thru Paint

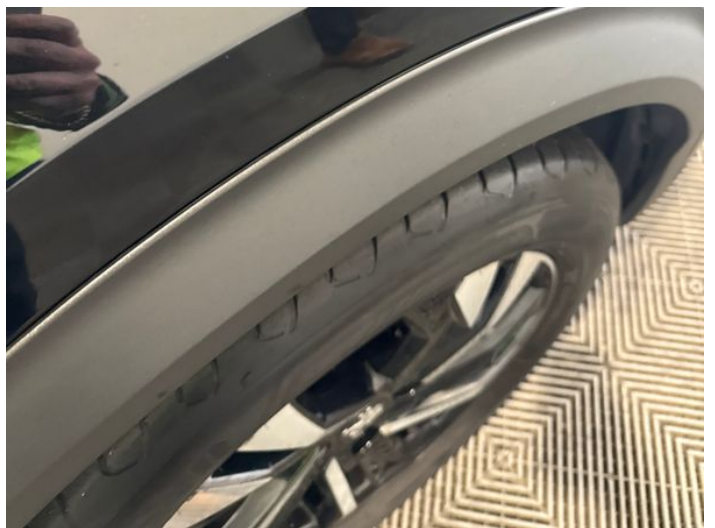
14: Wing osf  
Chipped  
1 To 5

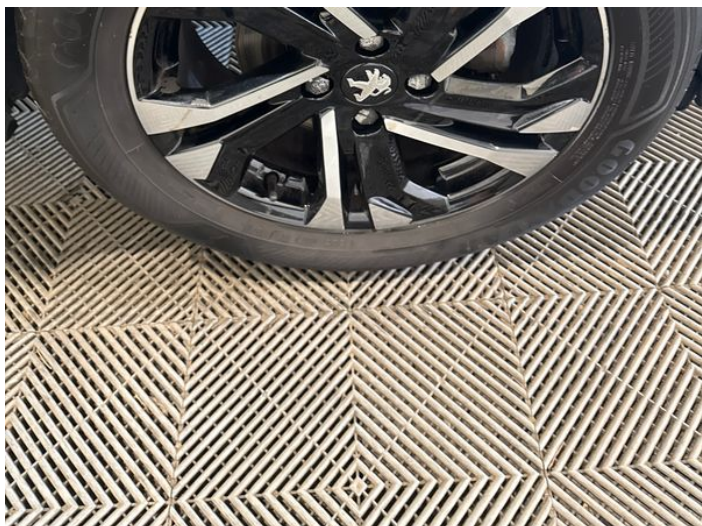
15: Wheel of  
Scratched  
Over 50mm
