# VEHICLE INSPECTION REPORT

LP62GVD

## Honda CR-V 2.0 i-VTEC EX 5dr Auto

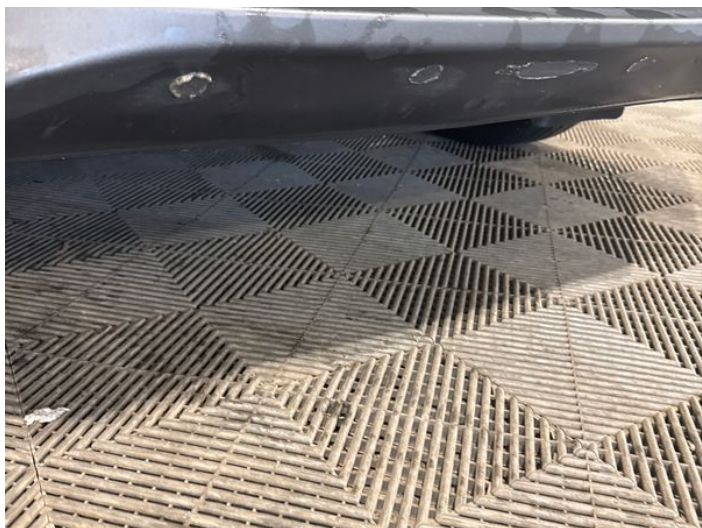
1: Bumper Front Moulding  
Broken  
Replace

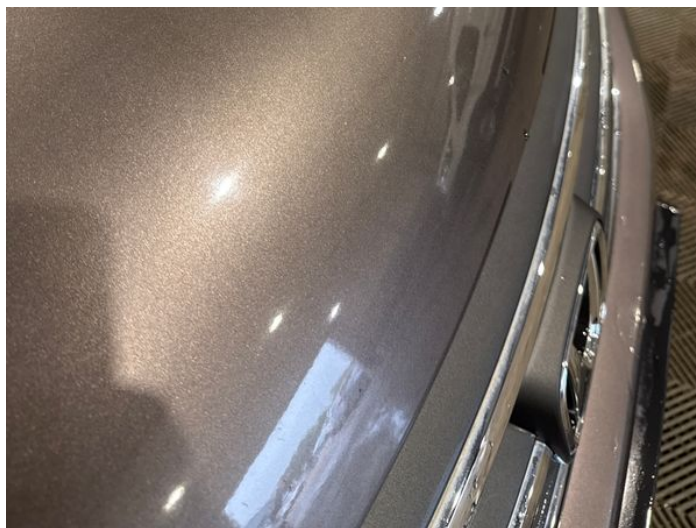
2: Bonnet  
Chipped  
1 To 5

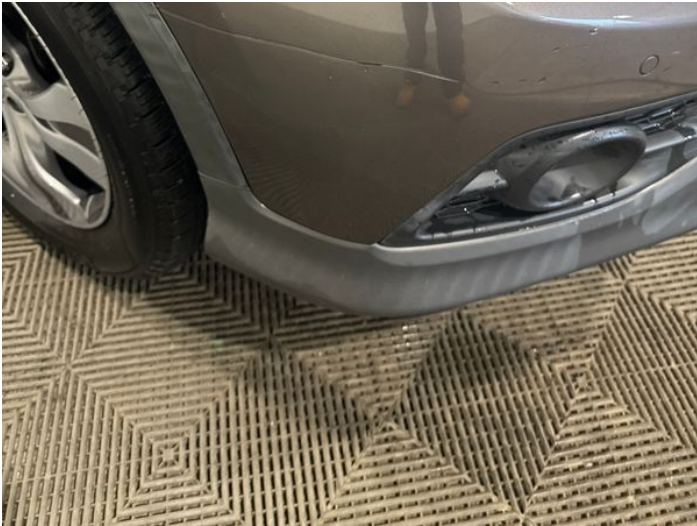
3: Bumper Front  
Scratched  
Over 100mm Thru Paint

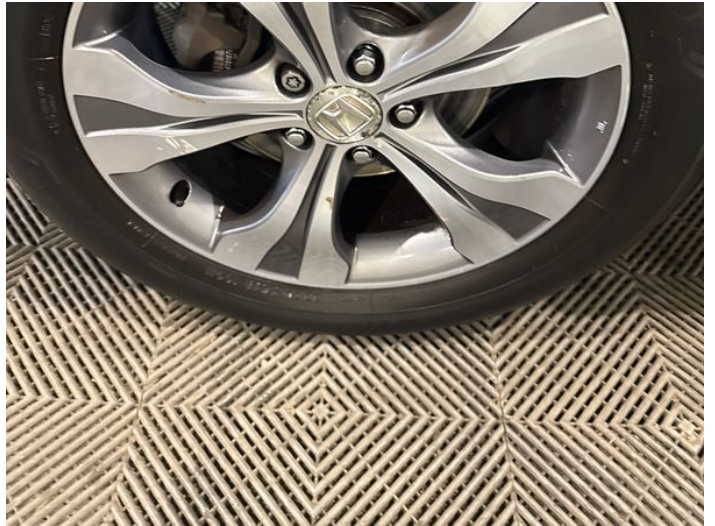
4: Wheel nsf  
Scratched  
Over 50mm

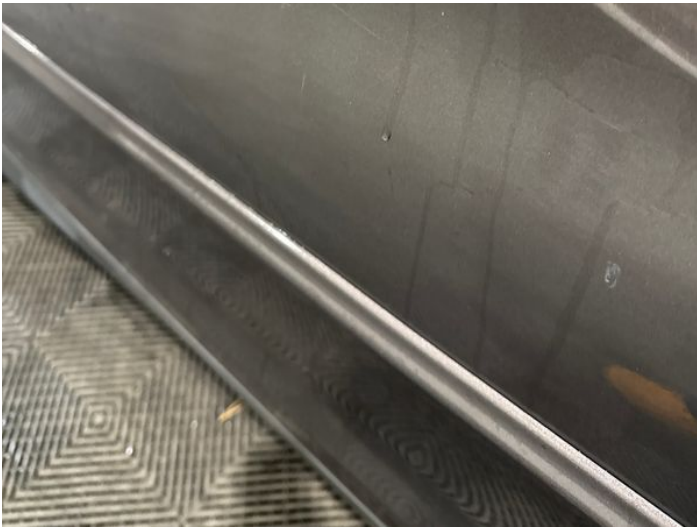
5: Door nsf  
Scratched  
Up To 25mm Thru Paint

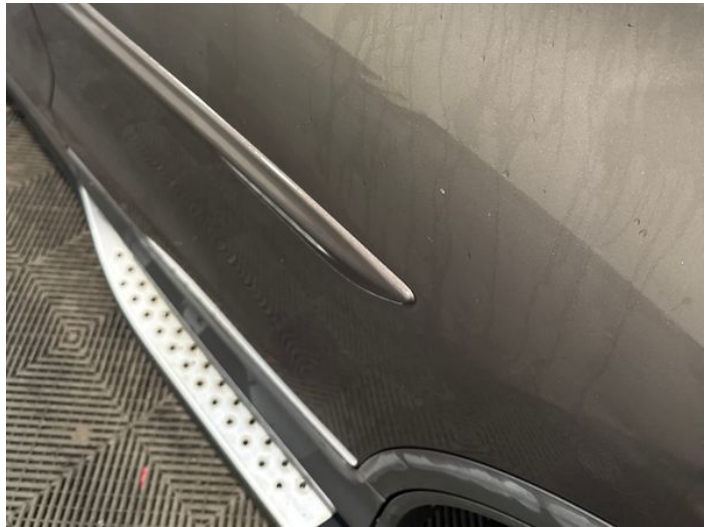
6: Door nsr  
Chipped  
1 To 5

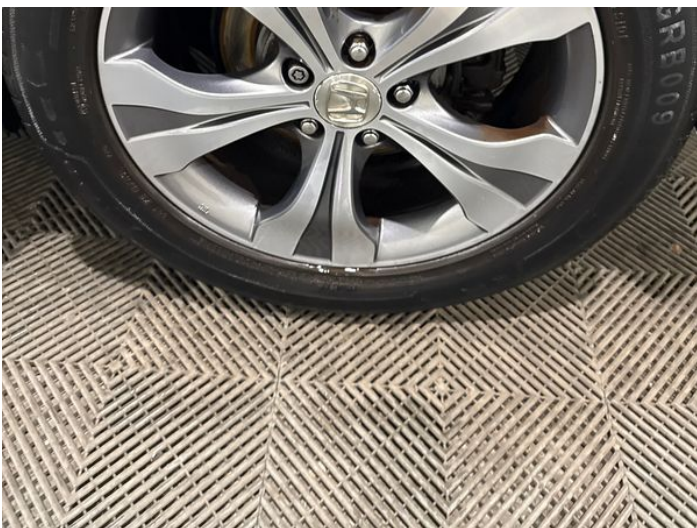
7: Wheel nsr  
Scratched  
Up To 50mm

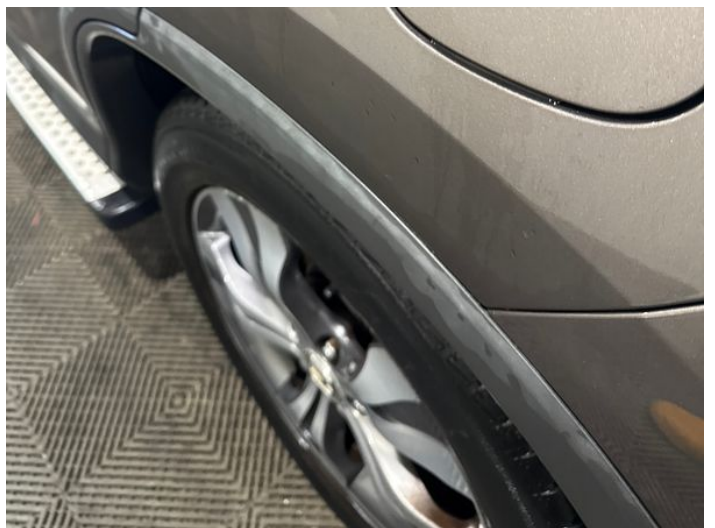
8: Qtr Panel nsr  
Dented  
Between 10mm + 30mm

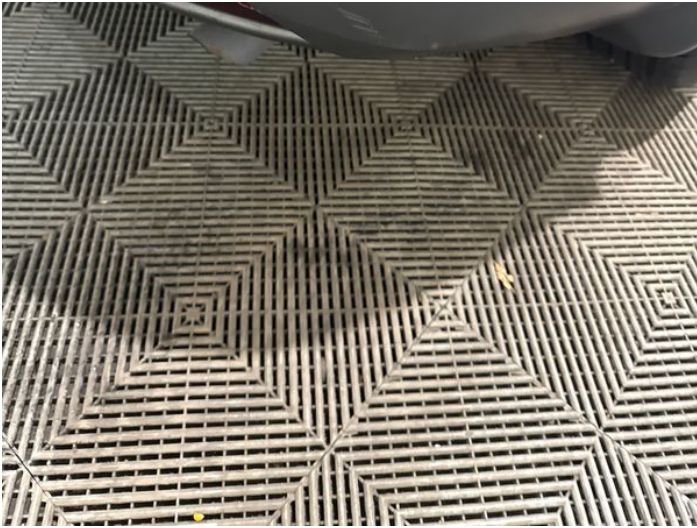
9: Bumper Rear Moulding  
Scuffed (Unpainted)  
Over 100mm

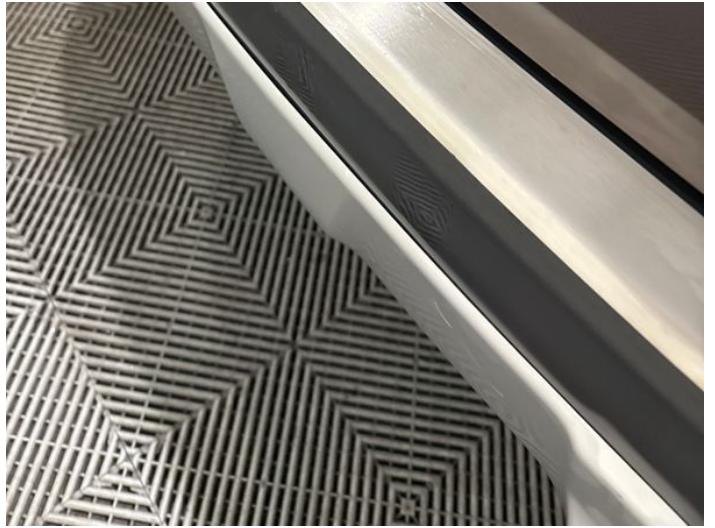
10: Bumper Rear Moulding  
Broken  
Replace

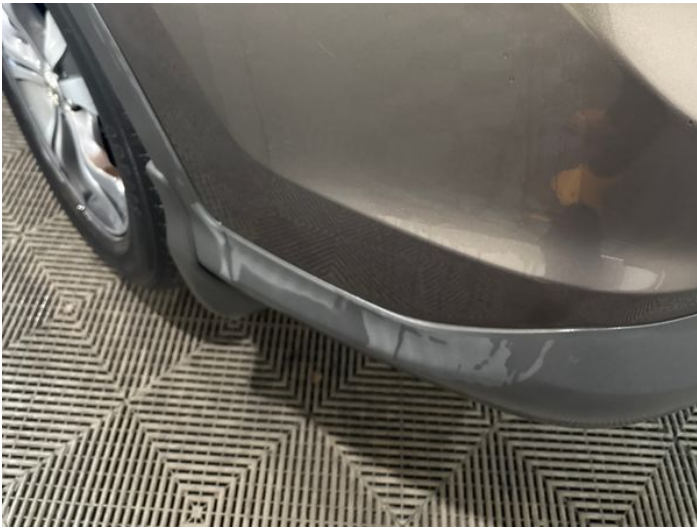
11: Bumper Rear  
Scratched  
25 to 100mm Thru Paint

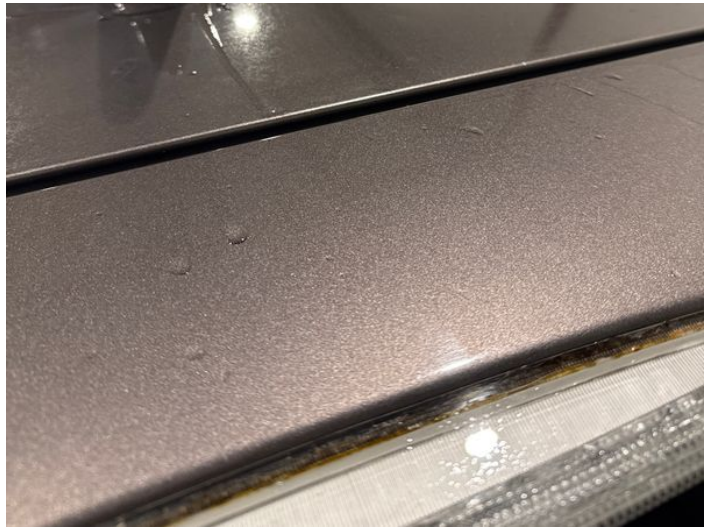
12: Roof  
Dented  
Between 10mm + 30mm

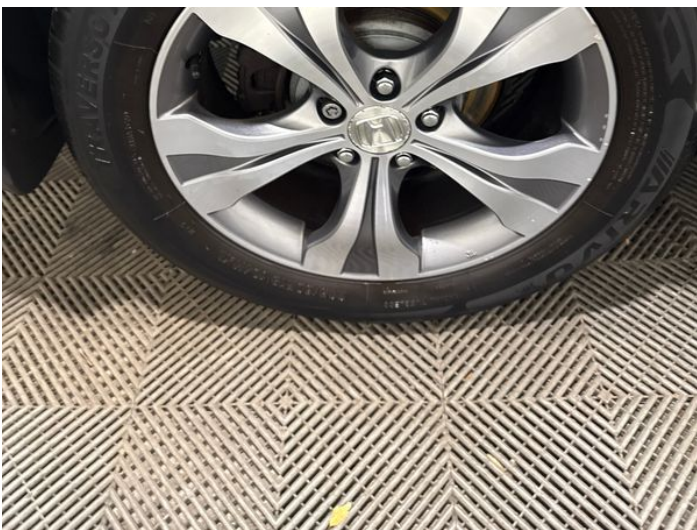
13: Wheel osf  
Scratched  
Up To 50mm

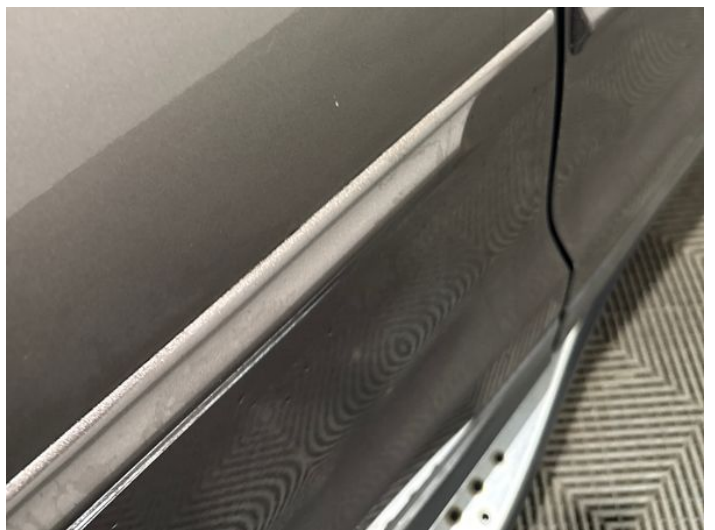
14: Door osr  
Chipped  
1 To 5

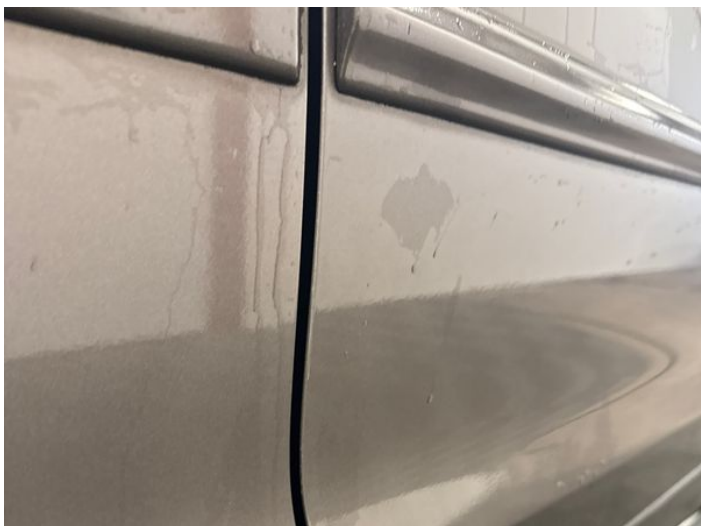
15: Door osf  
Chipped  
Edge Chip

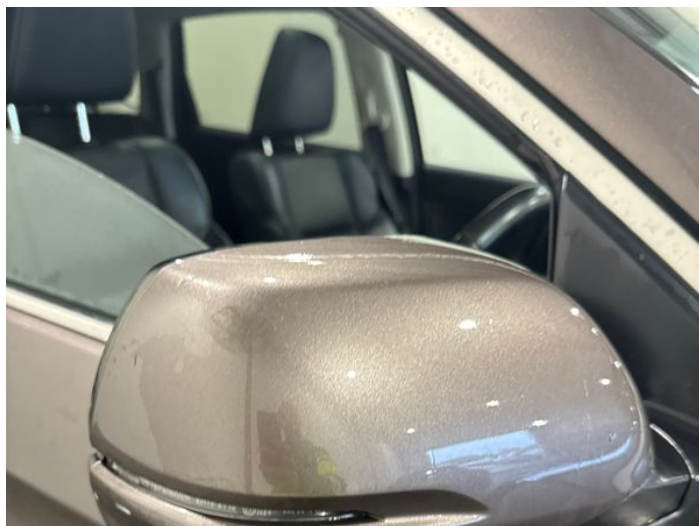
16: Door Mirror Assy osf  
Scratched (Painted)  
UpTo 25mm Thru Paint

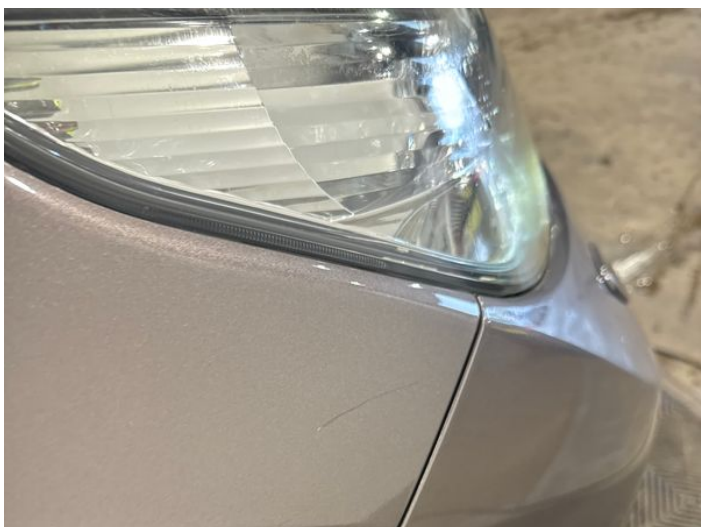
17: Wing osf  
Scratched  
Over 25mm Thru Paint

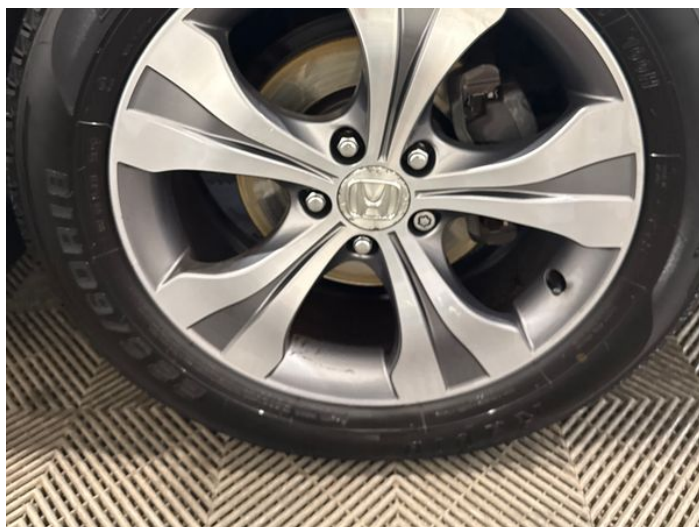
18: Wheel osf  
Scratched  
Up To 50mm

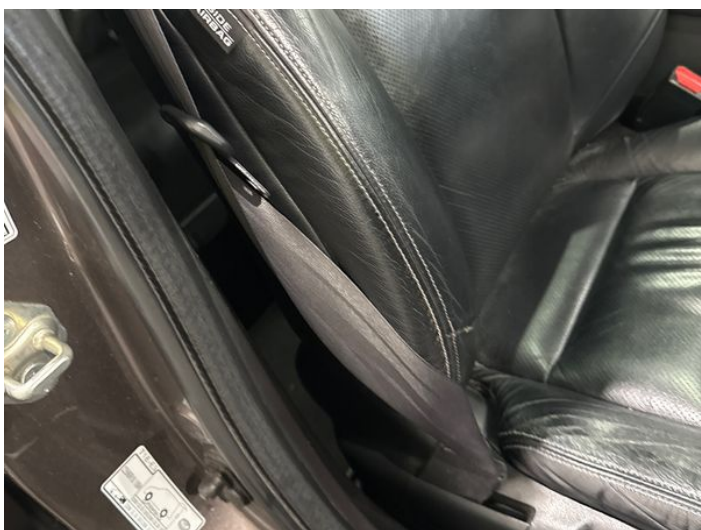
19: Seat Back Cover osf  
Scuffed  
Over 25mm
