# VEHICLE INSPECTION REPORT

**RF65MTK**

## Honda Civic 1.8 i-VTEC SR 5dr Auto

nama  
GRADE  
4

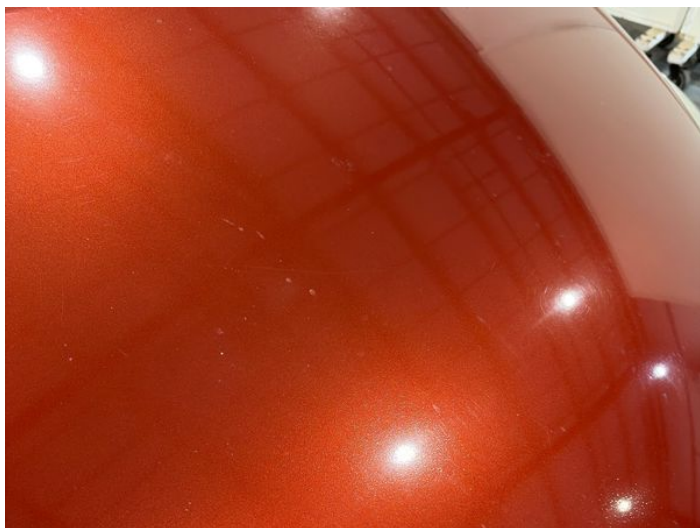
1: Bonnet  
Poor Previous Repair  
Poor Paint

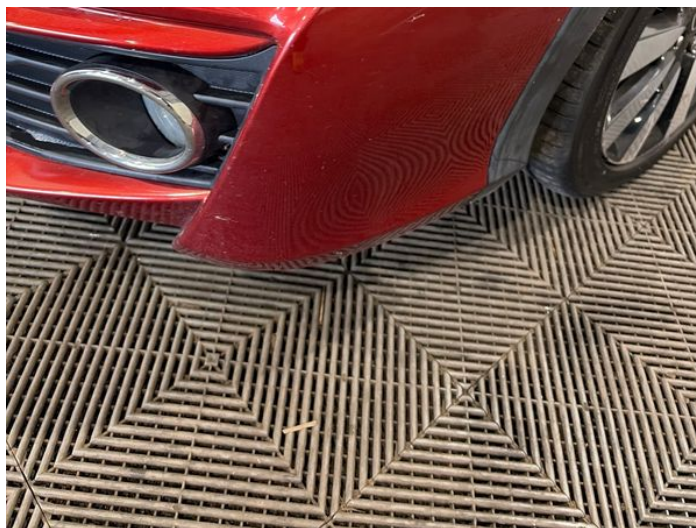
2: Bumper Front  
Scratched  
25 to 100mm Thru Paint

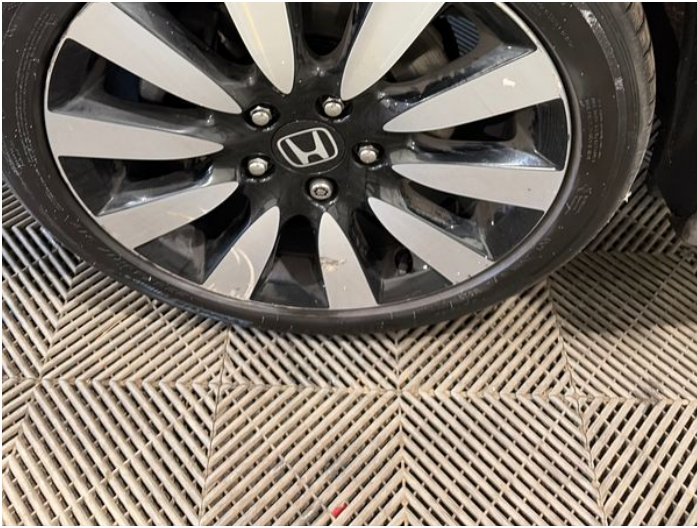
3: Wheel nsf  
Scratched  
Over 50mm

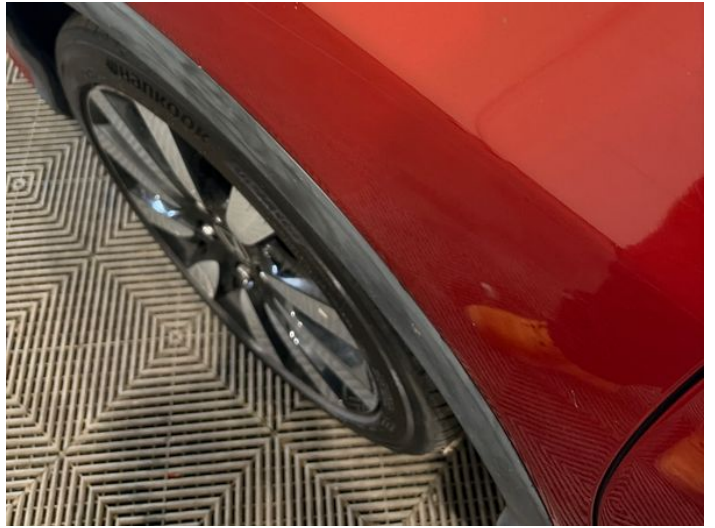
4: Wing nsf  
Chipped  
1 To 5

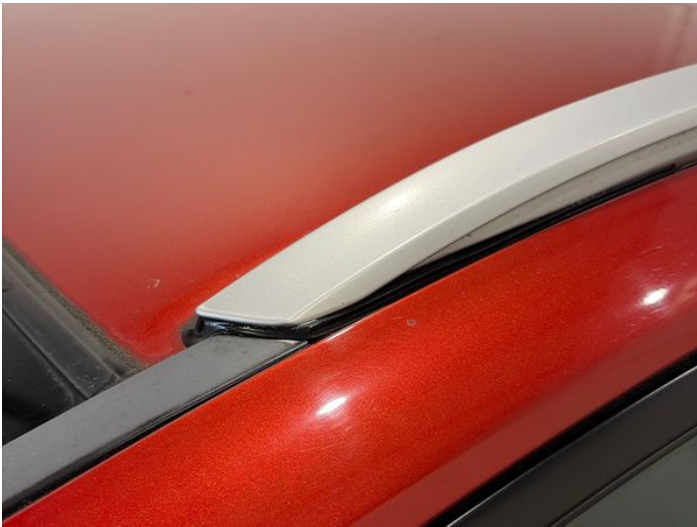
5: A Post ns  
Chipped  
1 To 5

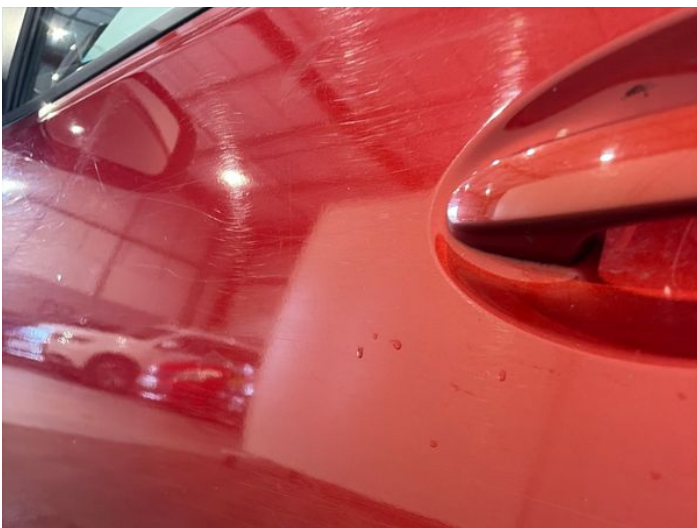
7: Door nsf  
Dented  
With Paint Damage

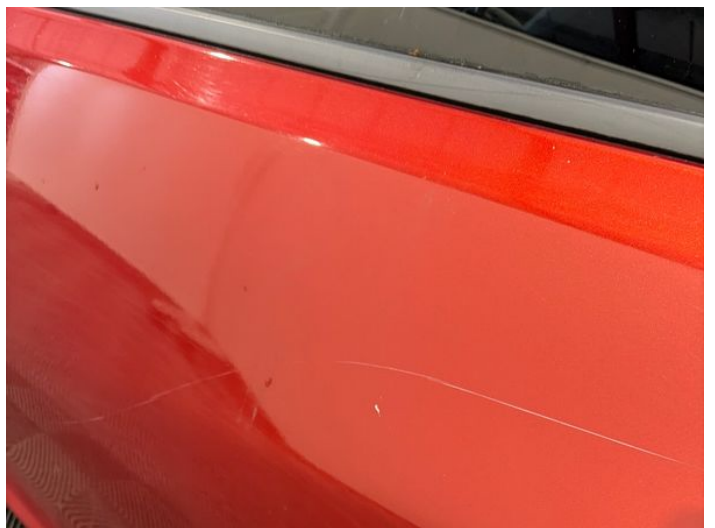
8: Door nsr  
Scratched  
Over 25mm Thru Paint

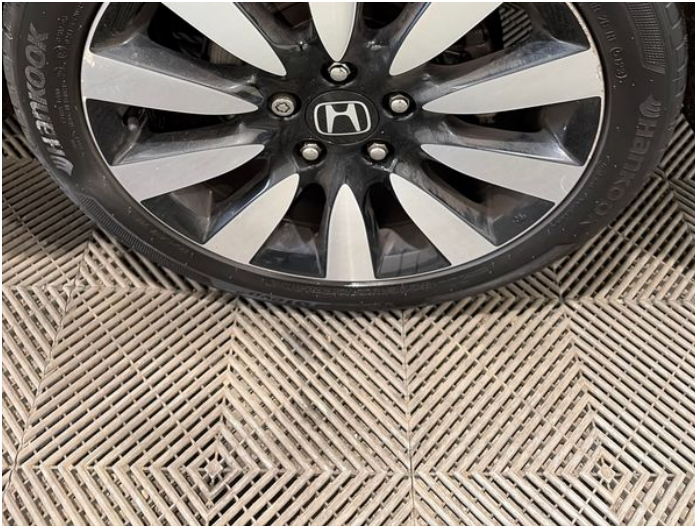
9: Wheel nsr  
Scratched  
Over 50mm

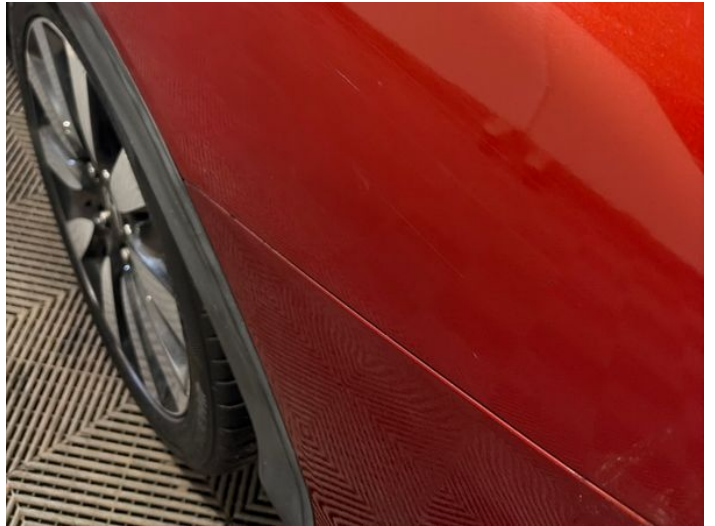
10: Qtr Panel nsr  
Scratched  
UpTo 25mm Thru Paint

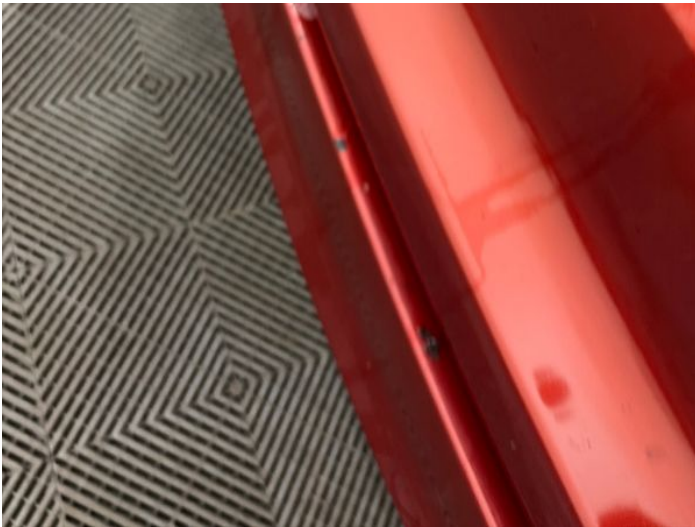
11: Bumper Rear  
Scratched  
25 to 100mm Thru Paint

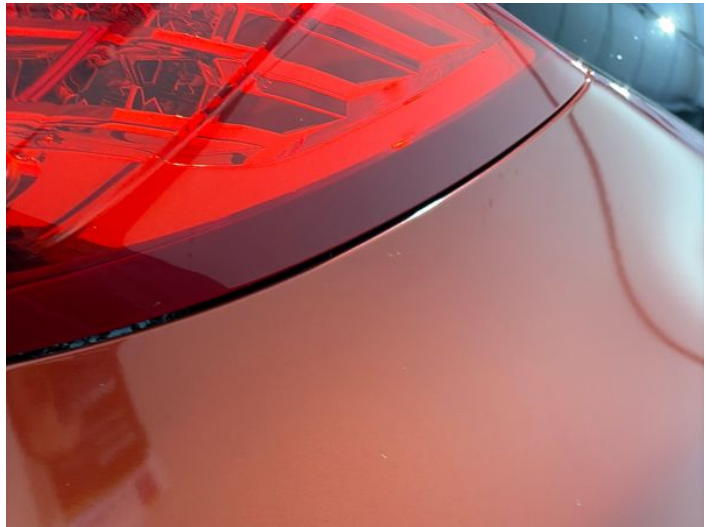
12: Qtr Panel osr  
Scratched  
Over 25mm Thru Paint

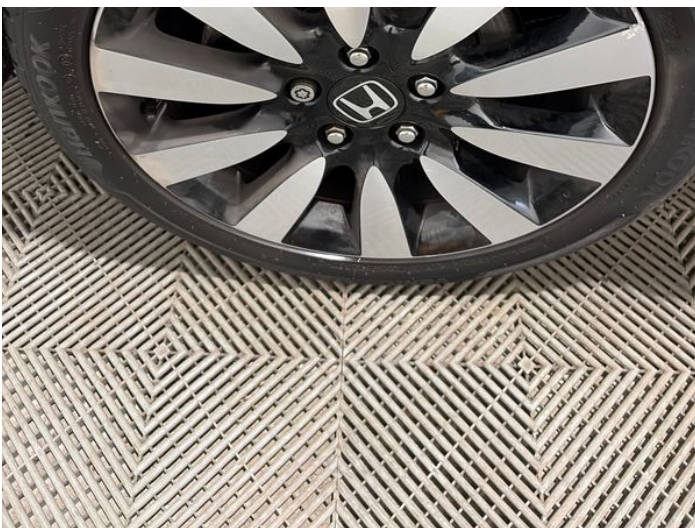
13: Wheel osr  
Scratched  
Up To 50mm

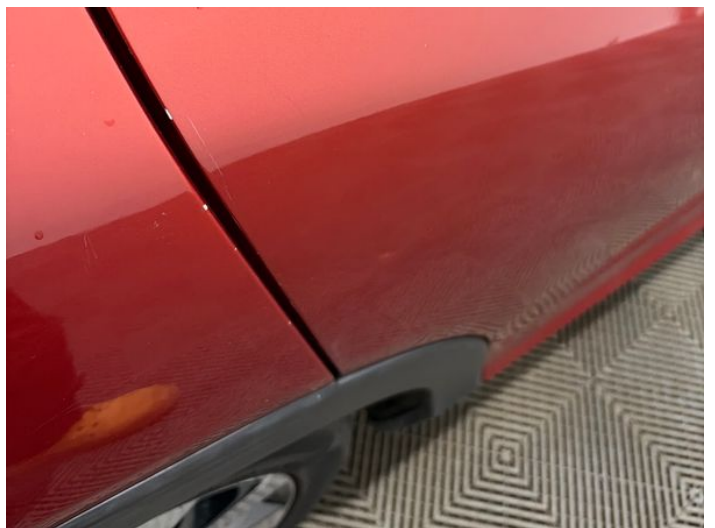
14: Door osr  
Scratched  
UpTo 25mm Thru Paint

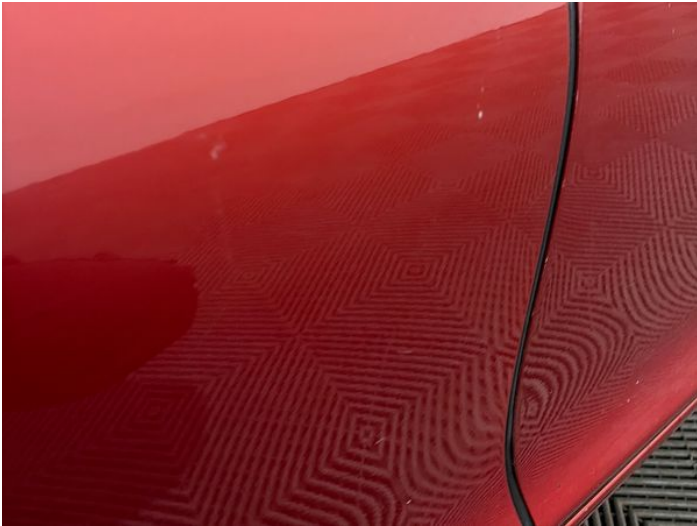
15: Door osr  
Chipped  
1 To 5

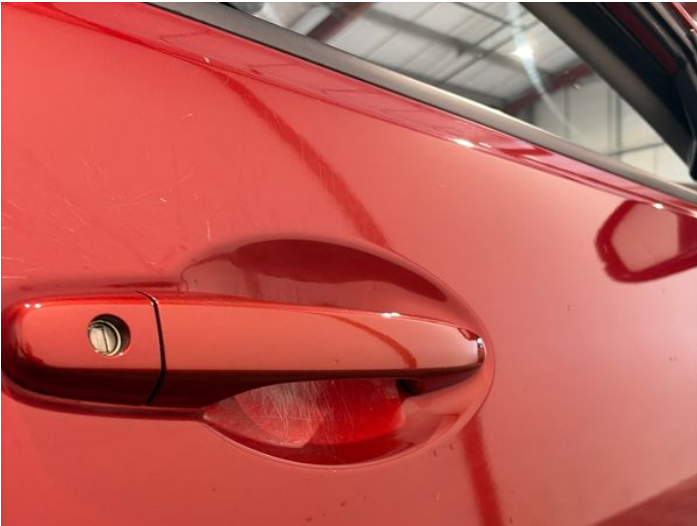
16: Door osf  
Scratched  
Over 25mm Thru Paint

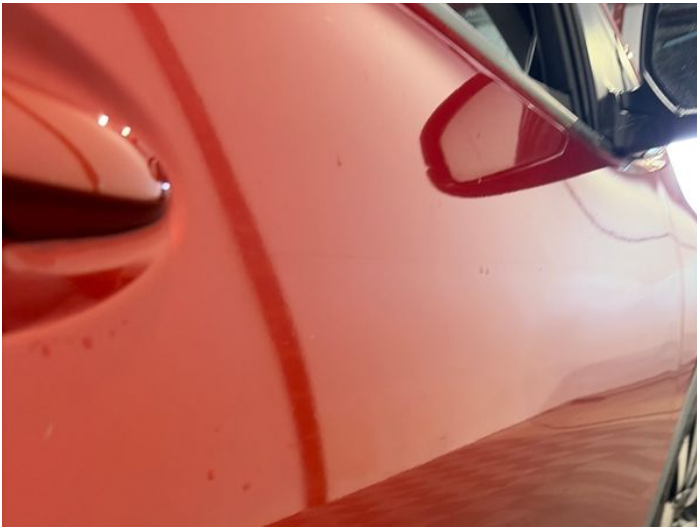
17: Door osf  
Dented  
2 Or Less UpTo 10mm

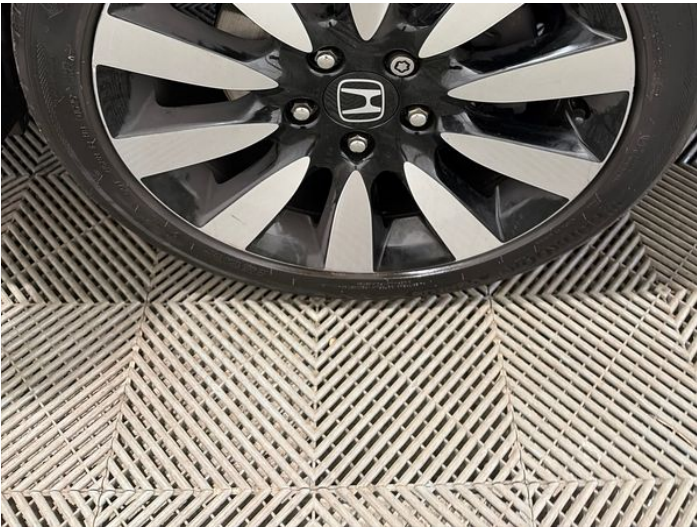
18: Wheel osf  
Scratched  
Over 50mm
