# VEHICLE INSPECTION REPORT

**RE64EKJ**

## Honda CR-V 2.0 i-VTEC EX 5dr

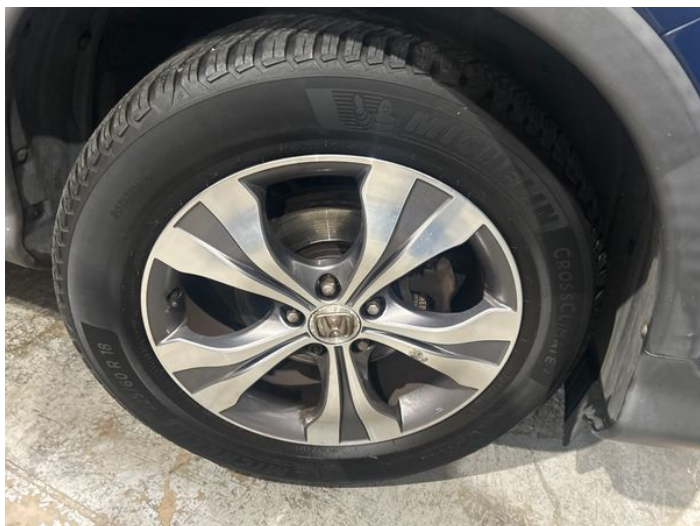
1: Wheel osf  
Corroded  
Light

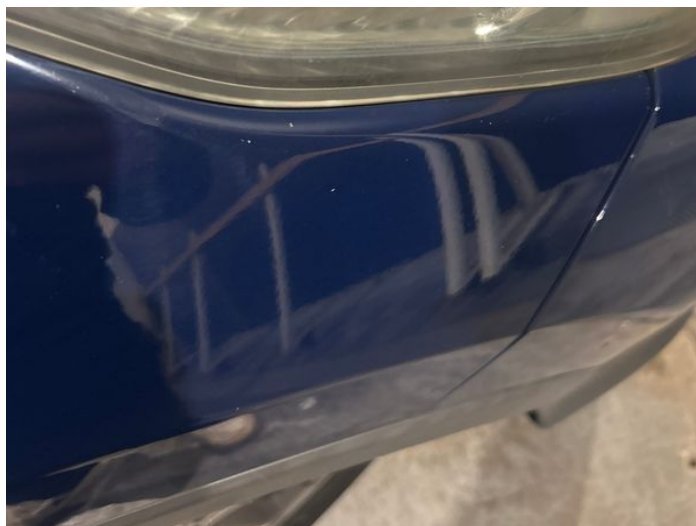
2: Wing osf  
Chipped  
1 To 5

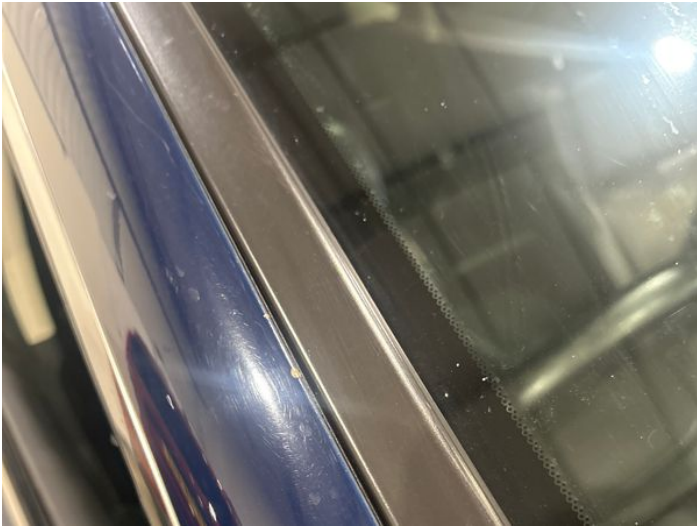
3: A Post os  
Chipped  
1 To 5

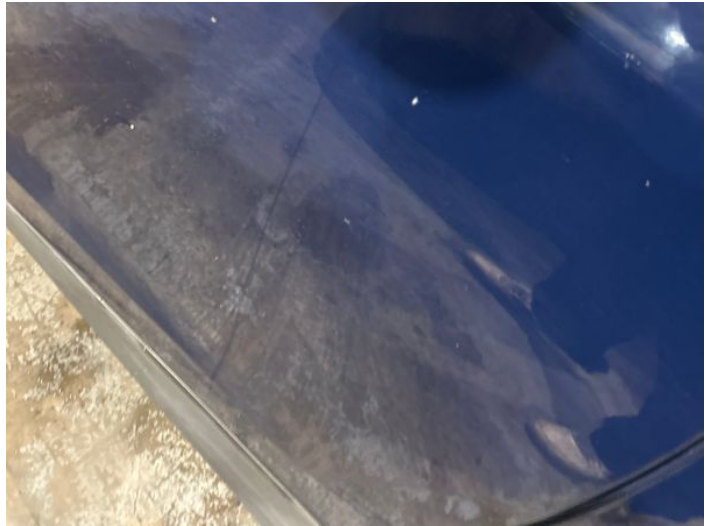
4: Door osf  
Chipped  
1 To 5

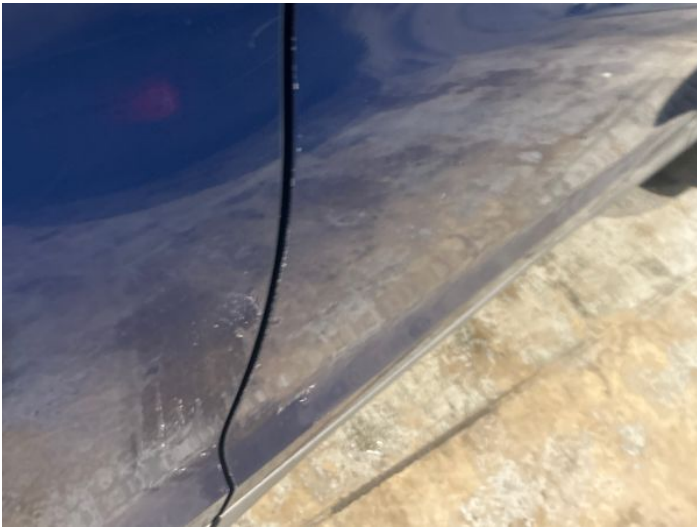
5: Door osf  
Chipped  
Edge Chip

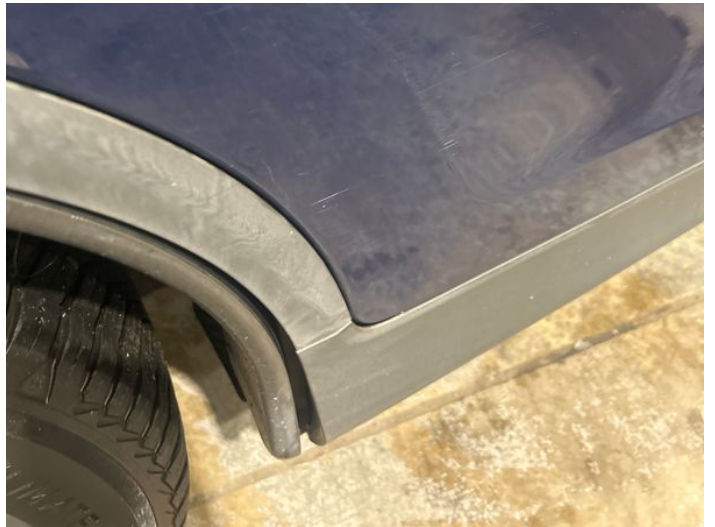
6: Door osr  
Scratched  
Over 25mm Thru Paint

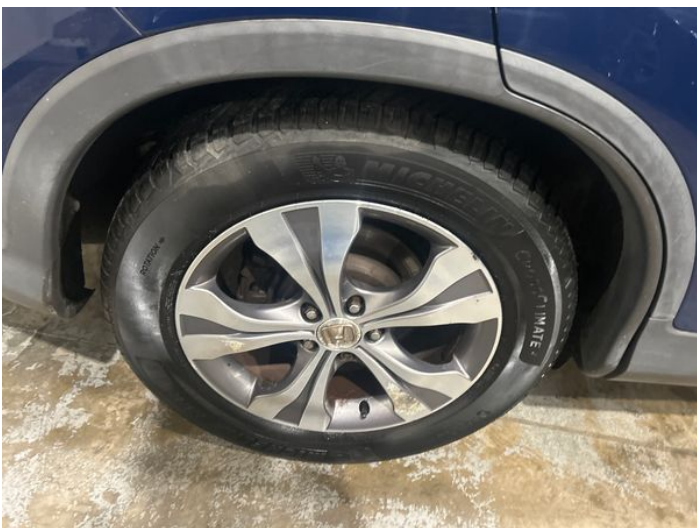
7: Wheel osr  
Corroded  
Light

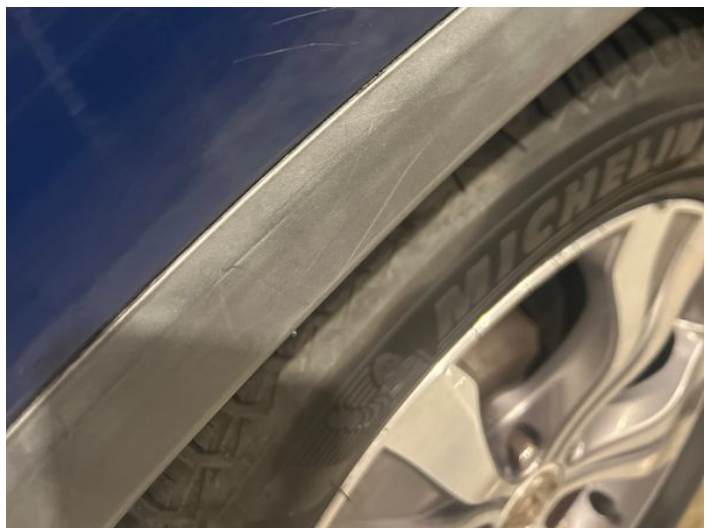
8: Qtr Panel osr  
Scratched  
UpTo 25mm Thru Paint

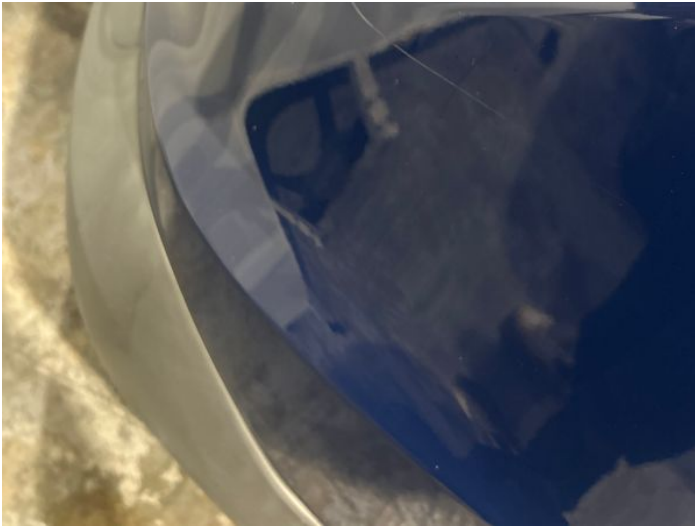
9: Bumper Rear  
Scratched  
Over 100mm Thru Paint

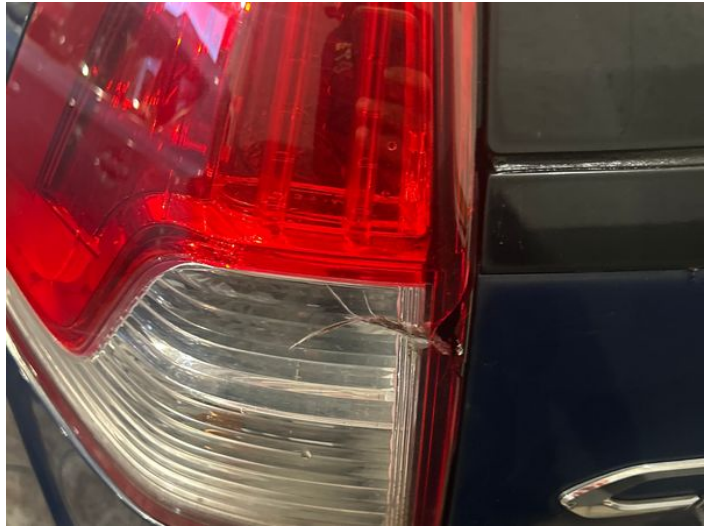
10: Lamp nsr  
Broken  
Replace

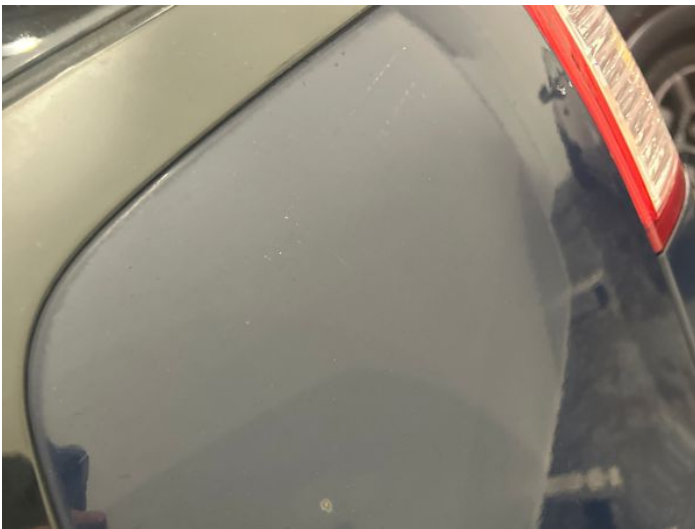
11: Tailgate  
Chipped  
1 To 5

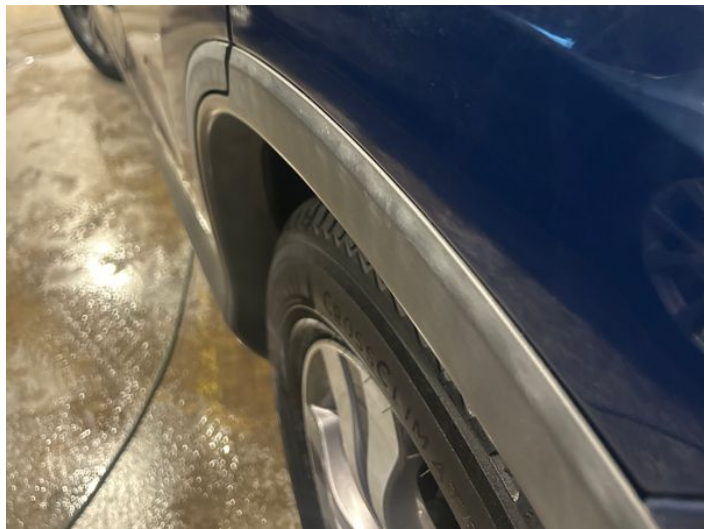
12: Qtr Panel nsr  
Dented  
Between 10mm + 30mm

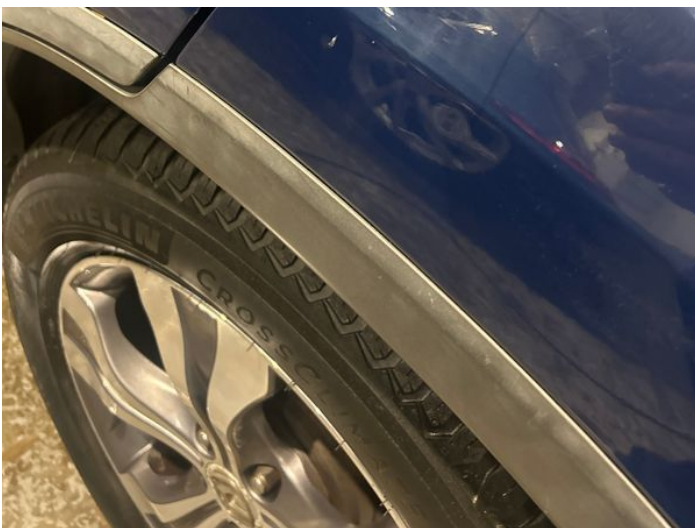
13: Qtr Panel nsr  
Chipped  
1 To 5

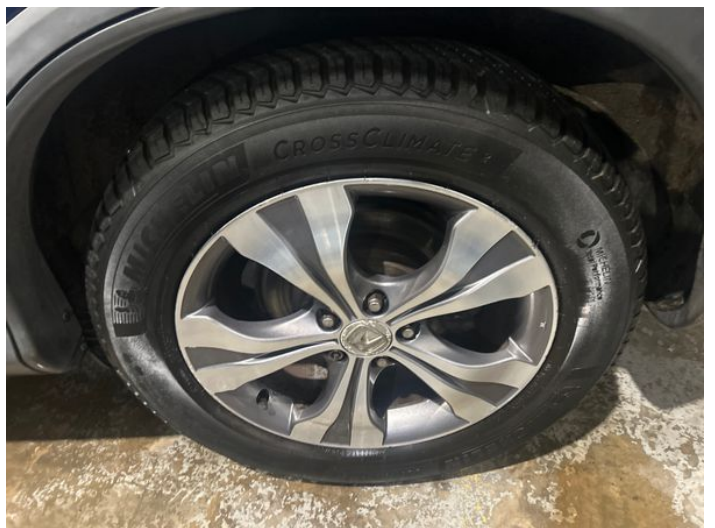
14: Wheel nsr  
Corroded  
Light

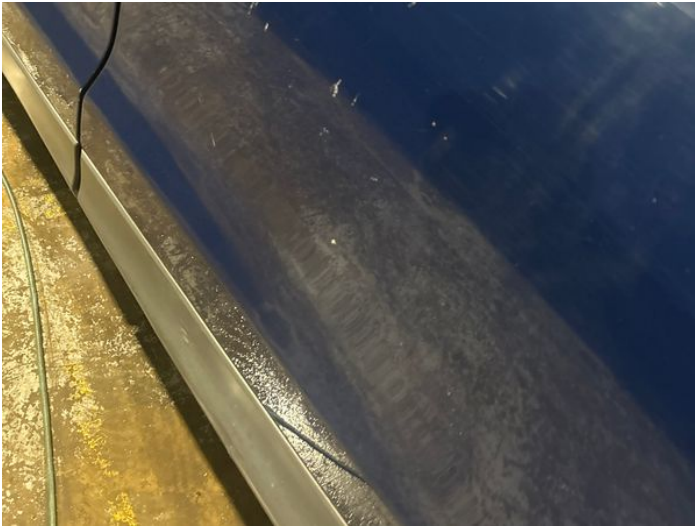
15: Door nsr  
Chipped  
Multiple Chips

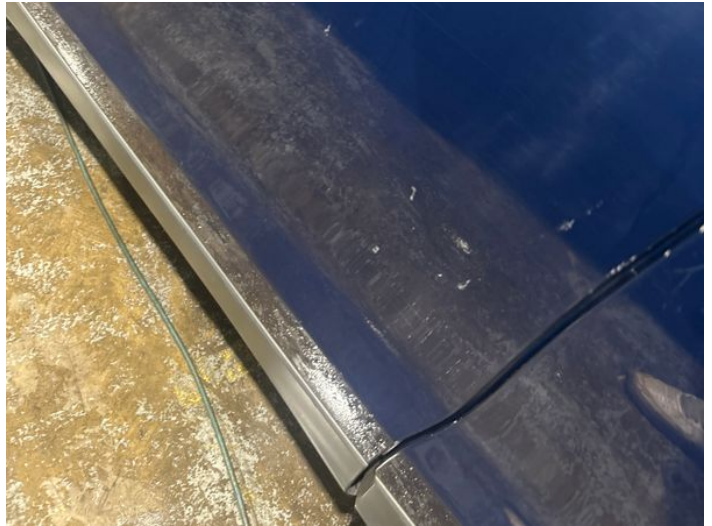
16: Door nsf  
Chipped  
Multiple Chips

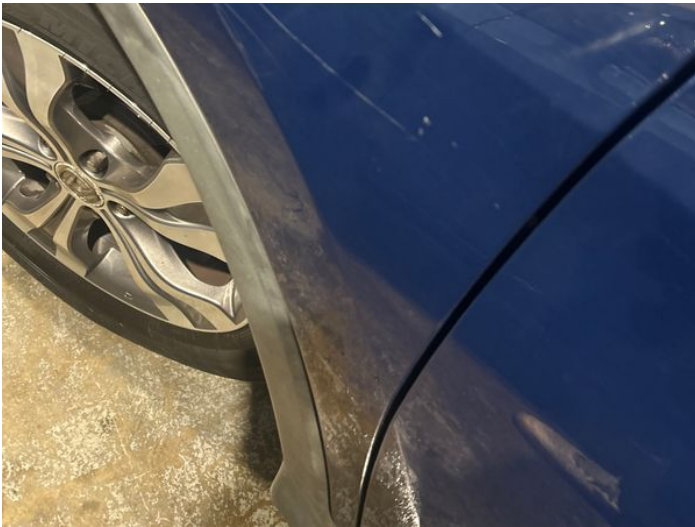
17: Wing nsf  
Scratched  
UpTo 25mm Thru Paint

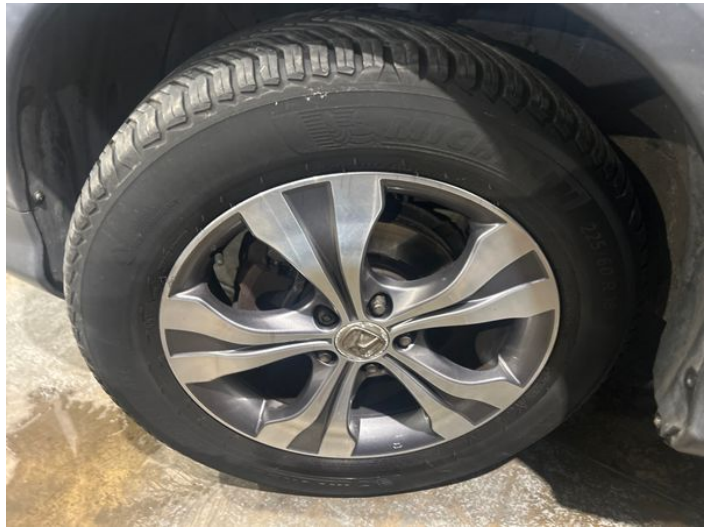
18: Wheel nsf  
Corroded  
Light

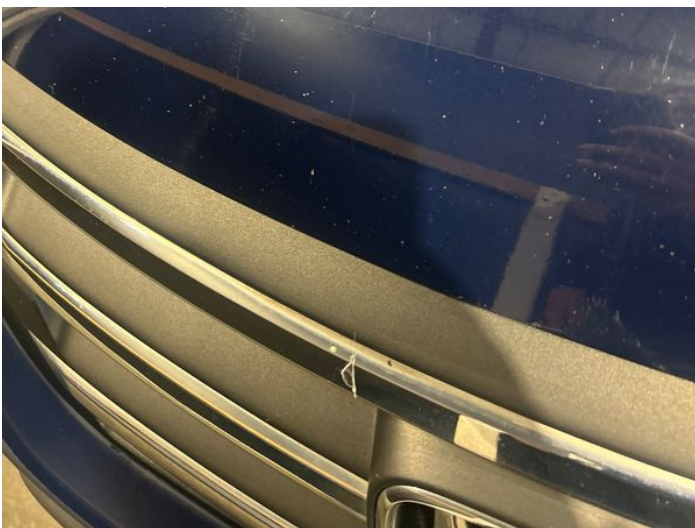
19: Bonnet  
Chipped  
Multiple Chips

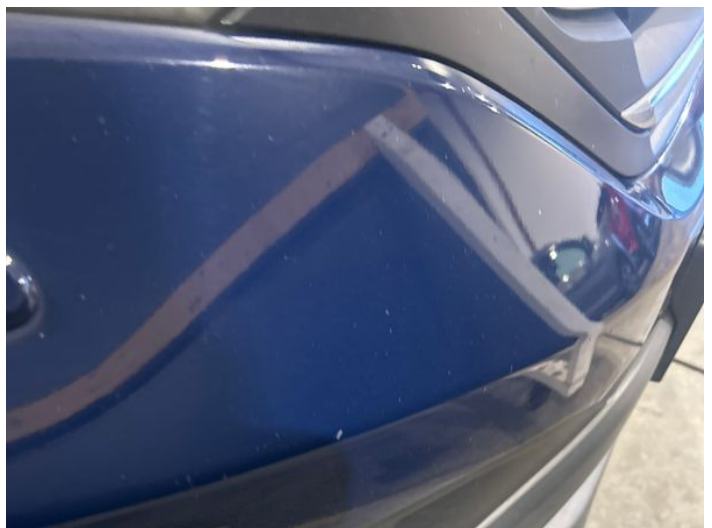
20: Bumper Front  
Chipped  
Multiple Chips
