## VEHICLE INSPECTION REPORT

**GU16TPF**

### Audi A3 1.4 TFSI 125 Sport 5dr [Nav]

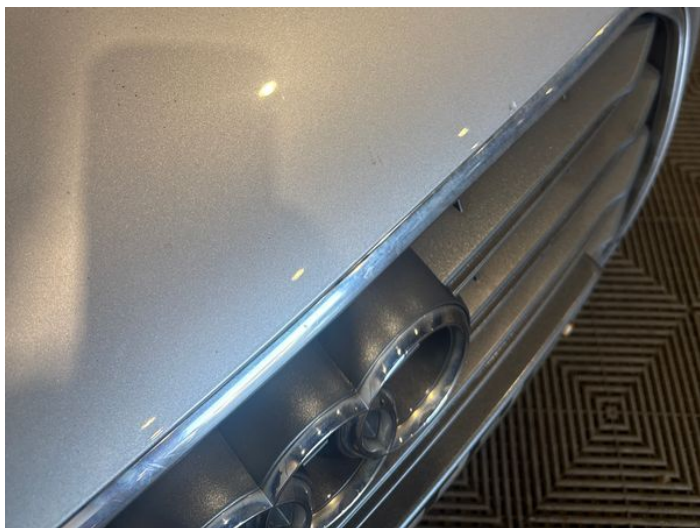
1: Bonnet  
Chipped  
1 To 5

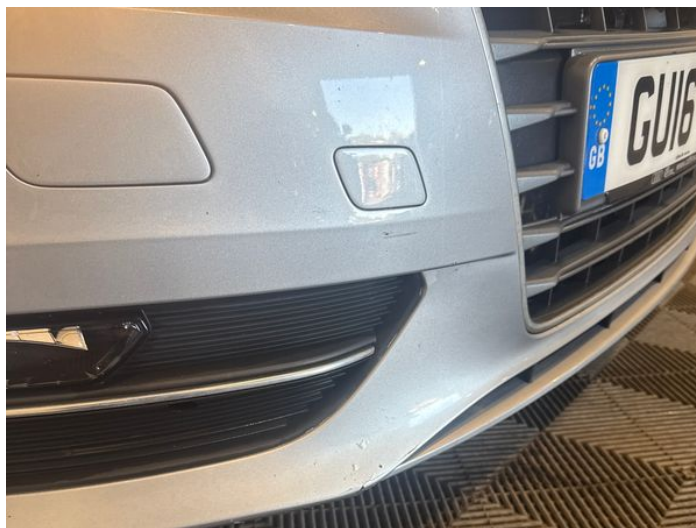
2: Bumper Front  
Dented  
With Paint Damage

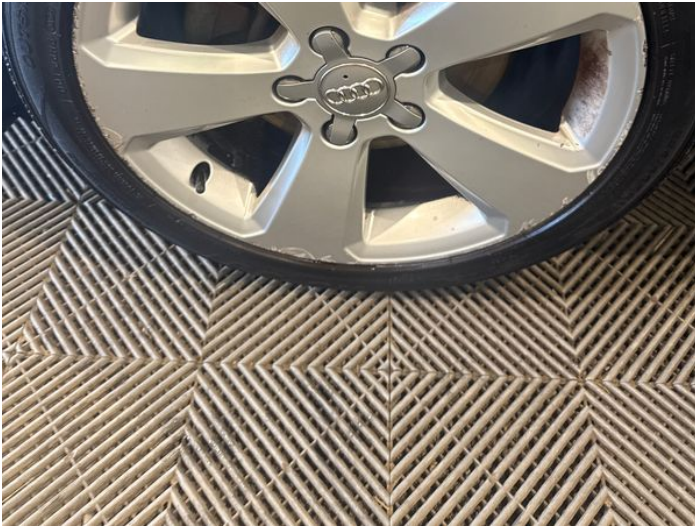
3: Wheel nsf  
Scratched  
Over 50mm

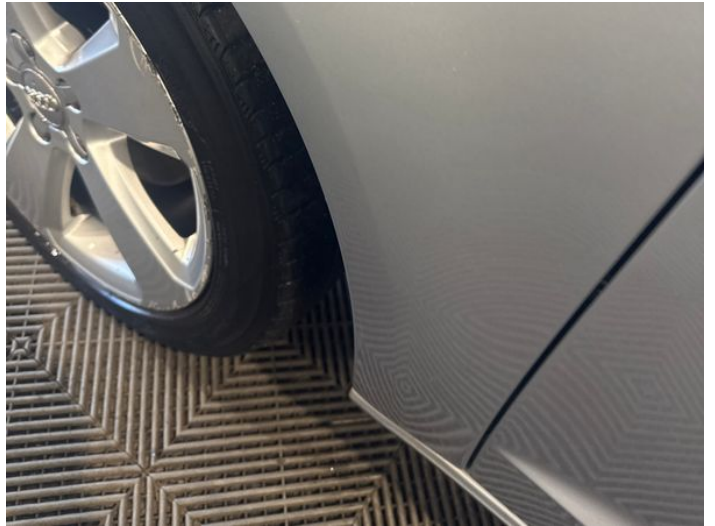
4: Wing nsf  
Chipped  
1 To 5

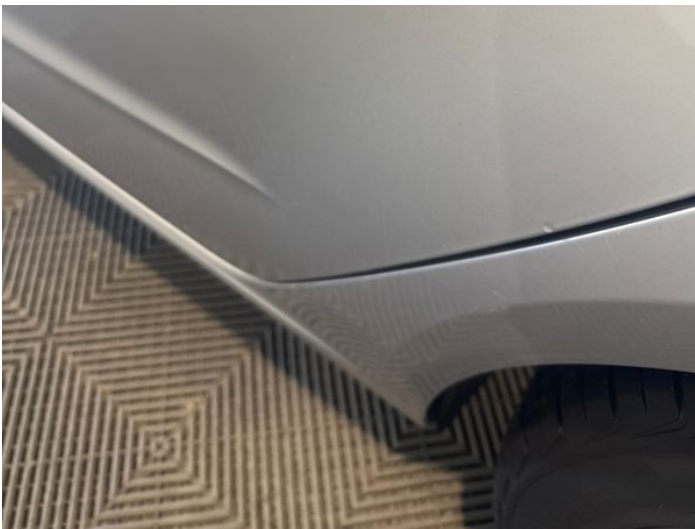
5: Door nsr  
Chipped  
1 To 5

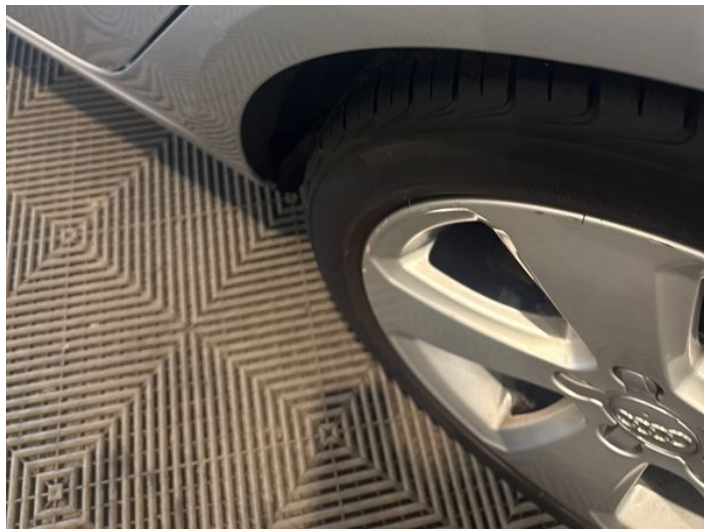
6: Qtr Panel nsr  
Scratched  
Over 25mm Thru Paint

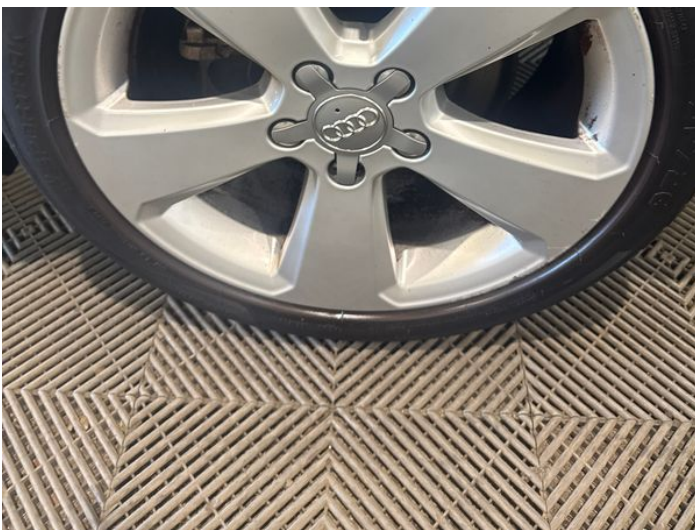
7: Wheel nsr  
Scratched  
Over 50mm

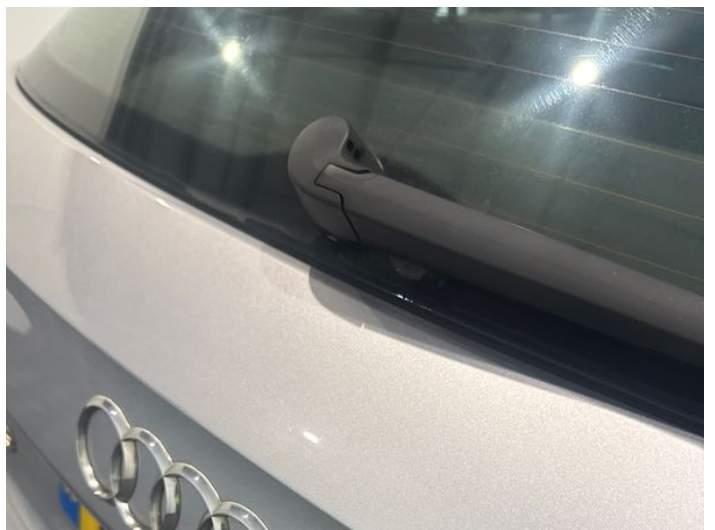
8: Tailgate  
Scratched  
UpTo 25mm Thru Paint

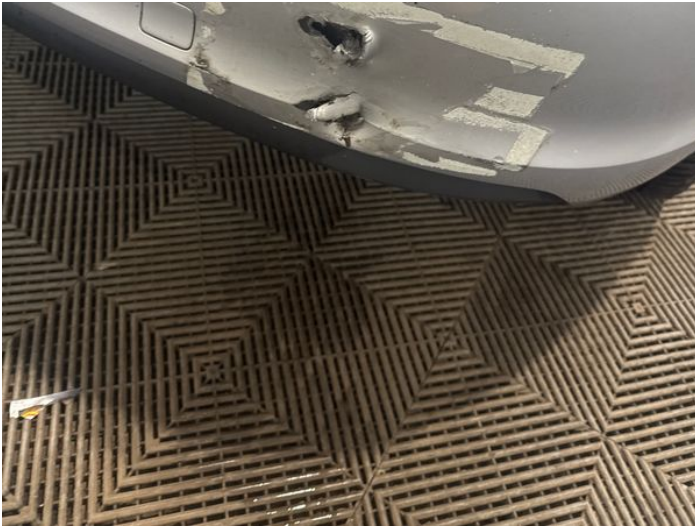
9: Bumper Rear  
Hole  
Over 25mm

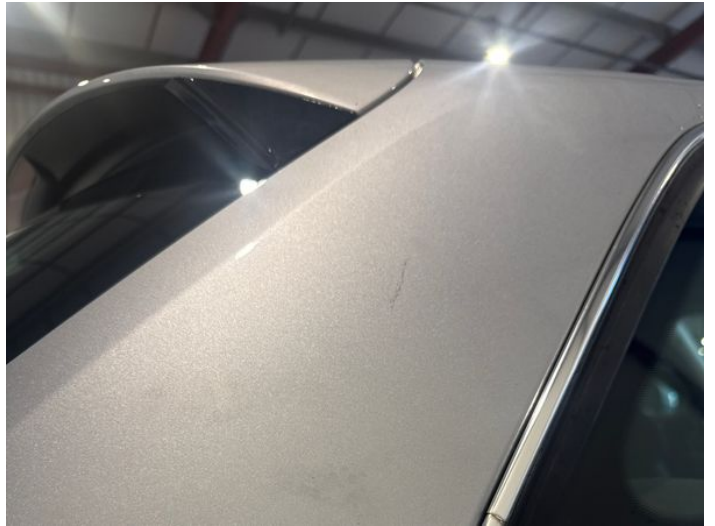
10: Qtr Panel osr  
Scratched  
Over 25mm Thru Paint

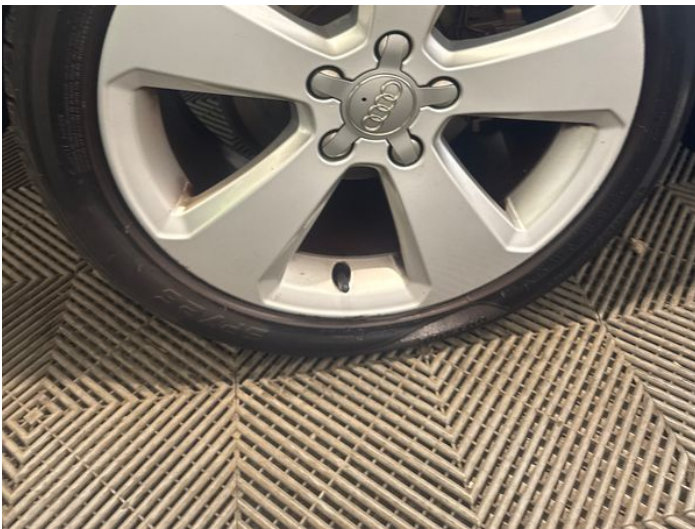
11: Wheel osr  
Scratched  
Over 50mm

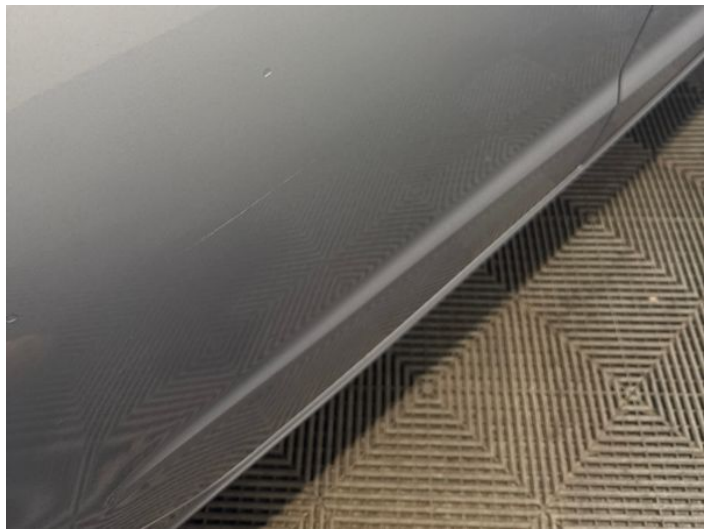
12: Door osr  
Dented  
With Paint Damage

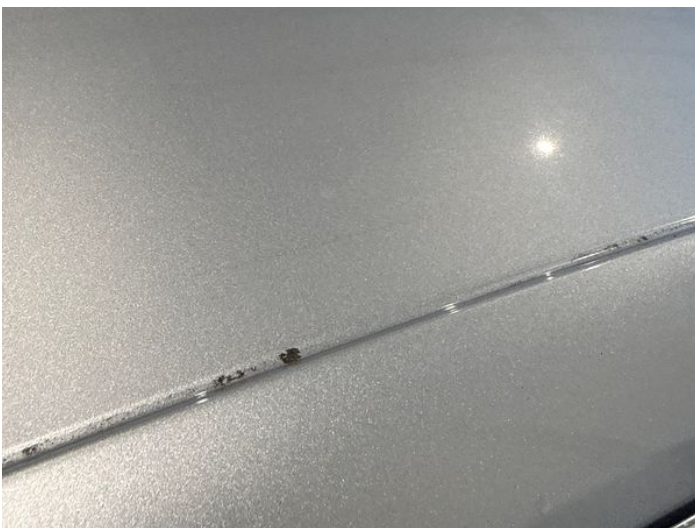
13: Roof  
Dented  
Between 10mm + 30mm

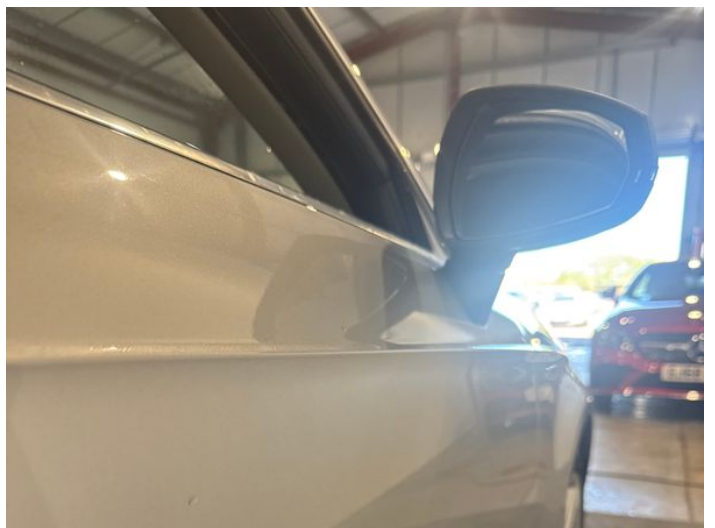
14: Door osf  
Dented  
Between 10mm + 30mm

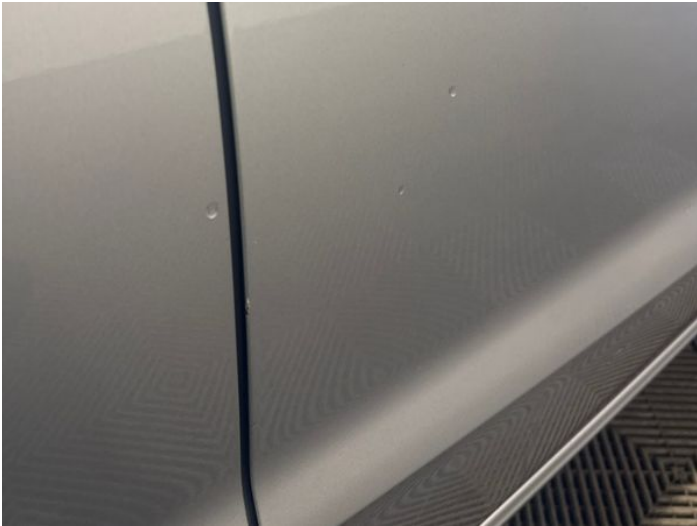
15: Door osf  
Chipped  
Edge Chip

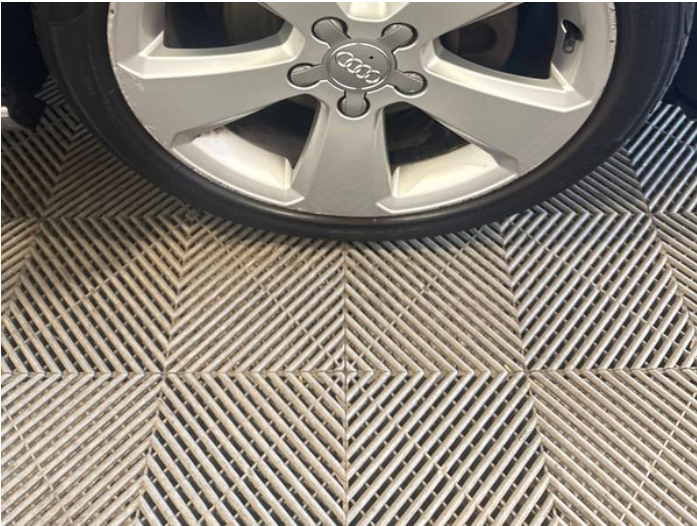
16: Wheel osf  
Scratched  
Over 50mm

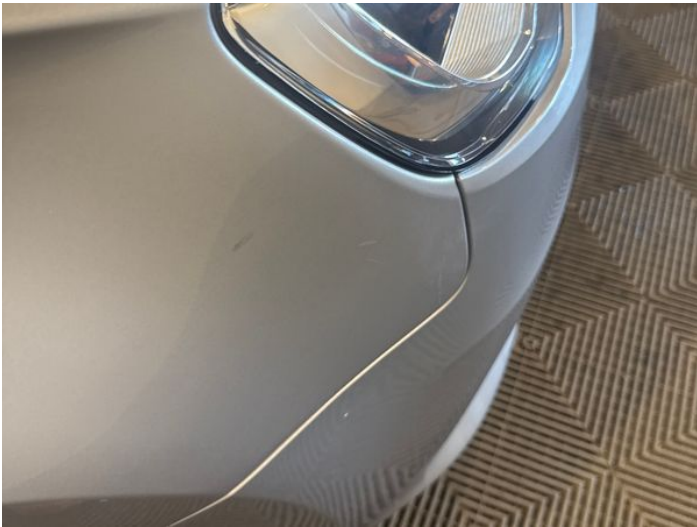
17: Wing osf  
Scratched  
Over 25mm Thru Paint
