# VEHICLE INSPECTION REPORT

**VK19VXA**

## Seat Tarraco 2.0 EcoTSI Xcellence First Ed Plus 5dr DSG 4Drive

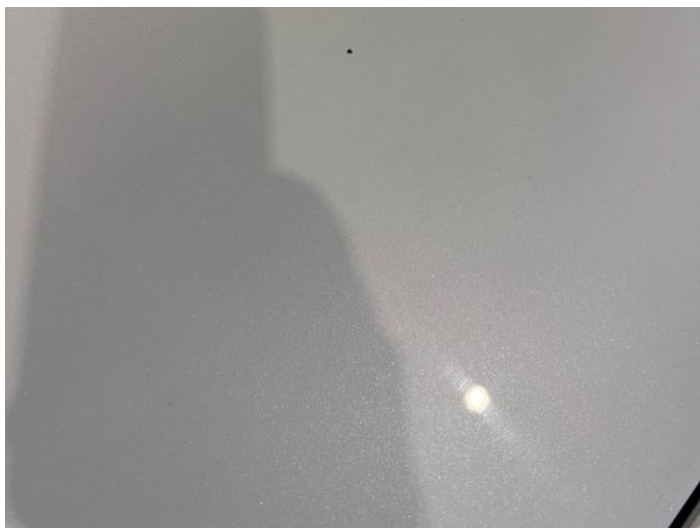
1: Bonnet  
Chipped  
1 To 5

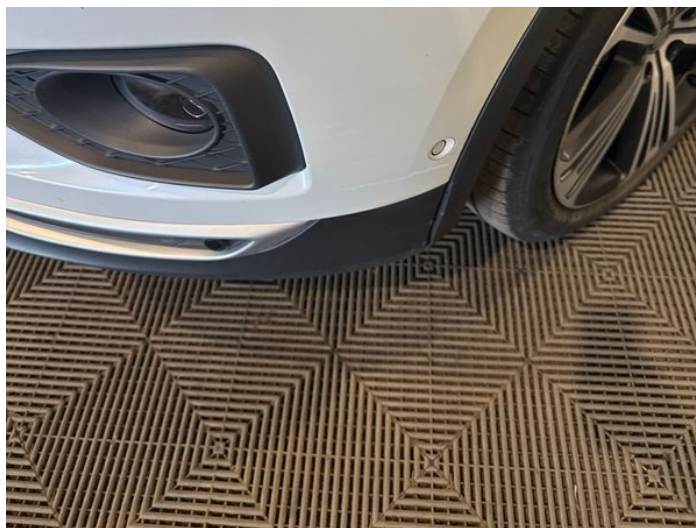
2: Bumper Front  
Scratched  
Over 100mm Thru Paint

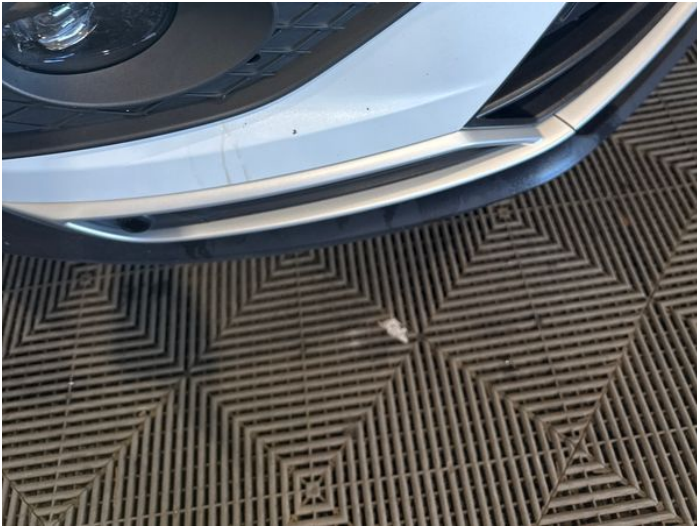
3: Bumper Front  
Chipped  
1 To 5

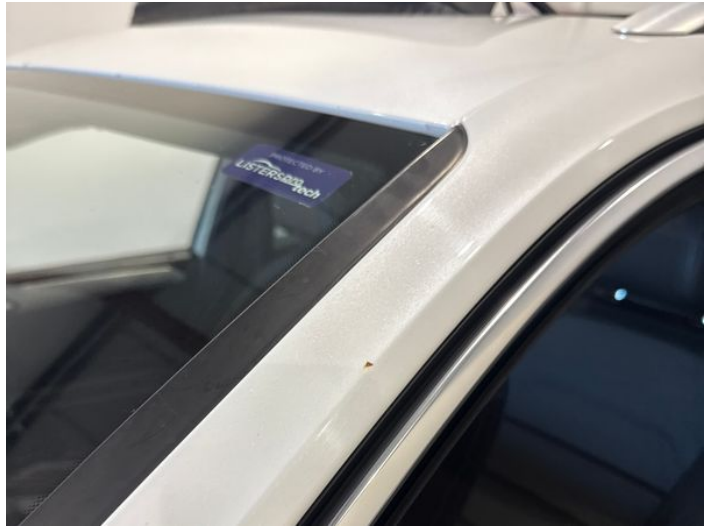
4: A Post ns  
Chipped  
1 To 5

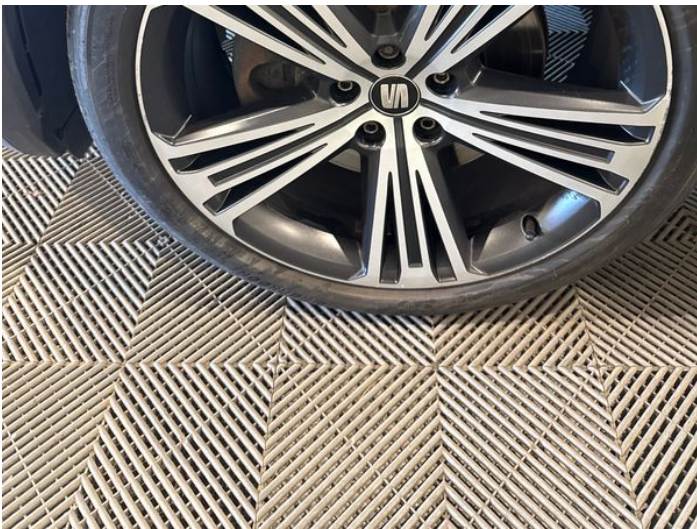
5: Wheel nsf  
Scratched  
Over 50mm

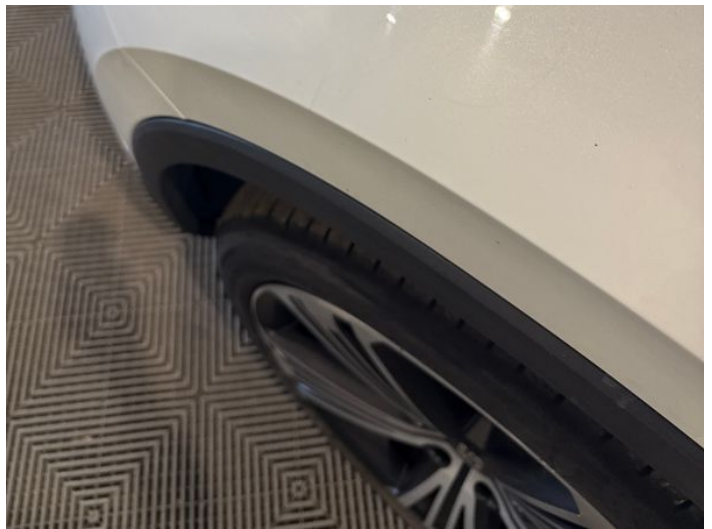
6: Wing nsf  
Chipped  
1 To 5

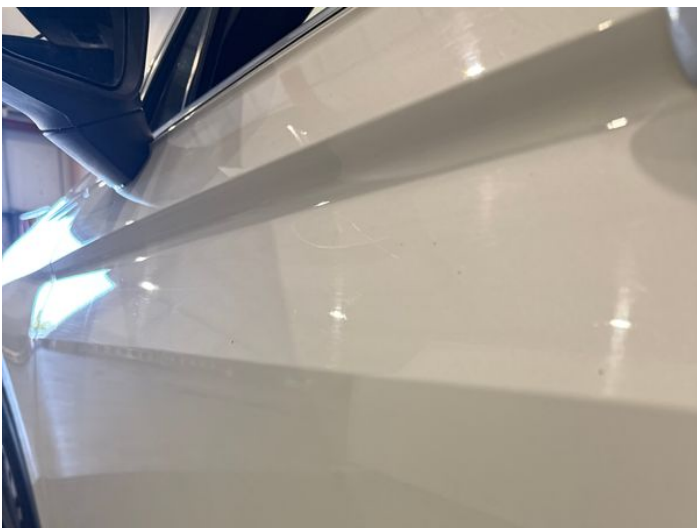
7: Door nsf  
Dented  
Between 10mm + 30mm

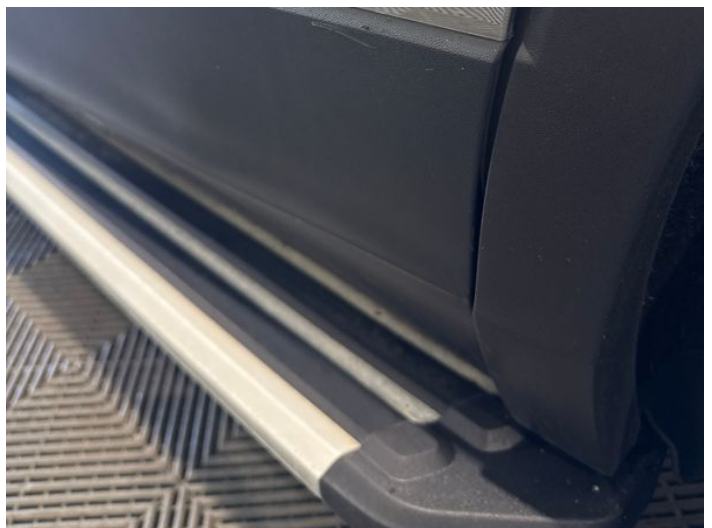
8: Door Moulding nsr  
Scratched (Painted)  
Over 25mm Thru Paint

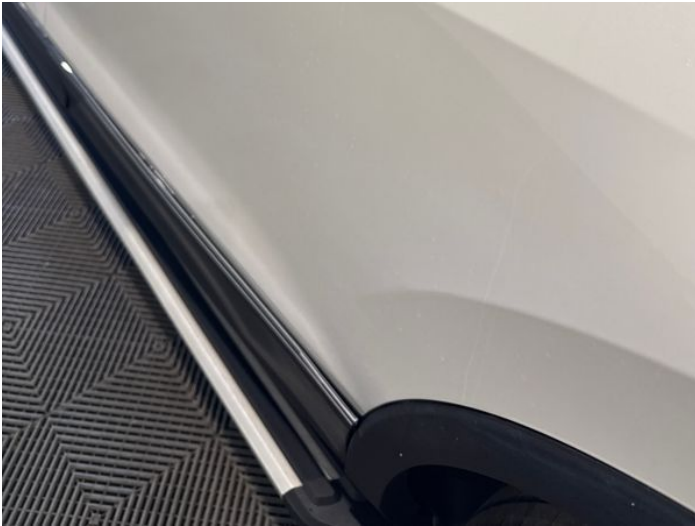
9: Door nsr  
Poor Previous Repair  
Poor Paint

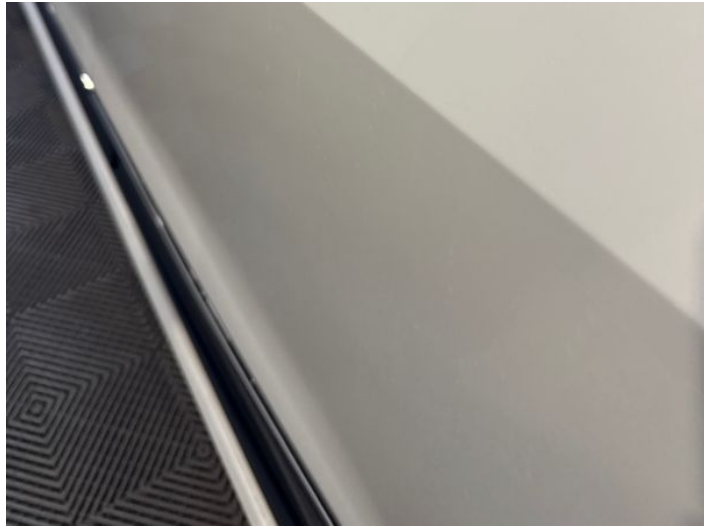
10: Door nsr  
Dented  
2 Or Less UpTo 10mm

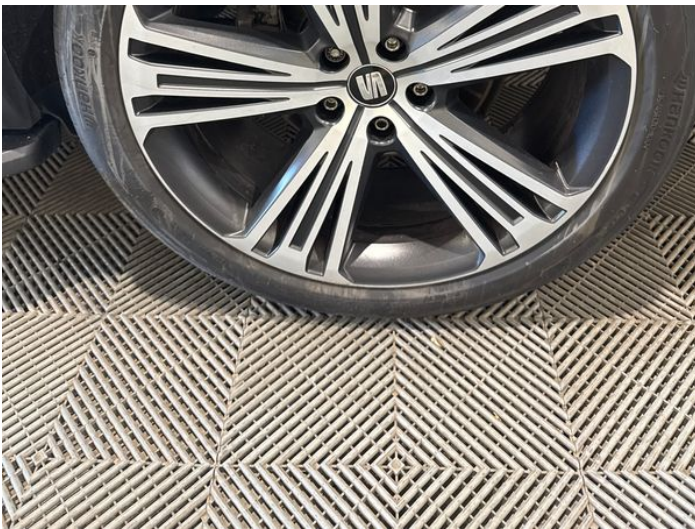
11: Wheel nsr  
Scratched  
Over 50mm

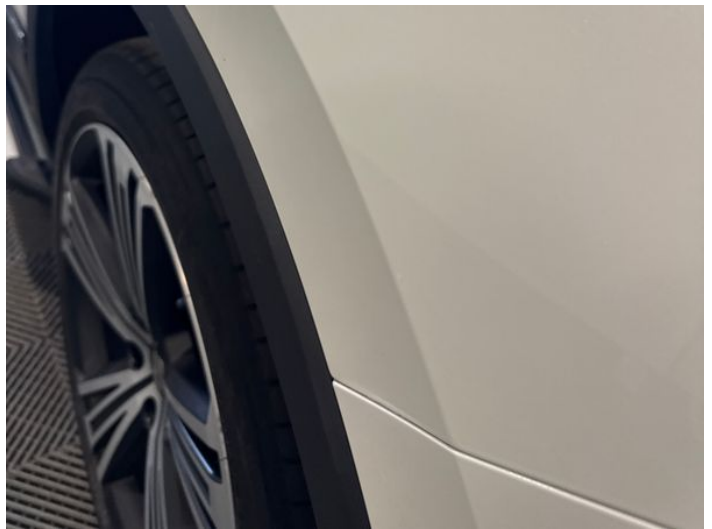
12: Qtr Panel nsr  
Dented  
2 Or Less UpTo 10mm

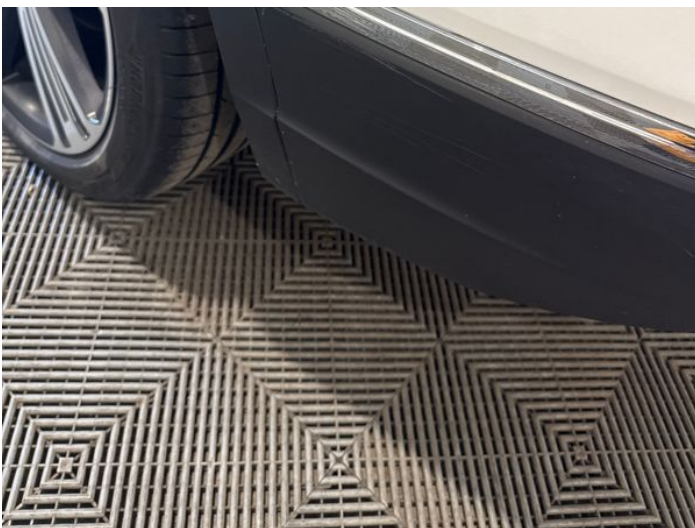
13: Bumper Rear Moulding  
Scuffed (Unpainted)  
Over 100mm

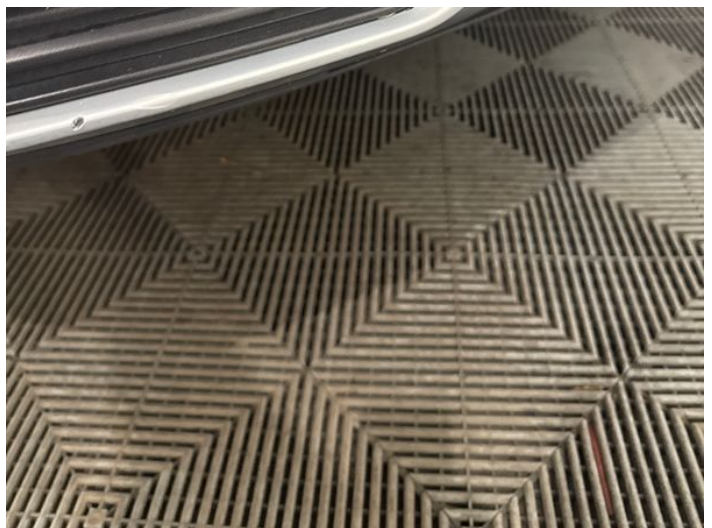
14: Bumper Rear Moulding  
Scratched (Painted)  
UpTo 25mm Thru Paint

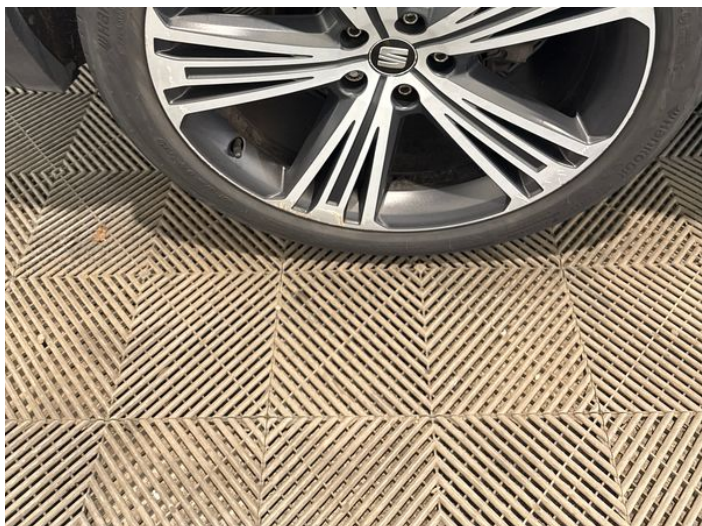
15: Wheel osr  
Scratched  
Over 50mm

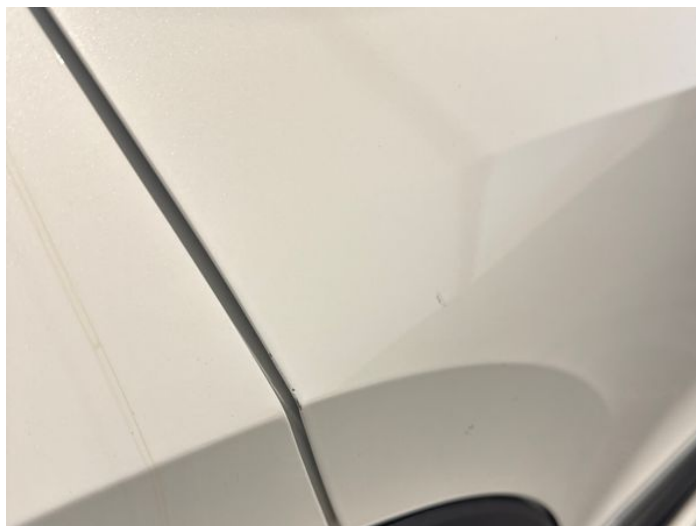
16: Door osr  
Chipped  
Edge Chip

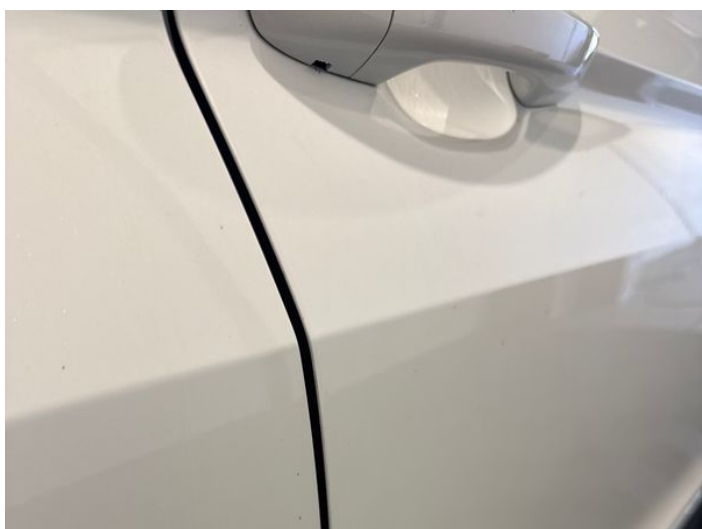
17: Door osf  
Chipped  
Edge Chip

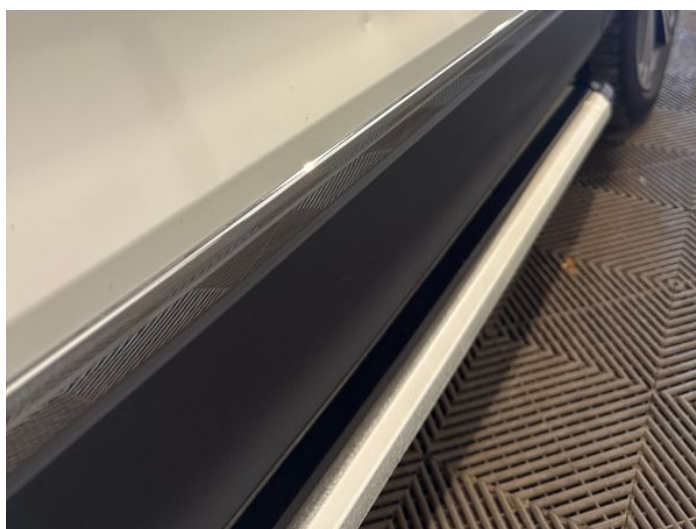
18: Door osf  
Dented  
Between 10mm + 30mm

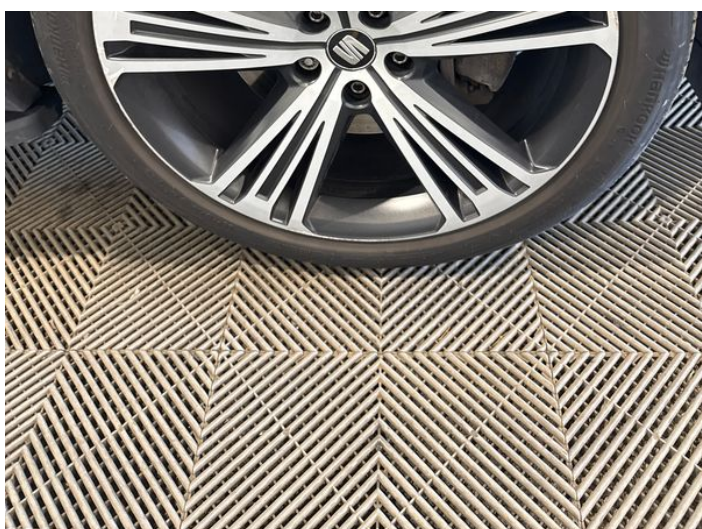
19: Wheel osf  
Scratched  
Over 50mm

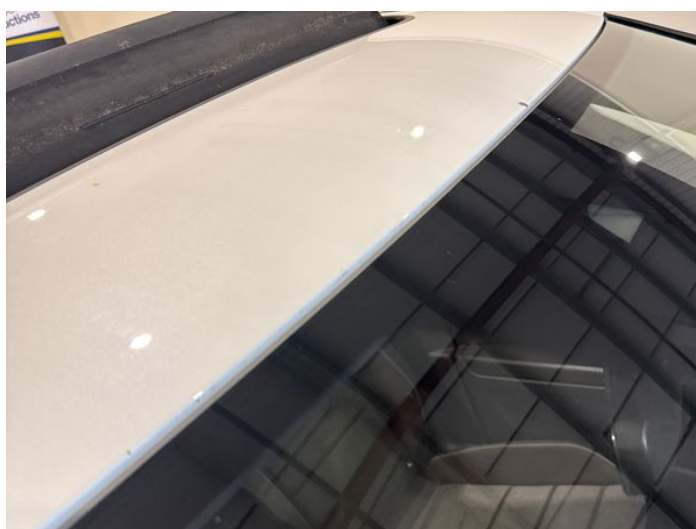
20: Roof  
Chipped  
Edge Chip

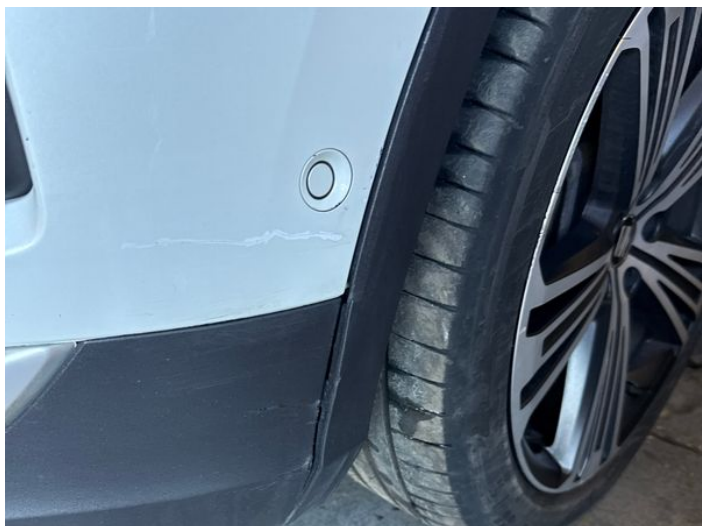
21: Wing Front Arch Extension ns  
Scuffed (Unpainted)  
Over 100mm
