# VEHICLE INSPECTION REPORT

**BU68XGS**

## Toyota Auris 1.8 Hybrid Icon Tech TSS 5dr CVT

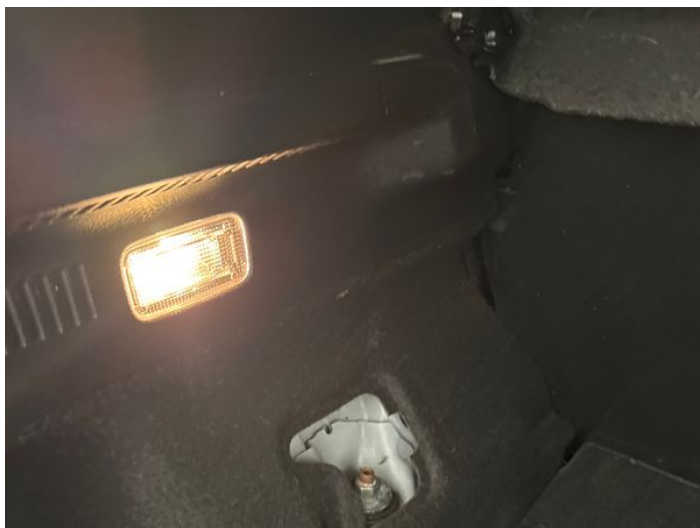
1: Fascia Trim  
Missing  
Replace

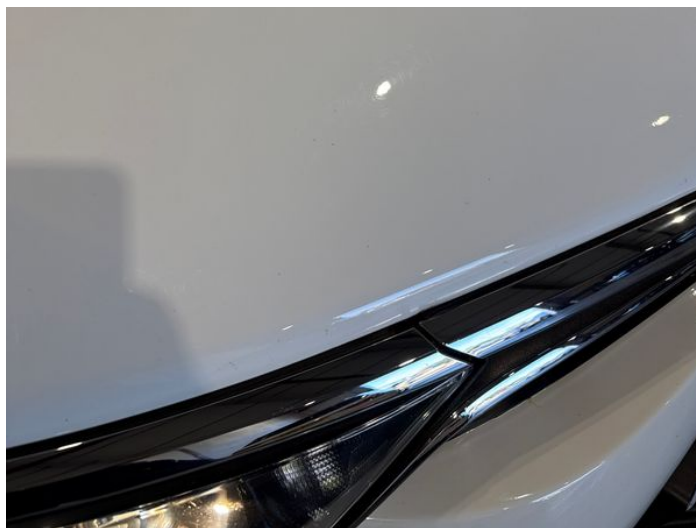
2: Bonnet  
Chipped  
1 To 5

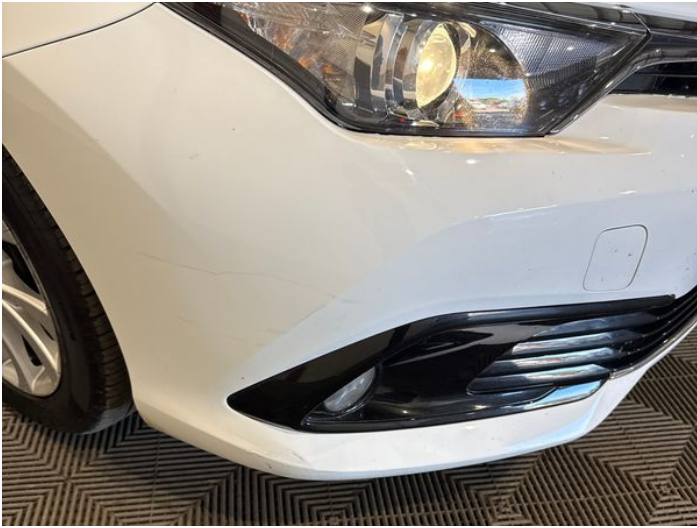
3: Bumper Front  
Scratched  
Over 100mm Thru Paint

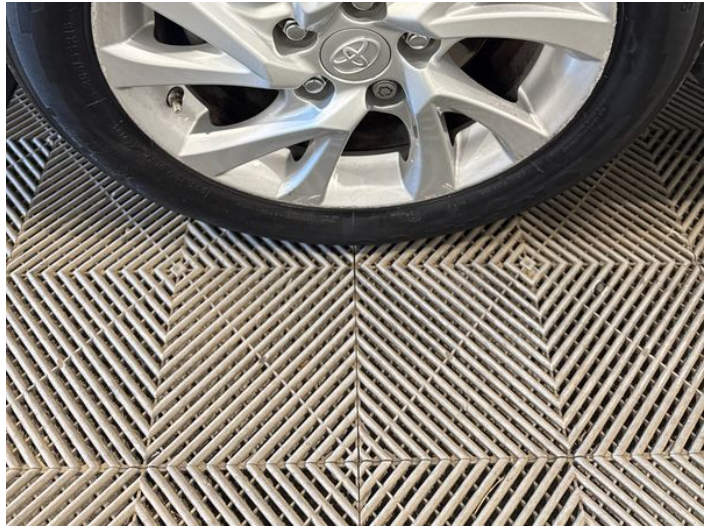
4: Wheel nsf  
Scratched  
Over 50mm

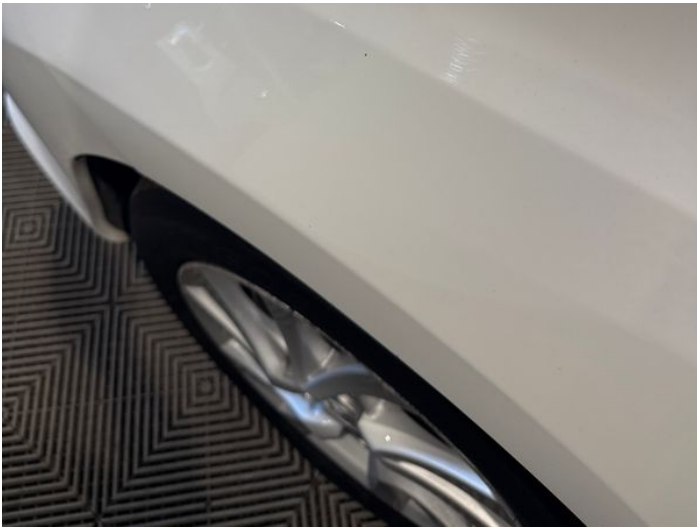
5: Wing nsf  
Chipped  
1 To 5

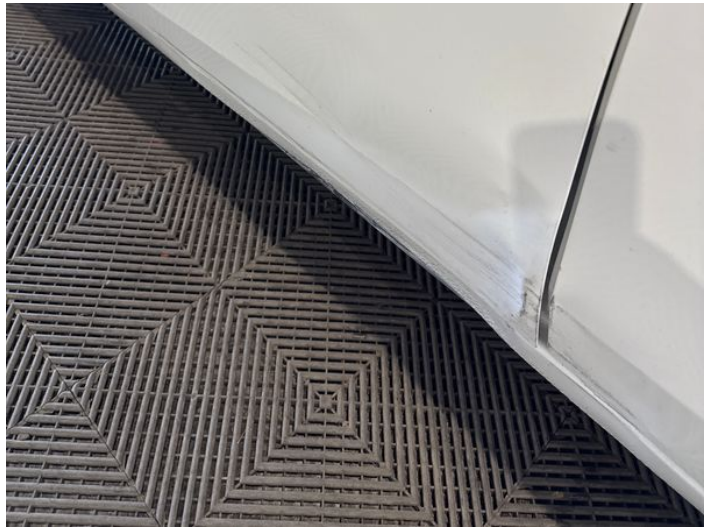
6: Door nsf  
Dented  
With Paint Damage

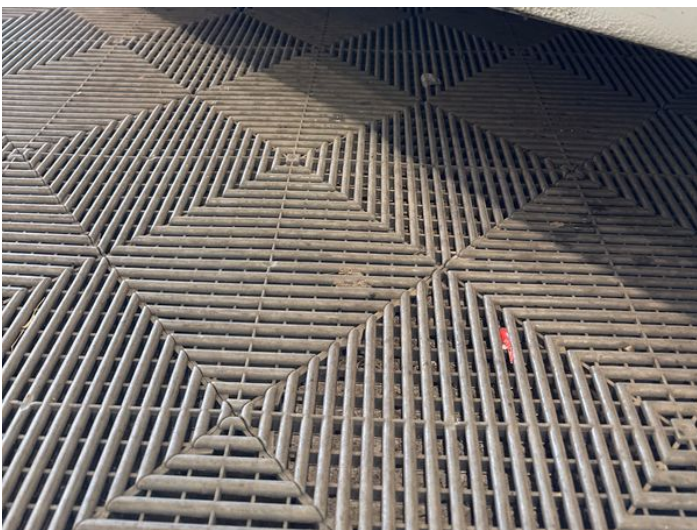
7: Sill ns  
Dented  
With Paint Damage

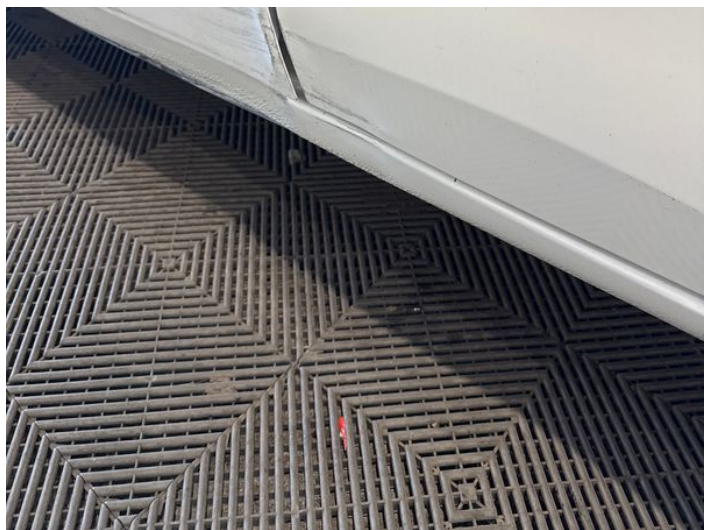
8: Door nsr  
Dented  
With Paint Damage

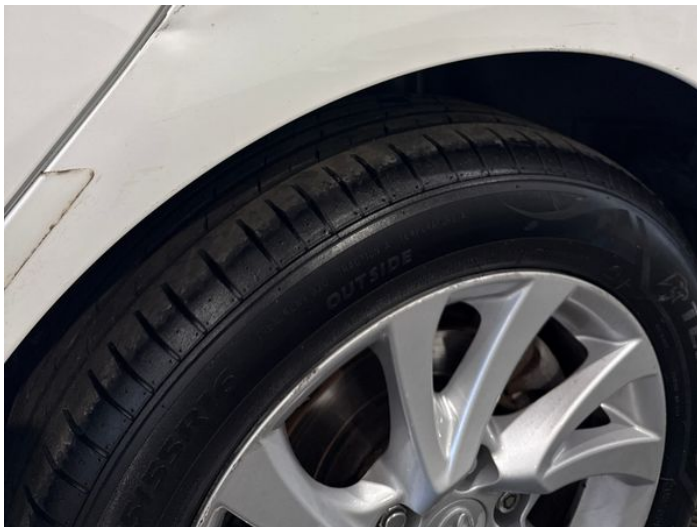
9: Qtr Panel nsr  
Dented  
With Paint Damage

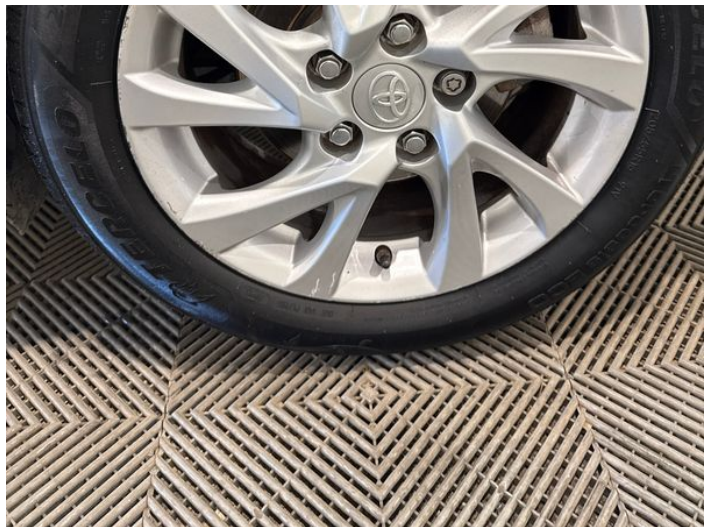
10: Wheel nsr  
Scratched  
Over 50mm

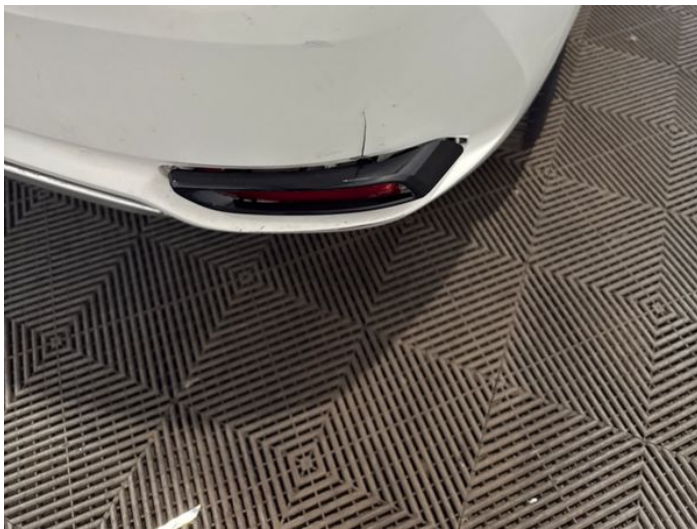
11: Bumper Rear  
Cracked  
Over 25mm

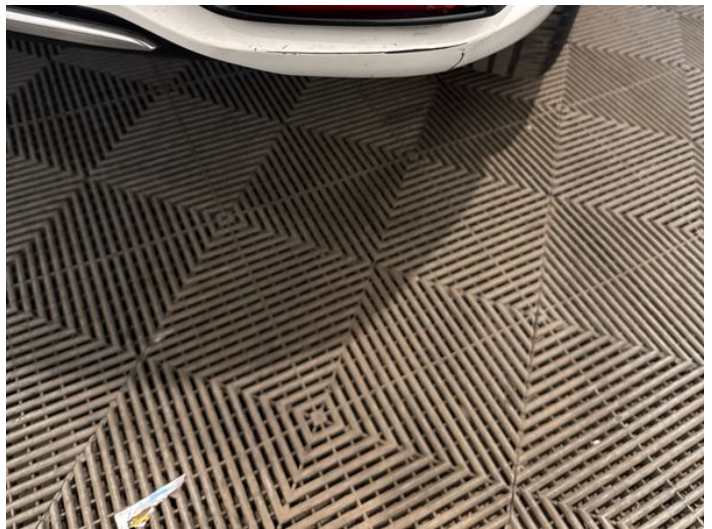
12: Bumper Reflector osr  
Broken  
Replace

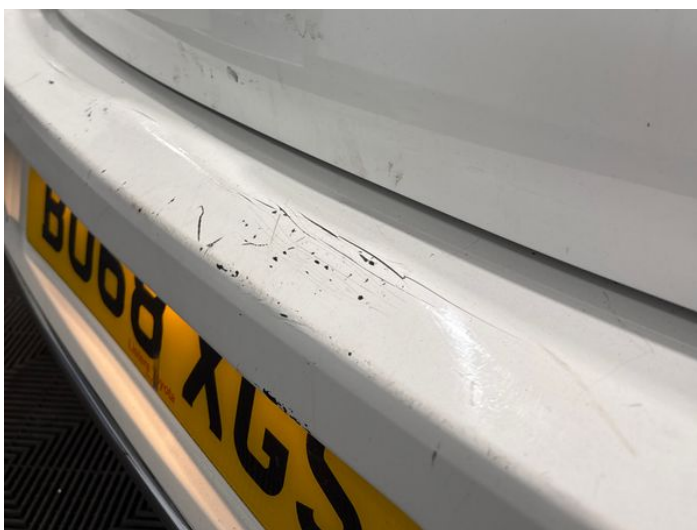
13: Tailgate  
Scratched  
Over 25mm Thru Paint

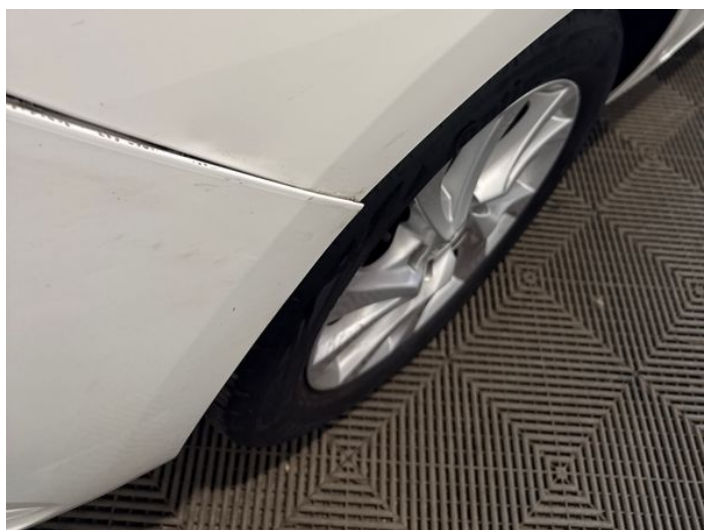
14: Qtr Panel osr  
Dented  
Between 10mm + 30mm

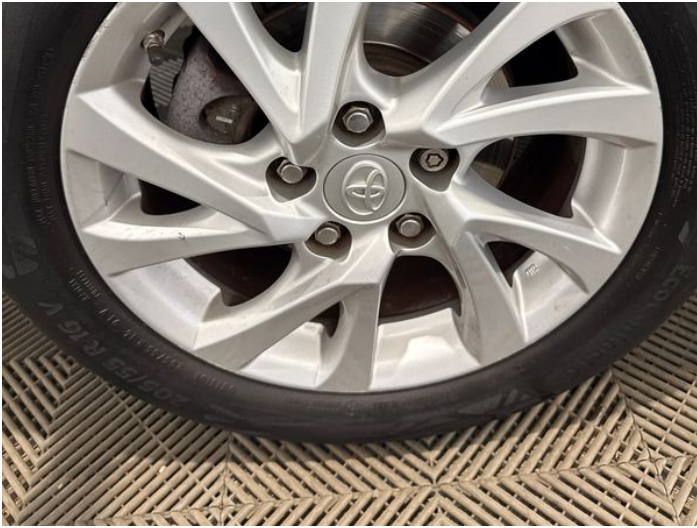
15: Wheel osr  
Scratched  
Over 50mm

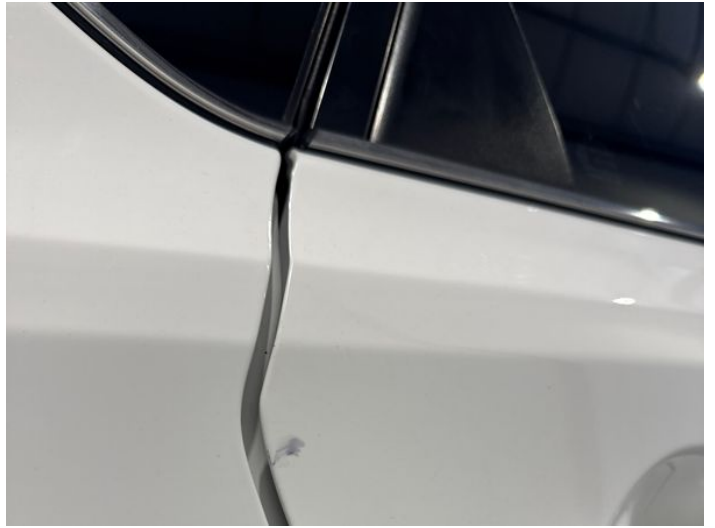
16: Door osr  
Scratched  
UpTo 25mm Thru Paint

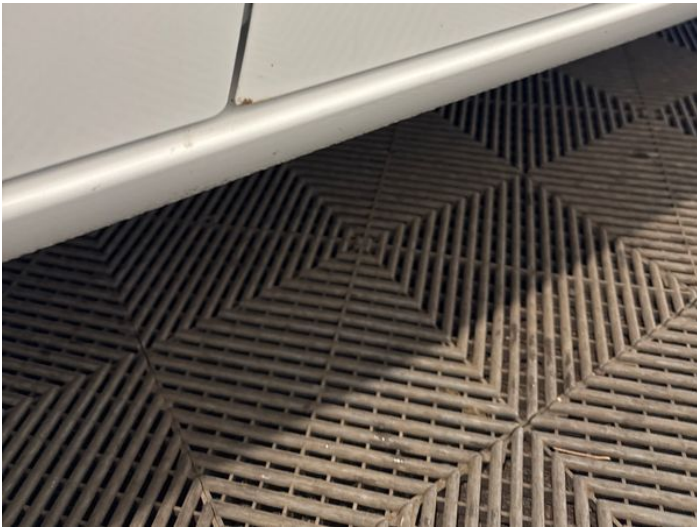
17: Door osf  
Rusted  
Over 5mm

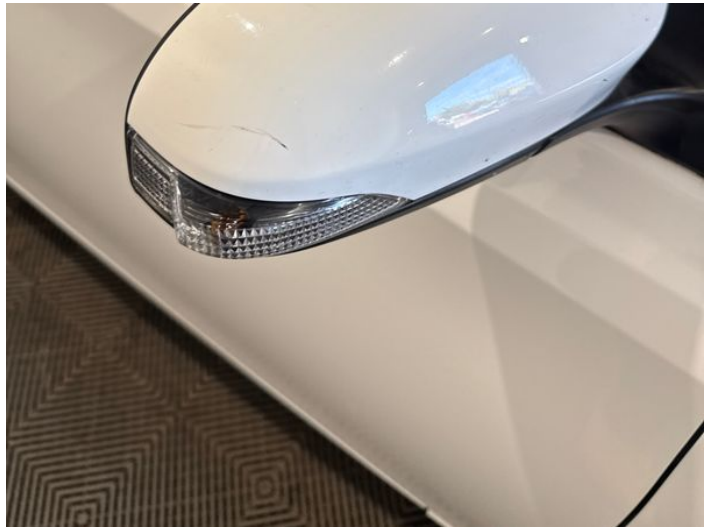
18: Door Mirror Assy osf  
Scratched (Painted)  
Over 25mm Thru Paint

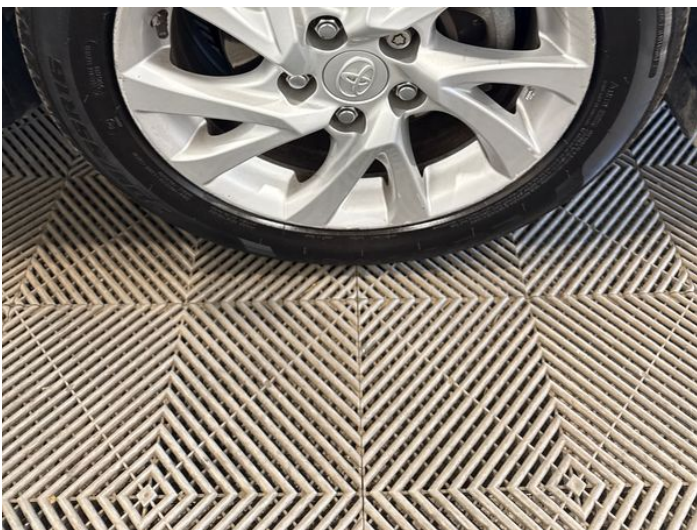
19: Wheel osf  
Scratched  
Over 50mm
