# VEHICLE INSPECTION REPORT

**MT18JPV**

## Citroen Grand C4 Picasso 1.6 BlueHDi Flair 5dr

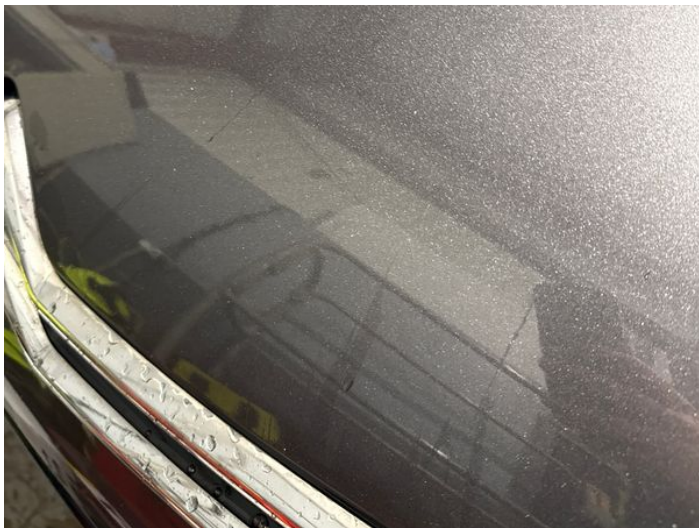
1: Bonnet  
Chipped  
1 To 5

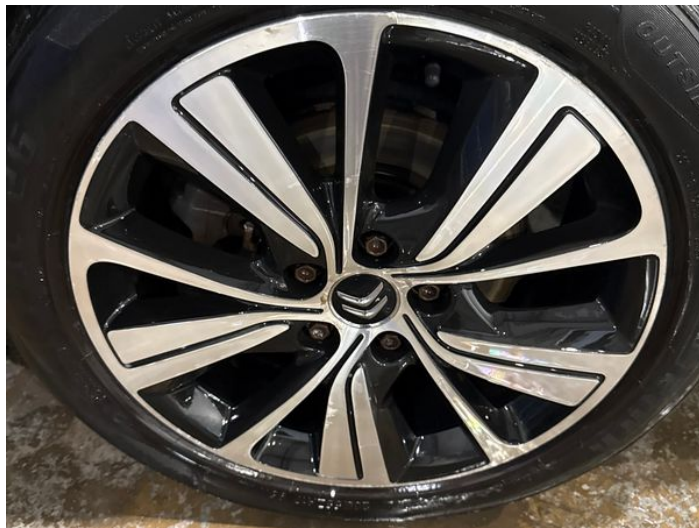
2: Wheel nsf  
Scratched  
Over 50mm

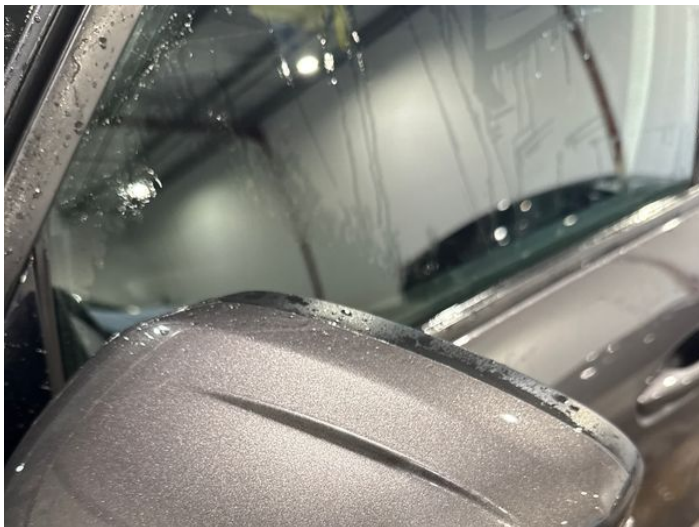
3: Door Mirror Assy nsf  
Scratched (Painted)  
UpTo 25mm Thru Paint

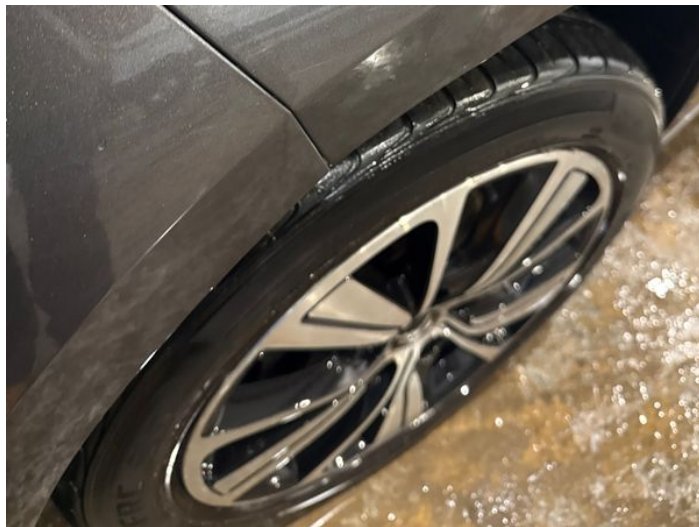
4: Wing nsf  
Scratched  
UpTo 25mm Thru Paint

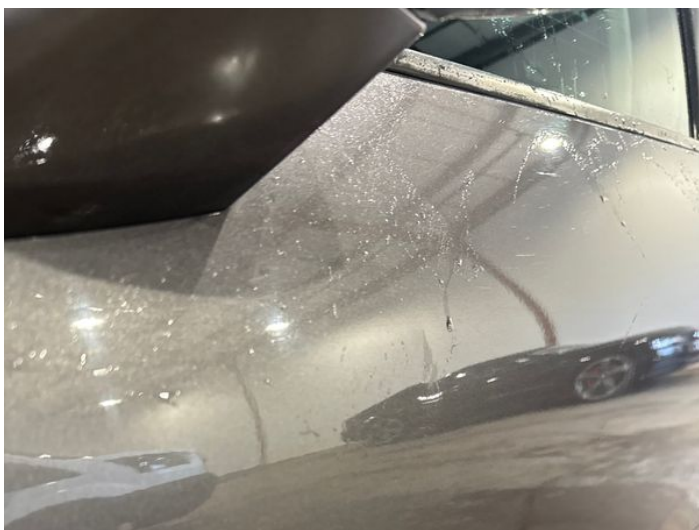
5: Door nsf  
Dented  
Between 10mm + 30mm

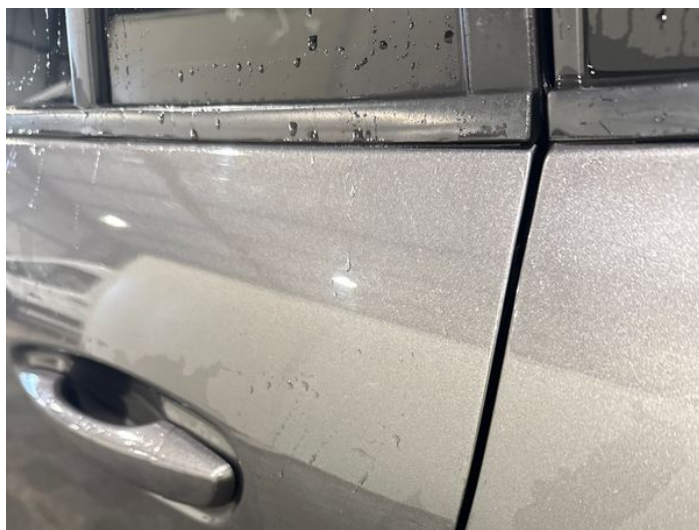
6: Door nsr  
Rusted  
Over 5mm

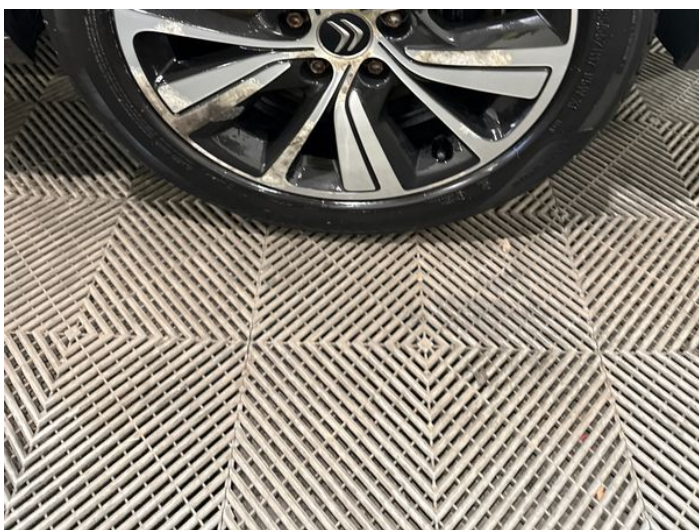
7: Wheel nsr  
Corroded  
Light

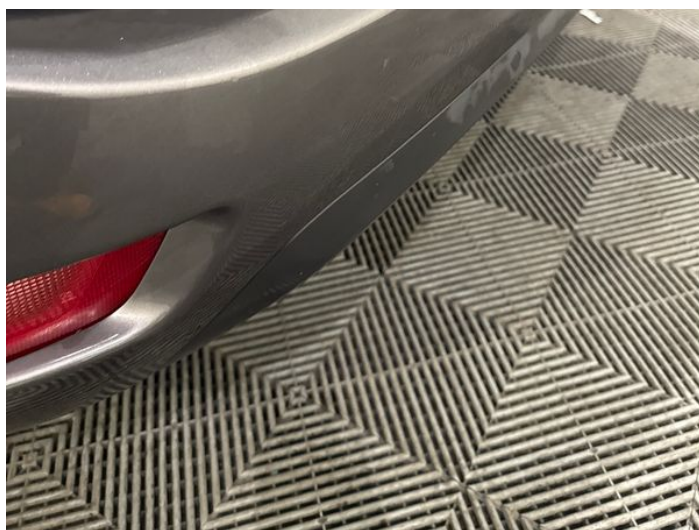
8: Bumper Rear  
Scratched  
25 to 100mm Thru Paint

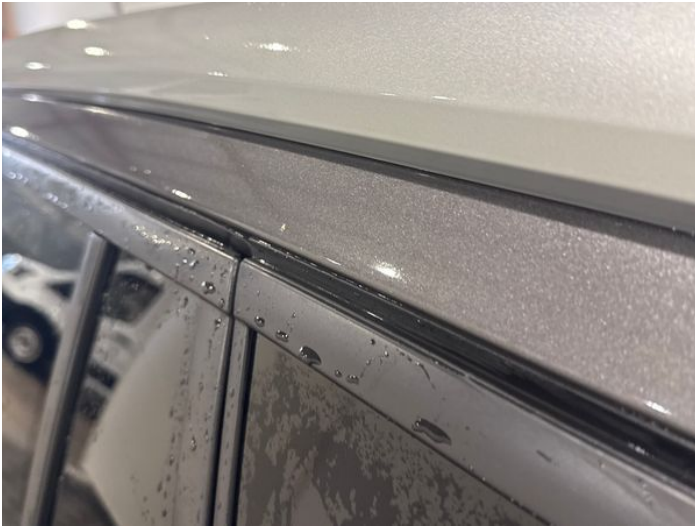
9: B Post ns  
Dented  
Between 10mm + 30mm

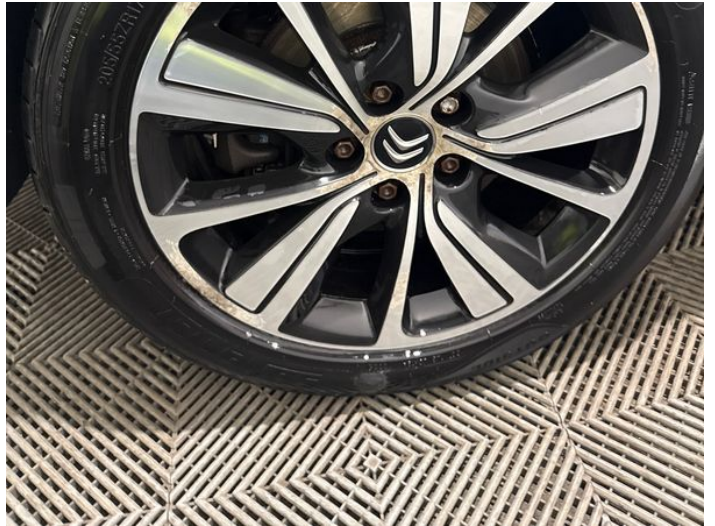
10: Wheel osr  
Corroded  
Light

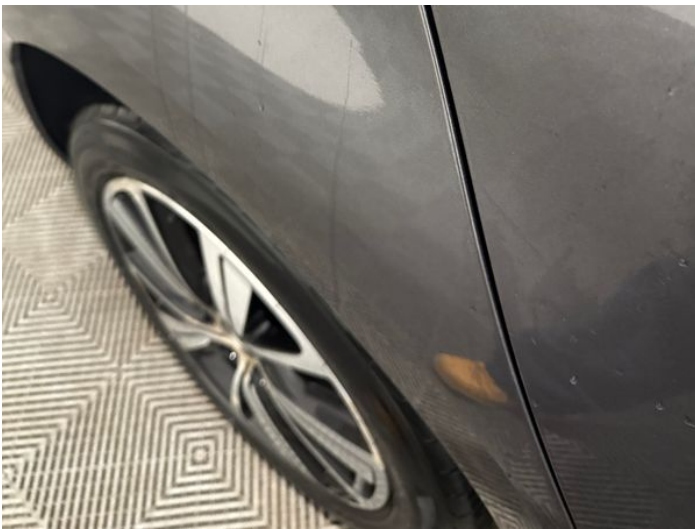
11: Qtr Panel osr  
Chipped  
Edge Chip

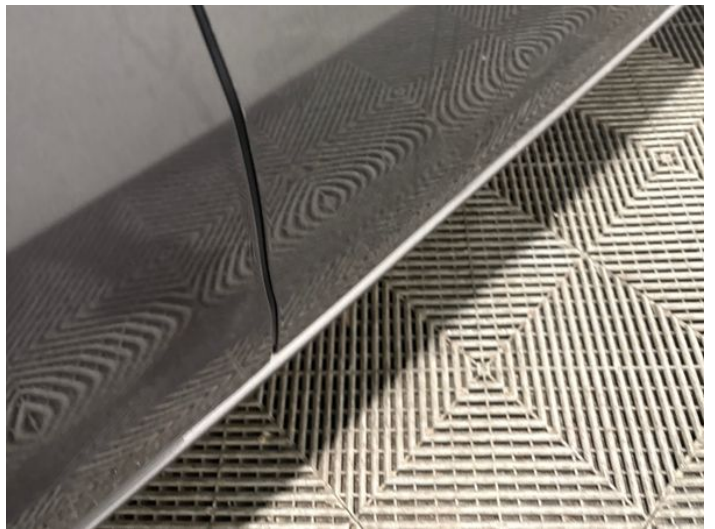
12: Door osf  
Chipped  
Edge Chip

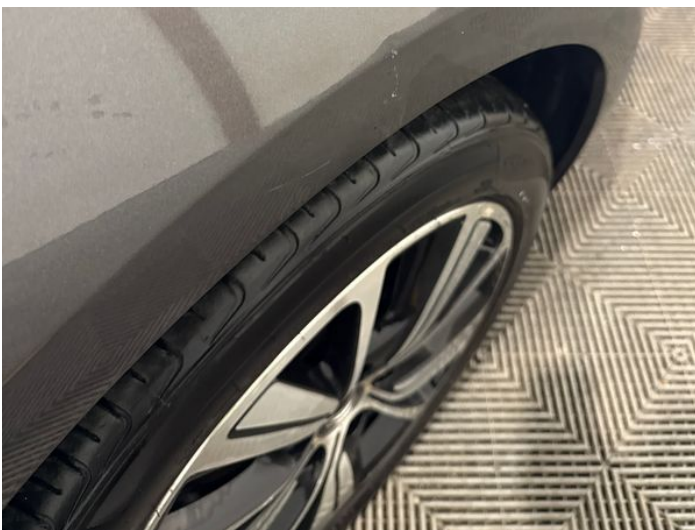
13: Wing nsf  
Dented  
Between 10mm + 30mm

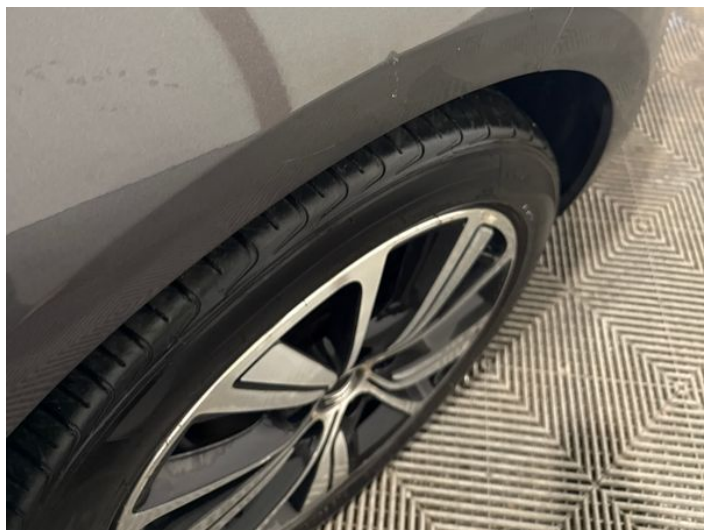
14: Wing osf  
Dented  
Between 10mm + 30mm

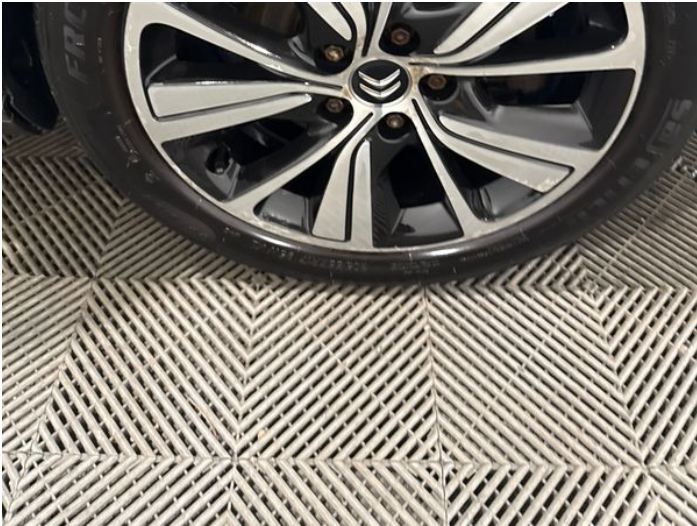
15: Wheel osf  
Scratched  
Over 50mm

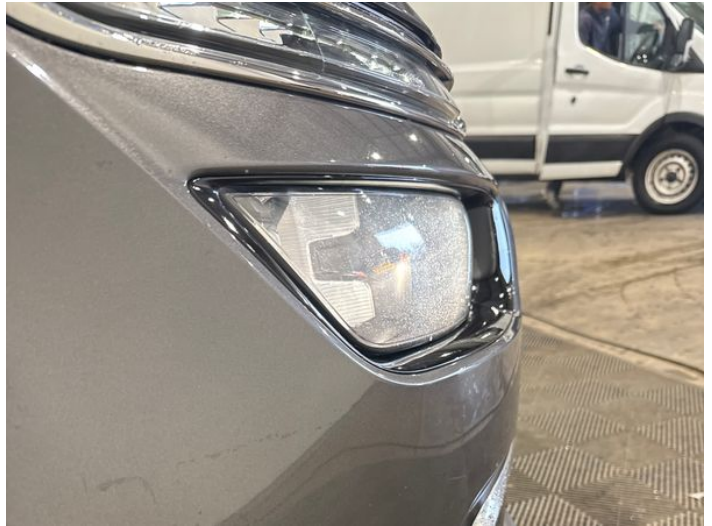
16: Bumper Front  
Scratched  
25 to 100mm Thru Paint

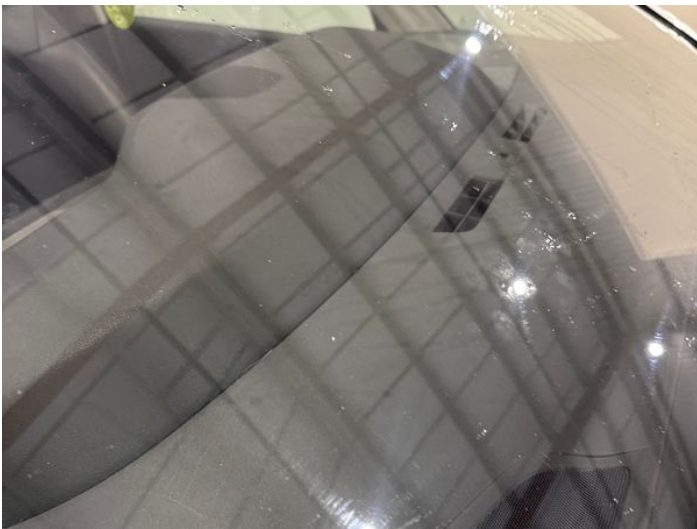
17: Screen Front  
Chipped  
UpTo 10mm

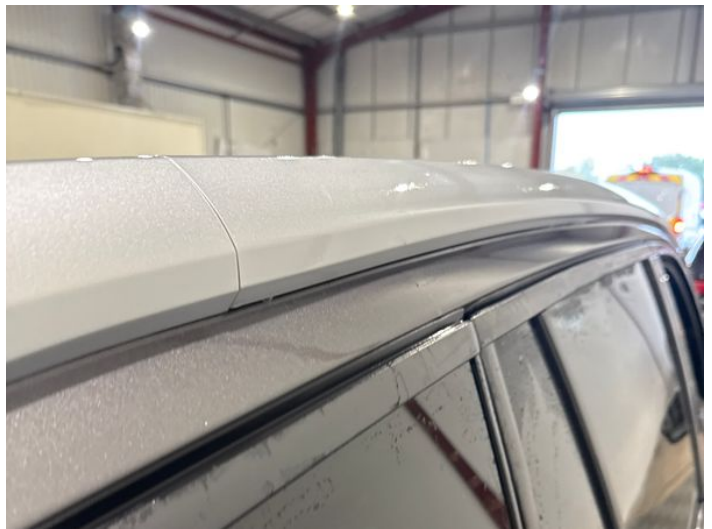
18: B Post os  
Dented  
Between 10mm + 30mm
