# VEHICLE INSPECTION REPORT

**DG60HDH**

## Volkswagen Tiguan 2.0 TDi Match 5dr DSG

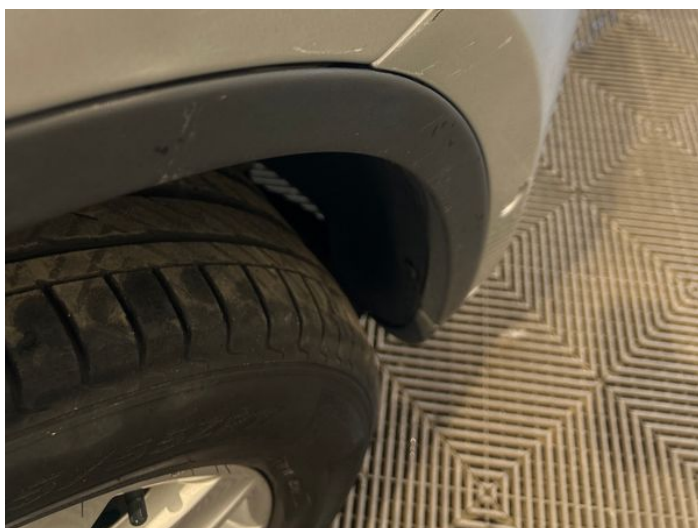
1: Wing of  
Dented  
With Paint Damage

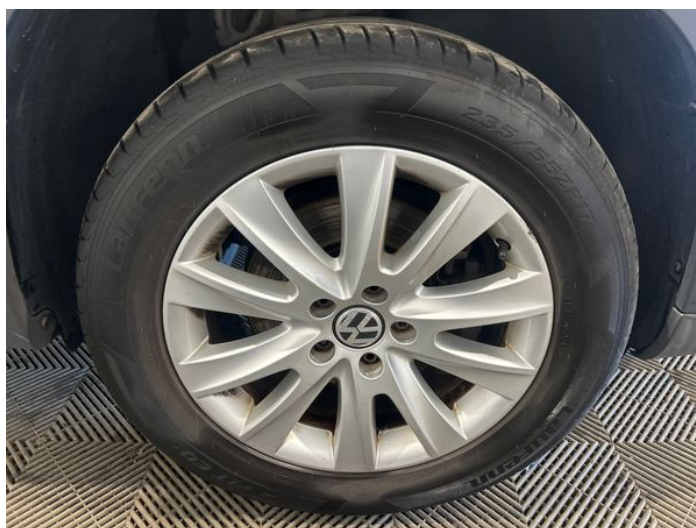
2: Wheel of  
Scratched  
Up To 50mm

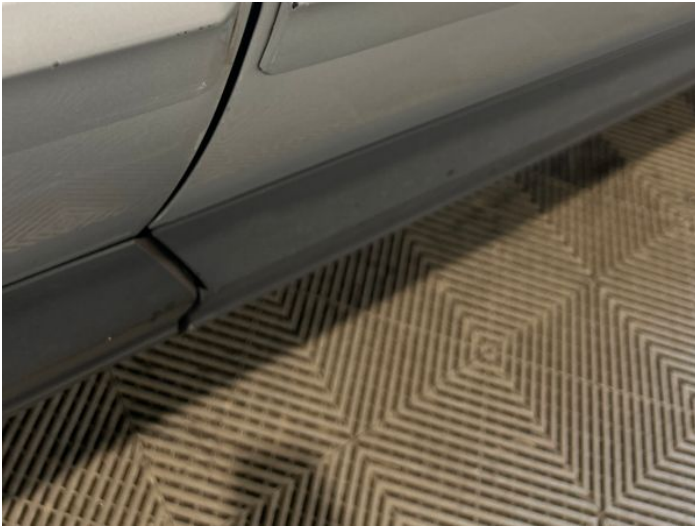
3: Door Moulding osf  
Scratched (Painted)  
UpTo 25mm Thru Paint

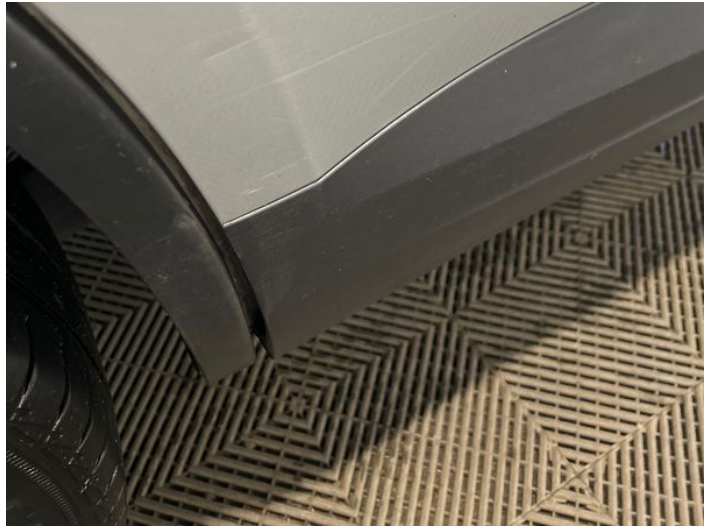
4: Door osr  
Scratched  
Over 25mm Thru Paint

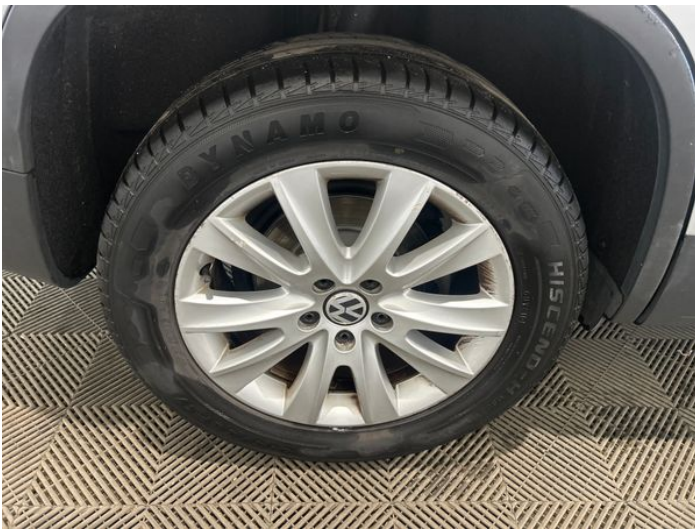
5: Wheel osr  
Scratched  
Over 50mm

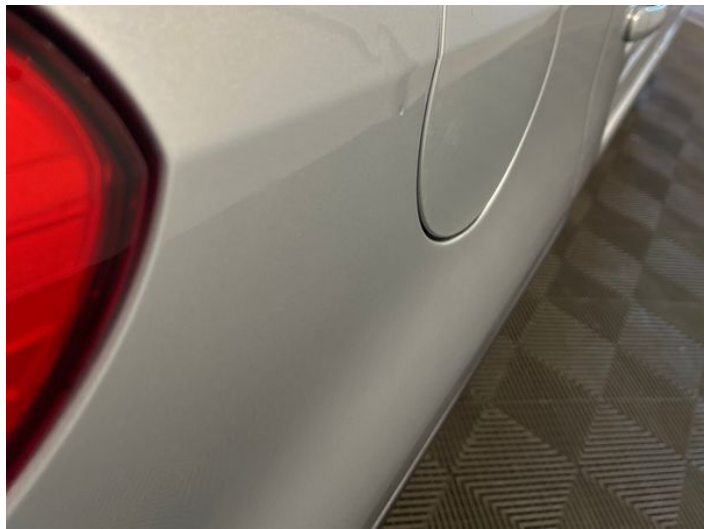
6: Qtr Panel osr  
Dented  
Between 10mm + 30mm

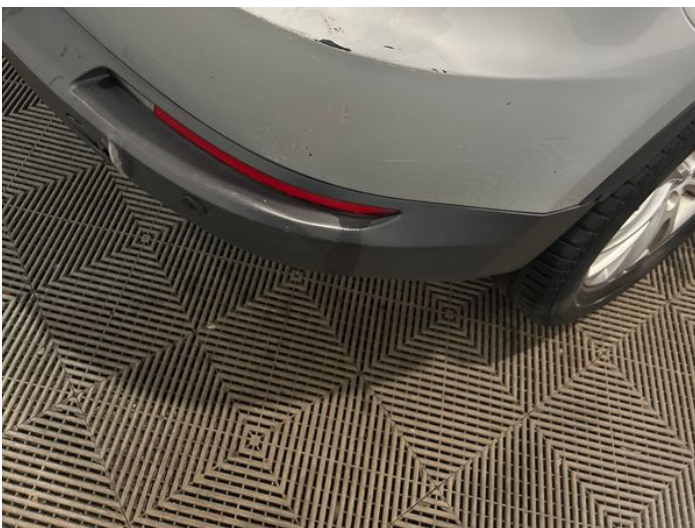
7: Bumper Rear  
Scratched  
Over 100mm Thru Paint

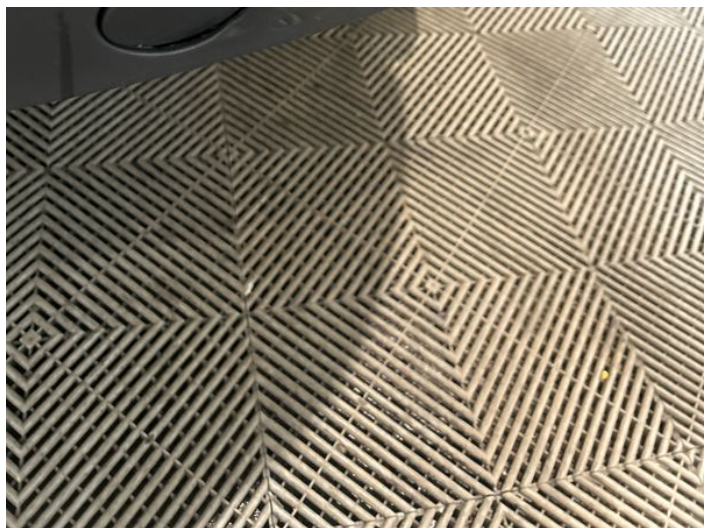
8: Bumper Rear Moulding  
Broken  
Replace

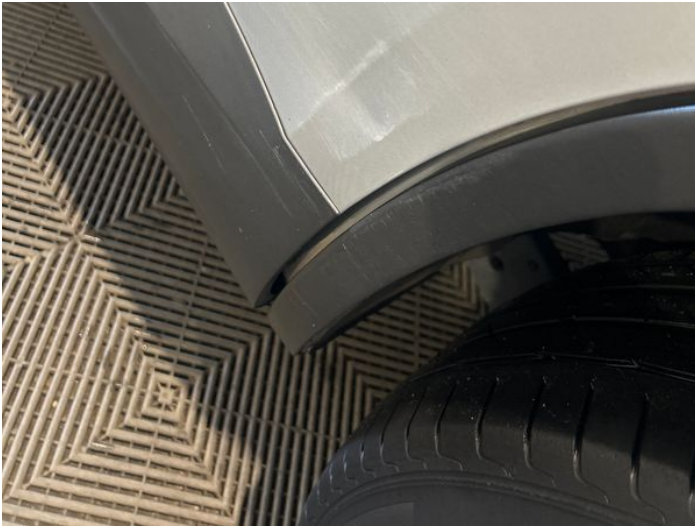
9: Door nsr  
Dented  
With Paint Damage

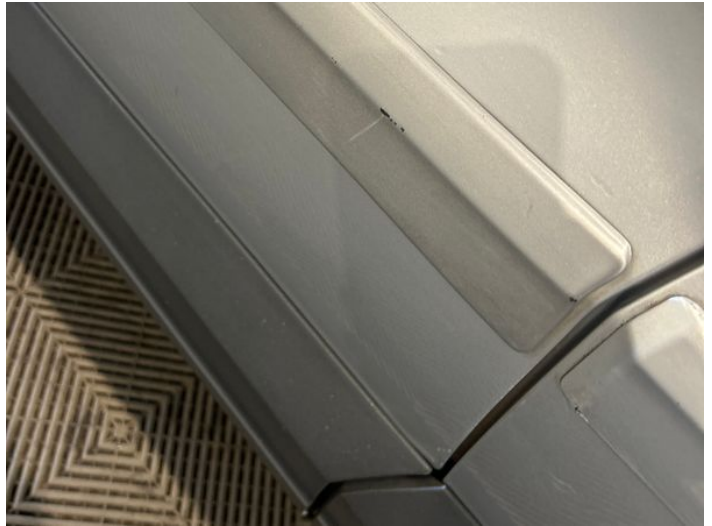
10: Door Moulding nsf  
Scratched (Painted)  
UpTo 25mm Thru Paint

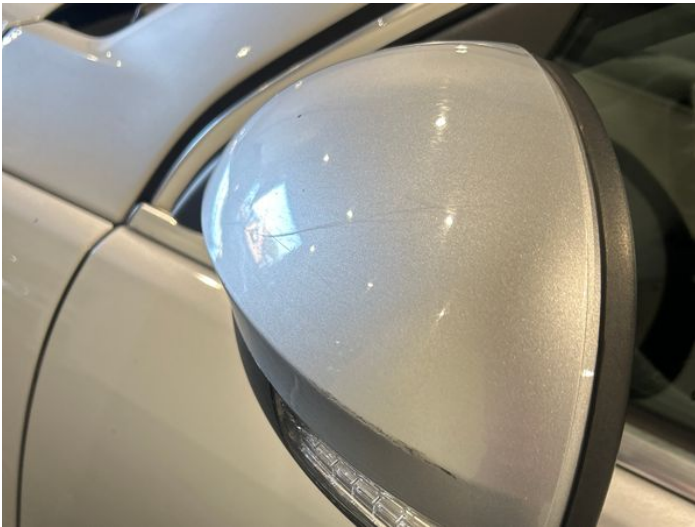
11: Door Mirror Assy nsf  
Scratched (Painted)  
Over 25mm Thru Paint

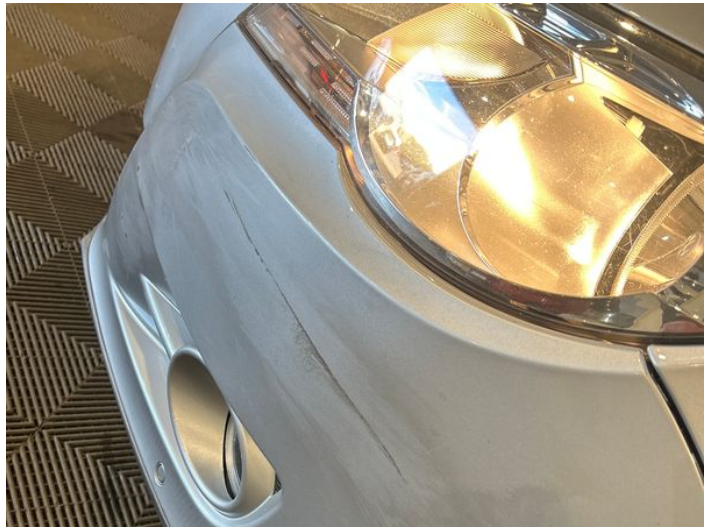
12: Bumper Front  
Poor Previous Repair  
Poor Paint

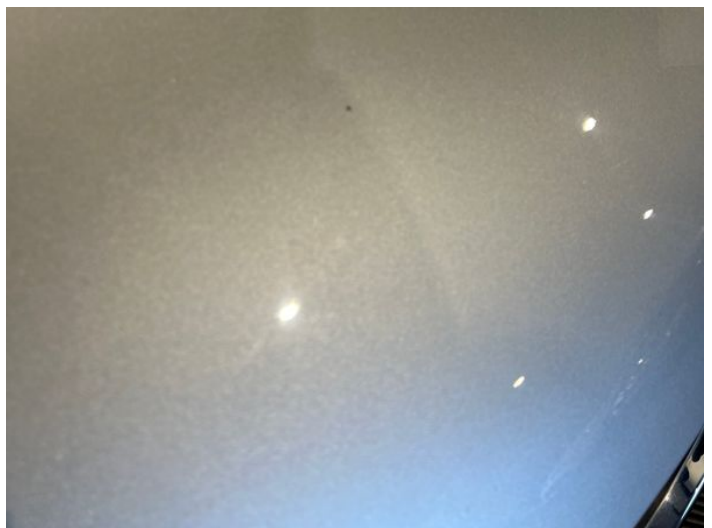
14: Bonnet  
Chipped  
1 To 5

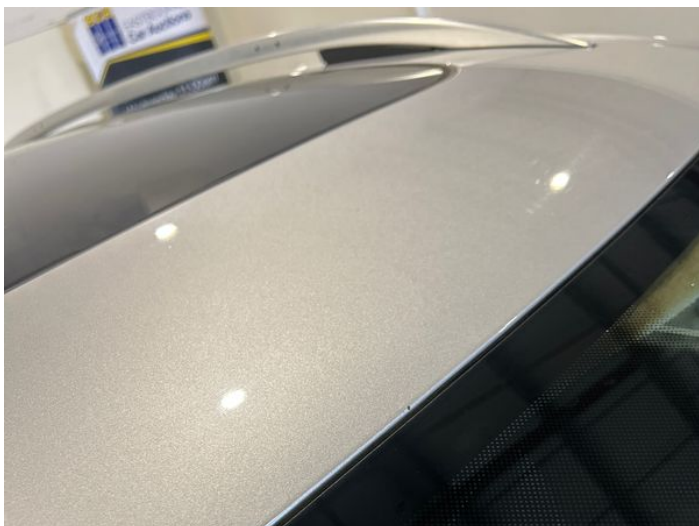
15: Roof  
Chipped  
1 To 5
