VEHICLE INSPECTION REPORT

AF57ZDD

Land Rover Discovery 2.7 Td V6 SE 5dr Auto

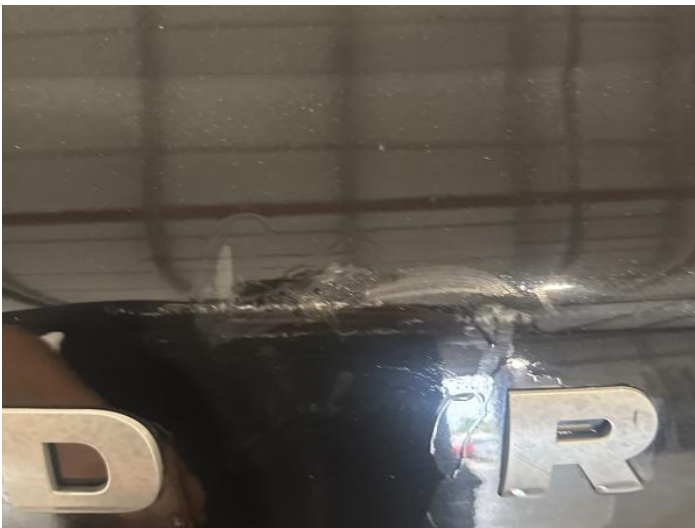
1: Bonnet
Scratched
Over 25mm Thru Paint

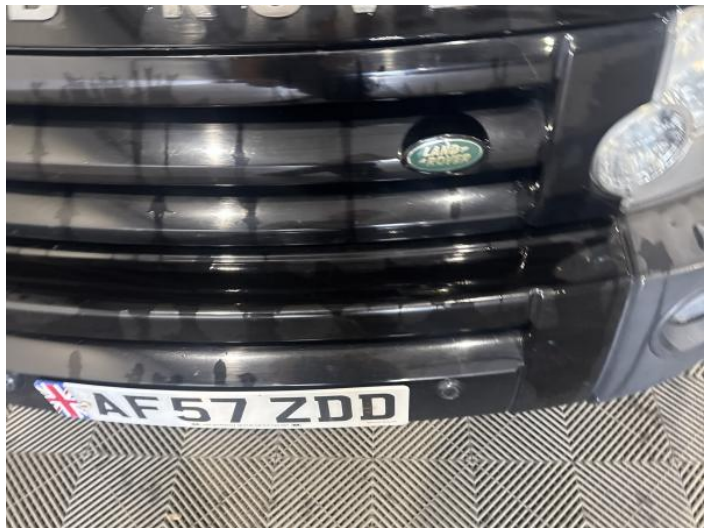
2: Bumper Front
Scratched
25 to 100mm Thru Paint

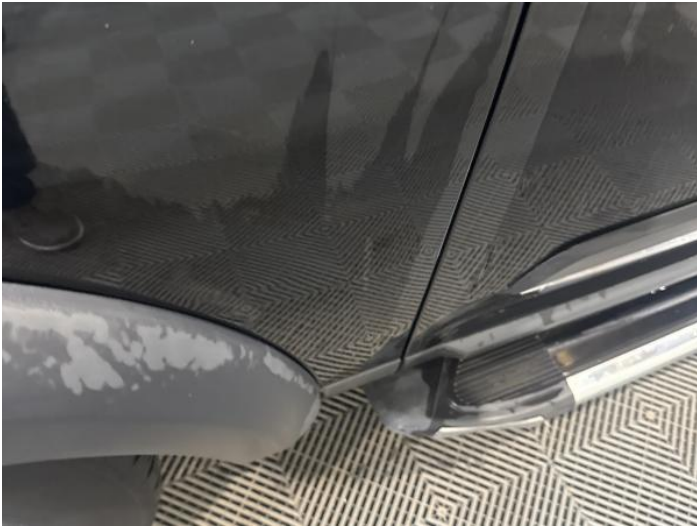
3: Wing nsf
Dented
Between 10mm + 30mm

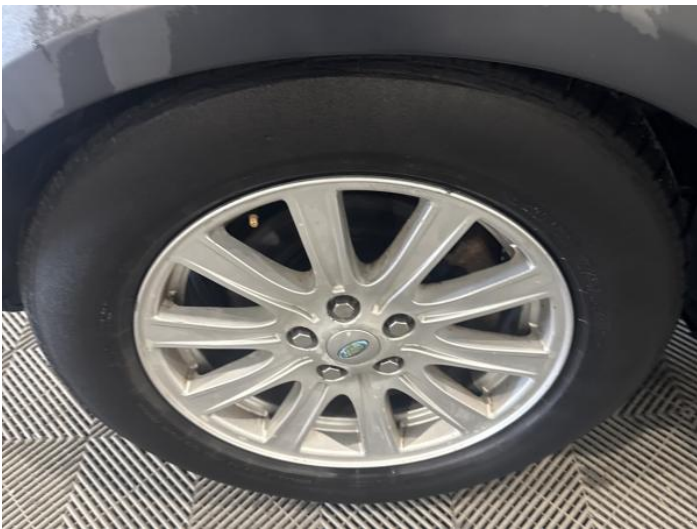
5: Wheel nsf
Scratched
Over 50mm

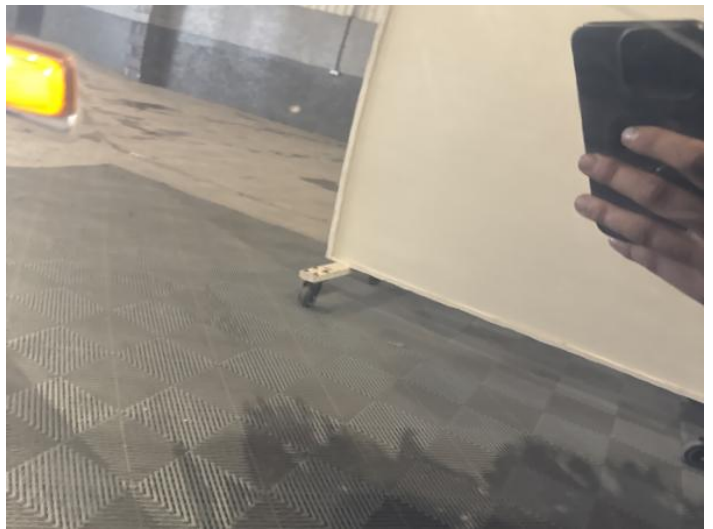
6: Door nsf
Chipped
1 To 5

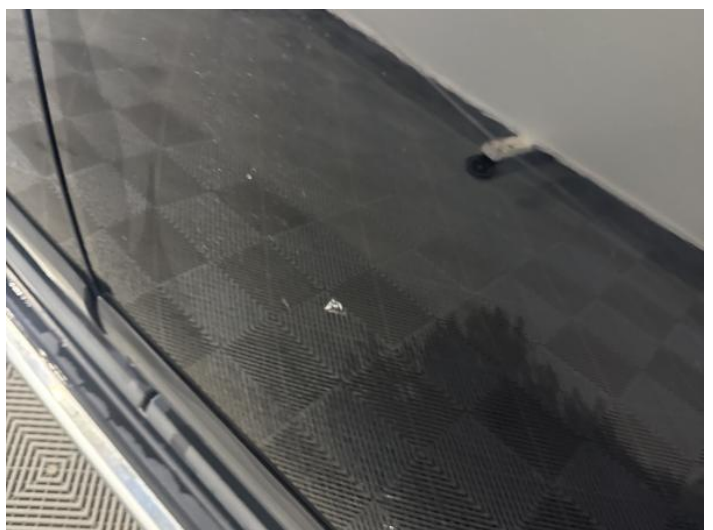
8: Door nsr
Scratched
UpTo 25mm Thru Paint

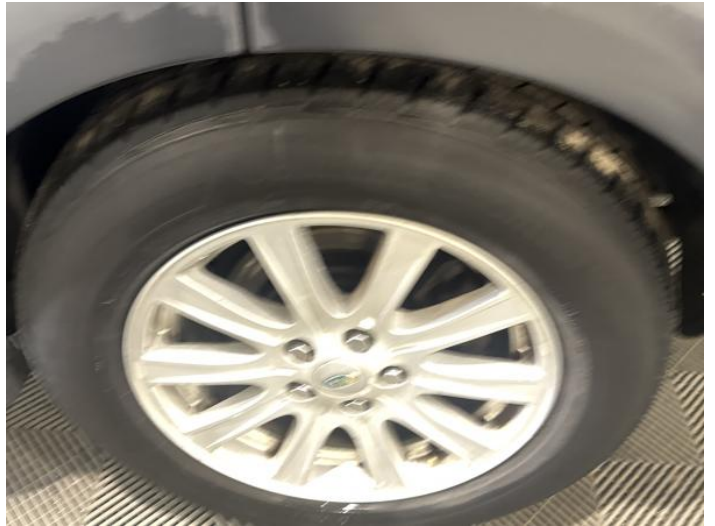
10: Wheel nsr
Scratched
Over 50mm

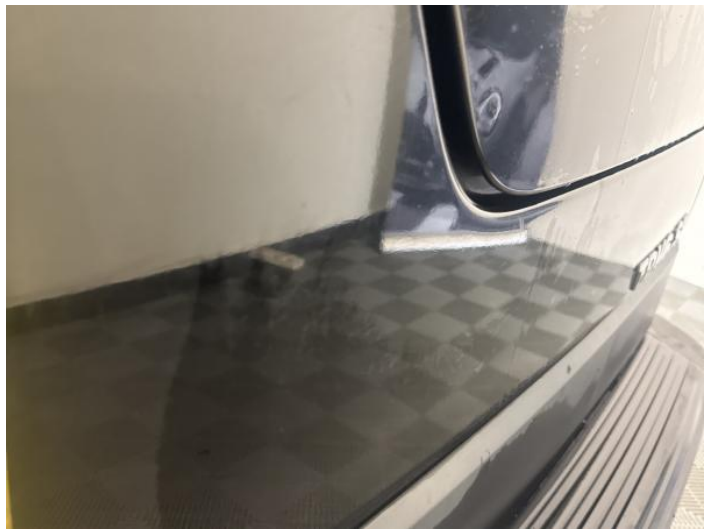
12: Boot Lid
Dented
2 Or Less UpTo 10mm

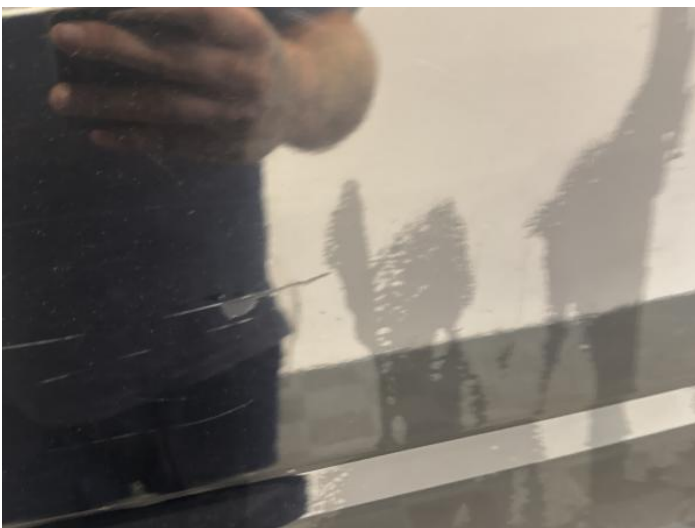
13: Qtr Panel osr
Scratched
Over 25mm Thru Paint

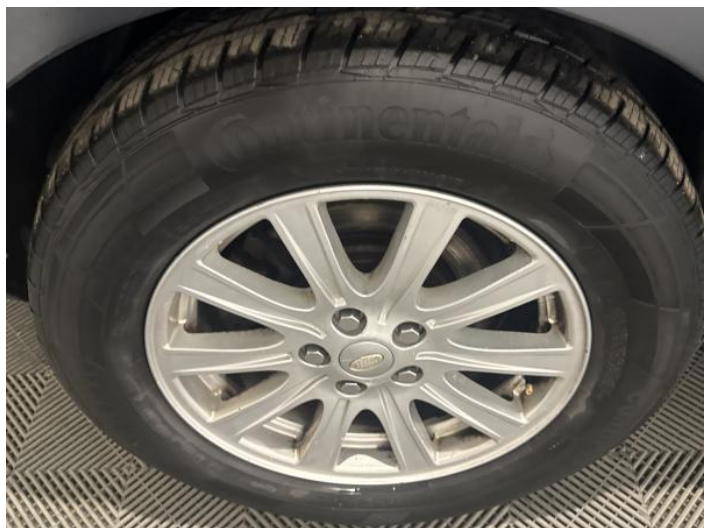
14: Wheel osr
Scratched
Over 50mm

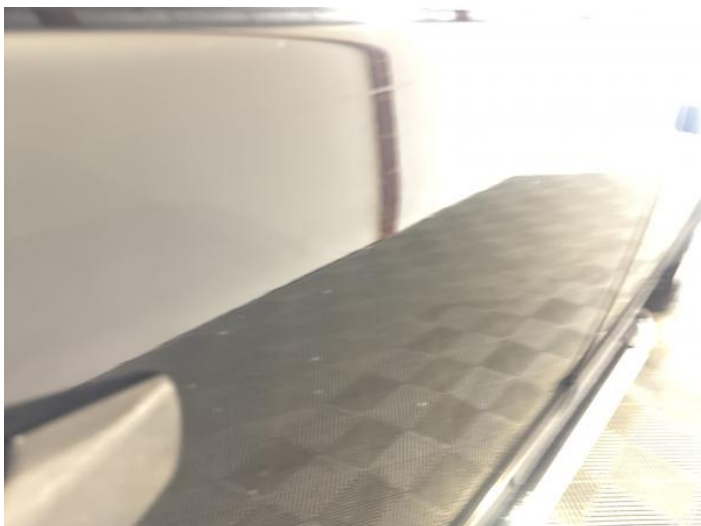
15: Door osr
Dented
With Paint Damage

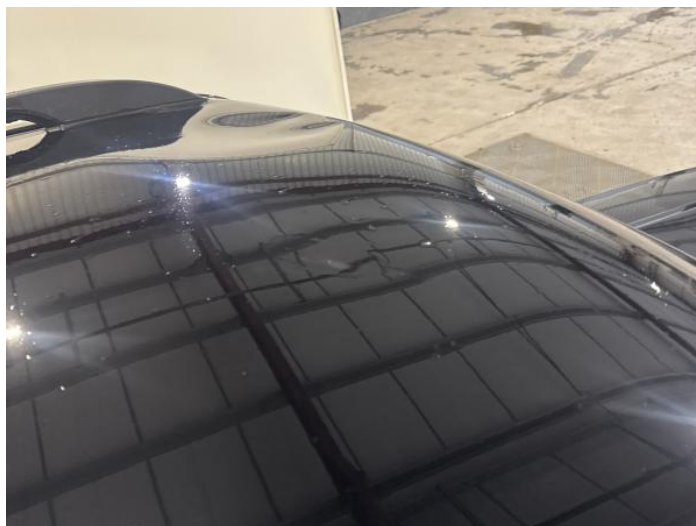
16: Roof
Dented
Between 10mm + 30mm

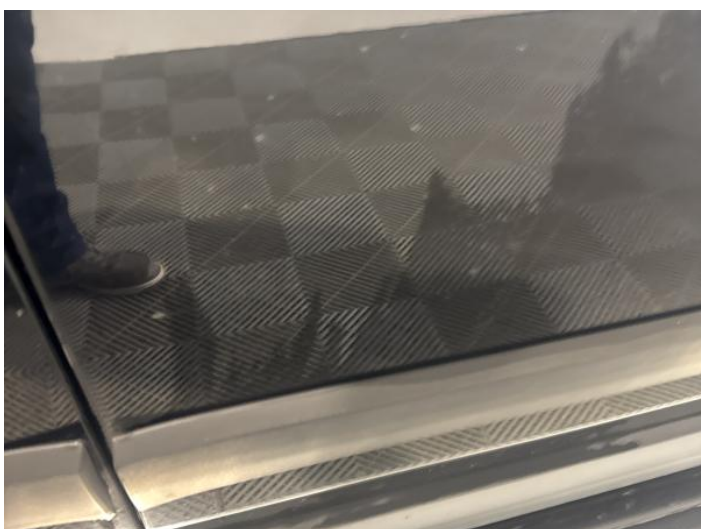
17: Door osf
Chipped
1 To 5

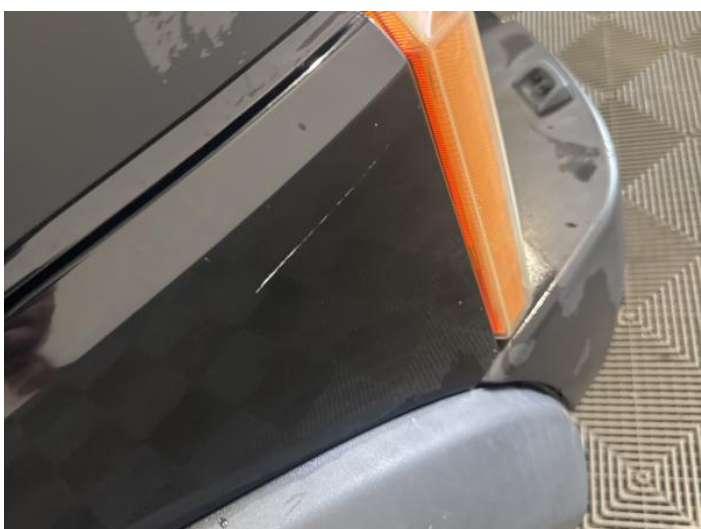
19: Wing osf
Scratched
Over 25mm Thru Paint

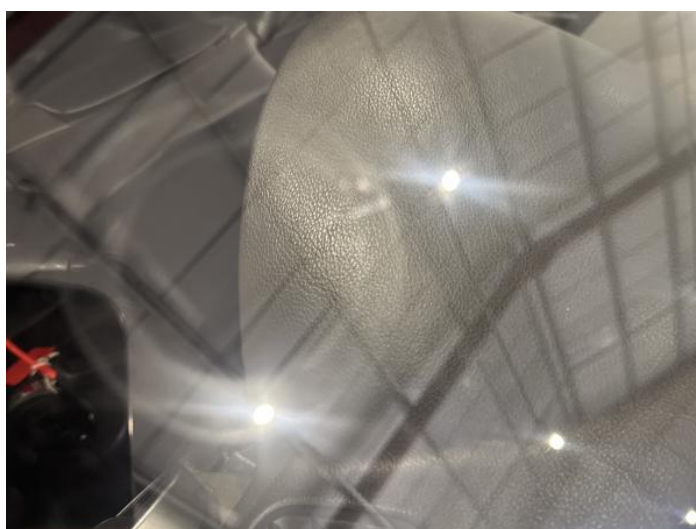
20: Screen Front
Chipped
UpTo 10mm

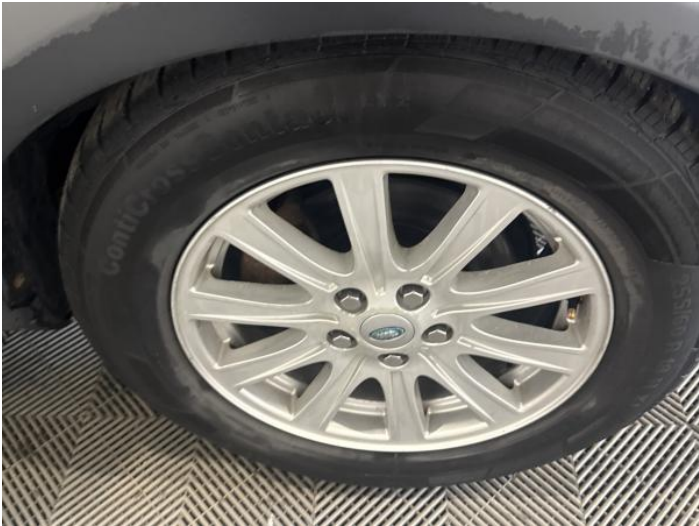
21: Wheel osf
Scratched
Over 50mm
