VEHICLE INSPECTION REPORT

BD64VYC

Peugeot 5008 1.6 HDi Active 5dr

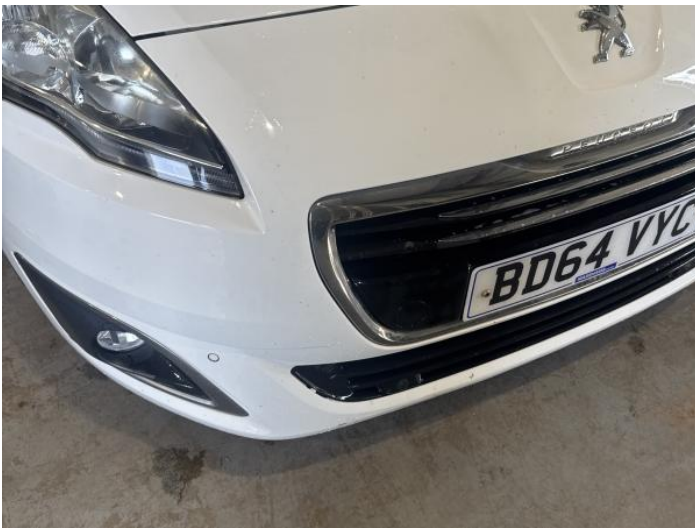
1: Bumper Front
Scratched
Over 100mm Thru Paint

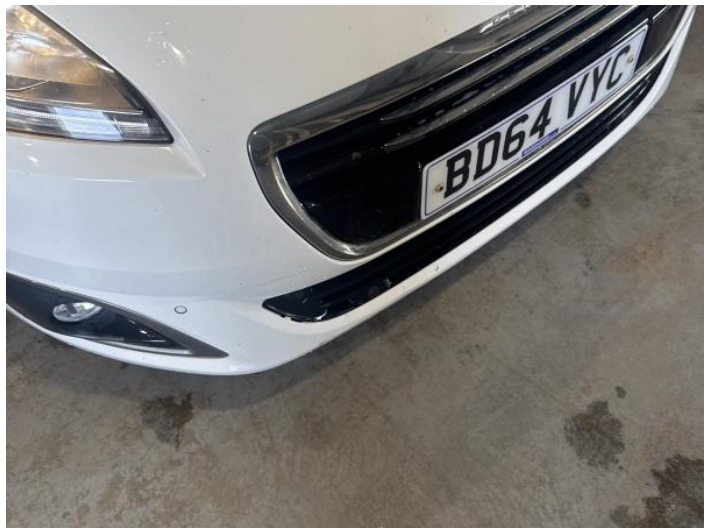
2: Bumper Front Grill
Broken
Replace

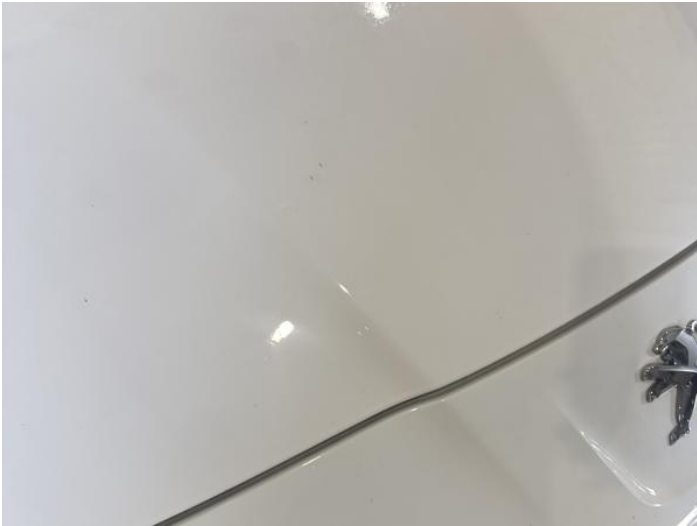
3: Bonnet
Chipped
1 To 5

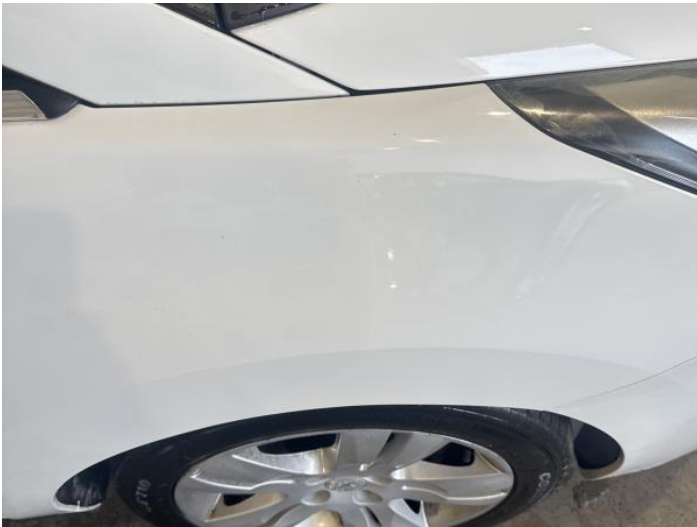
5: Wing osf
Chipped
1 To 5

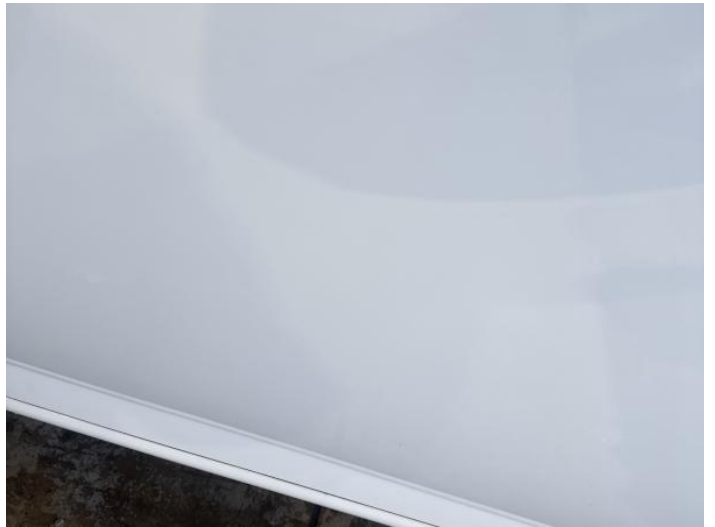
6: Door osf
Chipped
1 To 5

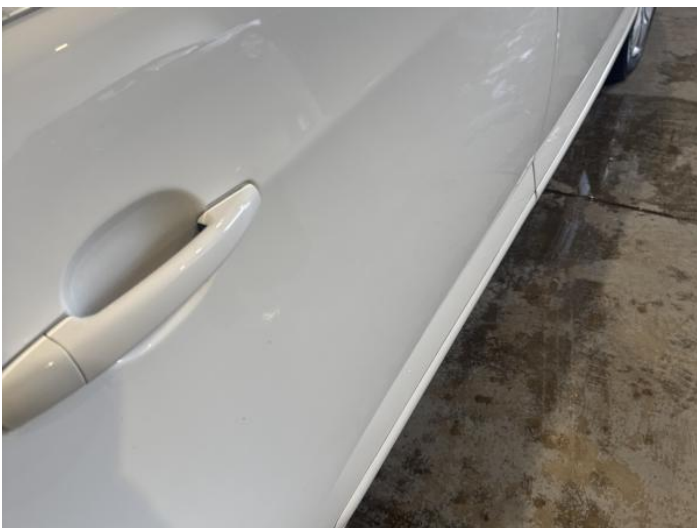
7: Door osr
Dented
2 Or Less UpTo 10mm

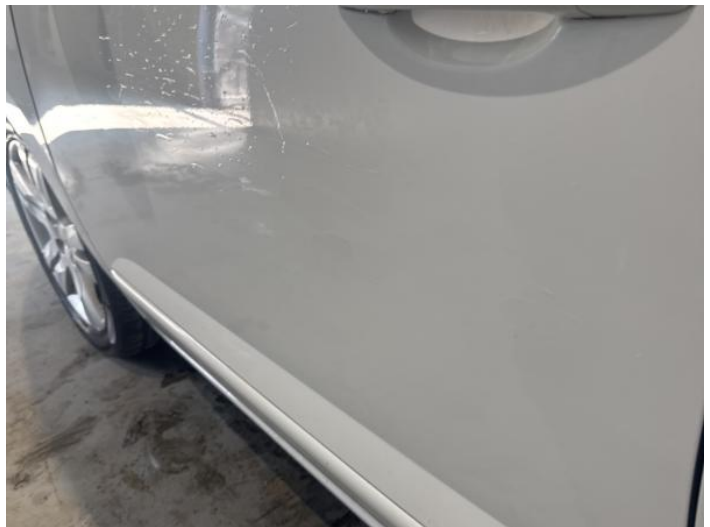
16: Door nsf
Dented
Over 2 UpTo 10mm

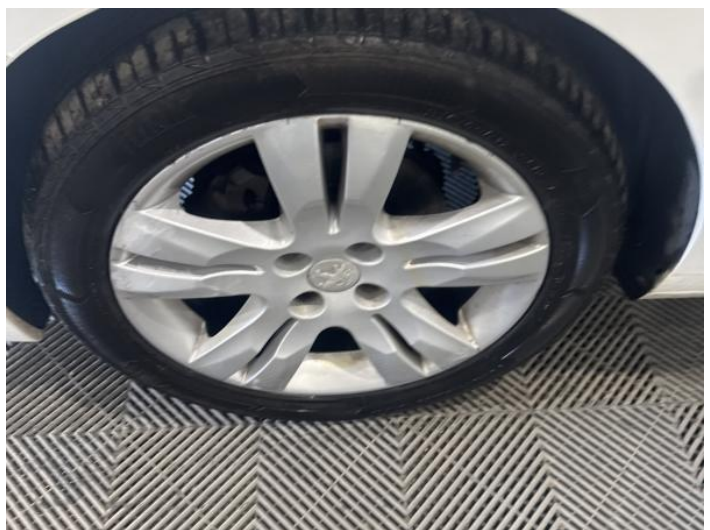
18: Wheel nsf
Scratched
Over 50mm

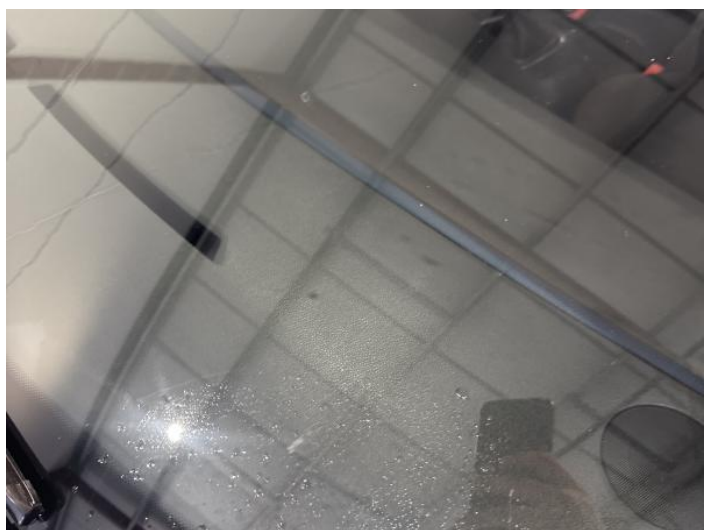
20: Screen Front
Chipped
UpTo 10mm
