VEHICLE INSPECTION REPORT

SC66XCE

Dacia Sandero 1.2 16V 75 Ambiance 5dr

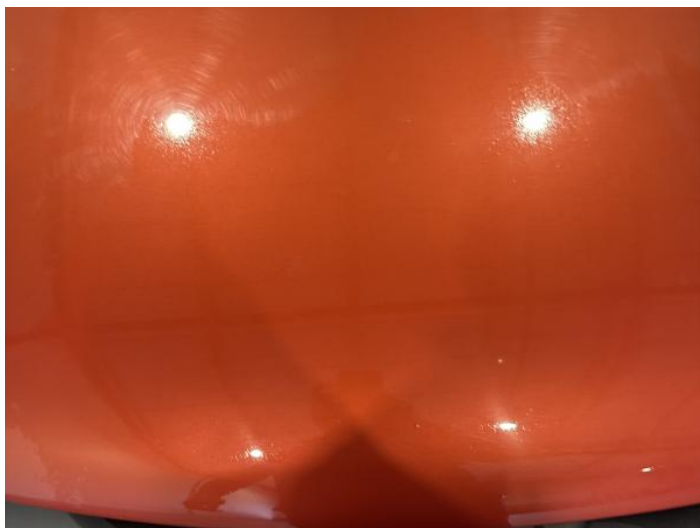
1: Bonnet
Dented
With Paint Damage

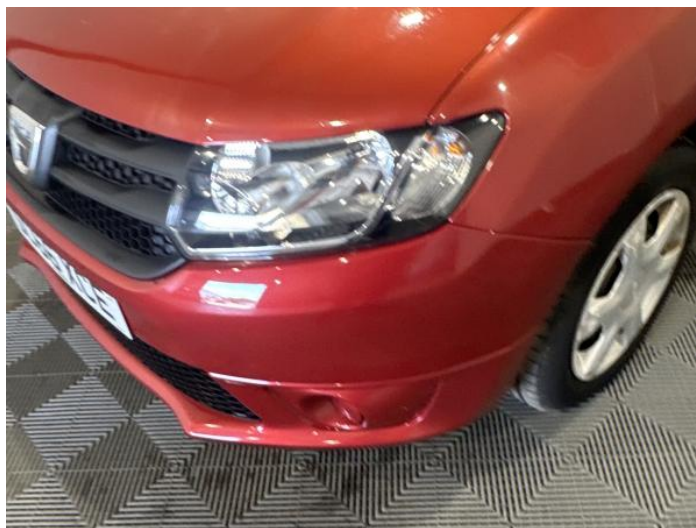
2: Bumper Front
Chipped
Multiple Chips

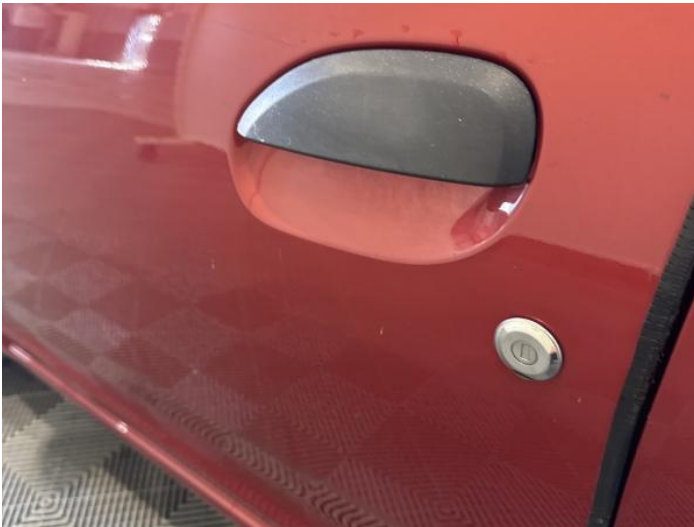
5: Door nsf
Dented
Over 2 UpTo 10mm

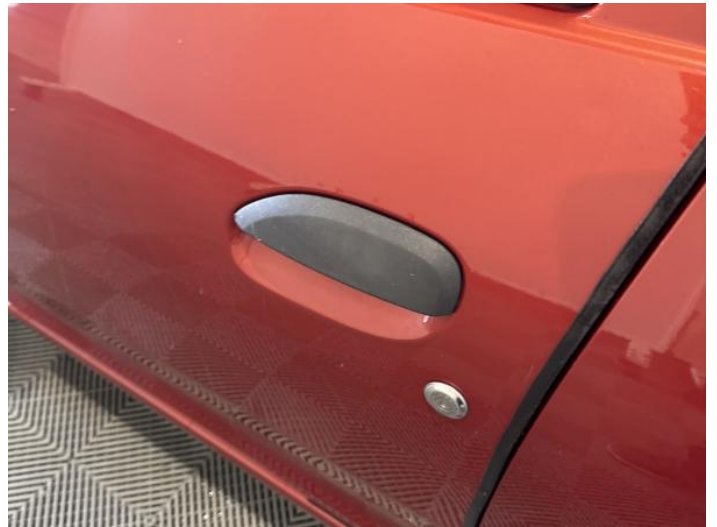
6: Door nsf
Chipped
1 To 5

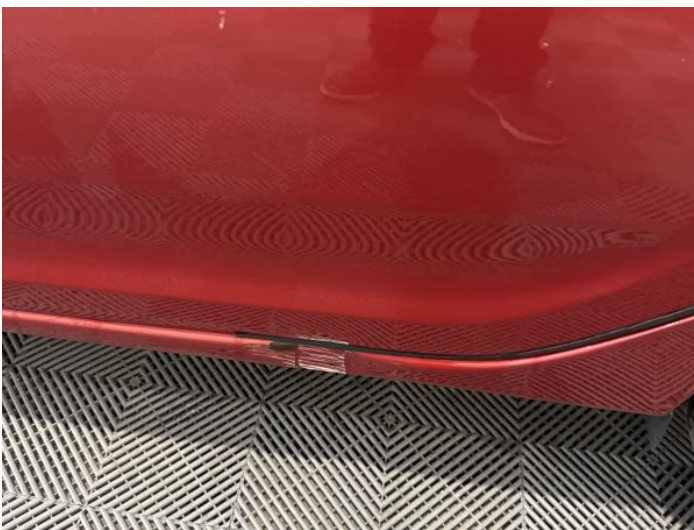
7: Door nsr
Dented
With Paint Damage

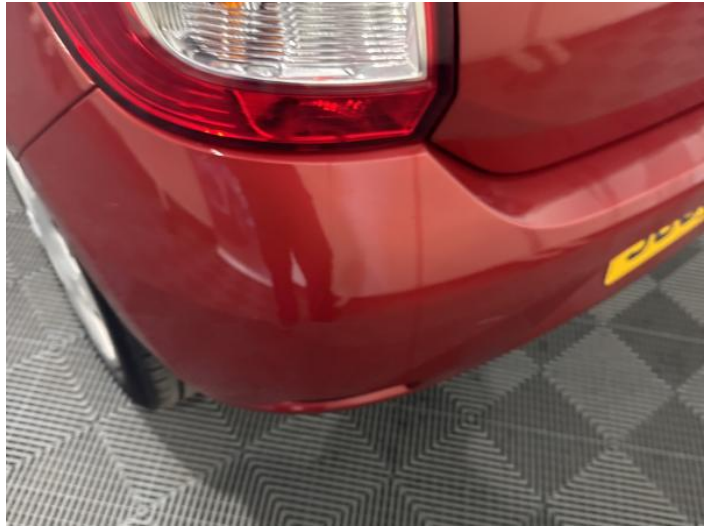
10: Bumper Rear
Scratched
Over 100mm Thru Paint

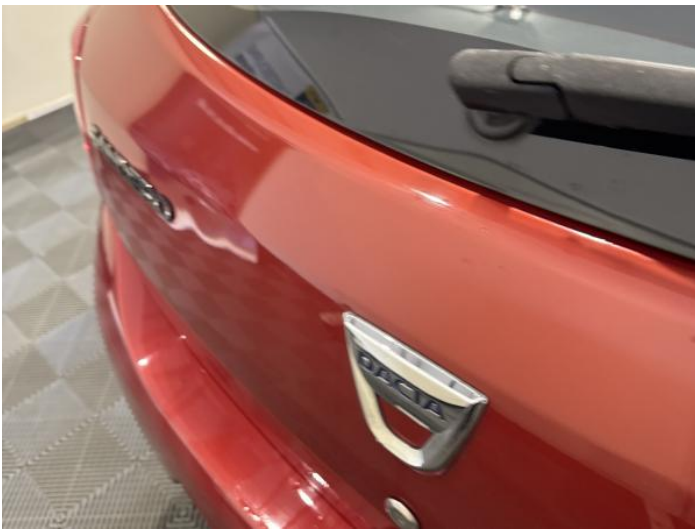
11: Boot Lid
Dented
Over 30mm

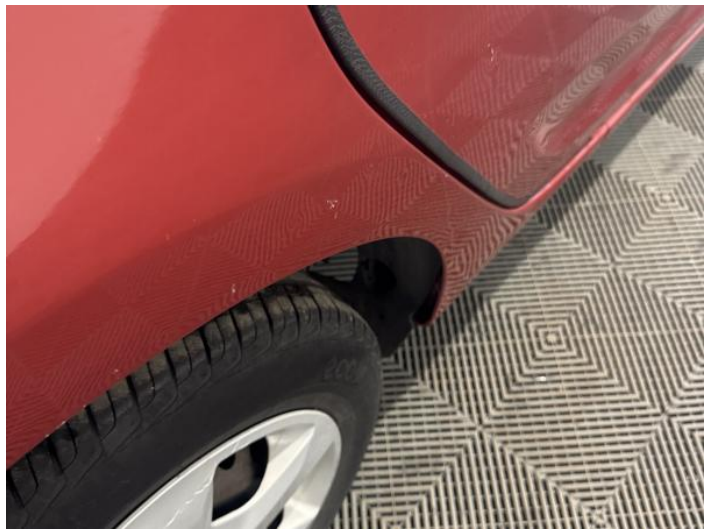
12: Qtr Panel osr
Dented
Over 30mm

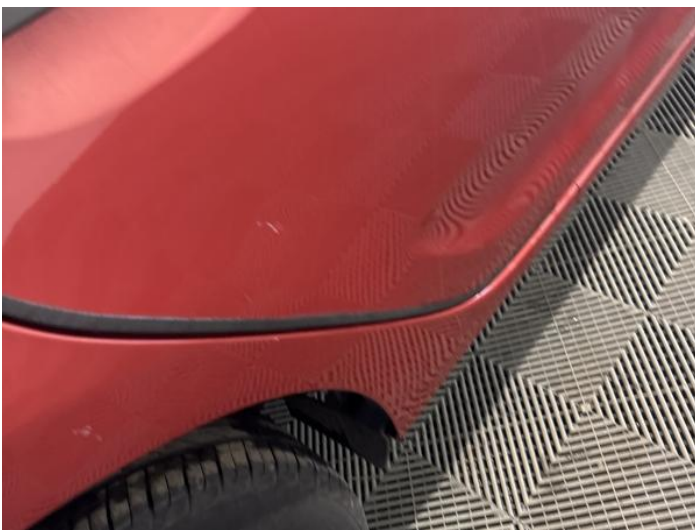
13: Door osr
Dented
With Paint Damage

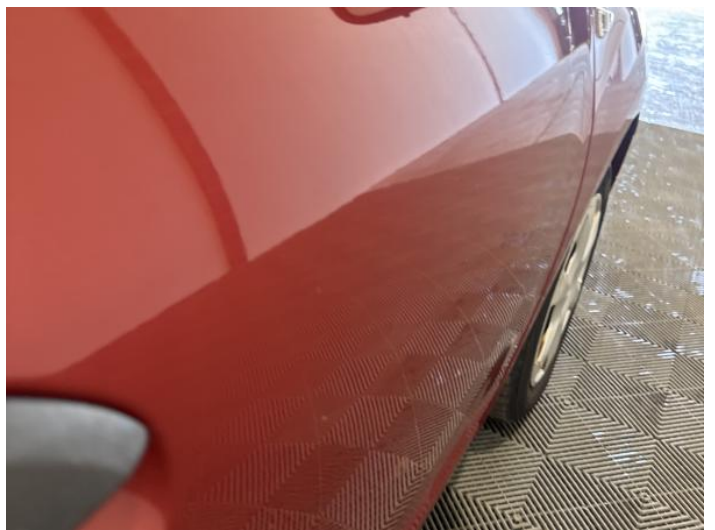
14: Door osf
Dented
Over 2 UpTo 10mm
