## **VEHICLE INSPECTION REPORT**

LR69KGZ

### DS Ds 3 1.2 PureTech 130 Performance Line 5dr EAT8

**Eastbourne Car Auctions**

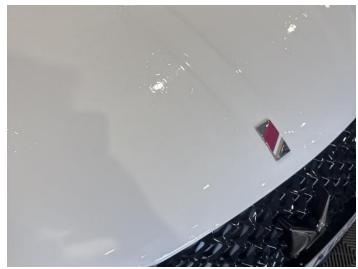
1: Bonnet Chipped 1 To 5

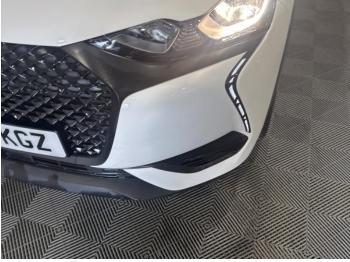
2: Bumper Front Scratched 25 to 100mm Thru Paint

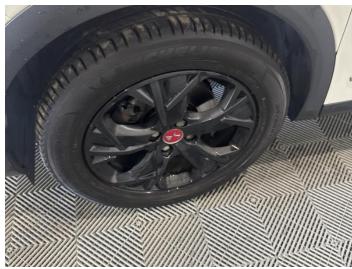
4: Wheel nsf Scratched Up To 50mm

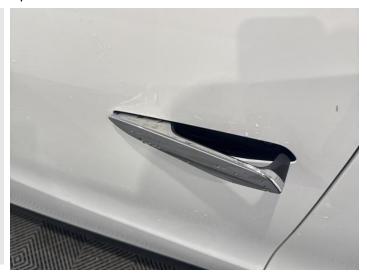
6: Door nsf Chipped 1 To 5

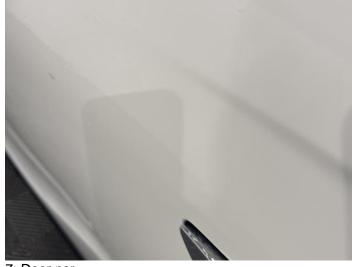
7: Door nsr Chipped 1 To 5

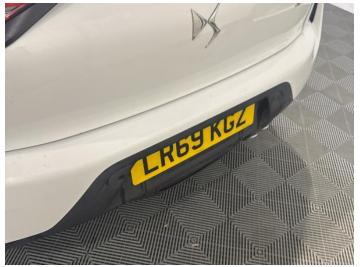
9: Bumper Rear Scratched 25 to 100mm Thru Paint

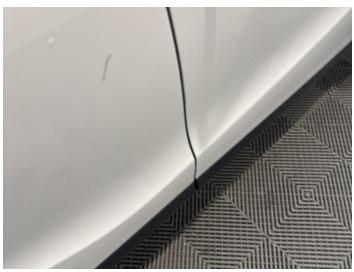
12: Door osrScratchedOver 25mm Not Thru Paint

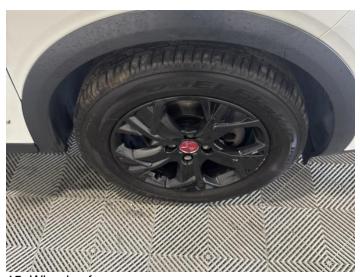
15: Wheel osf Scratched Over 50mm
