# VEHICLE INSPECTION REPORT

**YH59DNV**

## BMW 3 Series 325d M Sport 5dr Step Auto

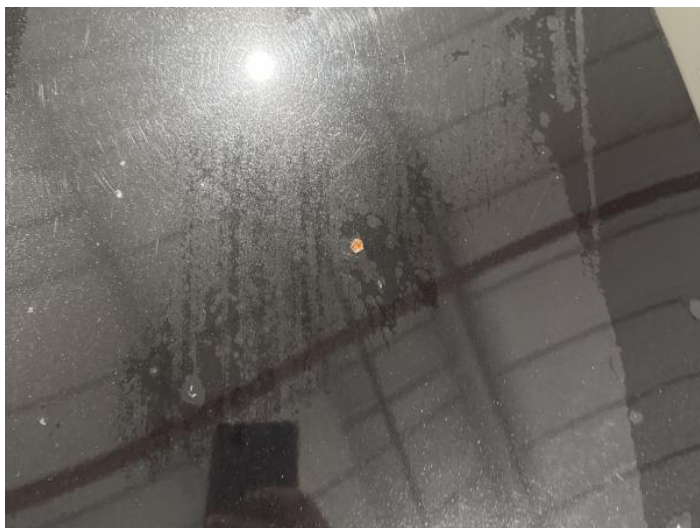
1: Bonnet  
Chipped  
Over 5mm

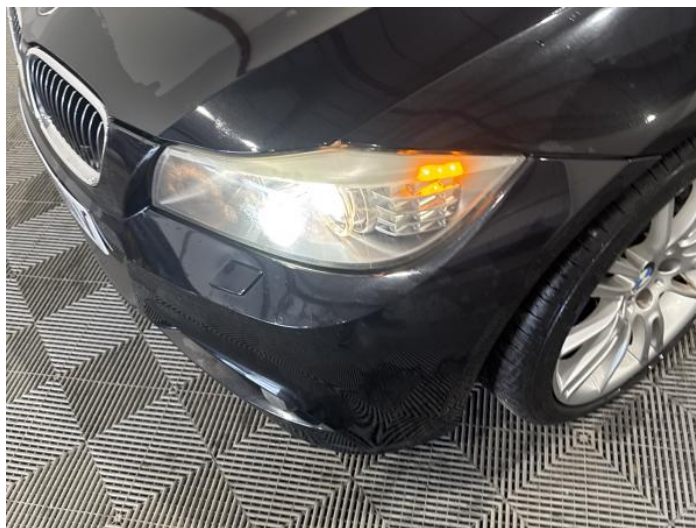
2: Bumper Front  
Scratched  
25 to 100mm Thru Paint

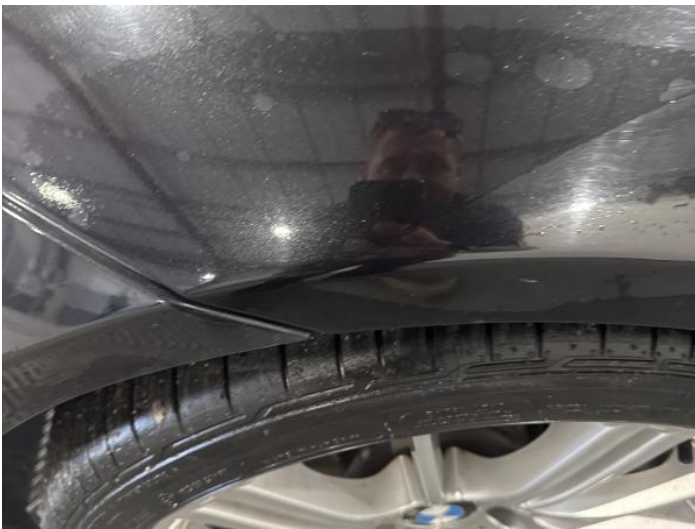
5: Wing nsf  
Chipped  
1 To 5

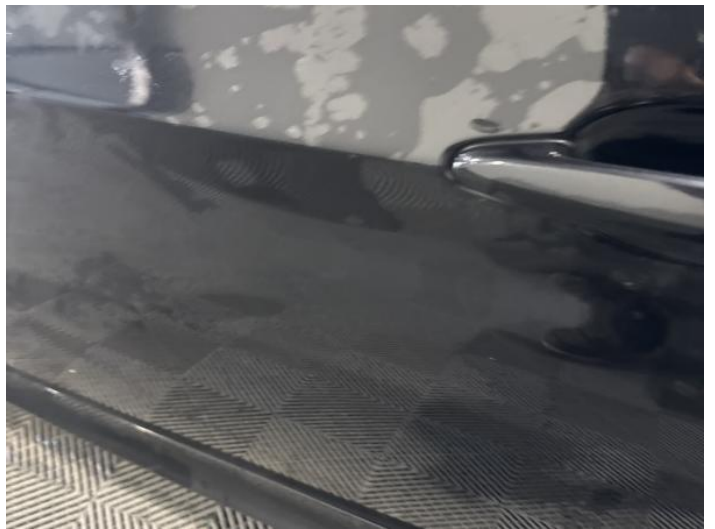
6: Door nsf  
Chipped  
1 To 5

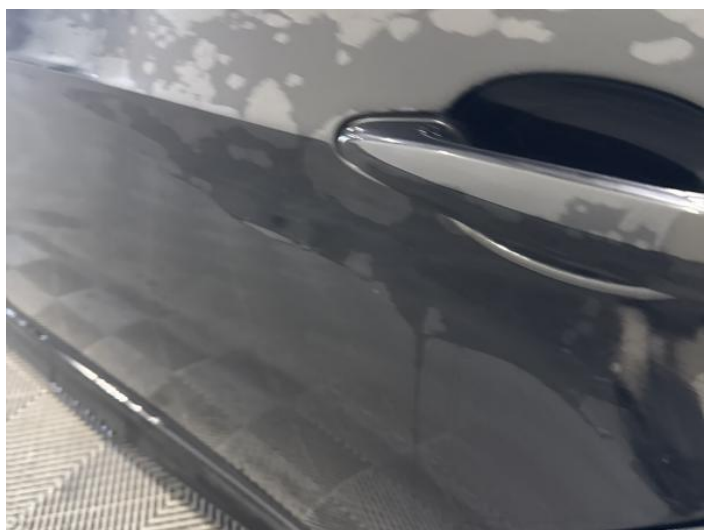
7: Door nsf  
Scratched  
Over 25mm Not Thru Paint

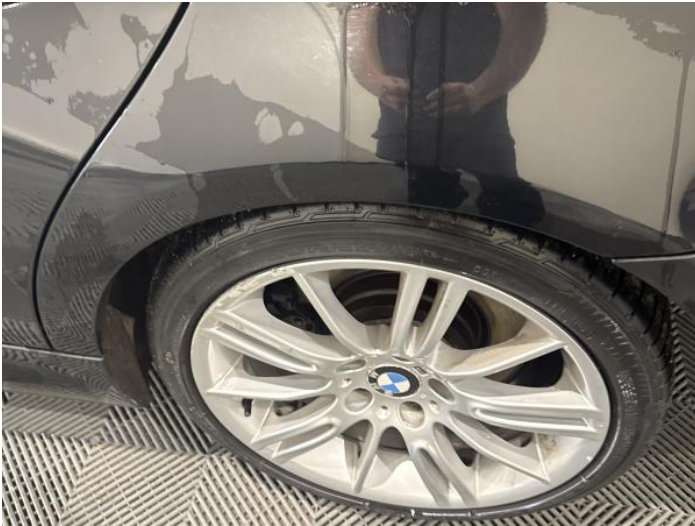
9: Wheel nsr  
Scratched  
Over 50mm

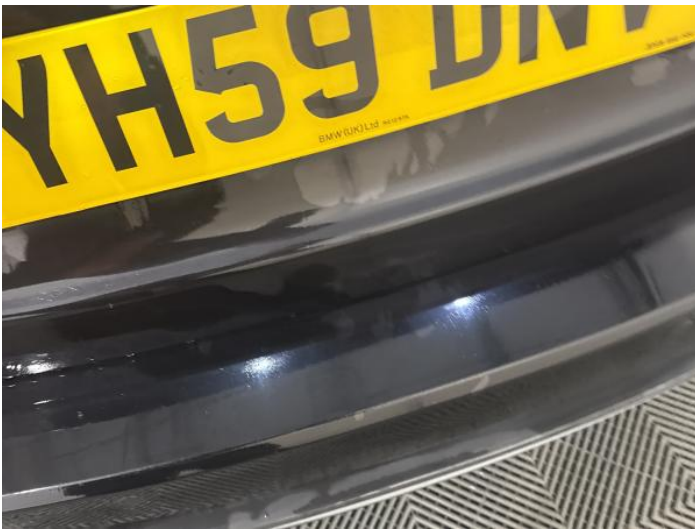
11: Bumper Rear  
Scratched  
25 to 100mm Thru Paint

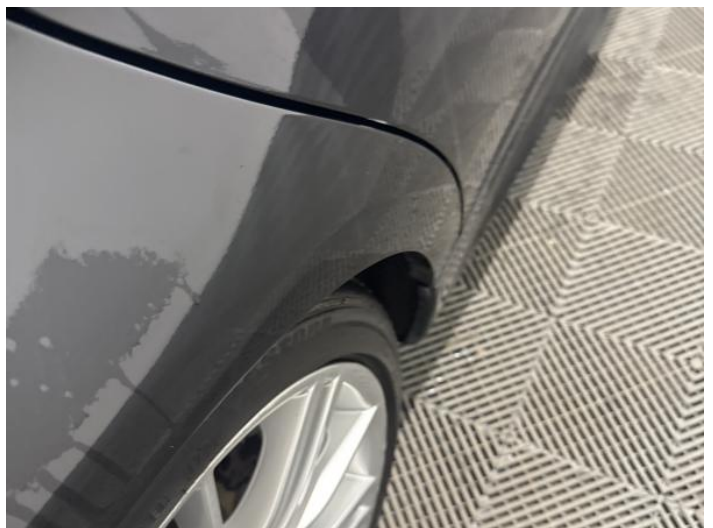
14: Qtr Panel osr  
Dented  
2 Or Less UpTo 10mm

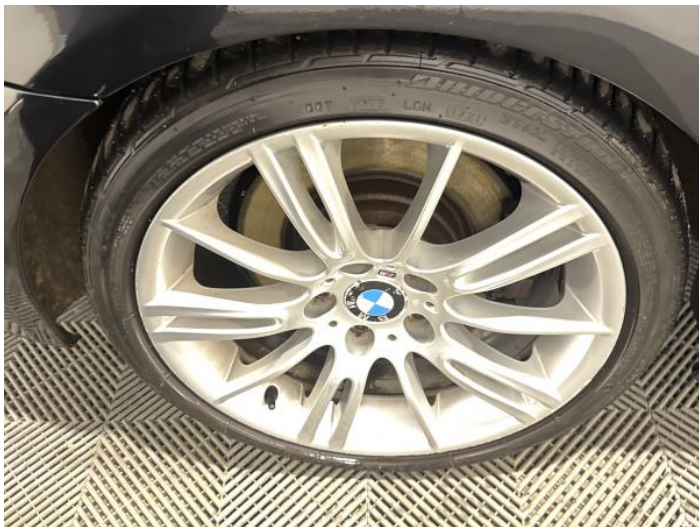
15: Wheel osr  
Scratched  
Over 50mm

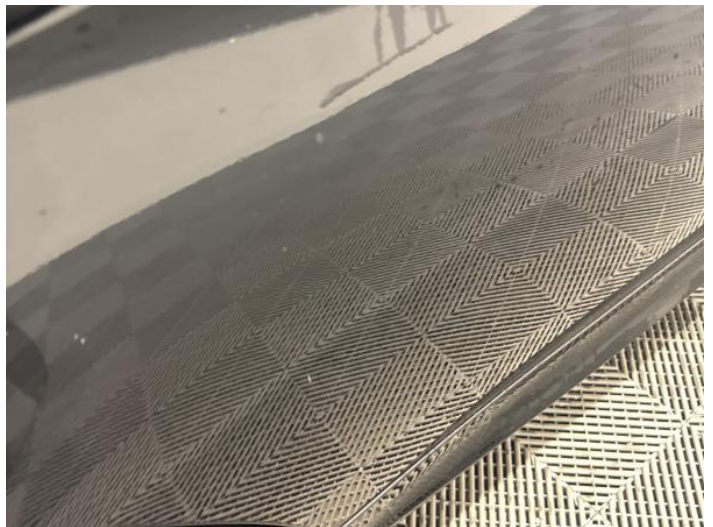
16: Door osr  
Chipped  
1 To 5

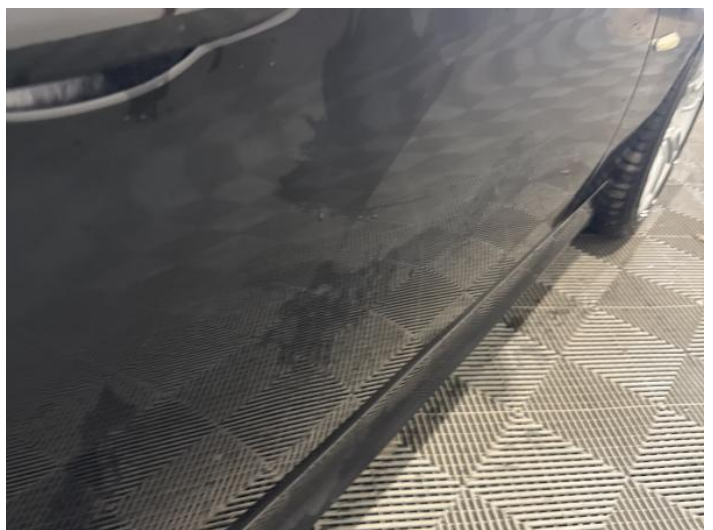
18: Door osf  
Chipped  
1 To 5

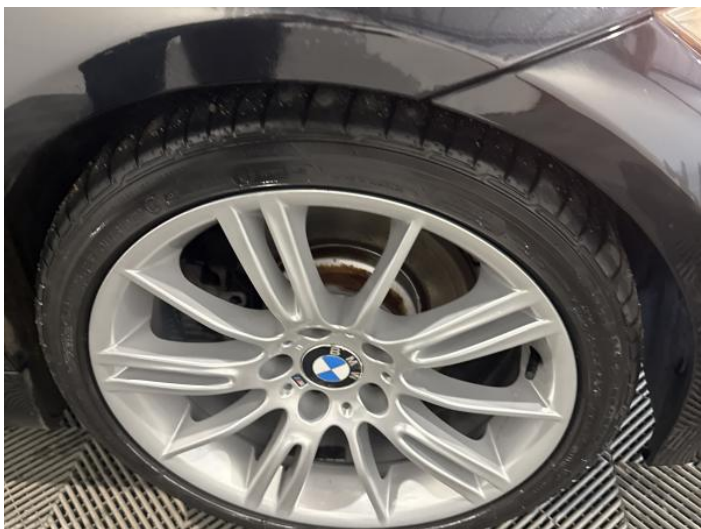
21: Wheel of  
Scratched  
Over 50mm
