VEHICLE INSPECTION REPORT

LY14FPE

Vauxhall Zafira 1.8i [120] Exclusiv 5dr

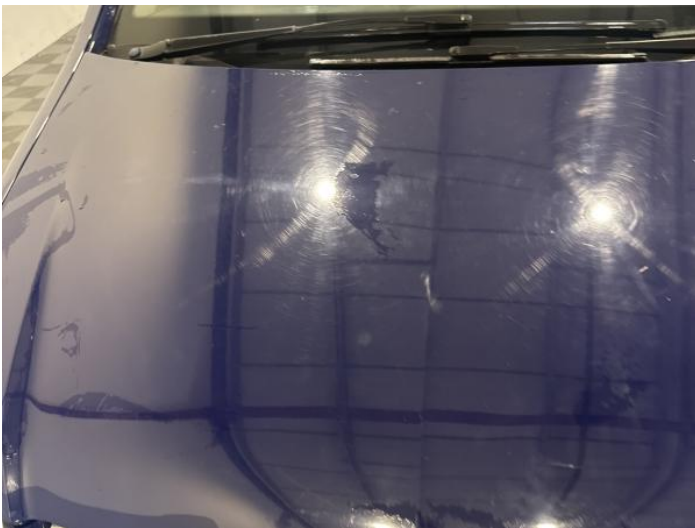
1: Bonnet
Chipped
Multiple Chips

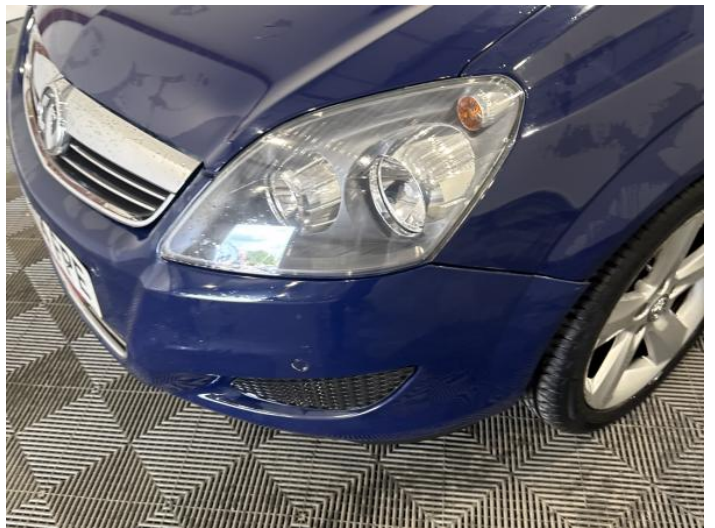
2: Bumper Front
Scratched
Over 100mm Thru Paint

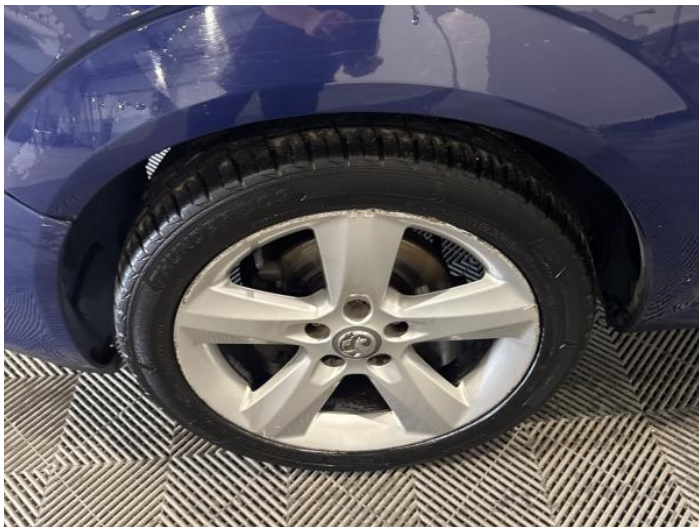
3: Wheel nsf
Scratched
Over 50mm

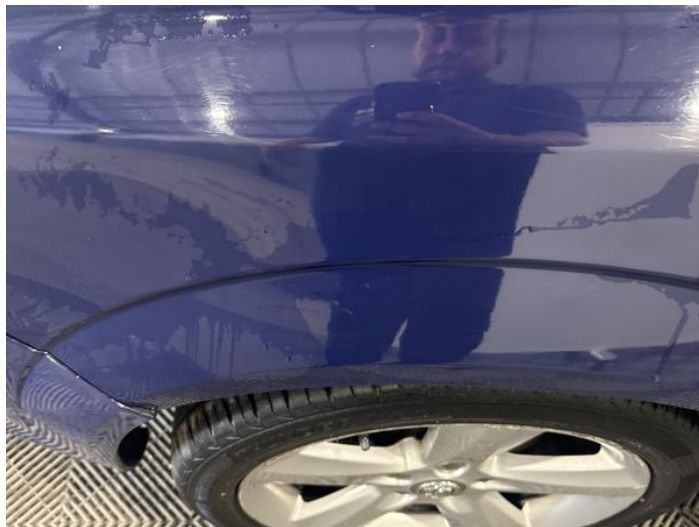
4: Wing nsf
Chipped
1 To 5

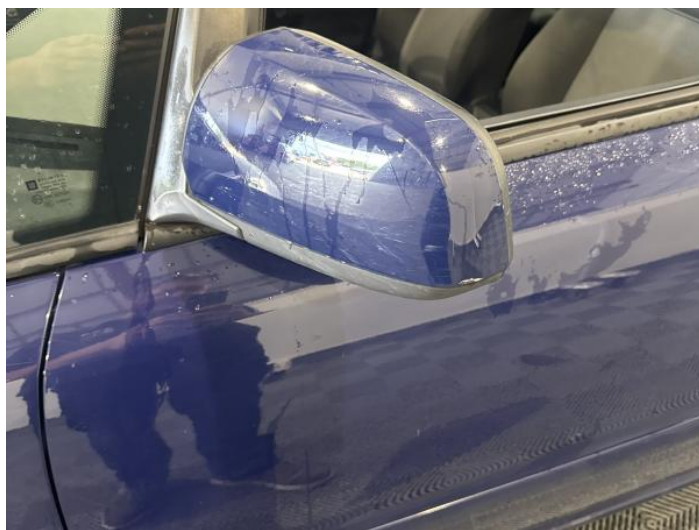
6: Door Mirror Assy nsf
Scratched (Painted)
Over 25mm Thru Paint

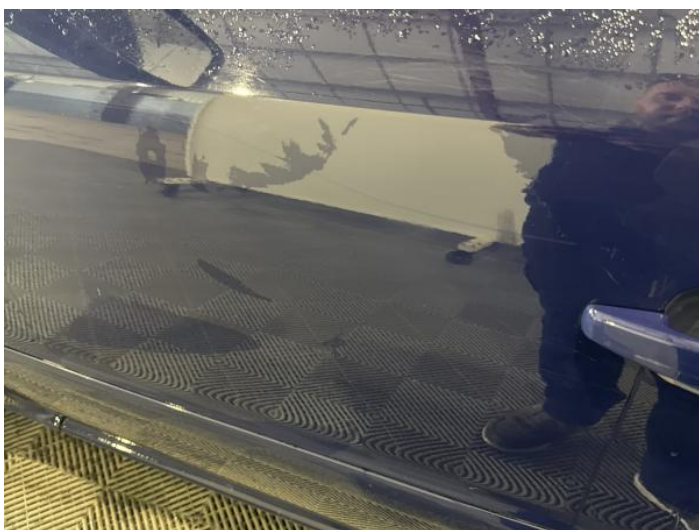
7: Door nsf
Chipped
1 To 5

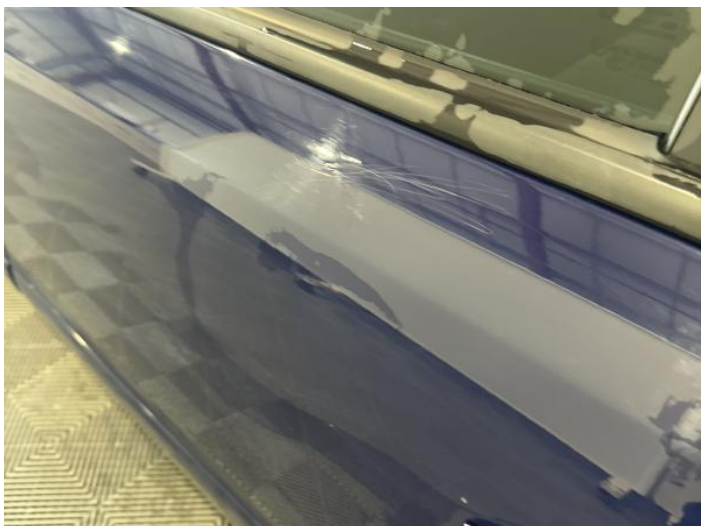
9: Door nsr
Chipped
1 To 5

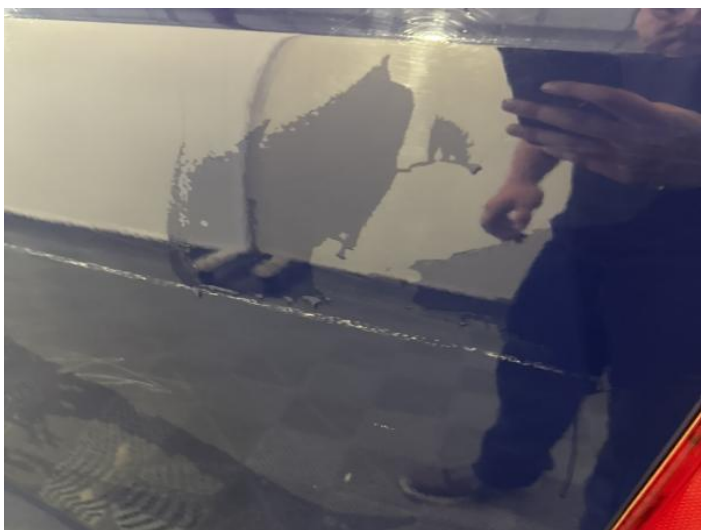
11: Qtr Panel nsr
Scratched
Over 25mm Thru Paint

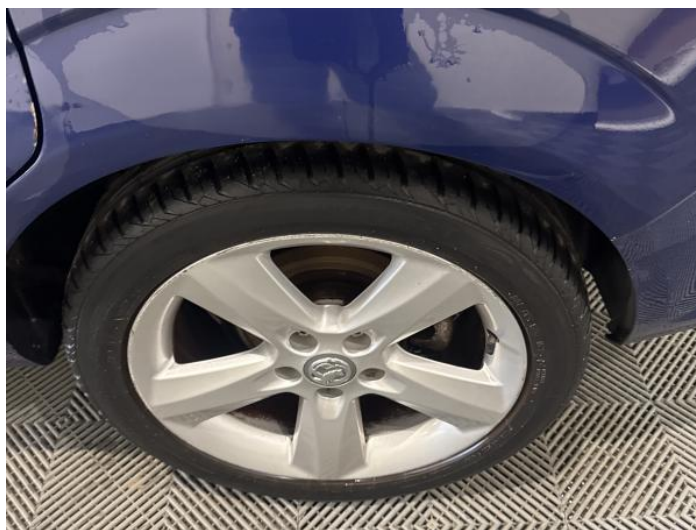
12: Wheel nsr
Scratched
Over 50mm

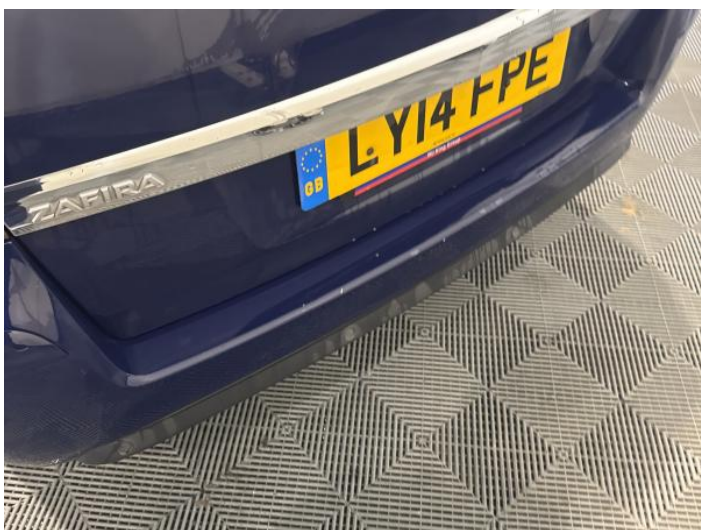
13: Bumper Rear
Scratched
Over 100mm Thru Paint

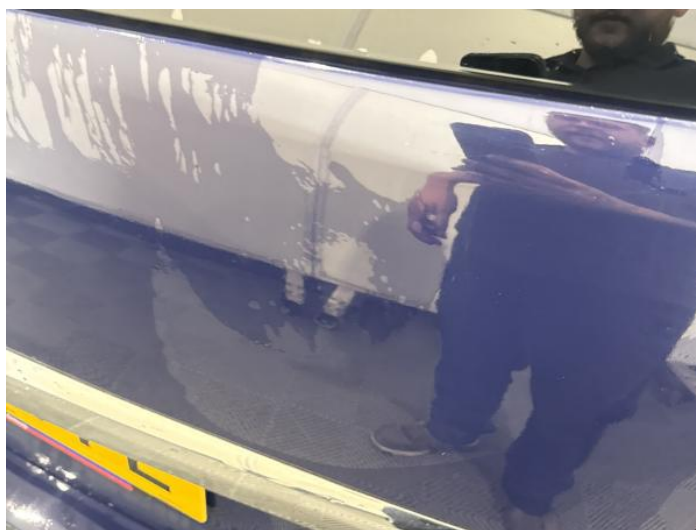
14: Boot Lid
Chipped
1 To 5

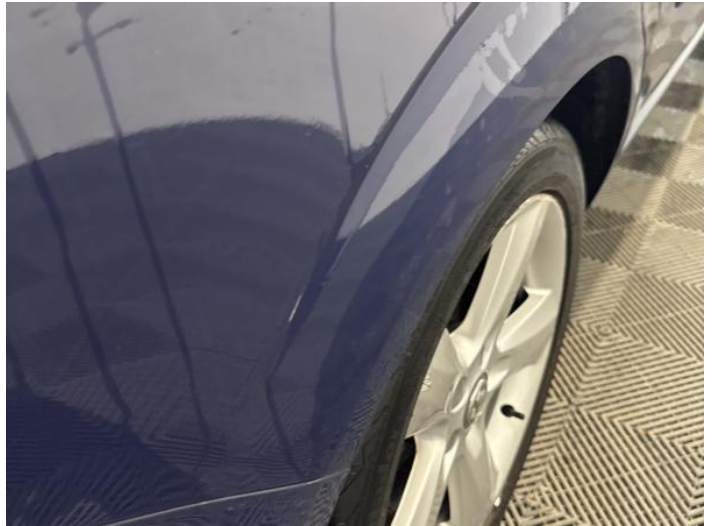
16: Qtr Panel osr
Scratched
Over 25mm Thru Paint

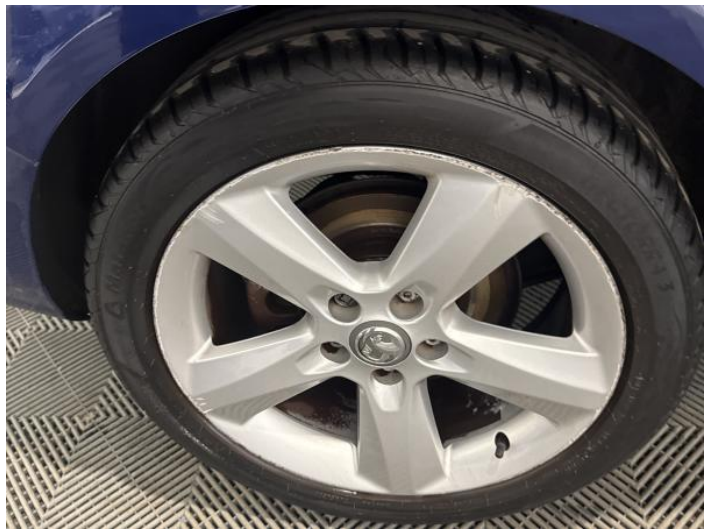
18: Wheel osr
Scratched
Over 50mm

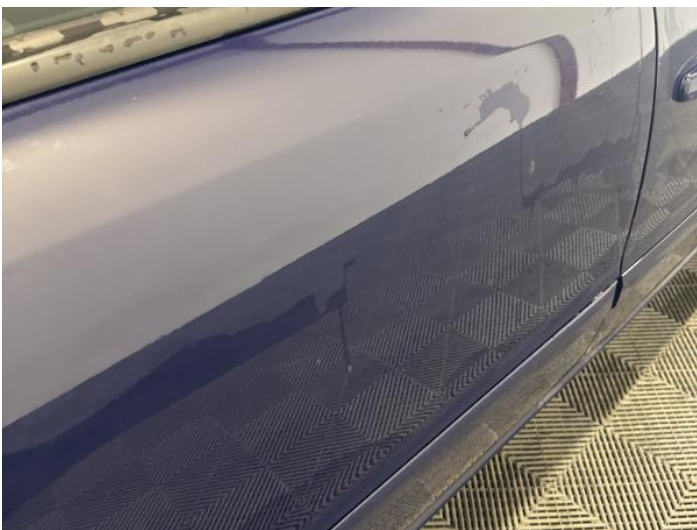
19: Door osr
Chipped
1 To 5

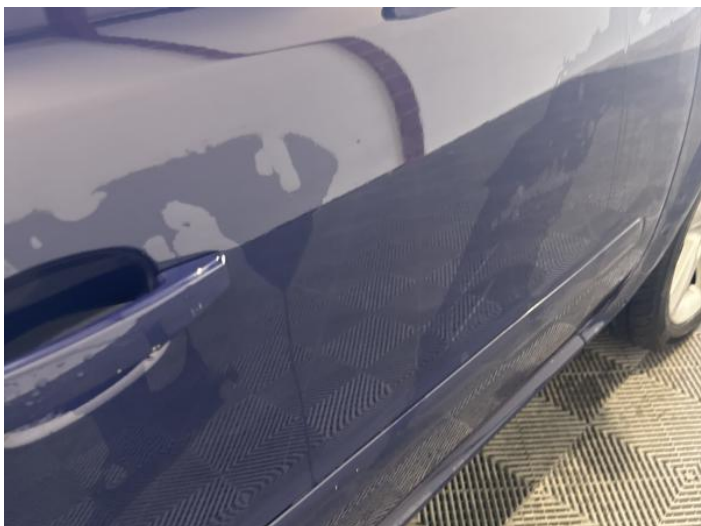
21: Door osf
Dented
Over 2 UpTo 10mm

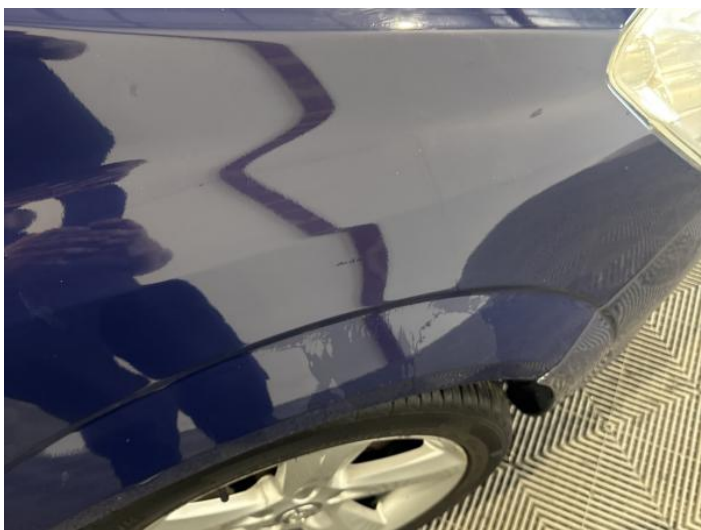
23: Wing osf
Chipped
1 To 5

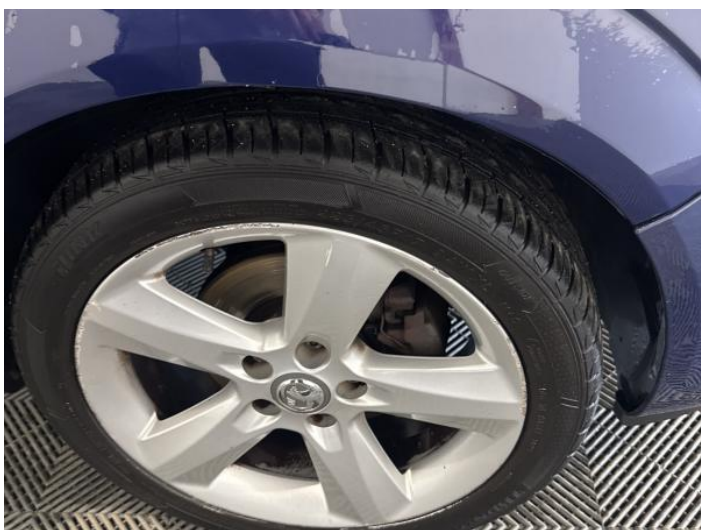
25: Wheel osf
Scratched
Over 50mm

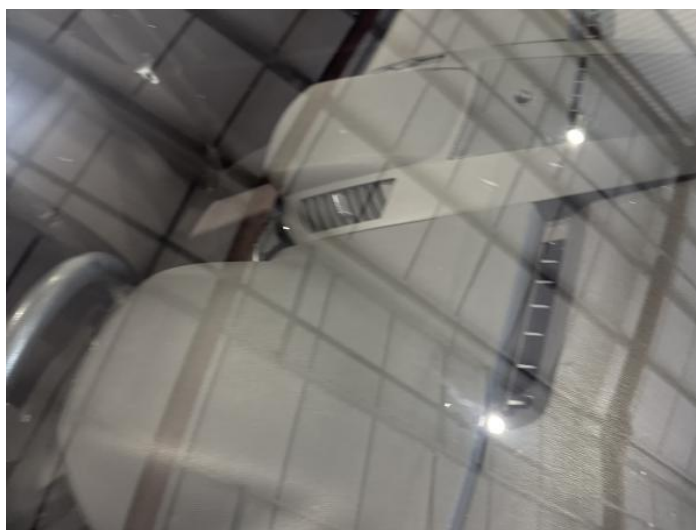
26: Screen Front
Chipped
UpTo 10mm
