VEHICLE INSPECTION REPORT

LG17EYW

Ford Mondeo 1.5 TDCi EConetic Style 5dr

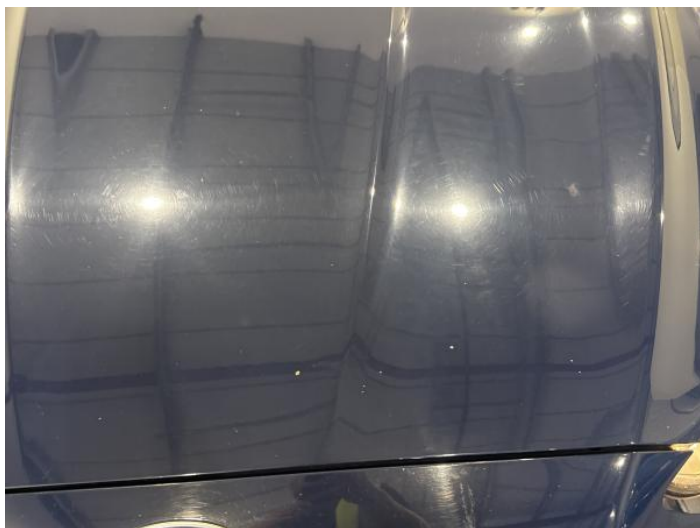
1: Bonnet
Chipped
Multiple Chips

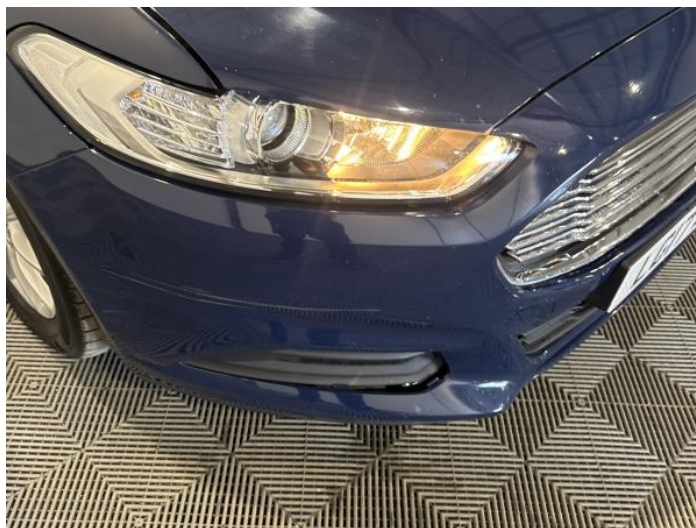
2: Bumper Front
Scratched
Over 100mm Thru Paint

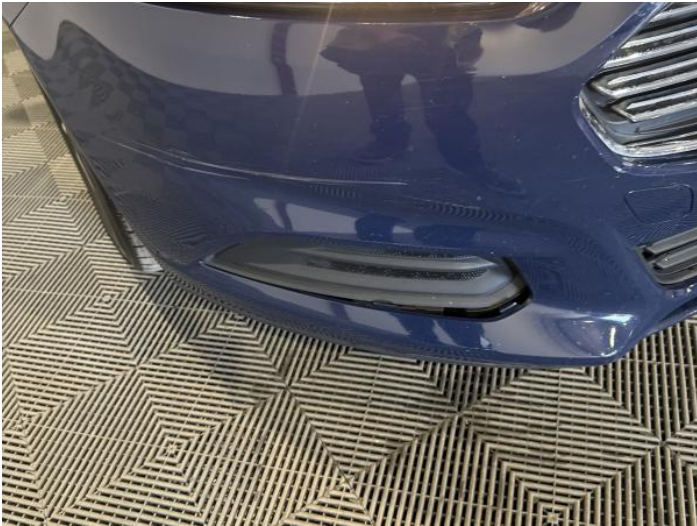
3: Bumper Front Moulding
Broken
Replace

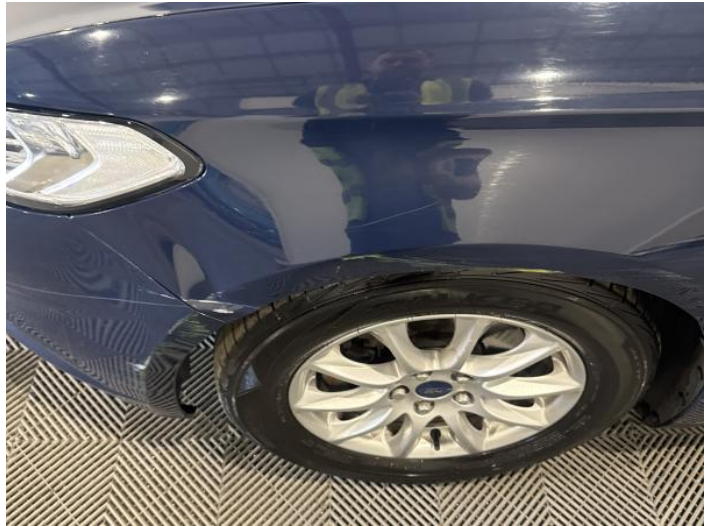
4: Wing nsf
Dented
With Paint Damage

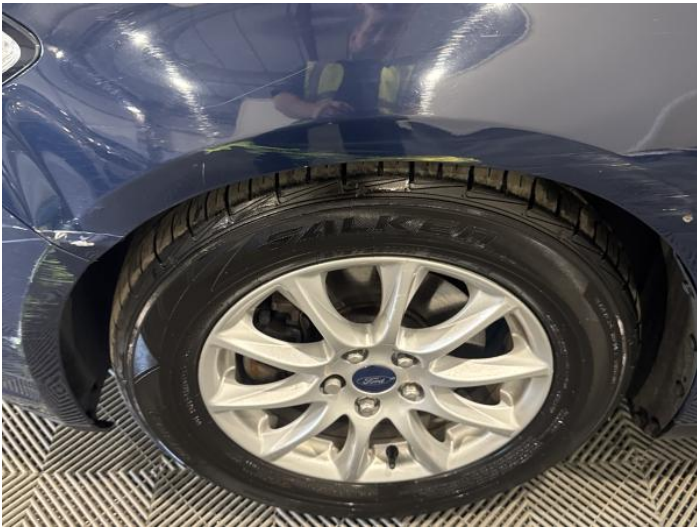
5: Wheel nsf
Scratched
Over 50mm

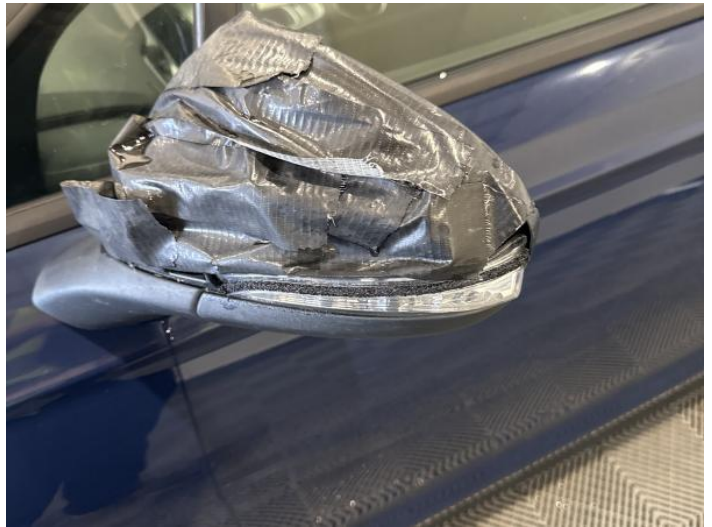
6: Door Mirror Assy nsf
Broken
Replace

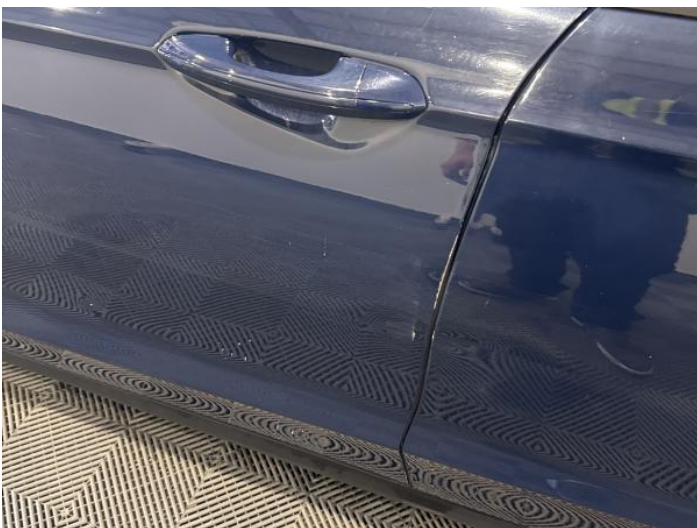
7: Door nsf
Dented
With Paint Damage

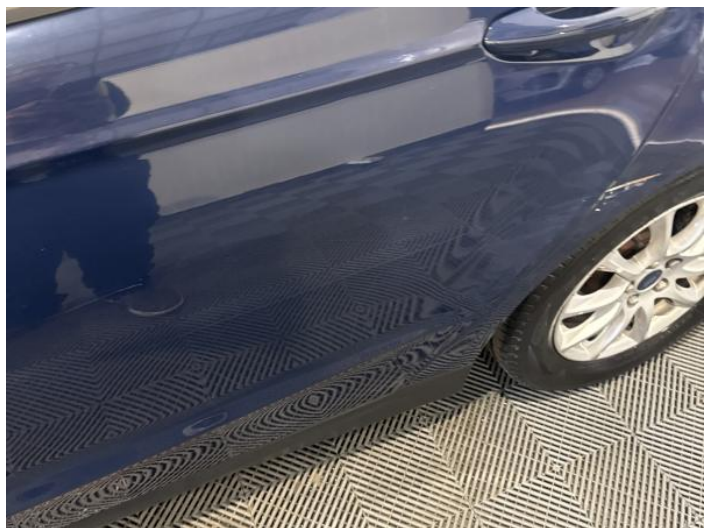
8: Door nsr
Dented
With Paint Damage

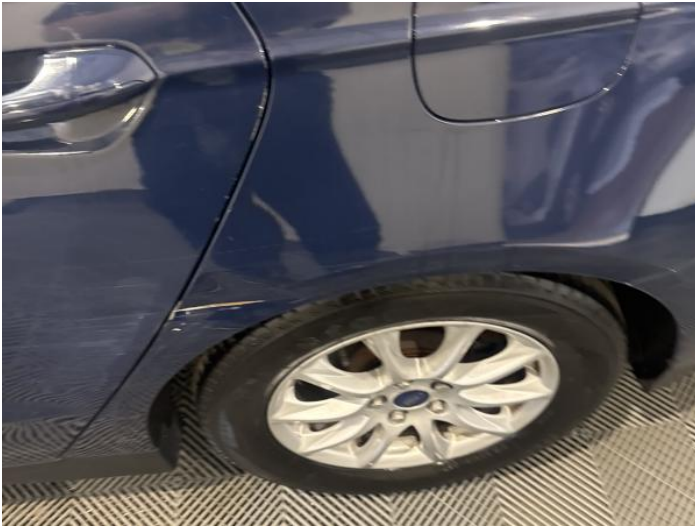
9: Qtr Panel nsr
Dented
With Paint Damage

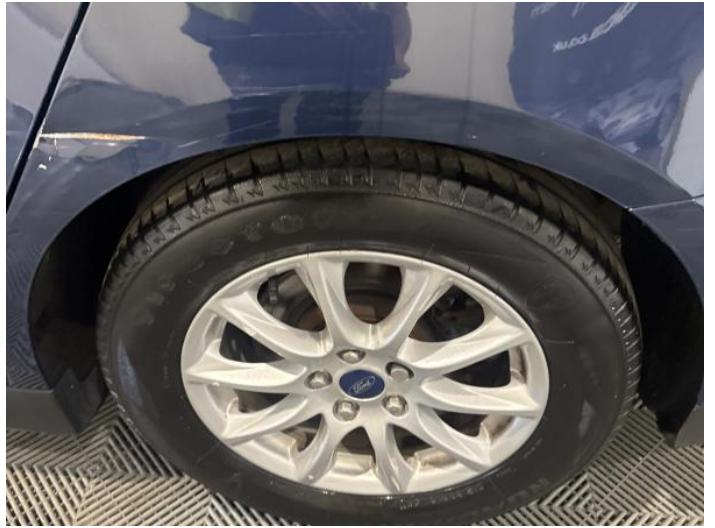
10: Wheel nsr
Scratched
Over 50mm

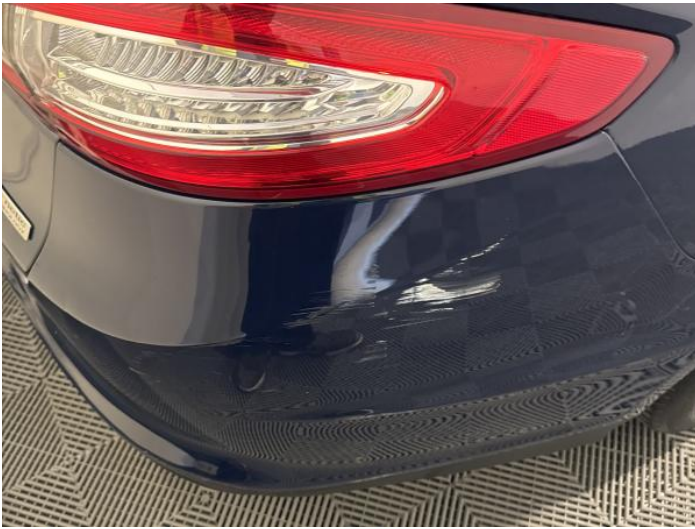
11: Bumper Rear
Scratched
Over 100mm Thru Paint

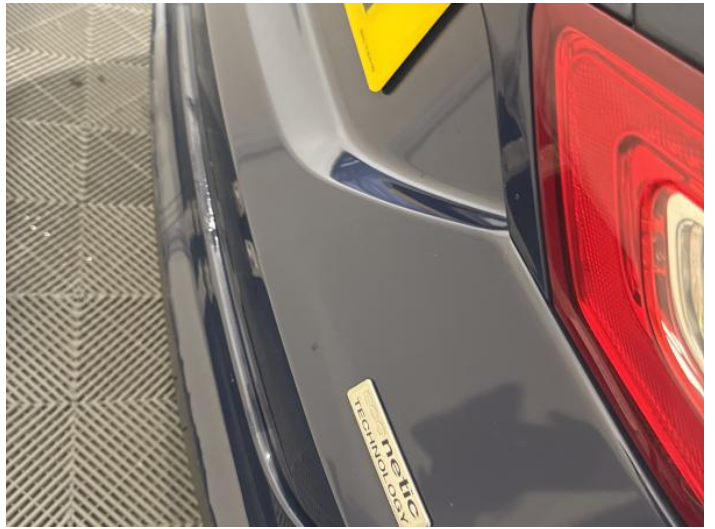
12: Boot Lid
Chipped
1 To 5

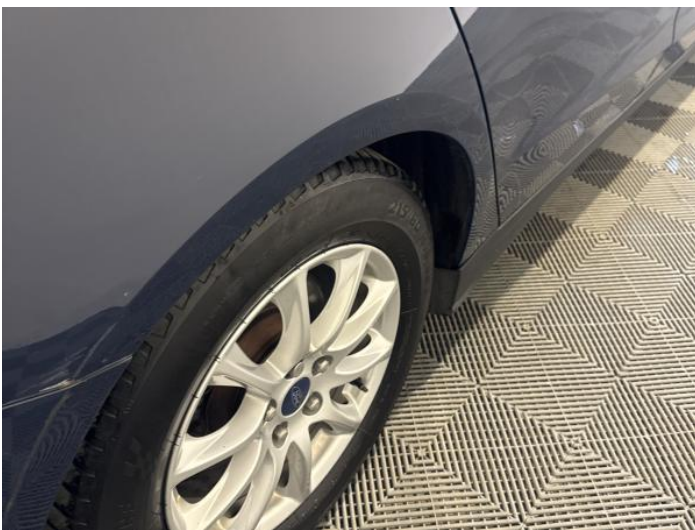
13: Qtr Panel osr
Dented
With Paint Damage

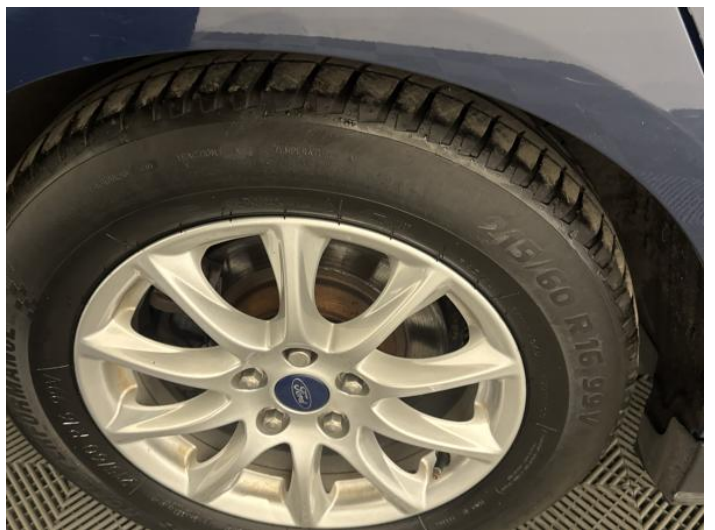
14: Wheel osr
Scratched
Over 50mm

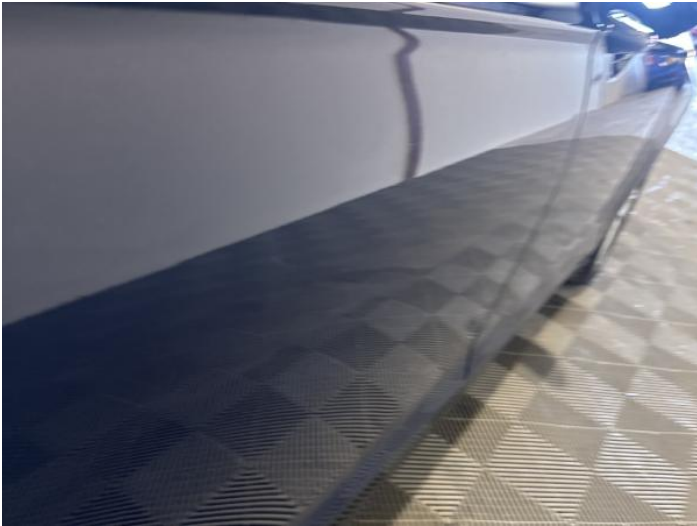
15: Door osf
Dented
Over 2 UpTo 10mm

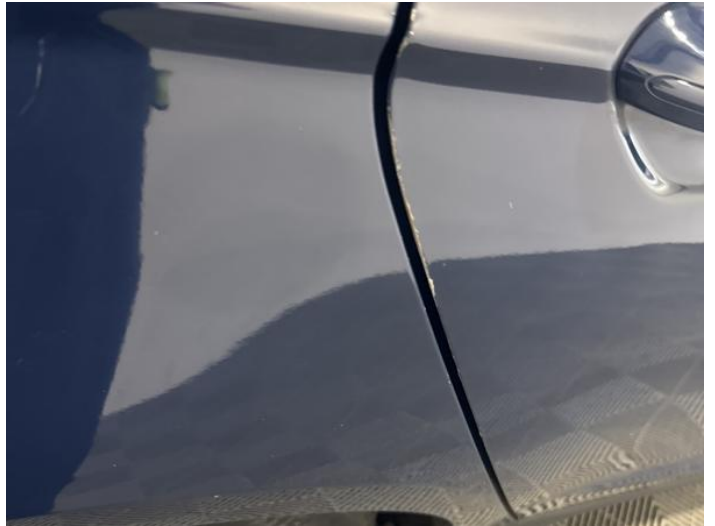
16: Door osr
Chipped
Edge Chip

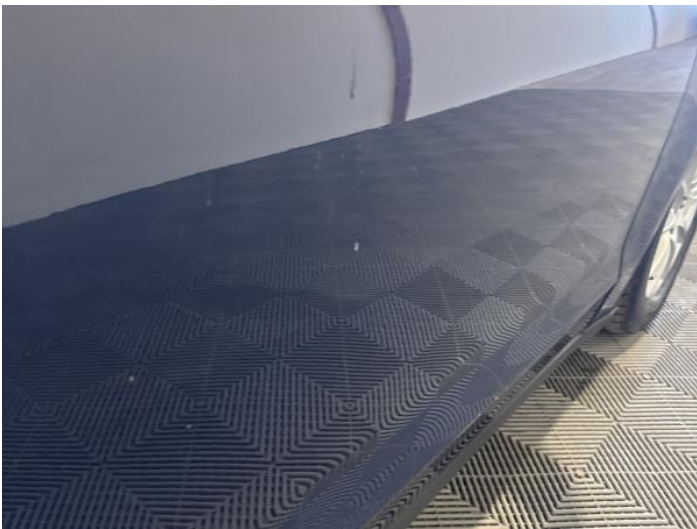
17: Door osf
Chipped
1 To 5

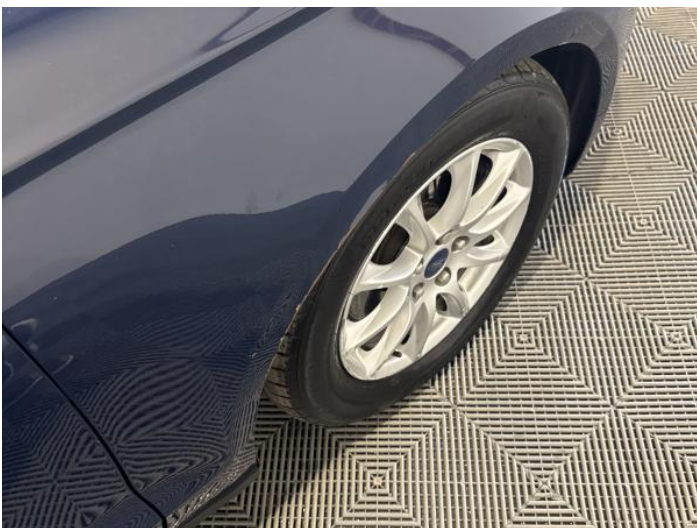
19: Wing osf
Dented
With Paint Damage

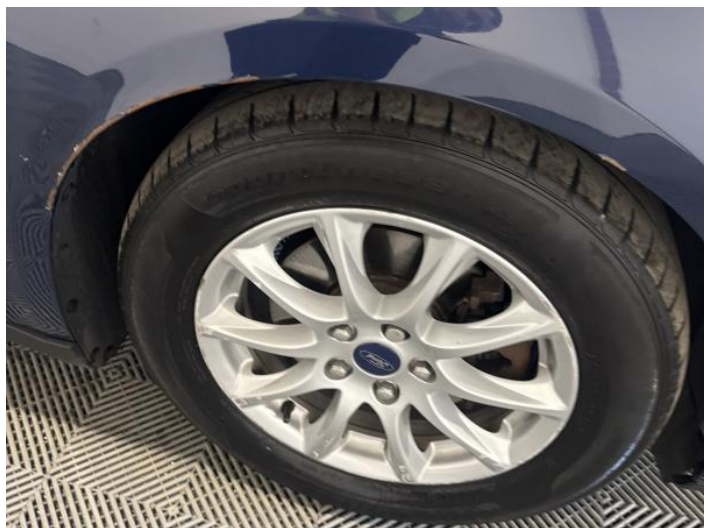
20: Wheel osf
Scratched
Over 50mm

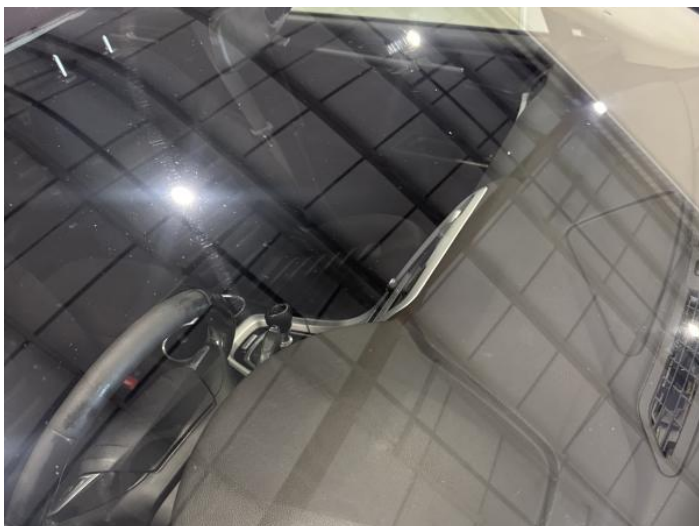
21: Screen Front
Chipped
UpTo 10mm

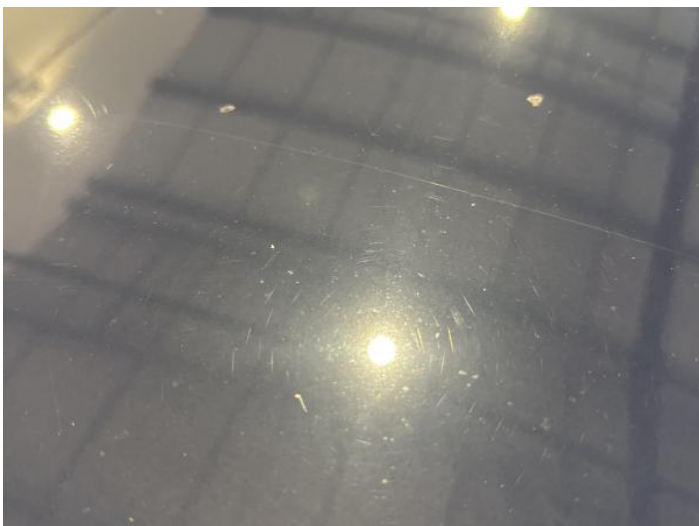
22: Roof
Chipped
1 To 5
