VEHICLE INSPECTION REPORT

NH06UFC

Nissan X-Trail 2.5 16v Aventura 5dr Auto

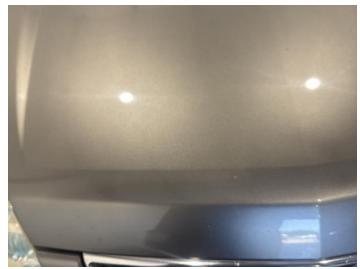
1: Bonnet Chipped 1 To 5

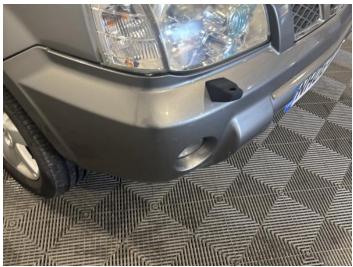
2: Bumper Front Scratched Over 100mm Thru Paint

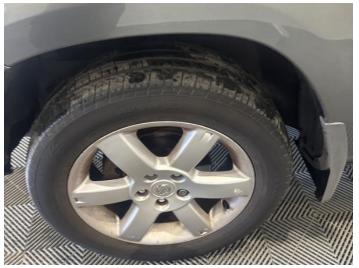
3: Wheel nsf Scratched Over 50mm

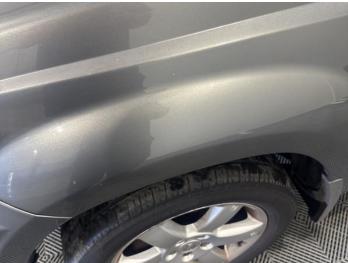
4: Wing nsf Chipped 1 To 5

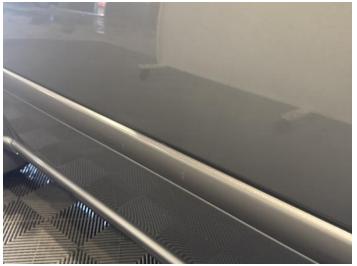
5: Door nsf Chipped 1 To 5

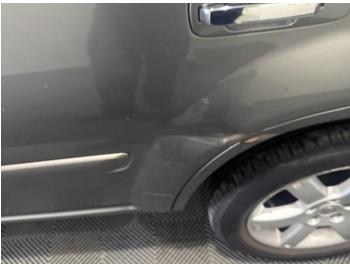
6: Door nsr Dented With Paint Damage

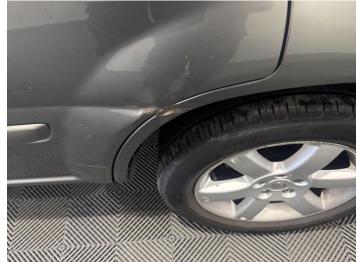
7: Qtr Panel nsr Dented With Paint Damage

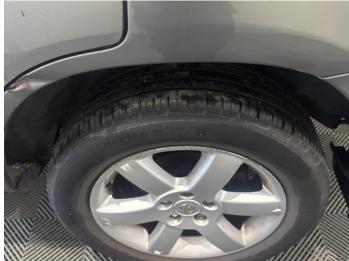
8: Wheel nsr Scratched Over 50mm

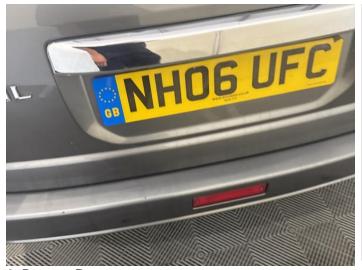
9: Bumper Rear Scratched Over 100mm Thru Paint

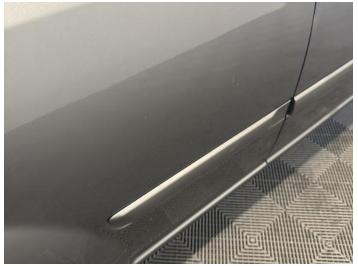
11: Door osrChipped1 To 5

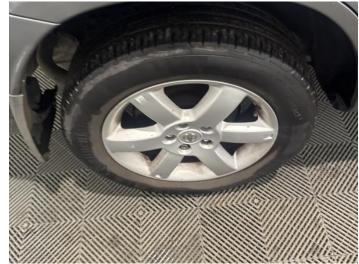
13: Wheel osr Scratched Over 50mm

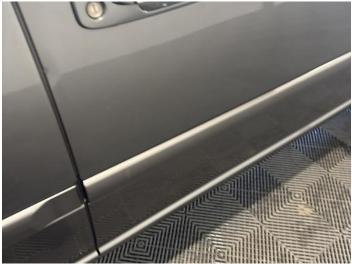
14: Door osf Dented Over 30mm

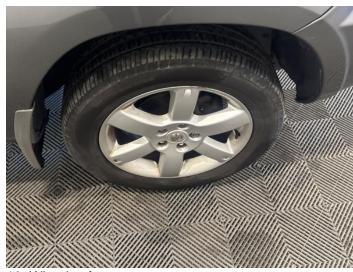
16: Wheel osf Scratched Over 50mm
