VEHICLE INSPECTION REPORT

BMW 1 Series 118i M Sport 5dr Step Auto

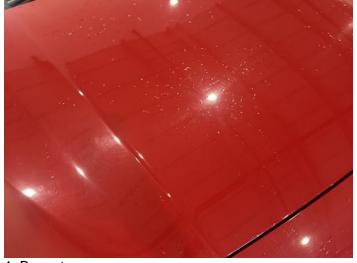
1: Bonnet Chipped 1 To 5

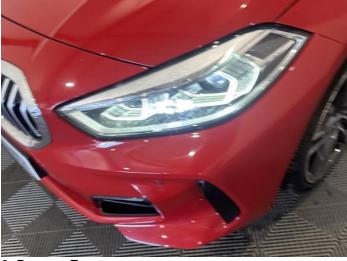
2: Bumper Front Chipped Multiple Chips

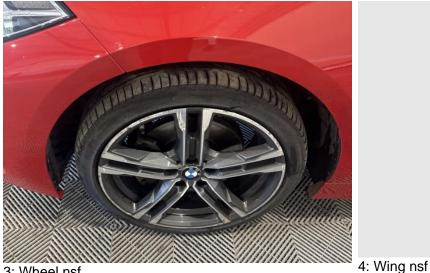
3: Wheel nsf Scratched Over 50mm

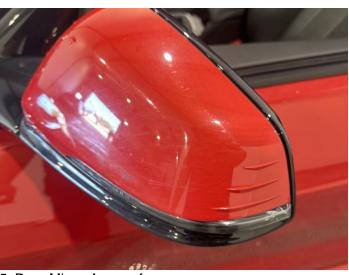
5: Door Mirror Assy nsf Scratched (Painted) UpTo 25mm Not Thru Paint

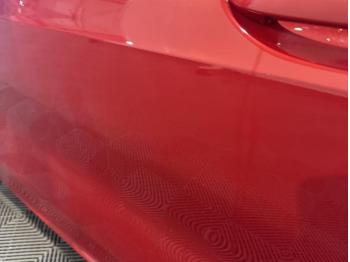
6: Door nsf Chipped 1 To 5

Scratched

Over 25mm Not Thru Paint

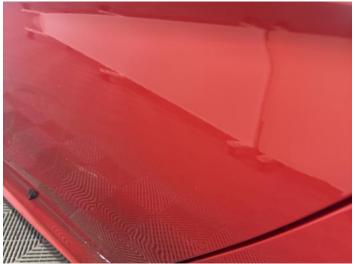
8: Door nsr Scratched Over 25mm Thru Paint

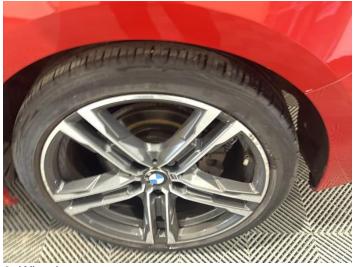
9: Wheel nsr Scratched Over 50mm

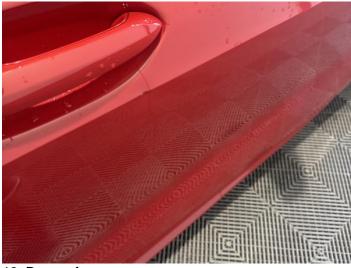
13: Door osf Dented Between 10mm + 30mm

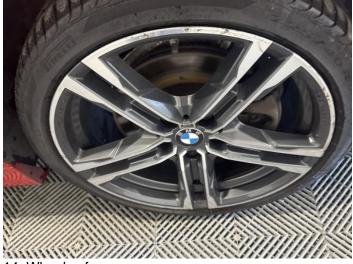
14: Wheel osf Scratched Over 50mm
