VEHICLE INSPECTION REPORT

HV04HJK

Volvo S/v40 Series D SE

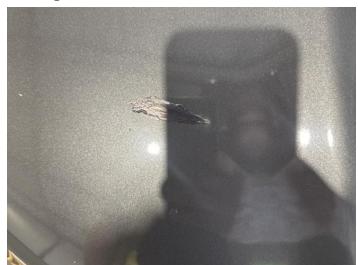
1: Bonnet Poor Previous Repair Poor Paint

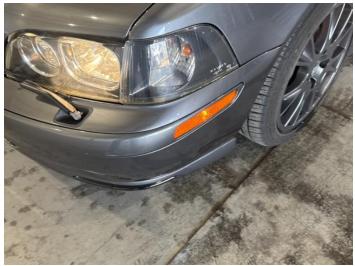
2: Bumper Front Scratched 25 to 100mm Thru Paint

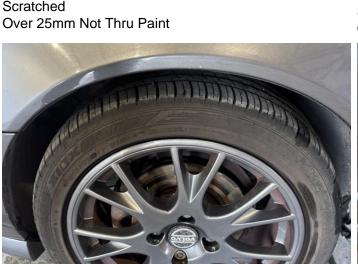
5: Wheel nsf Scratched Up To 50mm

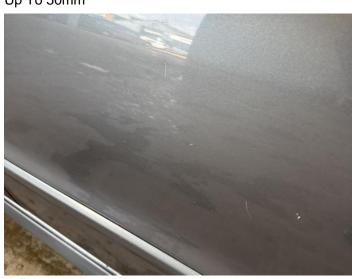
7: Door nsr Dented 2 Or Less UpTo 10mm

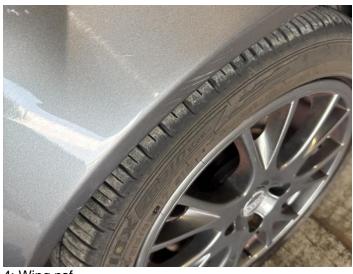
4: Wing nsf Scratched Over 25mm Not Thru Paint

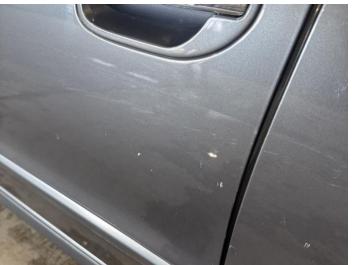
6: Door nsf Scratched Over 25mm Thru Paint

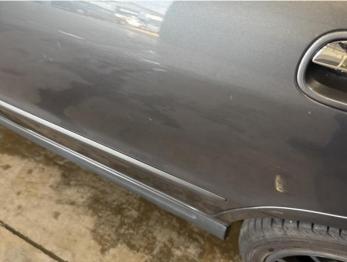
8: Door nsr Chipped 1 To 5

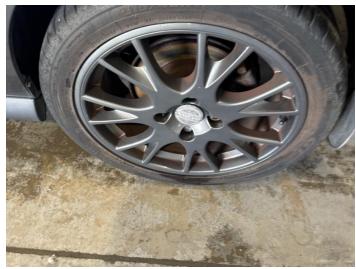
9: Wheel nsr Scratched Up To 50mm

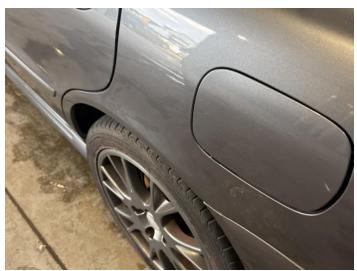
10: Qtr Panel nsr Chipped 1 To 5

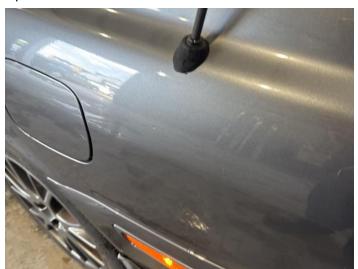
11: Qtr Panel nsr Dented Between 10mm + 30mm

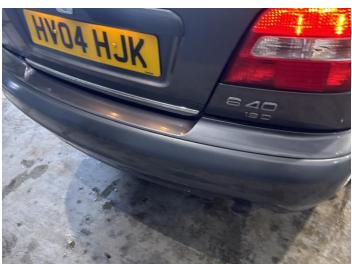
12: Bumper Rear Scratched 25 to 100mm Thru Paint

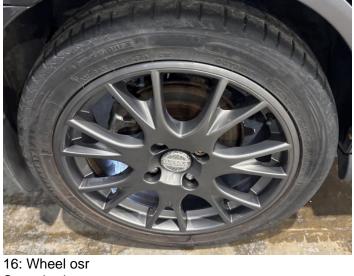
16: Wheel osr Scratched Up To 50mm

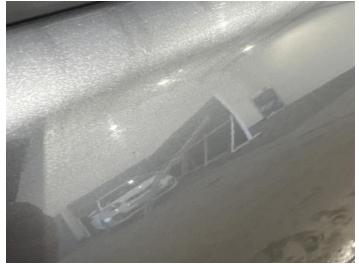
17: Door osr Poor Previous Repair Poor Paint

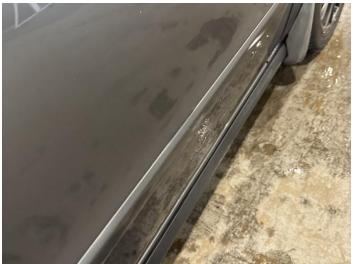
18: Door osf Chipped 1 To 5

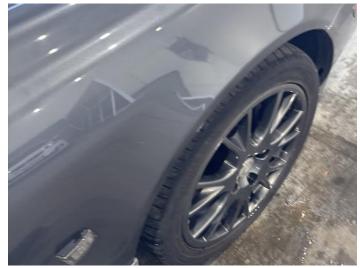
19: Wing osf Chipped 1 To 5

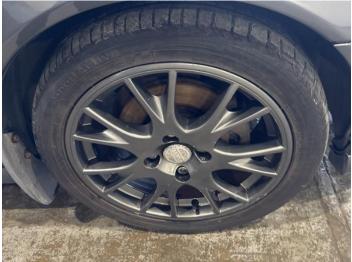
20: Wheel osf Scratched Up To 50mm

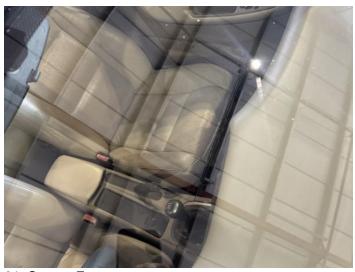
21: Screen Front Chipped UpTo 10mm
