VEHICLE INSPECTION REPORT

RO70VZK

Renault ZOE 100kW i GT Line R135 50kWh 5dr Auto Vehicle

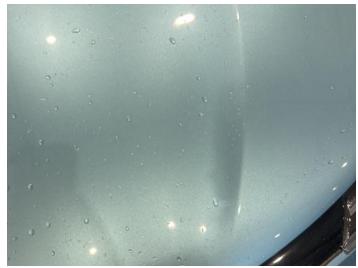
1: Bonnet Chipped 1 To 5

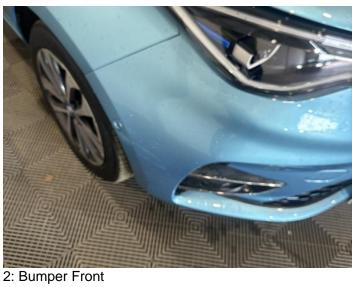
2: Bumper Front Scratched 25 to 100mm Thru Paint

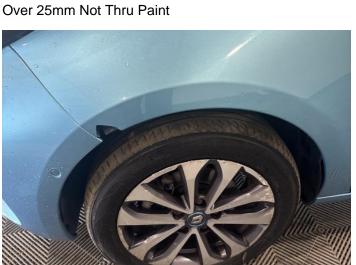
5: Wheel nsf Scratched Over 50mm

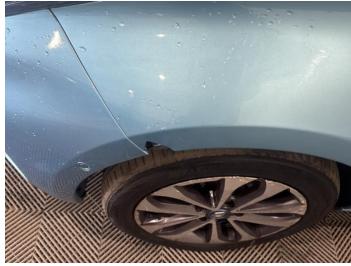
4: Wing nsf Cracked Replace

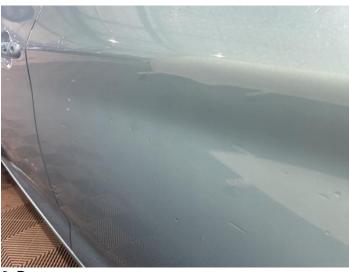
8: Door nsr Dented 2 Or Less UpTo 10mm

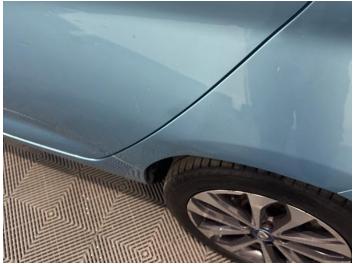
9: Qtr Panel nsr Dented Over 30mm

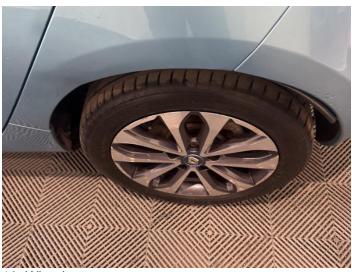
10: Wheel nsrScratchedOver 50mm

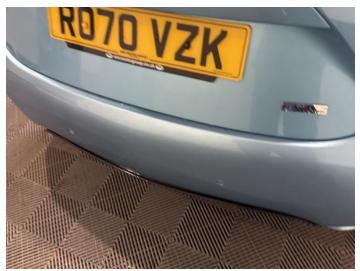
11: Bumper Rear Chipped Multiple Chips

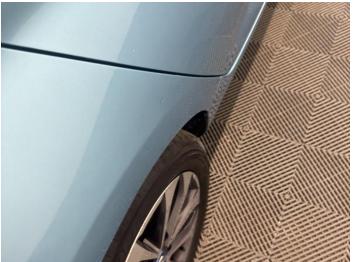
12: Qtr Panel osr Dented Between 10mm + 30mm

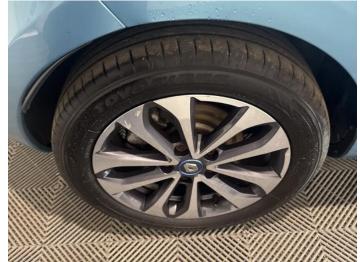
13: Wheel osr Scratched Over 50mm

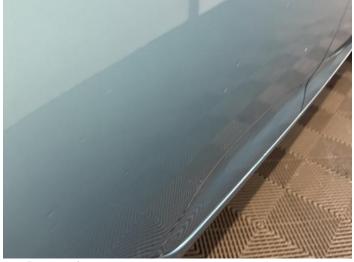
14: Door osf Chipped 1 To 5

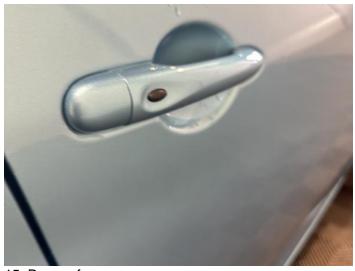
15: Door osf Dented Between 10mm + 30mm

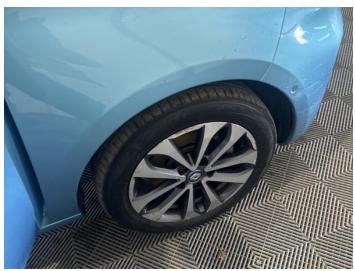
16: Wheel osf Scratched Over 50mm
