# VEHICLE INSPECTION REPORT

**EF15YJX**

## Ford Kuga 2.0 TDCi 150 Titanium 5dr 2WD

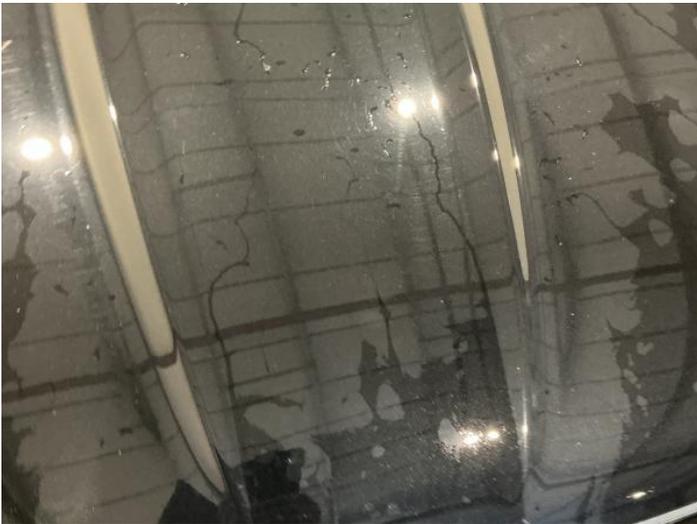
1: Bonnet  
Chipped  
1 To 5

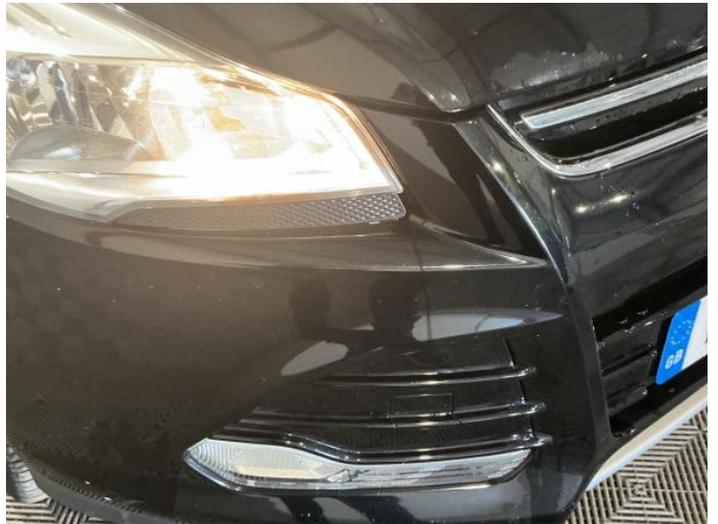
2: Bumper Front  
Scratched  
Over 100mm Thru Paint

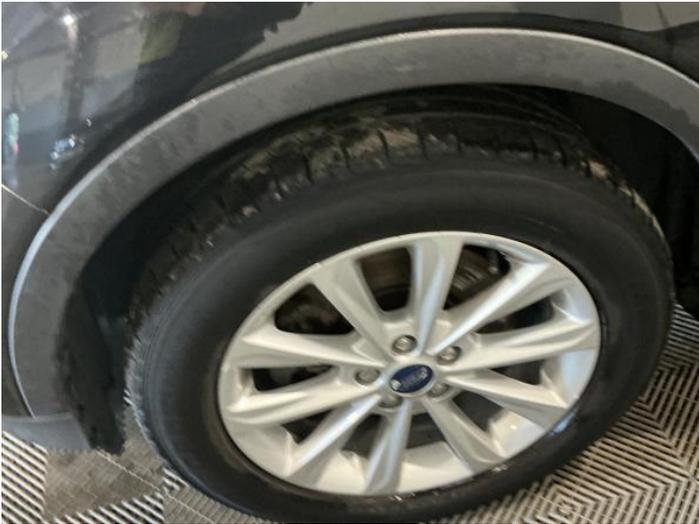
3: Wheel nsf  
Scratched  
Over 50mm

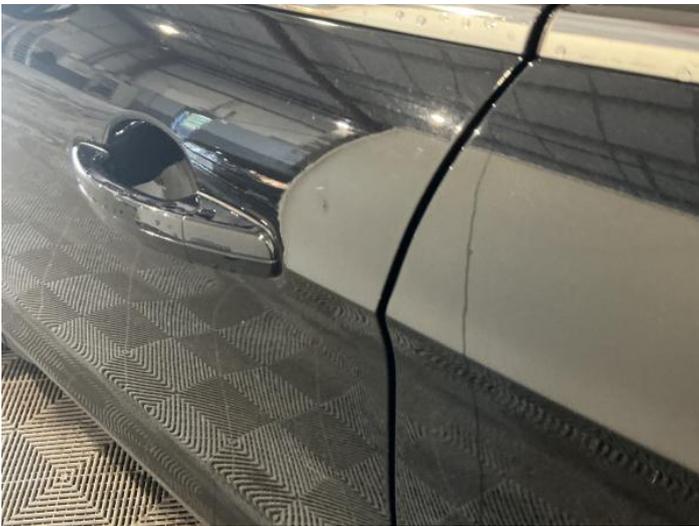
5: Door nsf  
Dented  
Over 2 UpTo 10mm

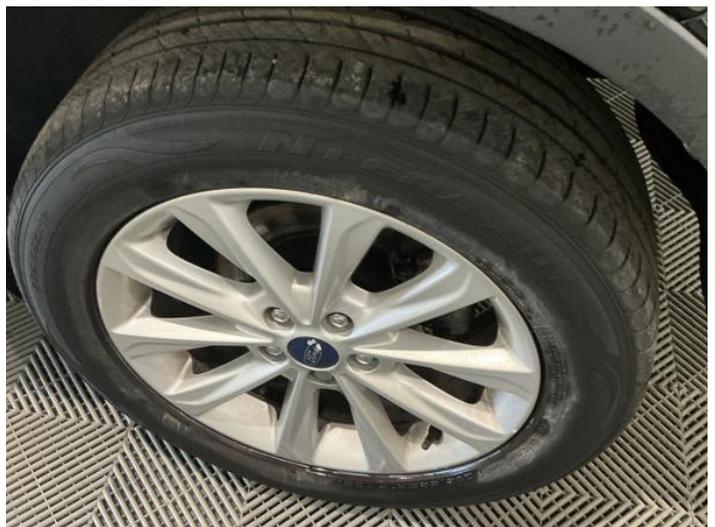
8: Wheel nsr  
Scratched  
Over 50mm

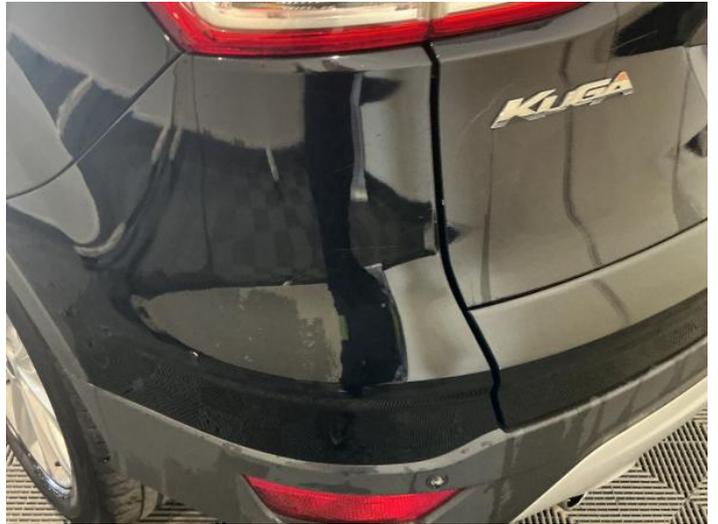
9: Qtr Panel nsr  
Scratched  
Over 25mm Not Thru Paint

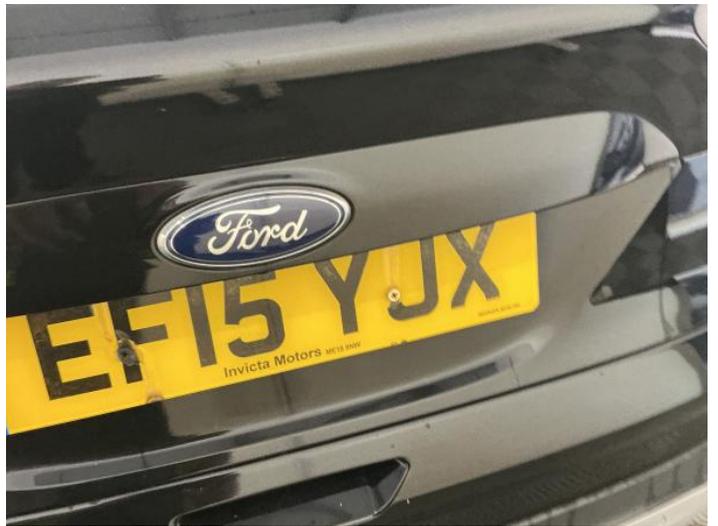
11: Bumper Rear  
Scratched  
Over 25mm Not Thru Paint

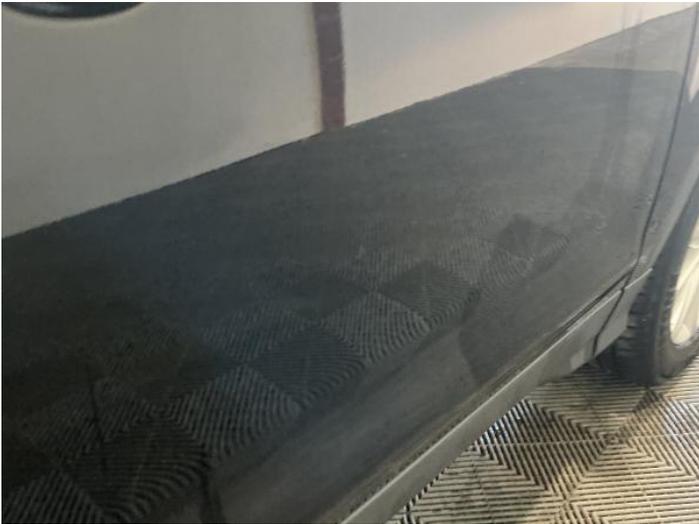
17: Door osf  
Chipped  
1 To 5

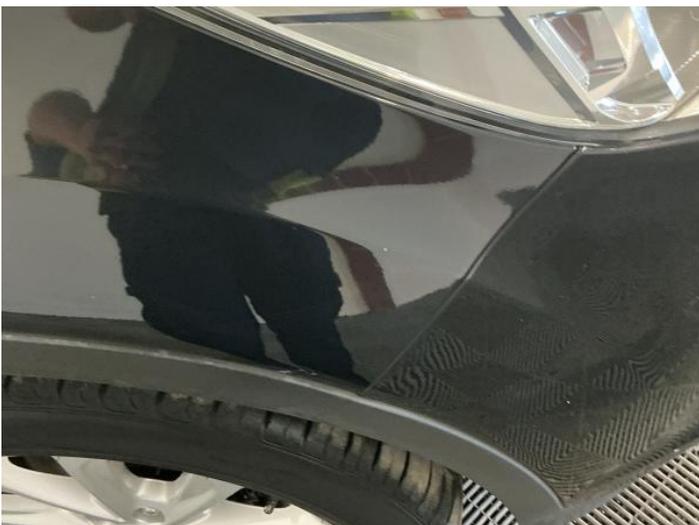
19: Wing osf  
Chipped  
1 To 5

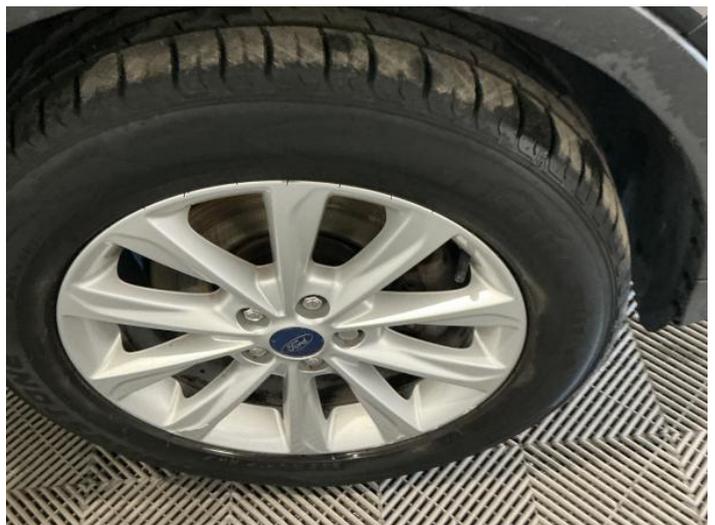
20: Wheel osf  
Scratched  
Up To 50mm

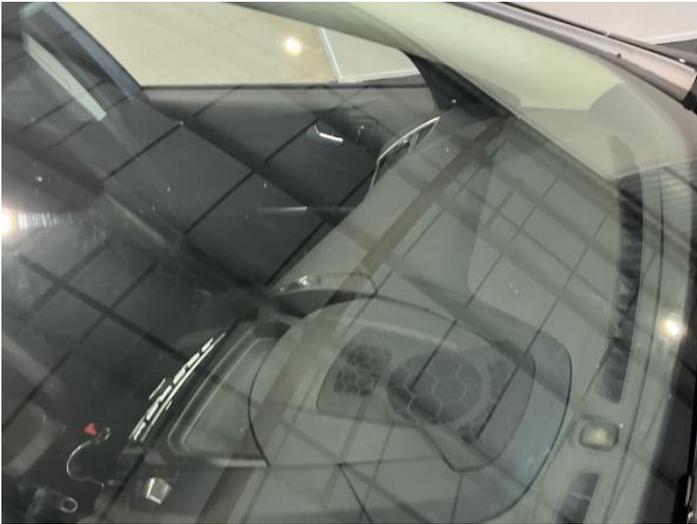
21: Screen Front  
Chipped  
UpTo 10mm

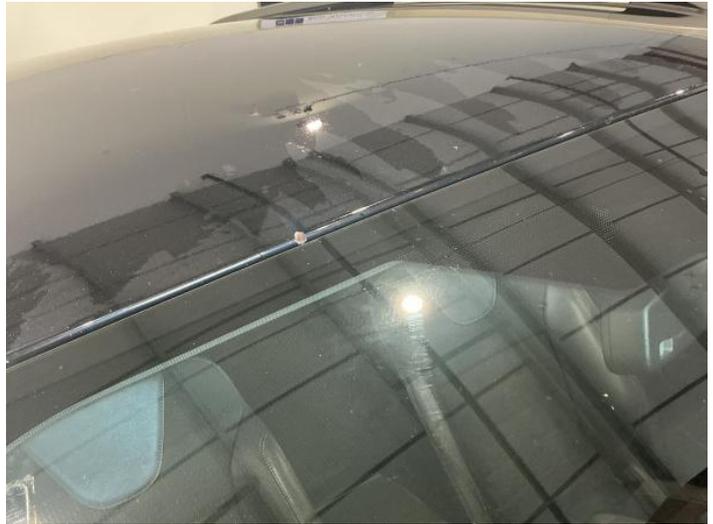
22: Roof  
Chipped  
Edge Chip
