# VEHICLE INSPECTION REPORT

**RA65ZZB**

## Renault Megane 1.5 dCi Dynamique Nav 5dr

**Non Runner**  
Inspection

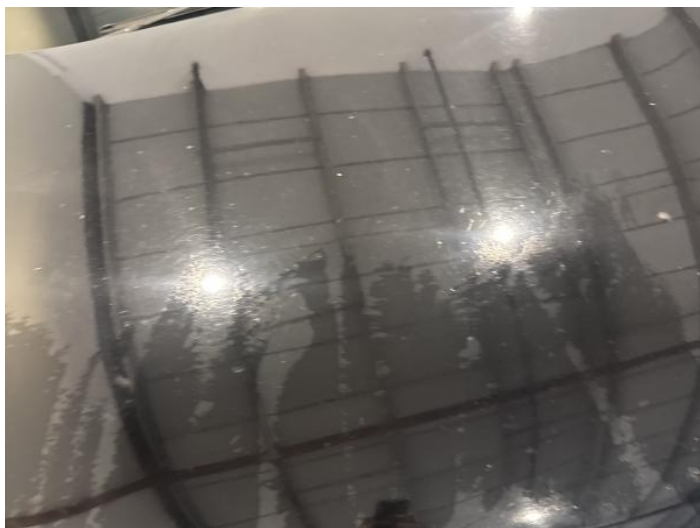
1: Bonnet  
Chipped  
Multiple Chips

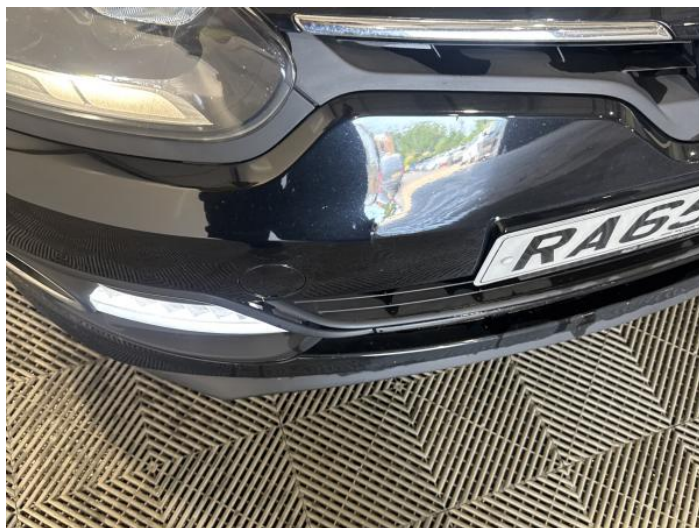
2: Bumper Front  
Dented  
With Paint Damage

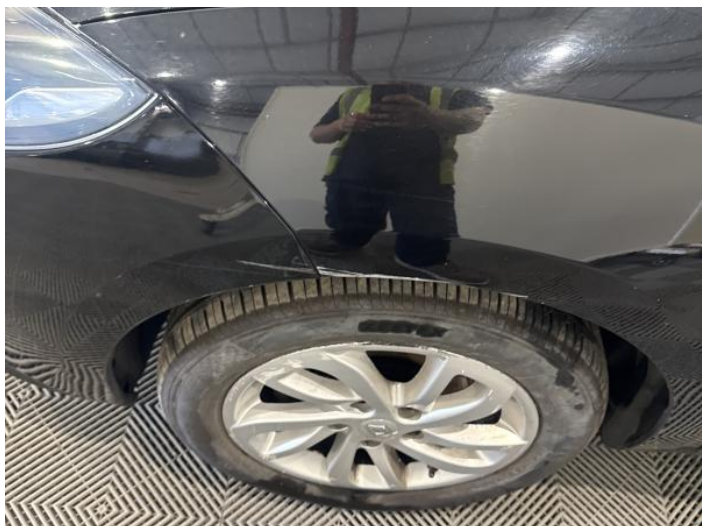
3: Wing nsf  
Scratched  
Over 25mm Thru Paint

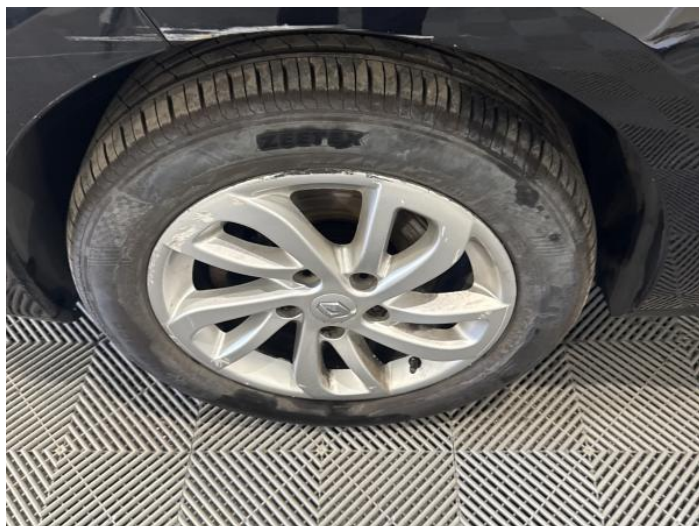
4: Wheel nsf  
Scratched  
Over 50mm

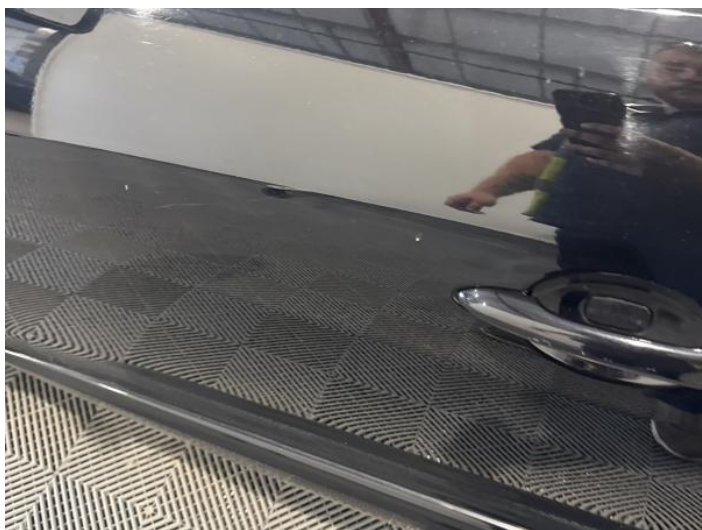
5: Door nsf  
Chipped  
1 To 5

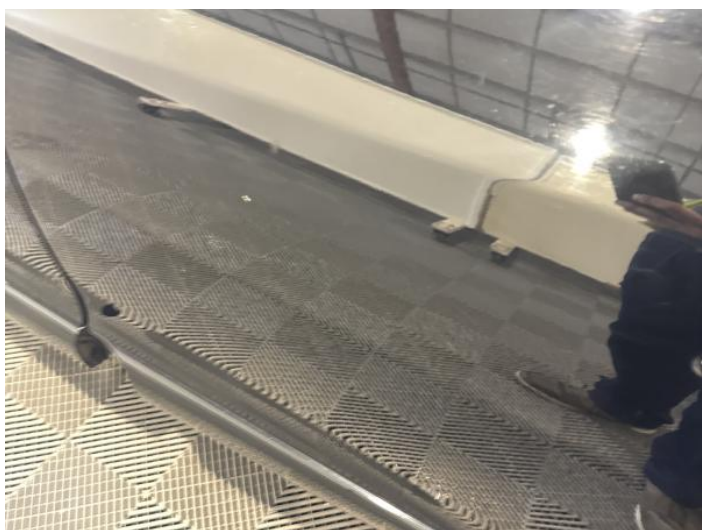
7: Door nsr  
Chipped  
1 To 5

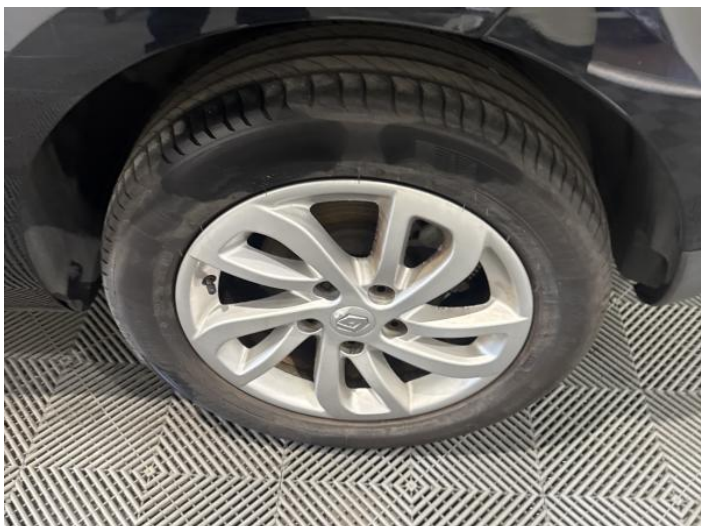
9: Wheel nsr  
Scratched  
Over 50mm

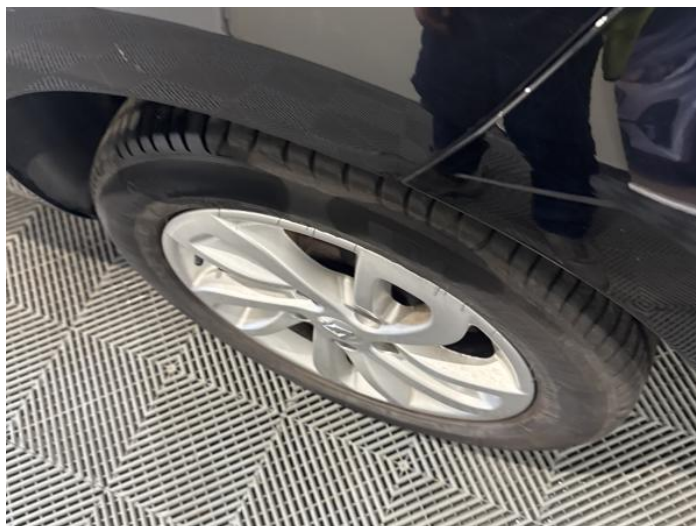
10: Qtr Panel nsr  
Dented  
Over 30mm

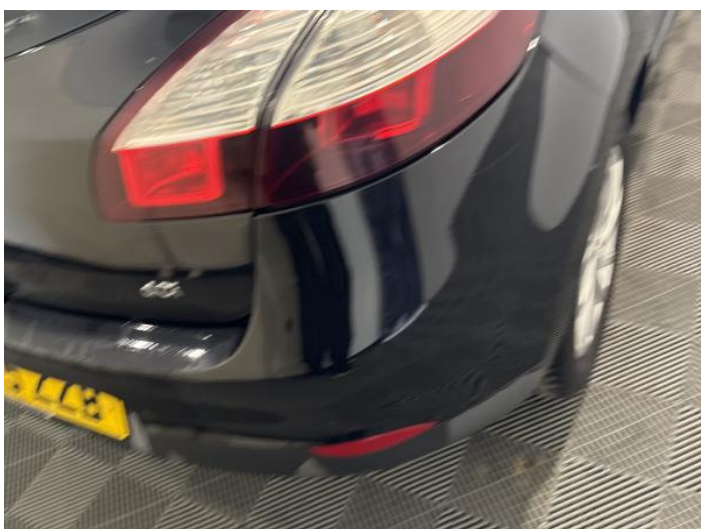
11: Bumper Rear  
Scratched  
25 to 100mm Thru Paint

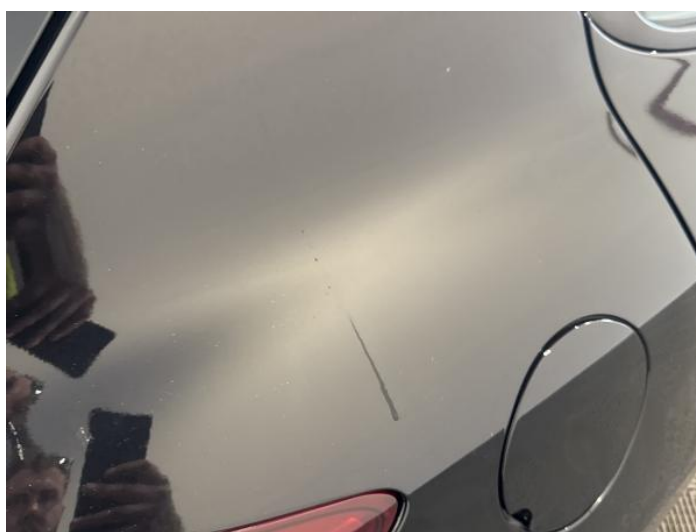
14: Qtr Panel osr  
Poor Previous Repair  
Poor Paint

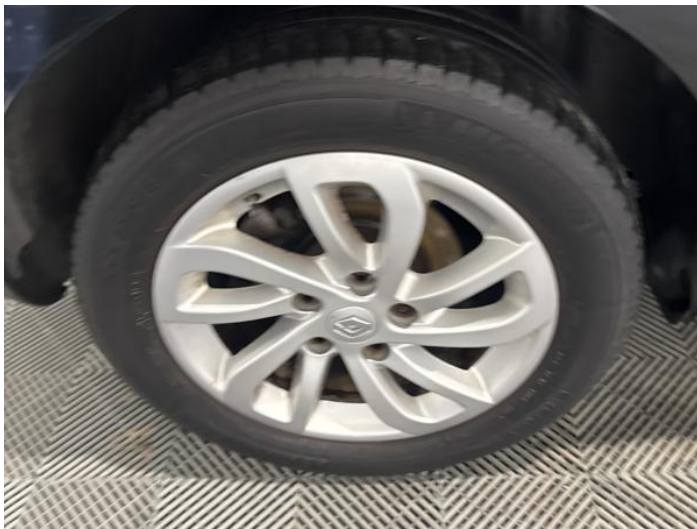
15: Wheel osr  
Scratched  
Up To 50mm

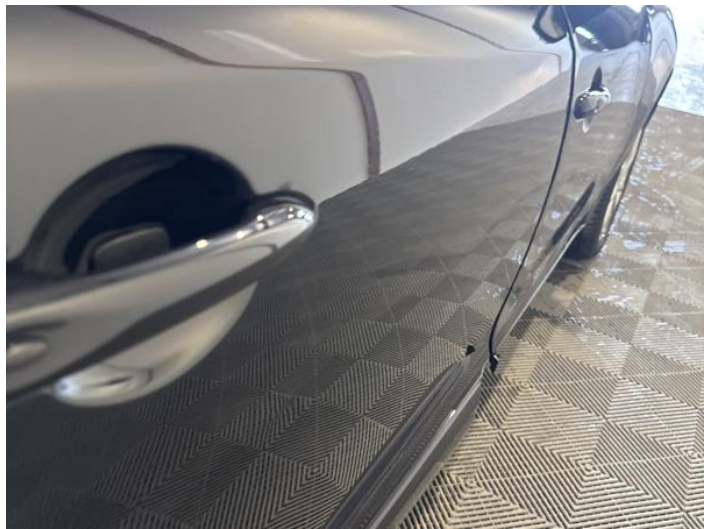
16: Door osr  
Dented  
Over 2 UpTo 10mm

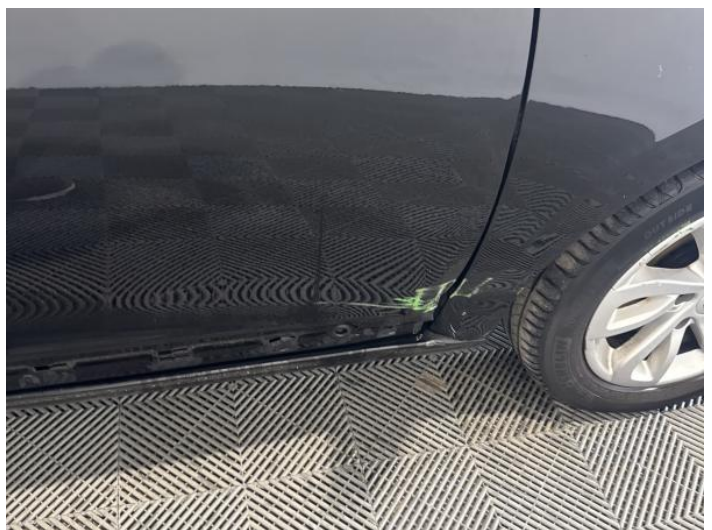
18: Door osf  
Dented  
With Paint Damage

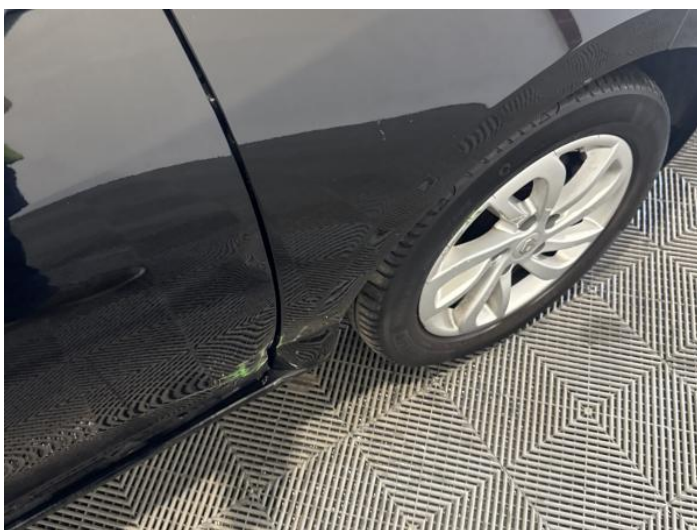
19: Wing osf  
Dented  
With Paint Damage

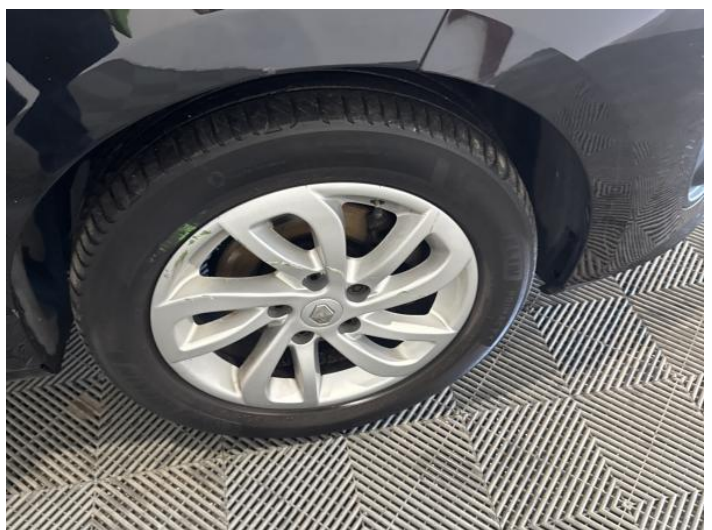
20: Wheel osf  
Scratched  
Over 50mm

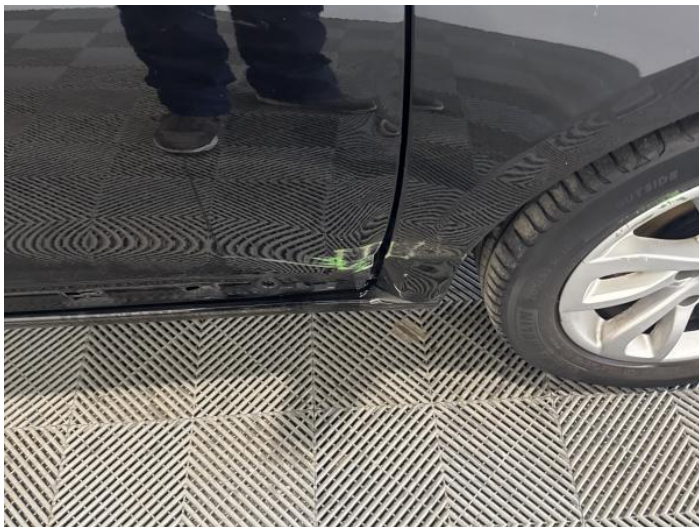
21: Sill os  
Dented  
With Paint Damage
