VEHICLE INSPECTION REPORT

RJ62ZWT

Renault Megane 1.5 dCi 110 Dynamique TomTom 5dr [Start Stop]

Cat: N Non Runner

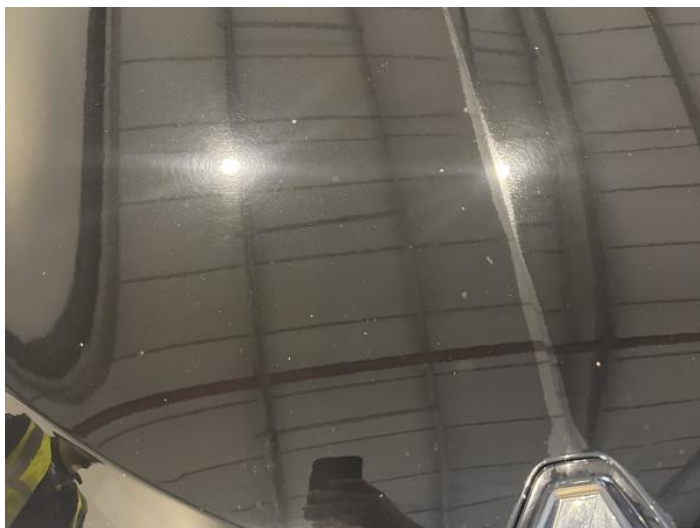
1: Bonnet
Chipped
Multiple Chips

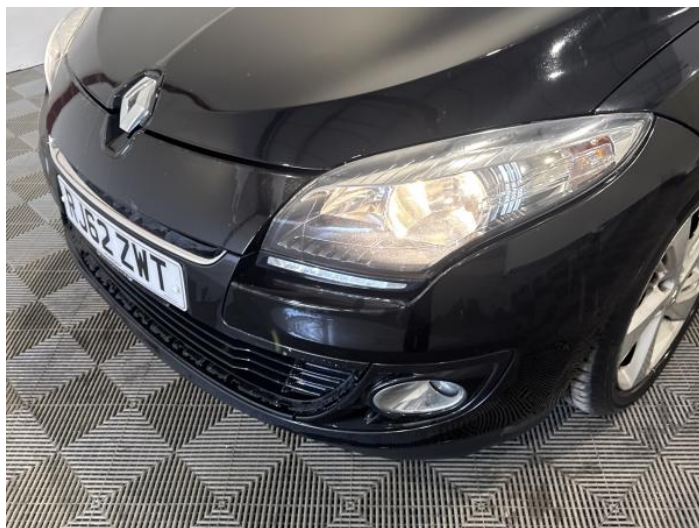
2: Bumper Front
Scratched
25 to 100mm Thru Paint

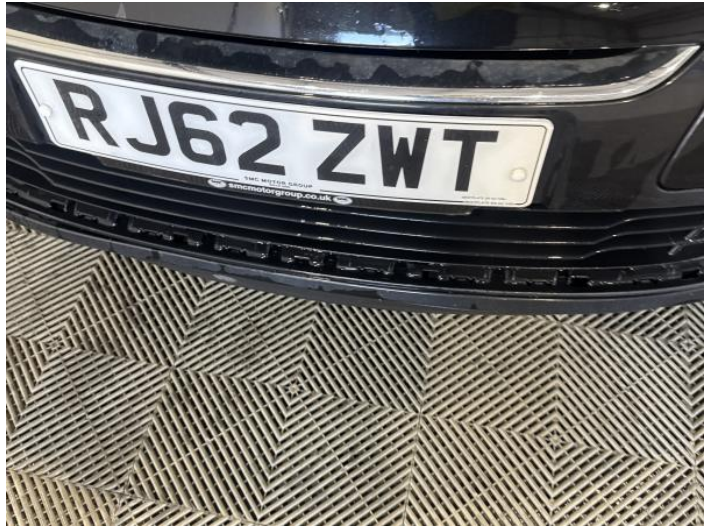
3: Bumper Front
Scratched
Over 25mm Not Thru Paint

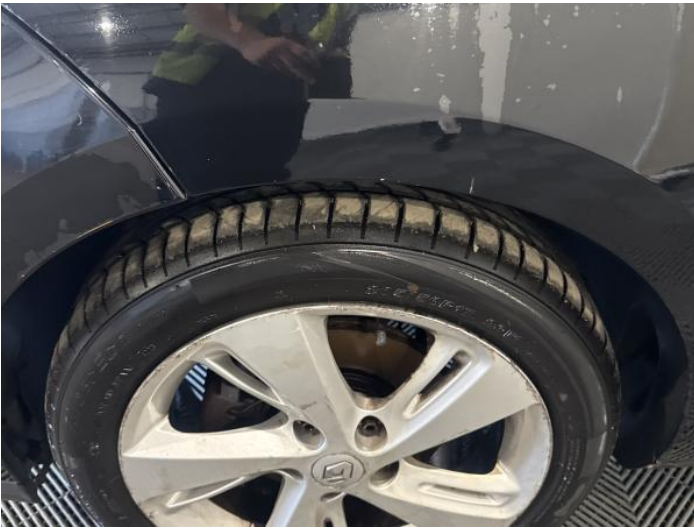
5: Wheel nsf
Scratched
Over 50mm

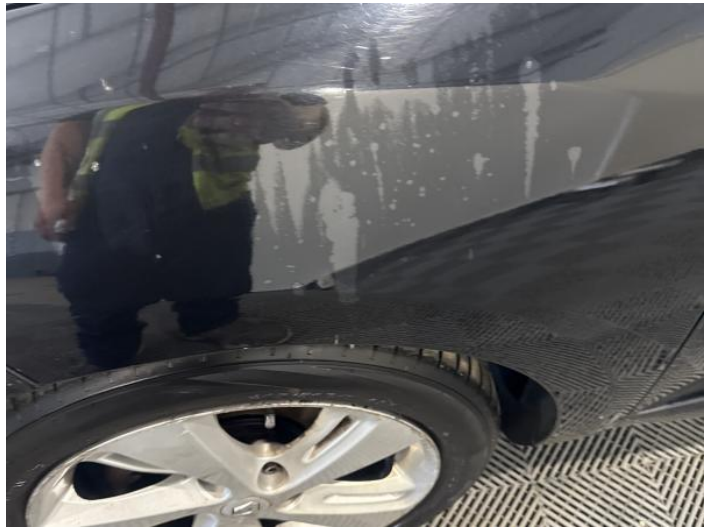
6: Wing nsf
Chipped
1 To 5

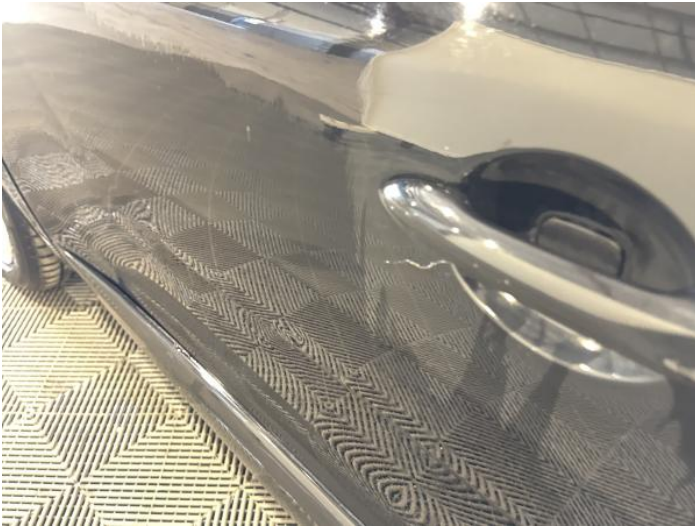
9: Door nsf
Dented
Over 30mm

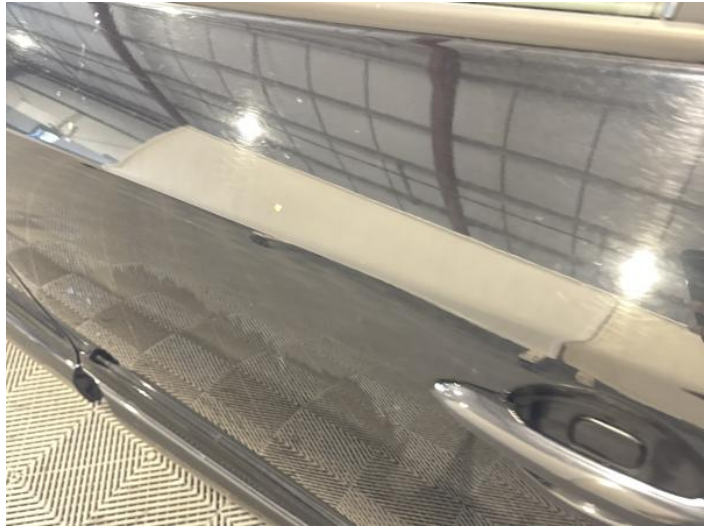
10: Door nsr
Chipped
1 To 5

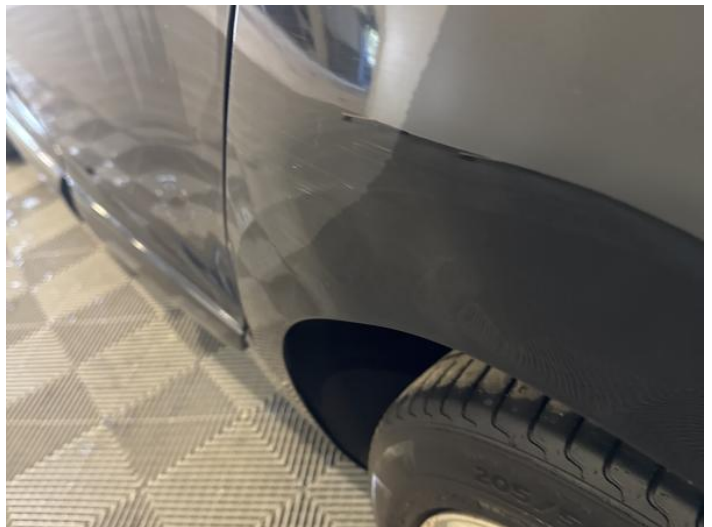
12: Qtr Panel nsr
Dented
Over 30mm

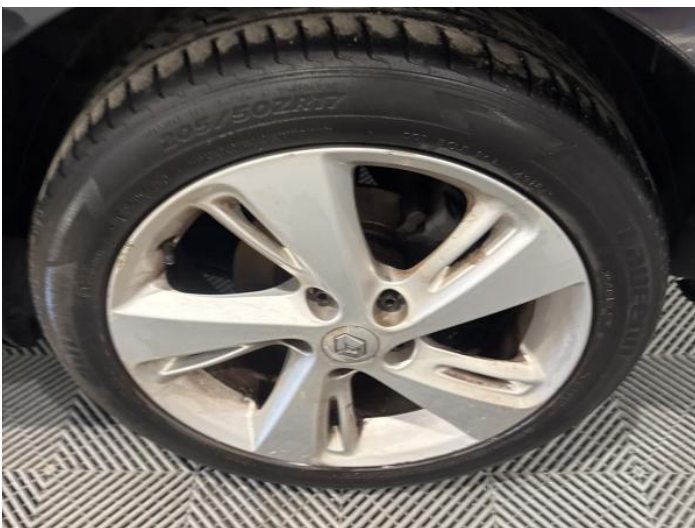
13: Wheel nsr
Scratched
Over 50mm

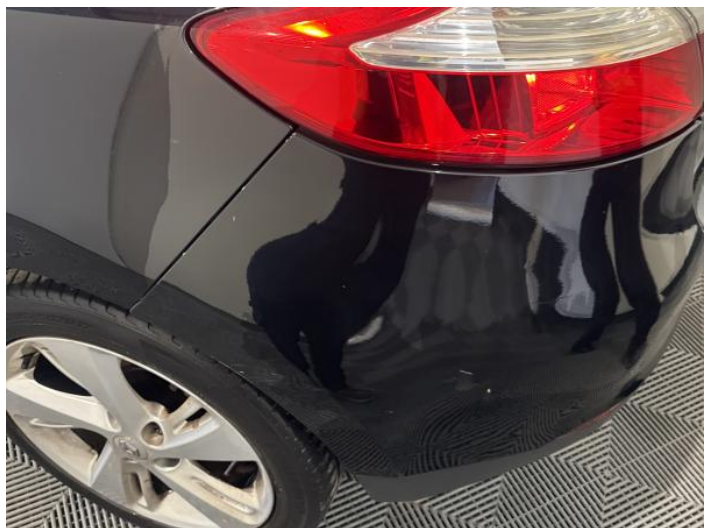
14: Bumper Rear
Scratched
Over 100mm Thru Paint

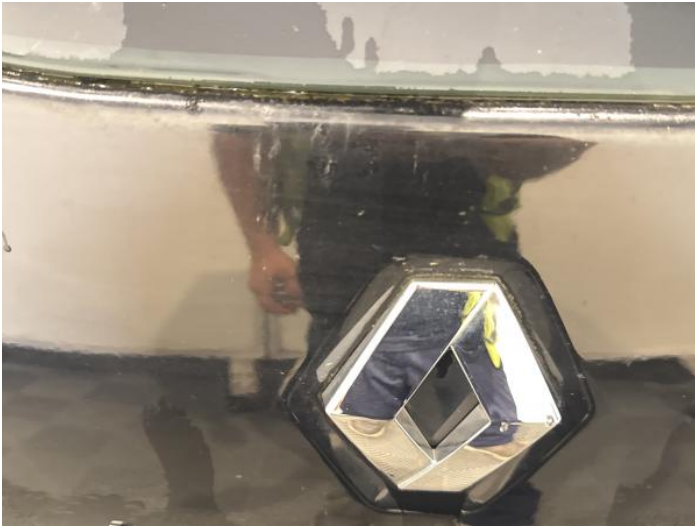
15: Boot Lid
Poor Previous Repair
Poor Paint

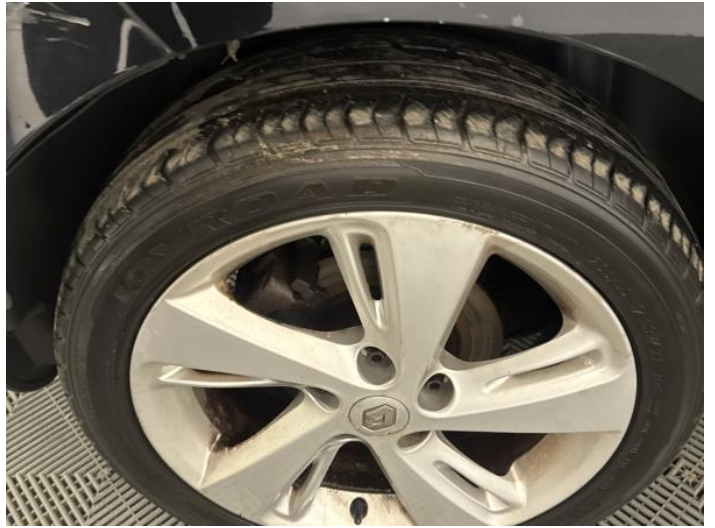
16: Wheel osr
Scratched
Over 50mm

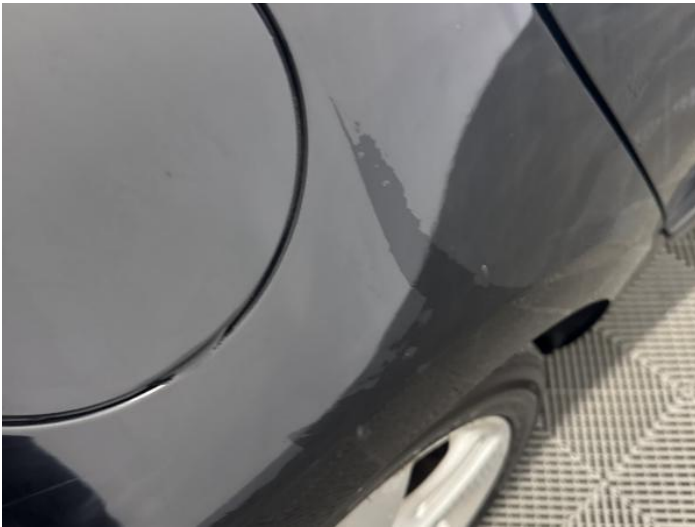
17: Qtr Panel osr
Chipped
1 To 5

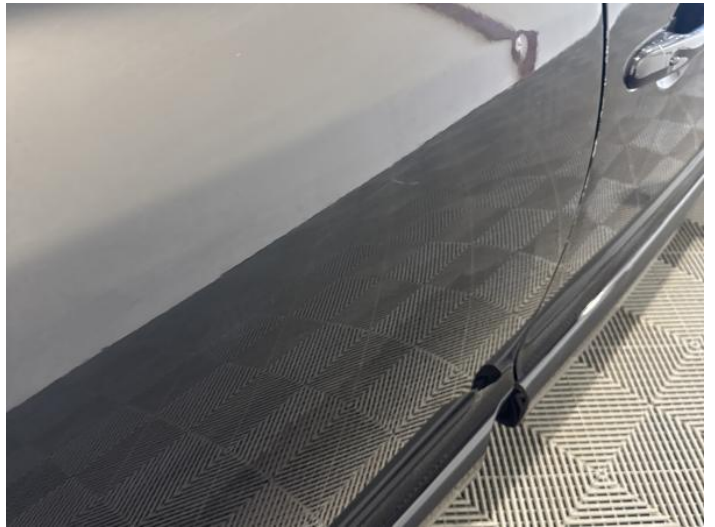
18: Door osr
Dented
Between 10mm + 30mm

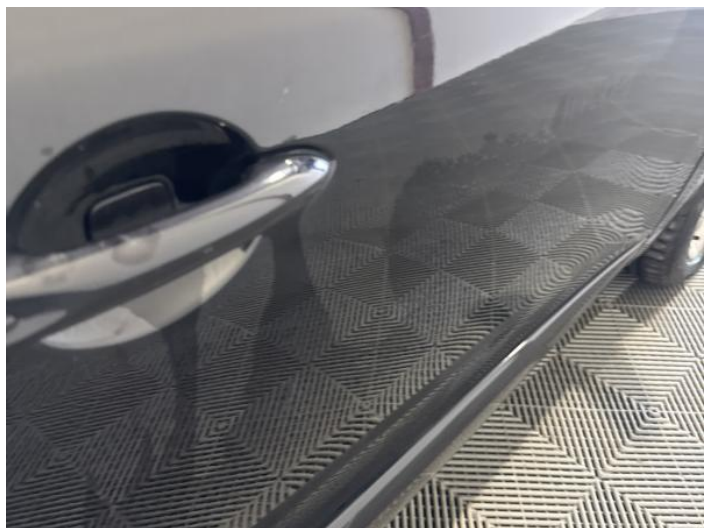
20: Door osf
Chipped
1 To 5

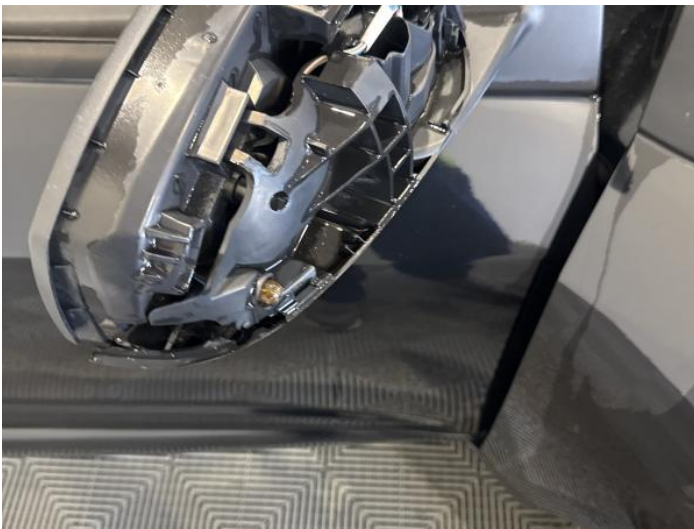
23: Door Mirror Assy osf
Broken
Replace

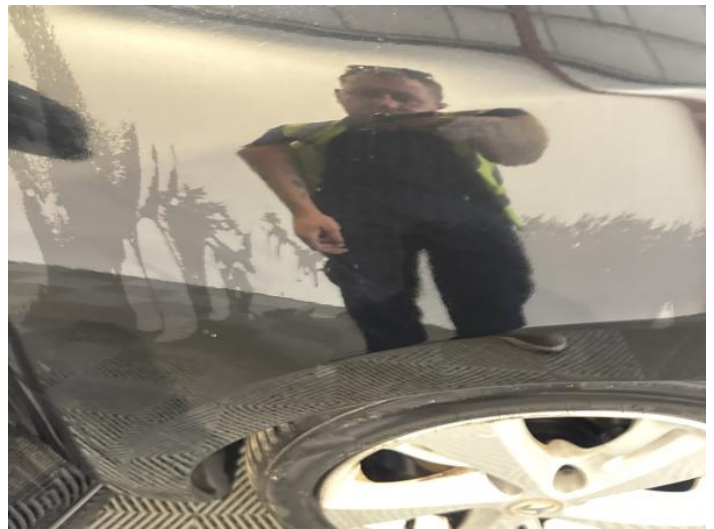
24: Wing osf
Chipped
1 To 5
