VEHICLE INSPECTION REPORT

YT69FJC

Hyundai I40 1.6 CRDi SE Nav 5dr

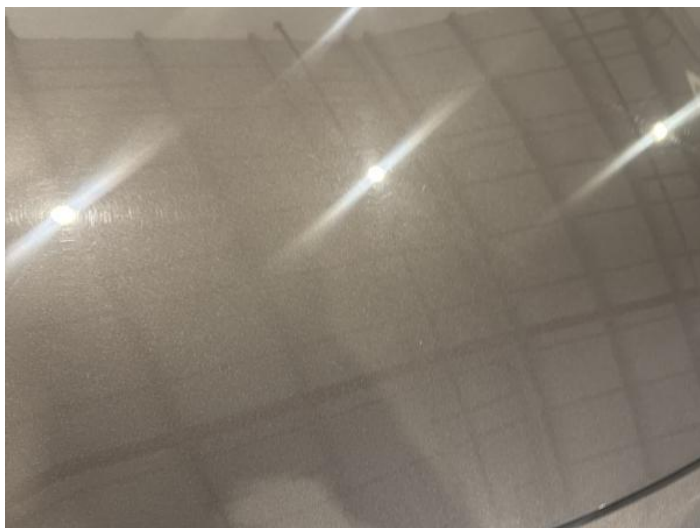
1: Bonnet
Chipped
1 To 5

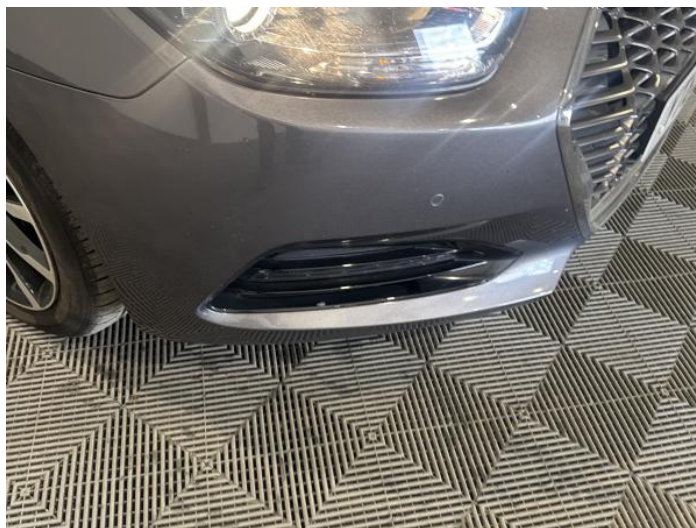
2: Bumper Front
Scratched
Over 100mm Thru Paint

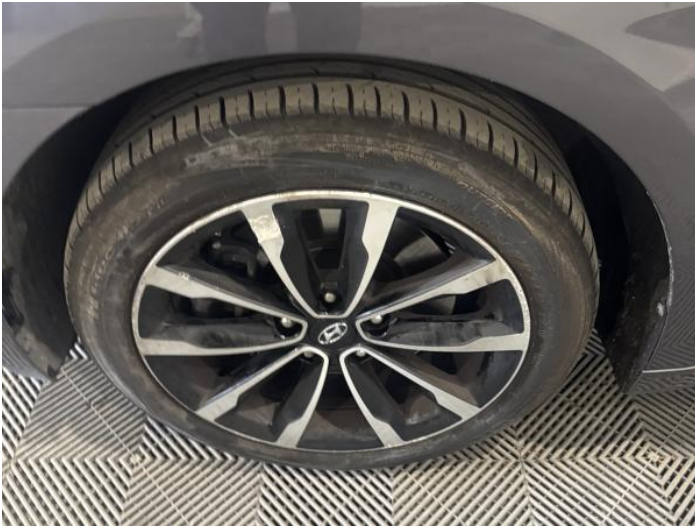
3: Wheel nsf
Scratched
Over 50mm

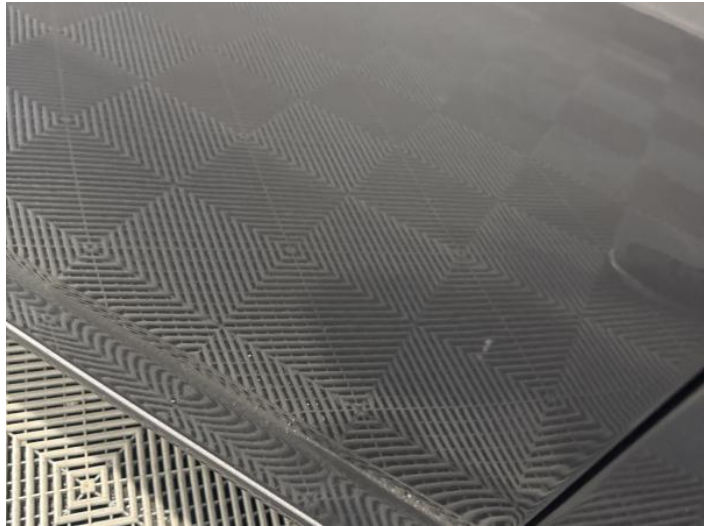
4: Door nsf
Chipped
1 To 5

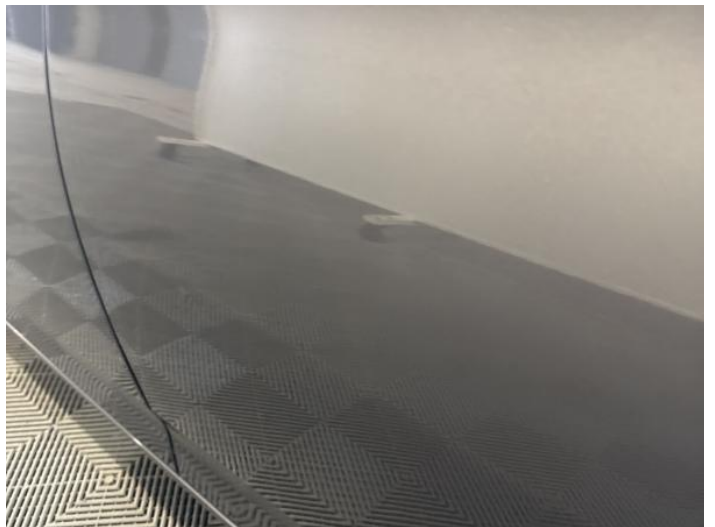
6: Door nsr
Dented
Between 10mm + 30mm

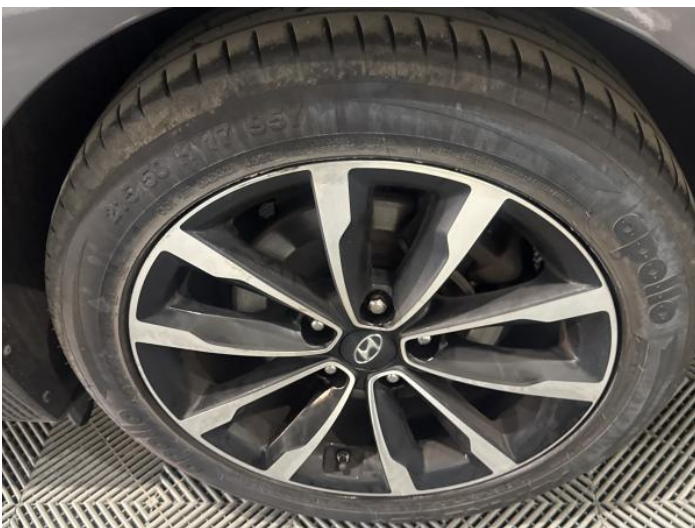
7: Wheel nsr
Scratched
Over 50mm

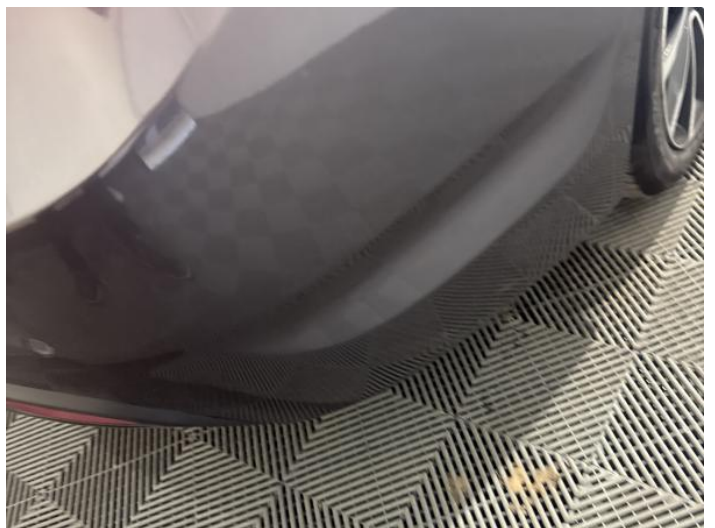
8: Bumper Rear
Scratched
25 to 100mm Thru Paint

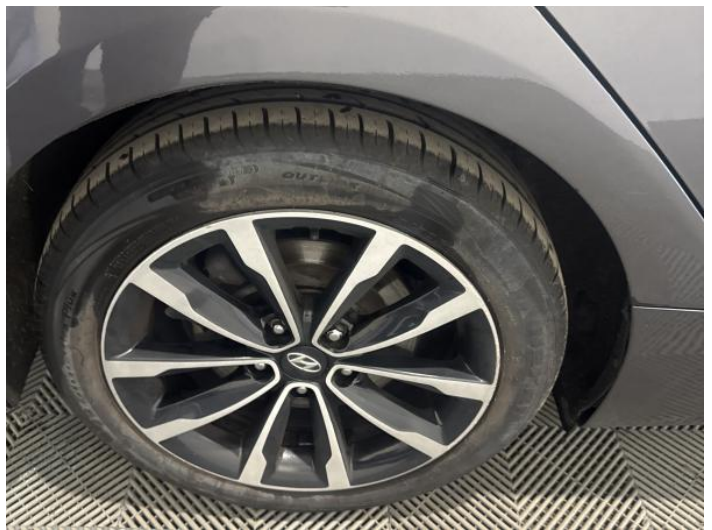
12: Wheel osr
Scratched
Up To 50mm

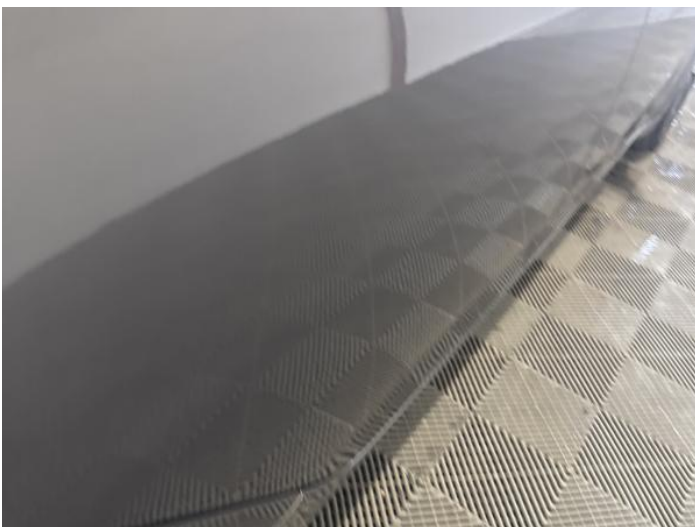
13: Door osr
Dented
Over 2 UpTo 10mm

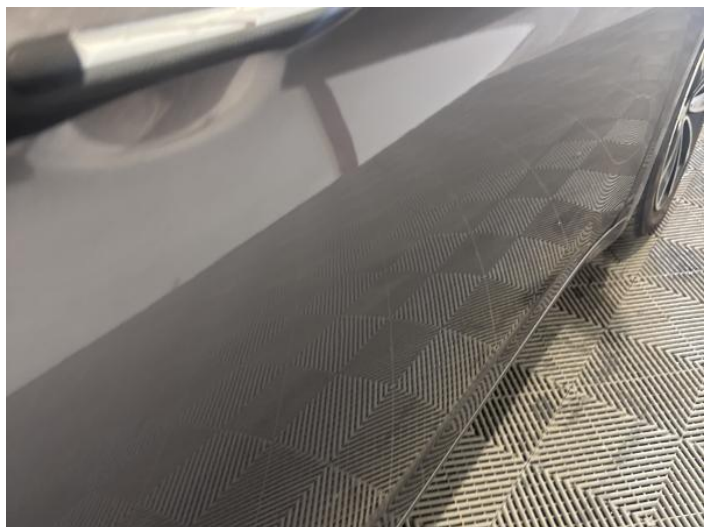
14: Door osf
Chipped
1 To 5
