VEHICLE INSPECTION REPORT

ET66MTU

Toyota RAV4 2.5 VVT-i Hybrid Business Ed Plus TSS 5dr CVT 2WD

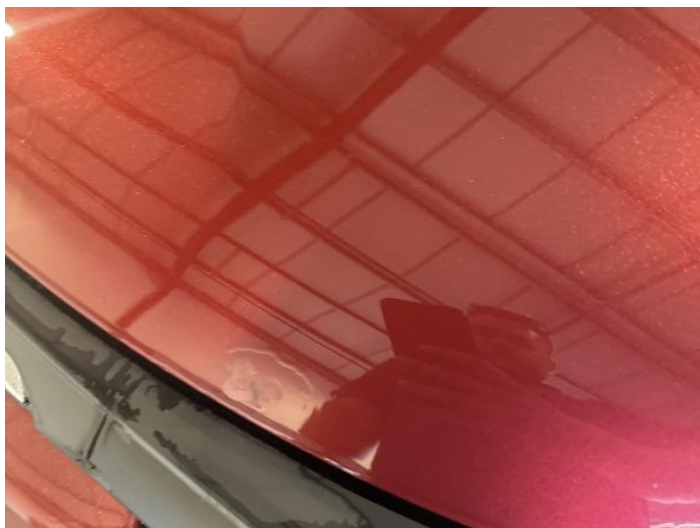
1: Bonnet
Chipped
1 To 5

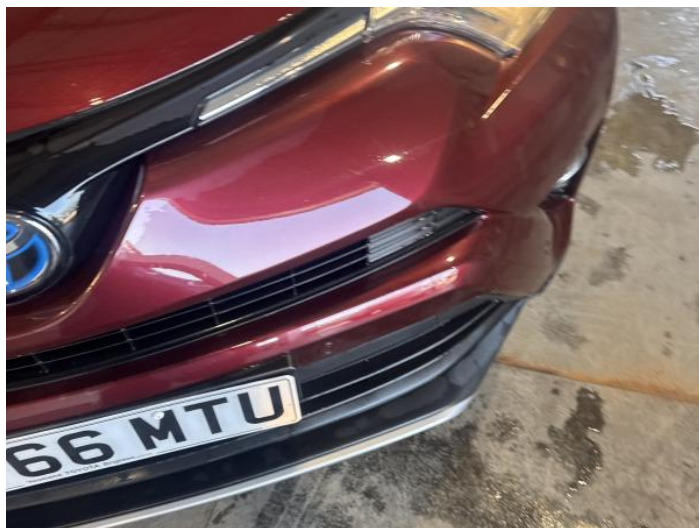
2: Bumper Front
Chipped
Multiple Chips

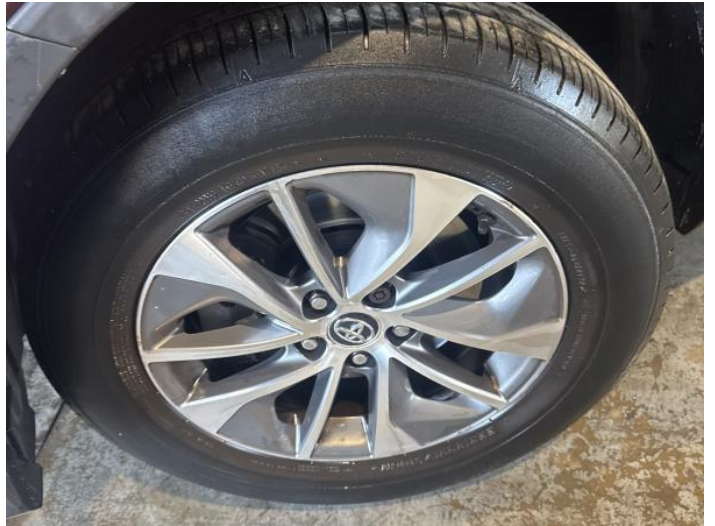
4: Wheel nsf
Scratched
Over 50mm

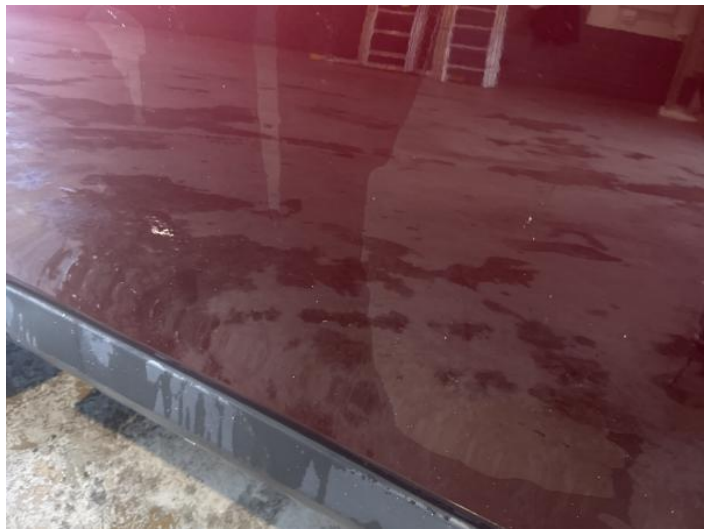
6: Door nsf
Chipped
Multiple Chips

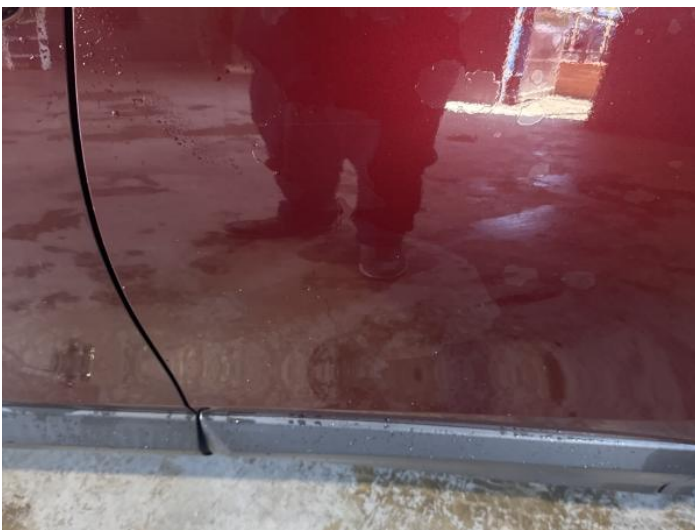
7: Door nsr
Chipped
Multiple Chips

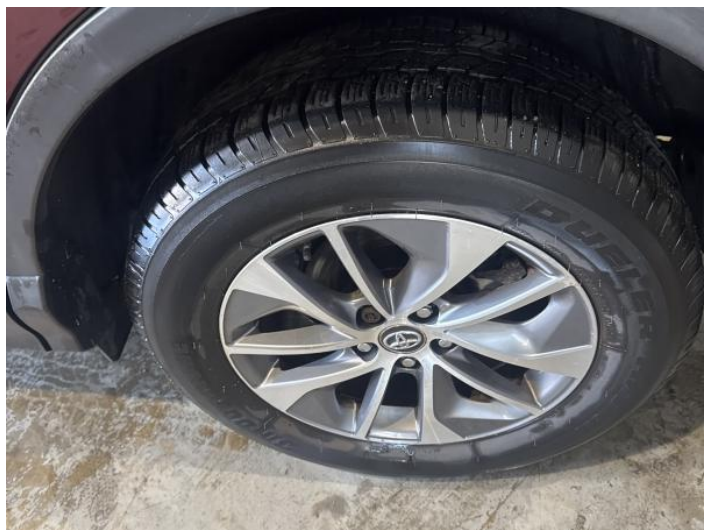
8: Wheel nsr
Scratched
Up To 50mm

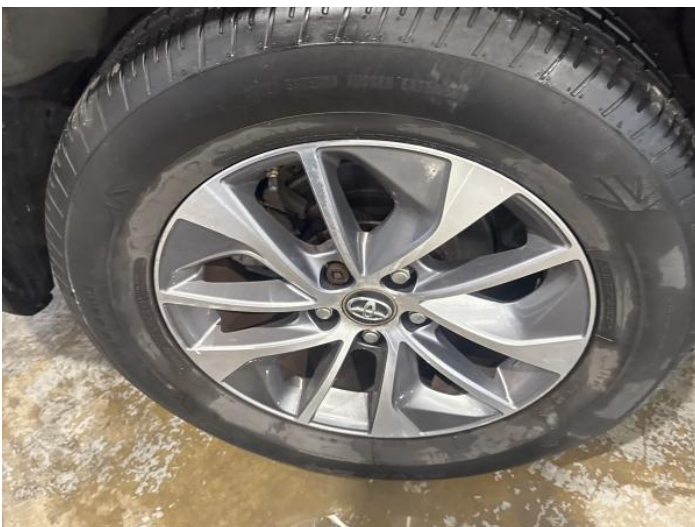
13: Wheel osr
Scratched
Over 50mm

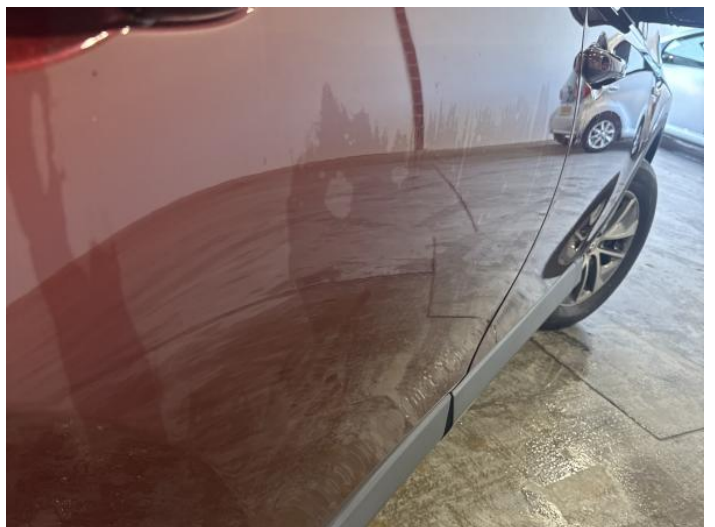
14: Door osr
Dented
Over 2 UpTo 10mm

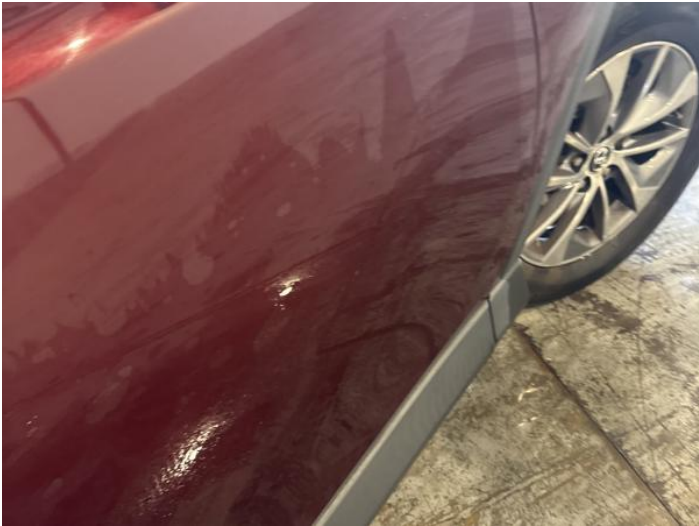
15: Door osf
Chipped
1 To 5

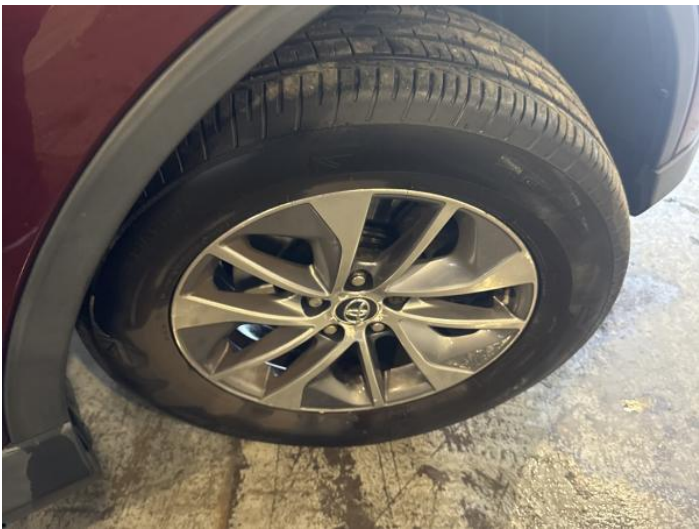
17: Wheel osf
Scratched
Over 50mm
