VEHICLE INSPECTION REPORT

LA60GFV

Renault Megane 1.6 16V I-Music 5dr

Imported
Inspection

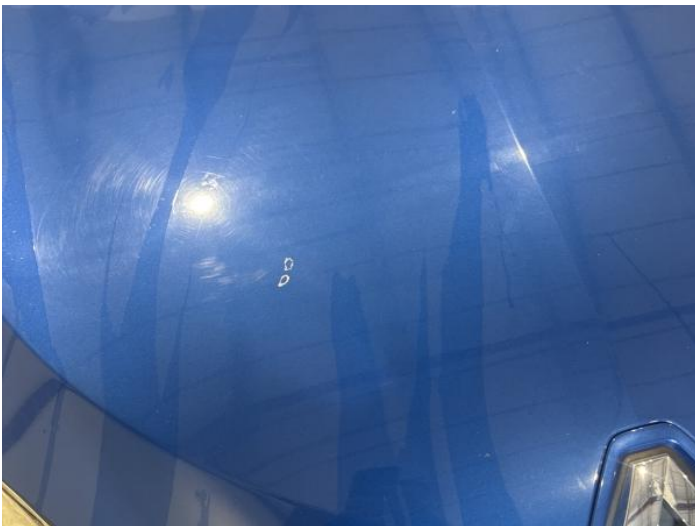
1: Bonnet
Chipped
Multiple Chips

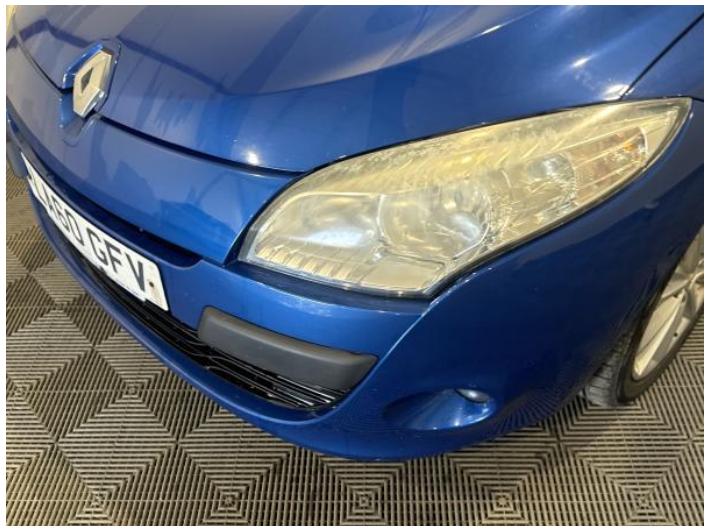
2: Bumper Front
Scratched
Over 100mm Thru Paint

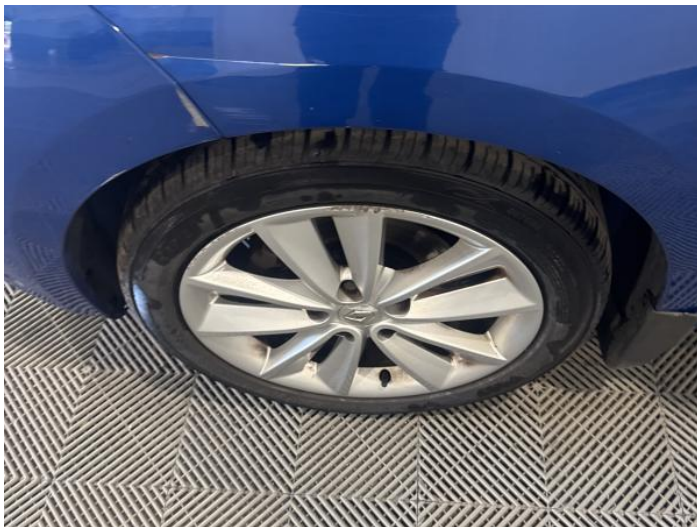
3: Wheel nsf
Scratched
Over 50mm

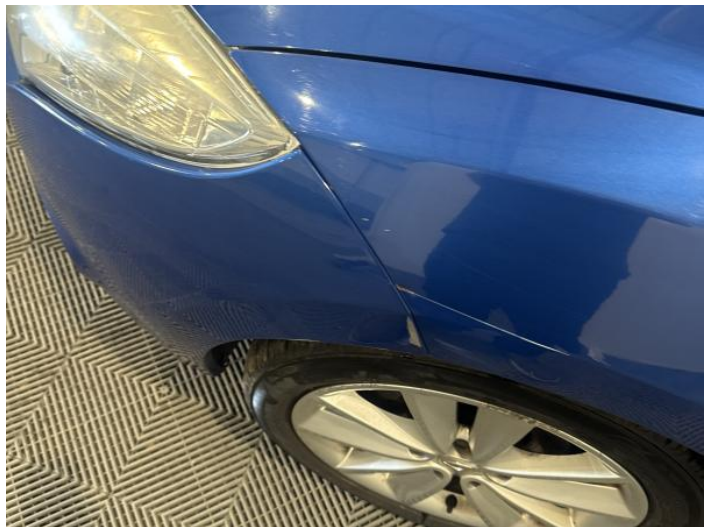
4: Wing nsf
Dented
With Paint Damage

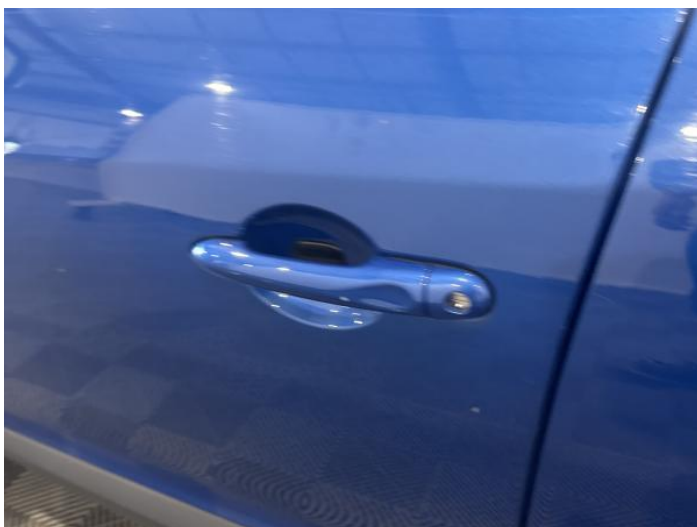
5: Door nsf
Chipped
1 To 5

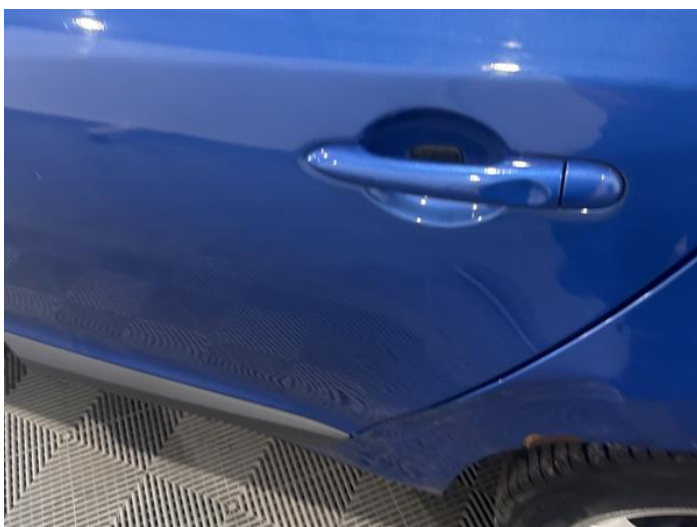
7: Door nsr
Dented
With Paint Damage

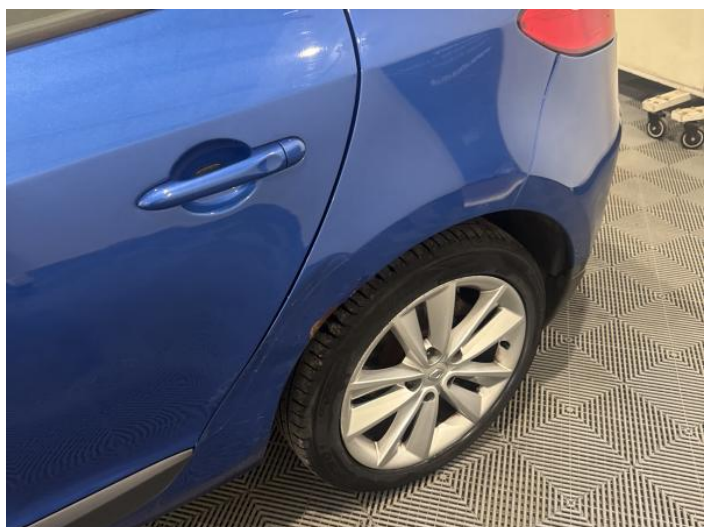
8: Qtr Panel nsr
Dented
With Paint Damage

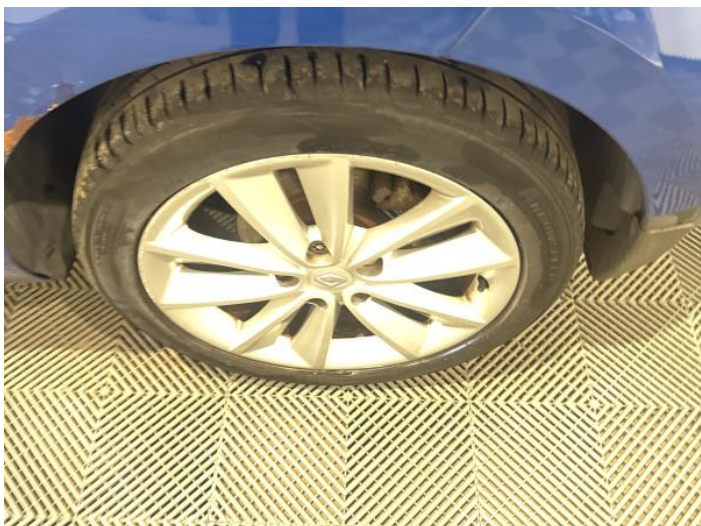
9: Wheel nsr
Scratched
Over 50mm

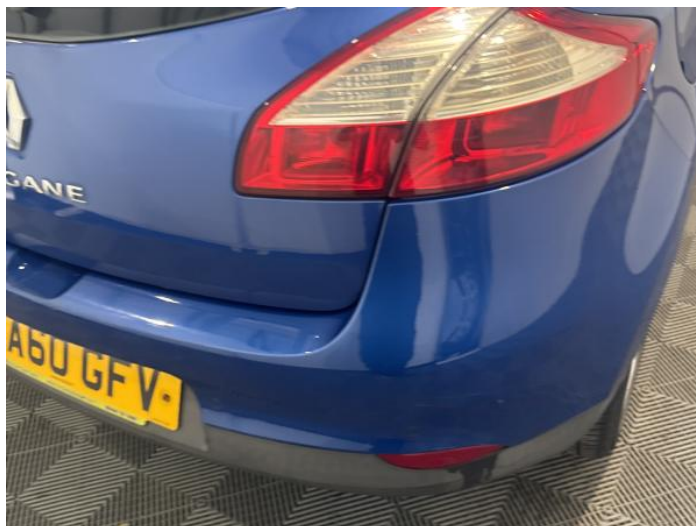
10: Bumper Rear
Scratched
Over 100mm Thru Paint

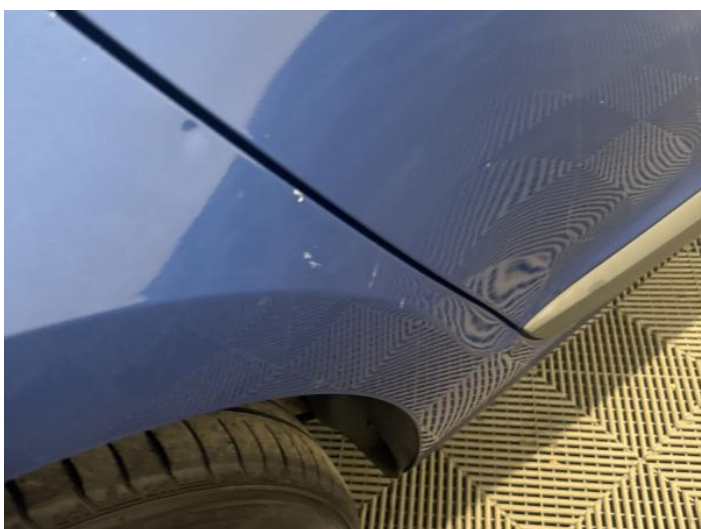
11: Qtr Panel osr
Dented
With Paint Damage

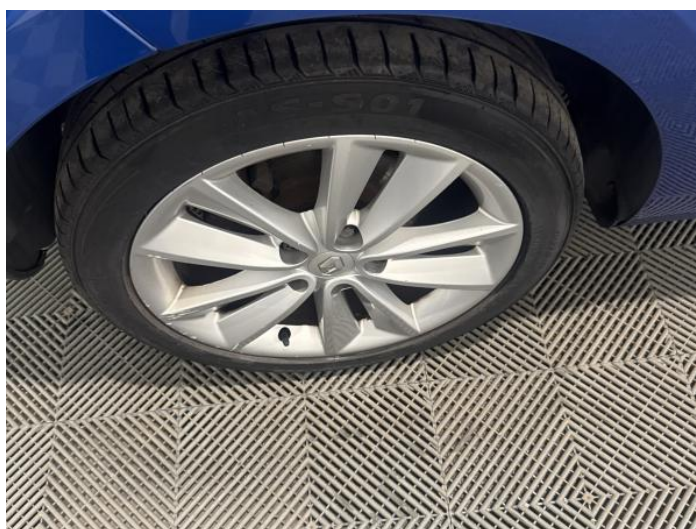
12: Wheel osr
Scratched
Over 50mm

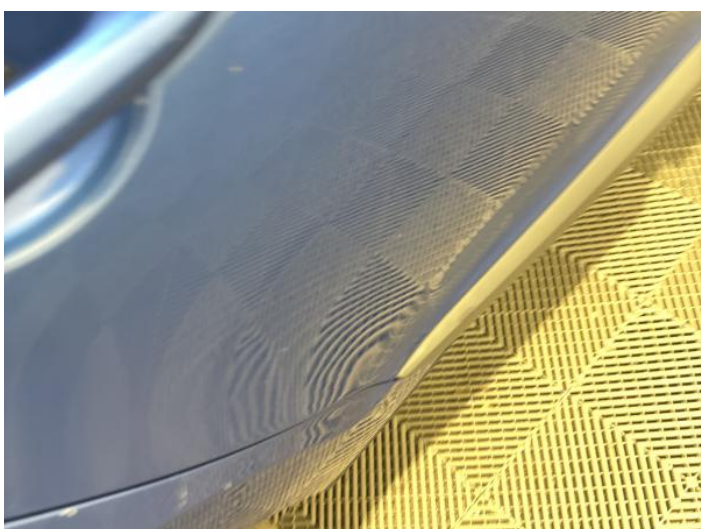
13: Door osr
Chipped
1 To 5

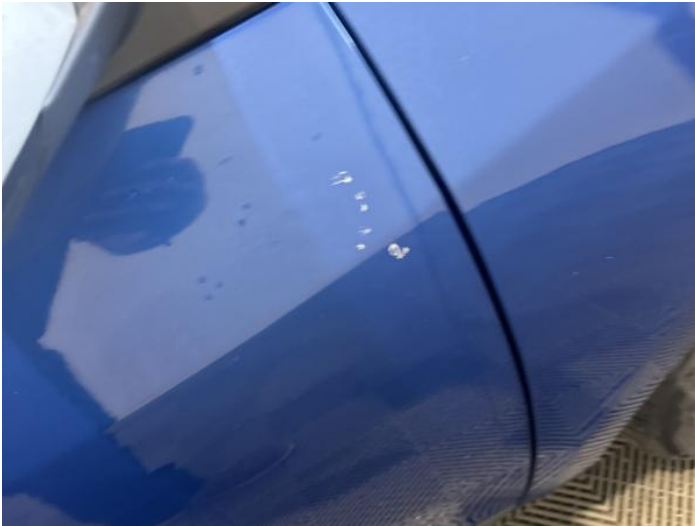
15: Door osf
Chipped
1 To 5

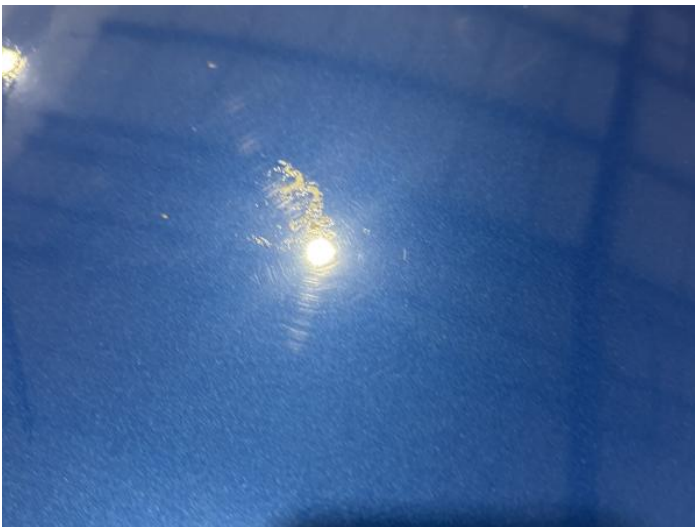
17: Roof
Poor Previous Repair
Paint Flake

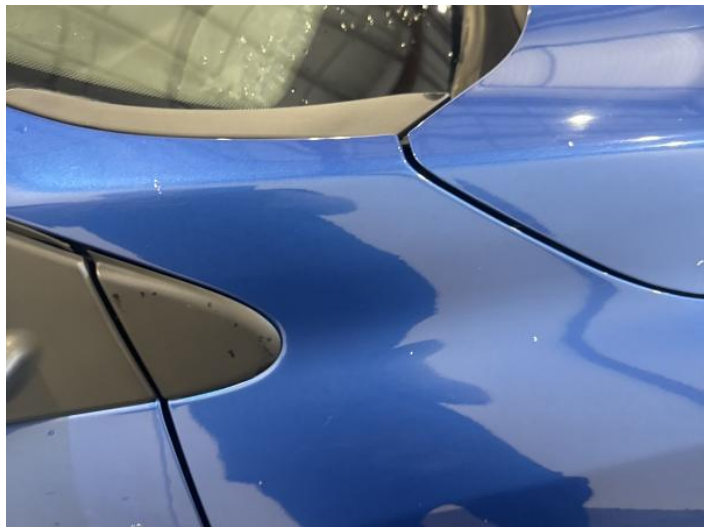
18: Wing osf
Chipped
1 To 5

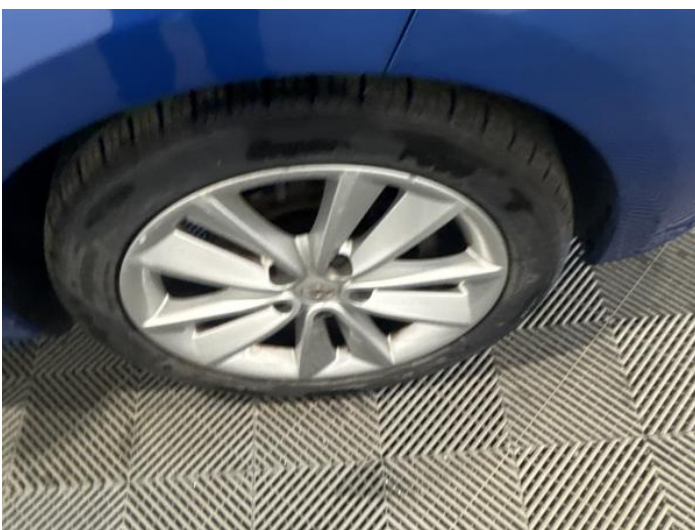
19: Wheel osf
Scratched
Over 50mm
