VEHICLE INSPECTION REPORT

BJ57ONU

Land Rover Freelander 2.2 Td4 SE 5dr

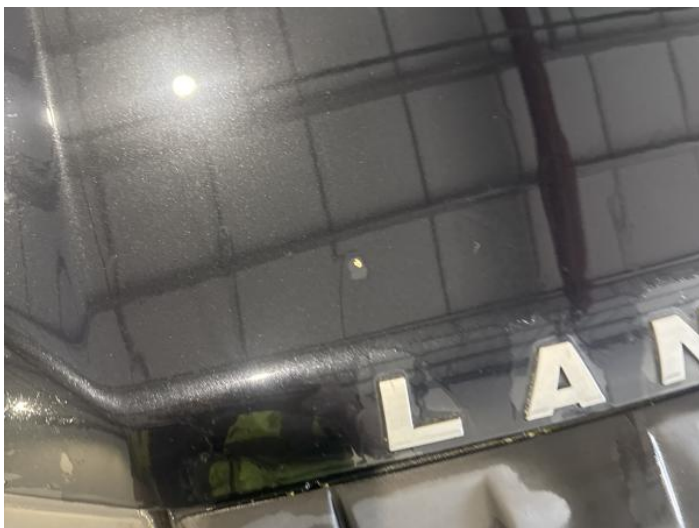
1: Bonnet
Chipped
Multiple Chips

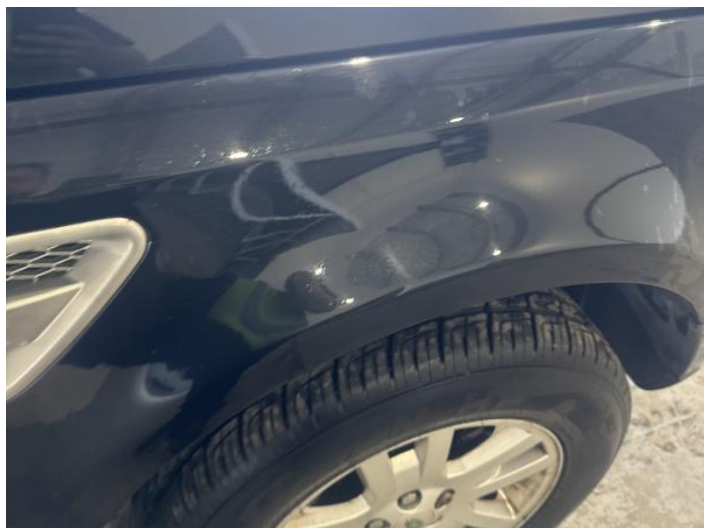
2: Wing osf
Chipped
1 To 5

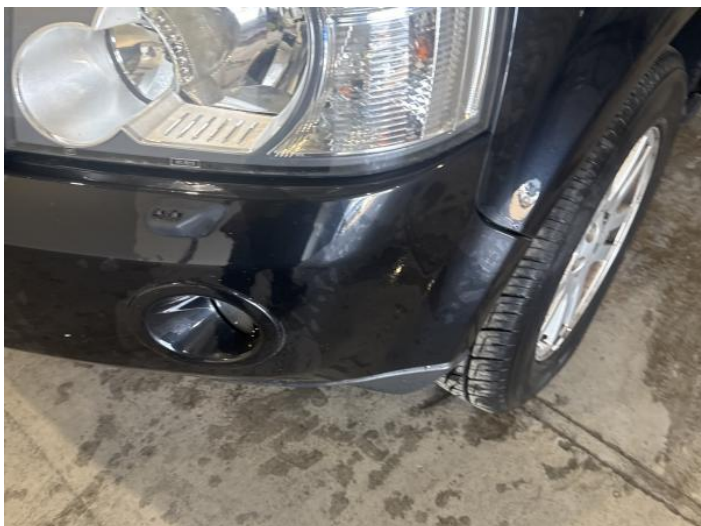
3: Bumper Front
Chipped
Multiple Chips

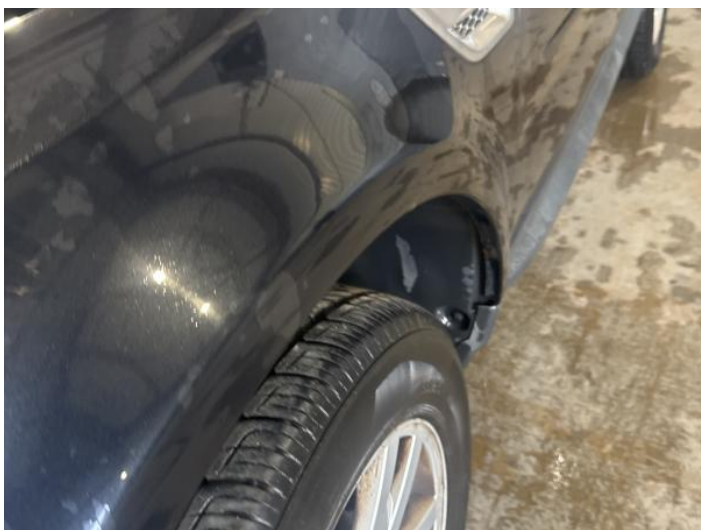
5: Wing nsf
Dented
Over 2 UpTo 10mm

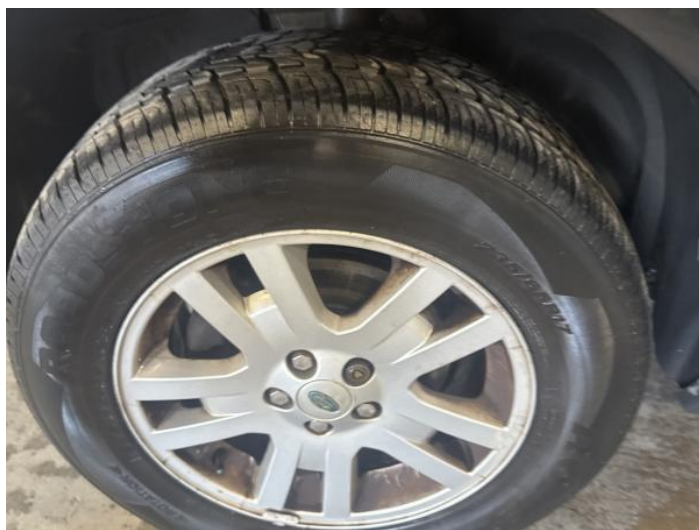
6: Wheel nsf
Scratched
Over 50mm

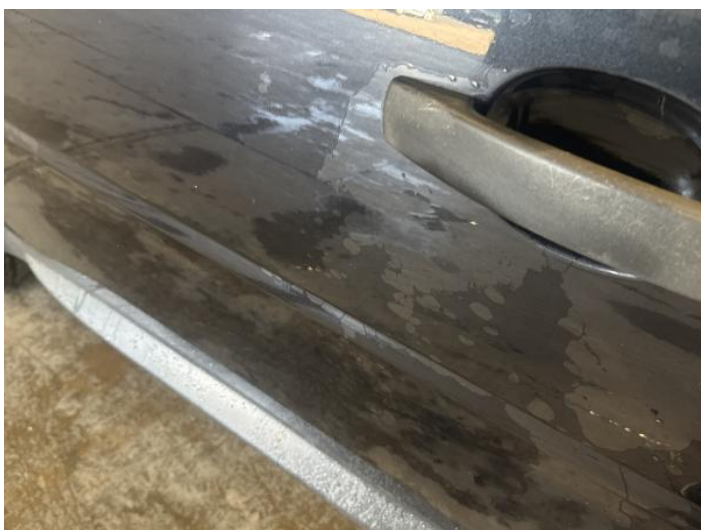
7: Door nsf
Chipped
1 To 5

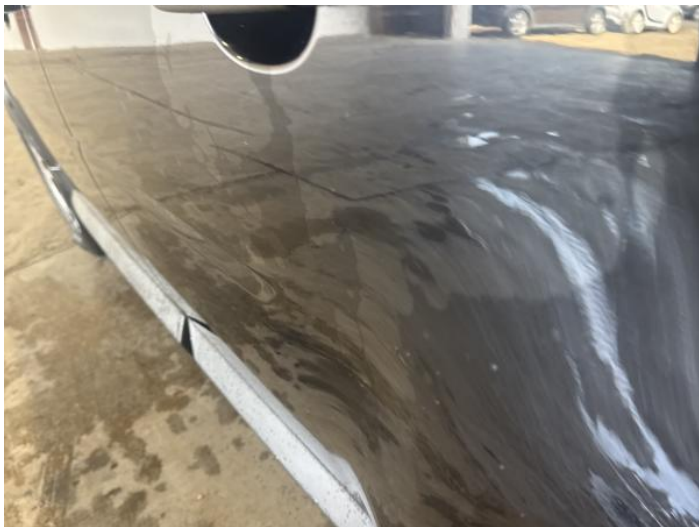
9: Door nsr
Dented
2 Or Less UpTo 10mm

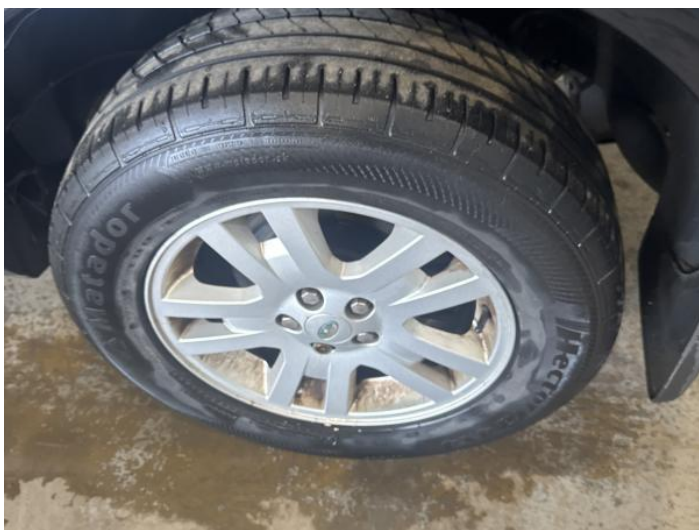
11: Wheel nsr
Scratched
Over 50mm

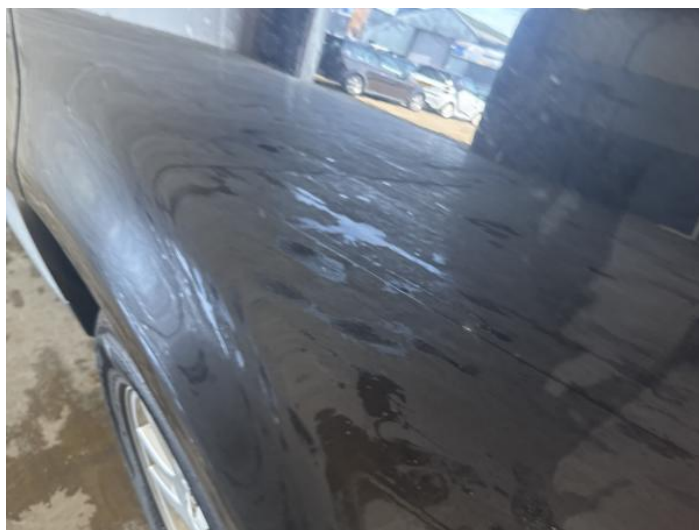
12: Qtr Panel nsr
Chipped
1 To 5

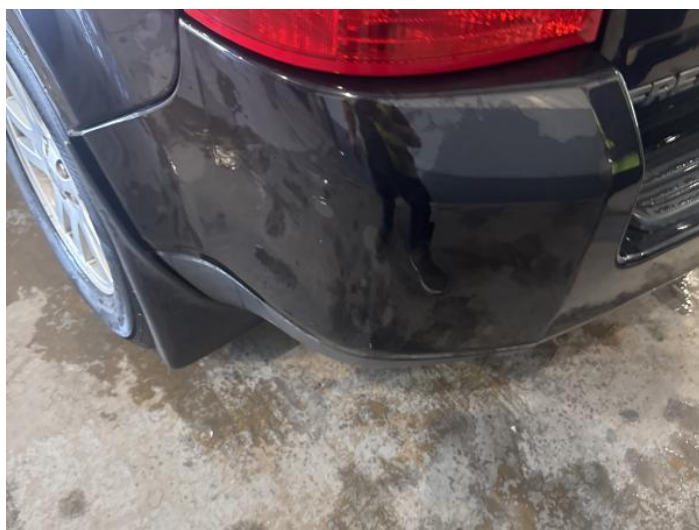
14: Bumper Rear
Scratched
25 to 100mm Thru Paint

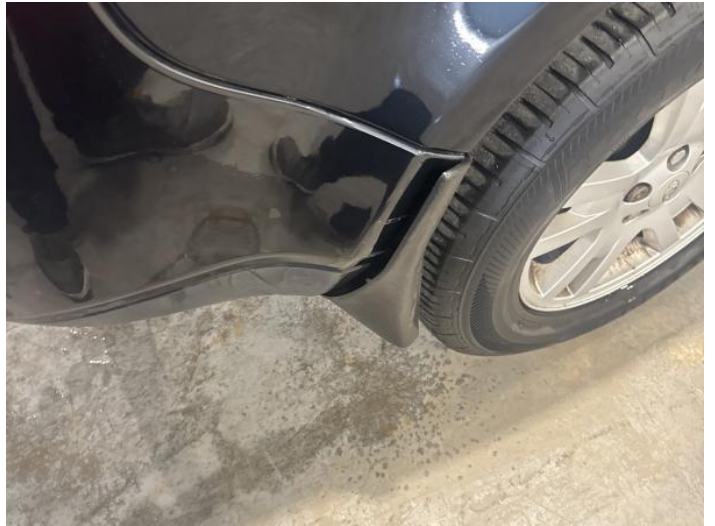
15: Bumper Rear
Scratched
Over 25mm Not Thru Paint

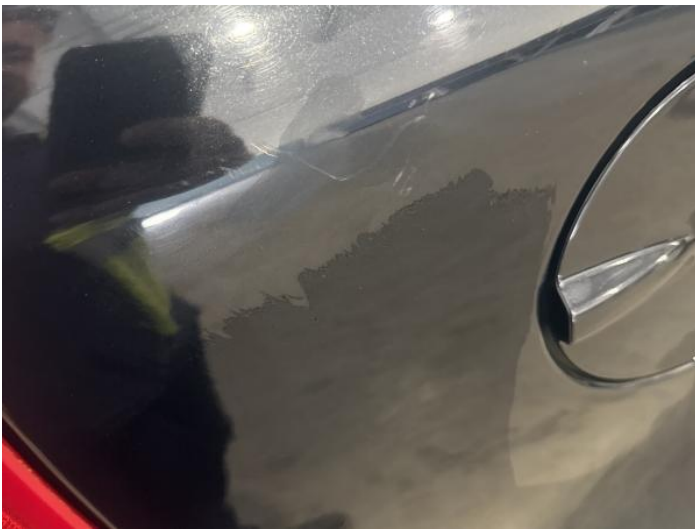
17: Qtr Panel osr
Dented
2 Or Less UpTo 10mm

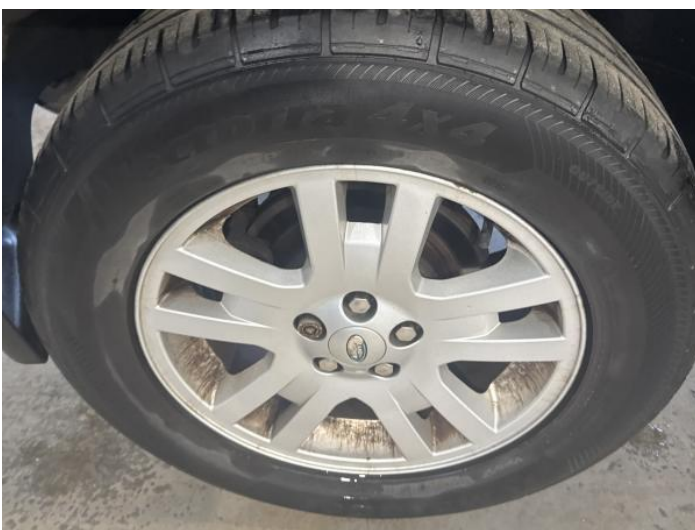
19: Wheel osr
Scratched
Over 50mm

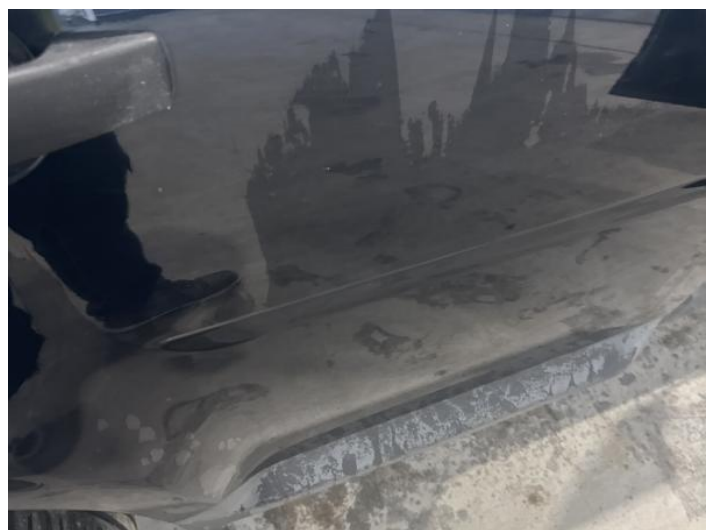
20: Door osr
Chipped
1 To 5

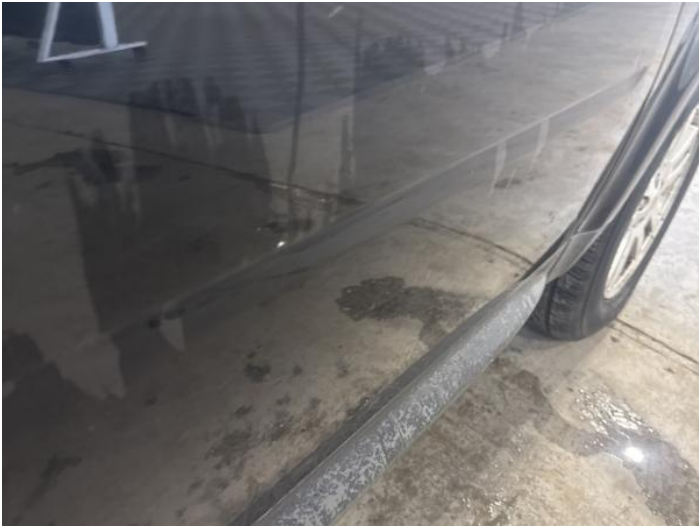
21: Door osf
Chipped
1 To 5

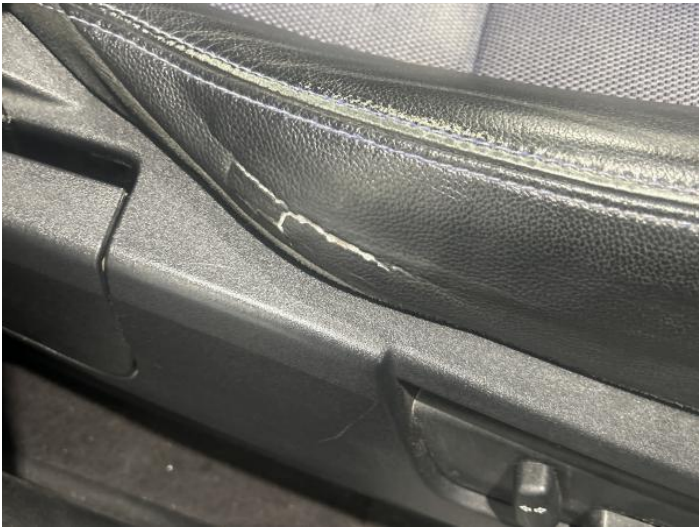
23: Seat Base Cover osf
Torn
Over 3mm
