VEHICLE INSPECTION REPORT

GU10WKV

Honda Jazz 1.4 i-VTEC ES 5dr

nama
GRADE
4

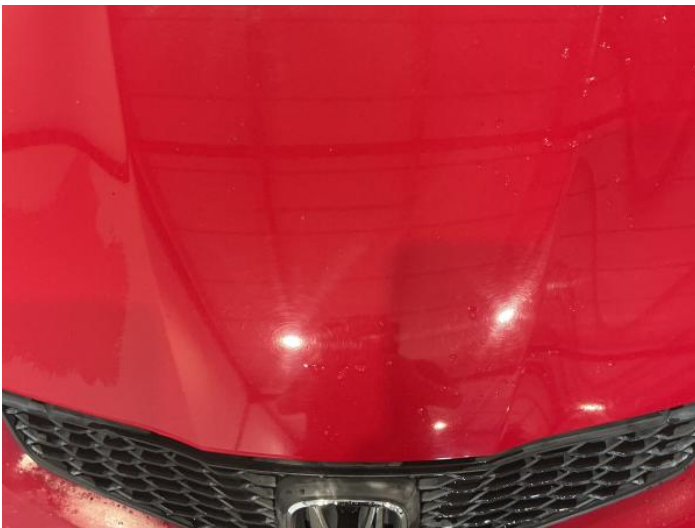
1: Bonnet
Poor Previous Repair
Paint Flake

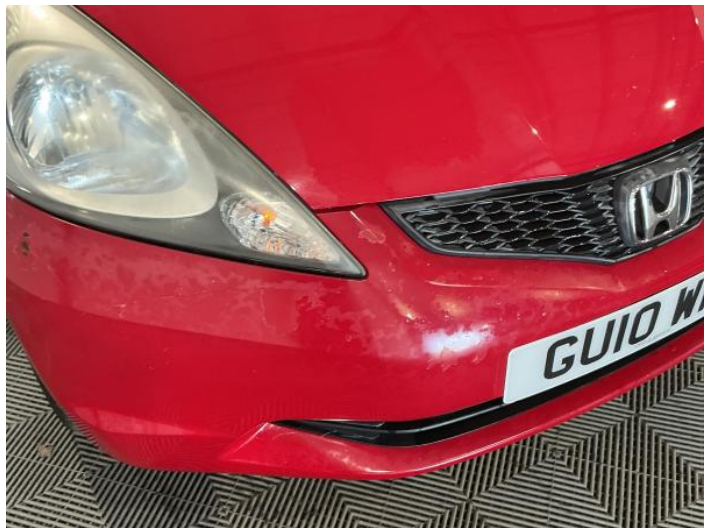
2: Bumper Front
Poor Previous Repair
Paint Flake

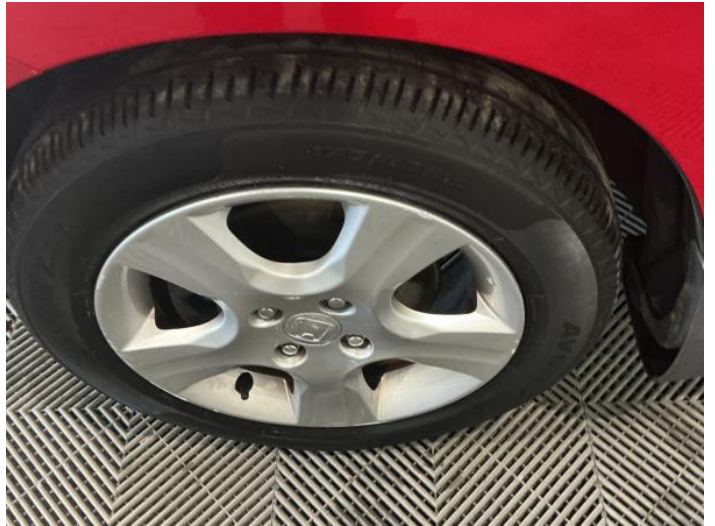
3: Wing nsf
Scratched
Over 25mm Not Thru Paint

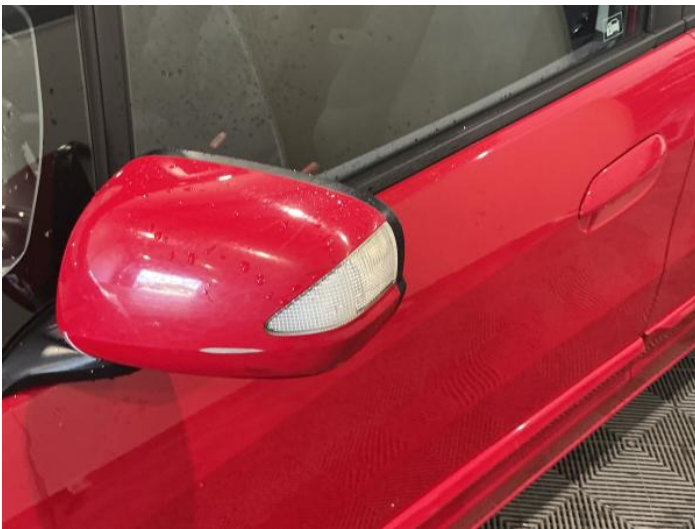
5: Door Mirror Assy nsf
Scratched (Painted)
Over 25mm Thru Paint

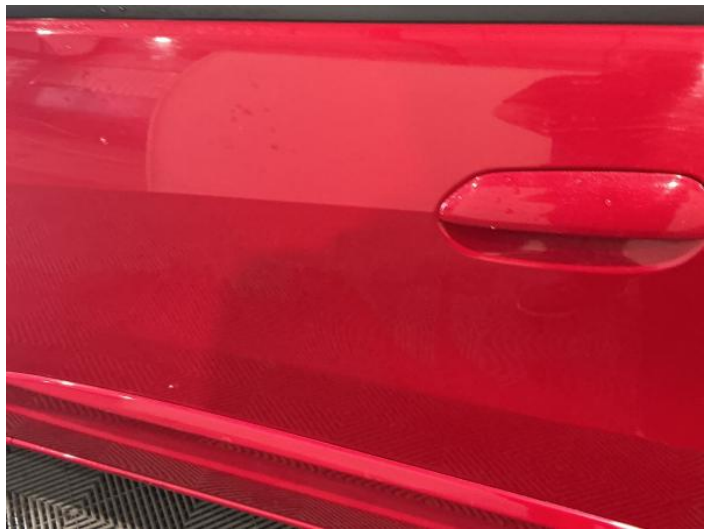
6: Door nsf
Dented
Over 2 UpTo 10mm

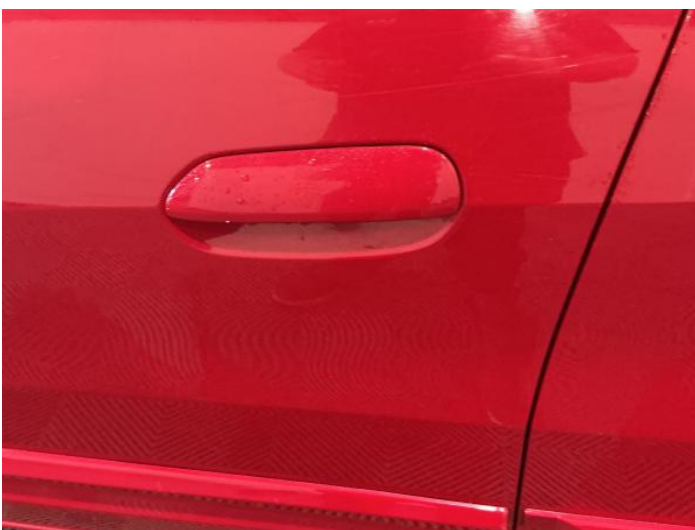
7: Door nsr
Chipped
1 To 5

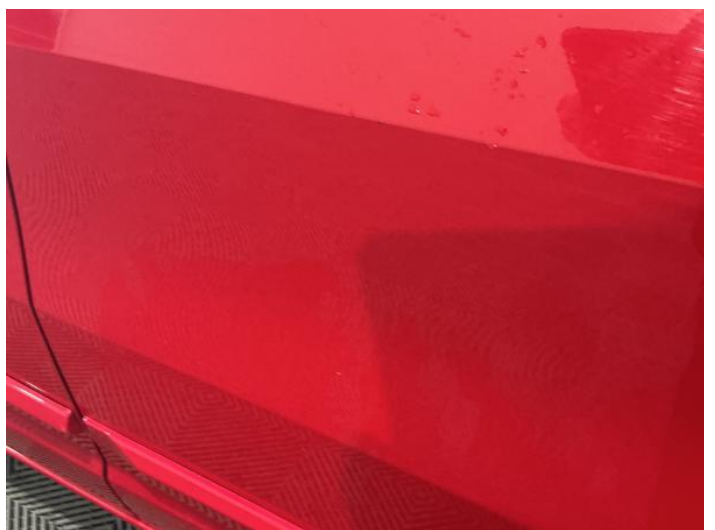
8: Door nsr
Dented
Between 10mm + 30mm

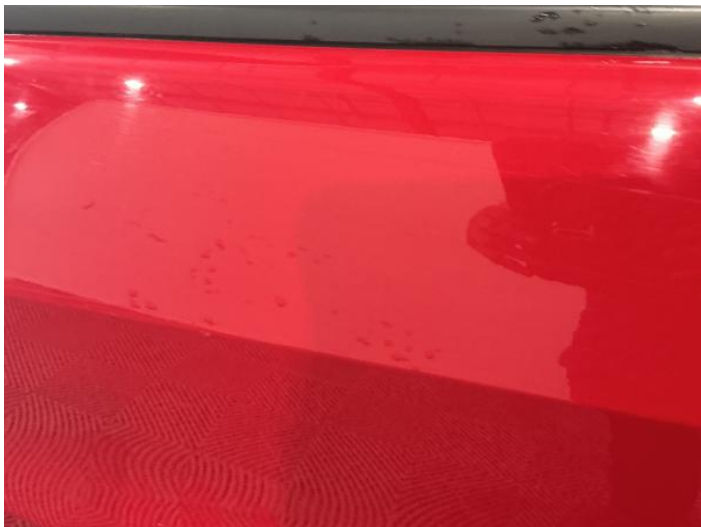
9: Door nsr
Chipped
1 To 5

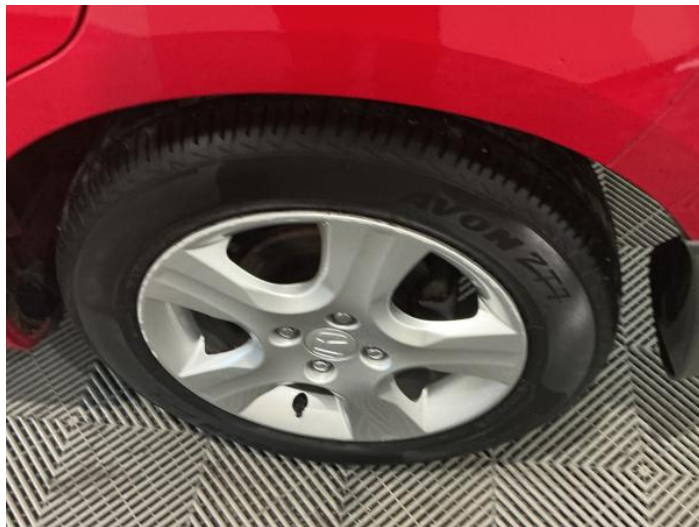
10: Wheel nsr
Scratched
Over 50mm

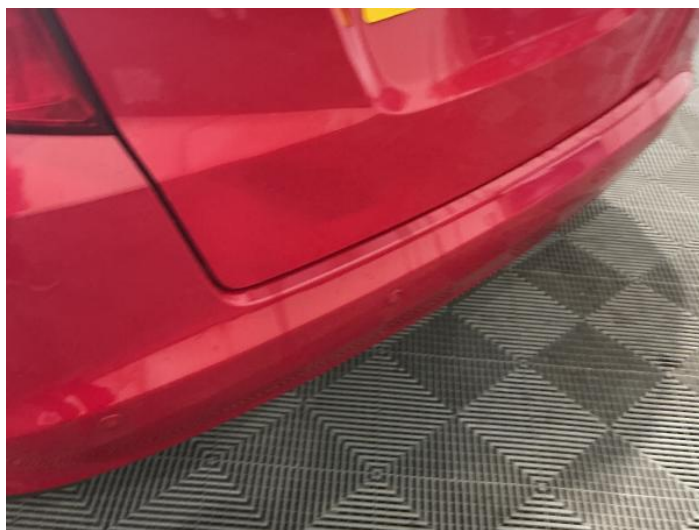
12: Bumper Rear
Scratched
Over 100mm Thru Paint

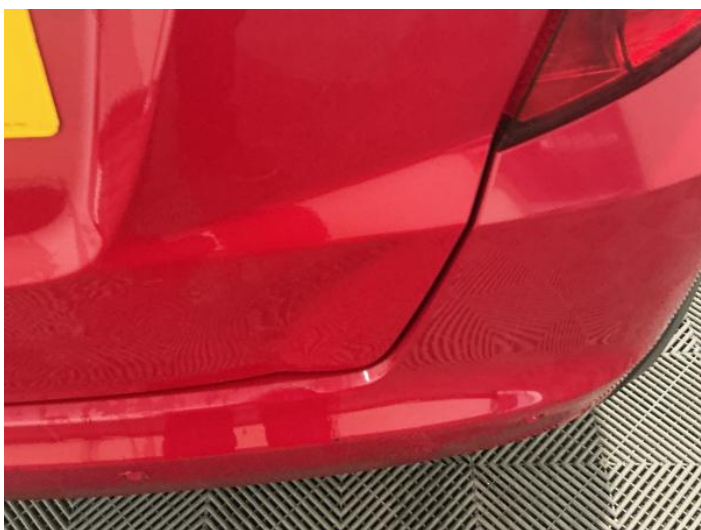
13: Boot Lid
Dented
Over 30mm

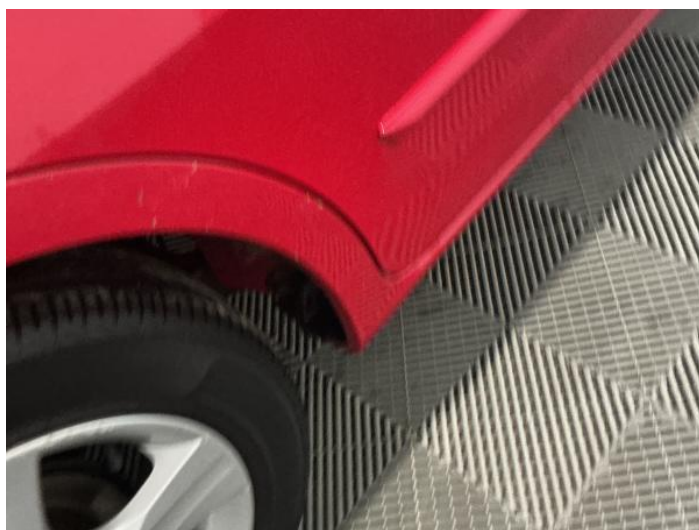
14: Qtr Panel osr
Dented
With Paint Damage

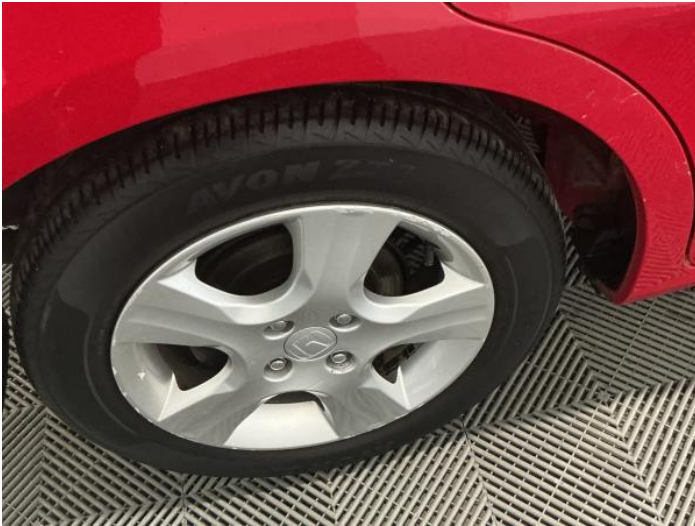
15: Wheel osr
Scratched
Over 50mm

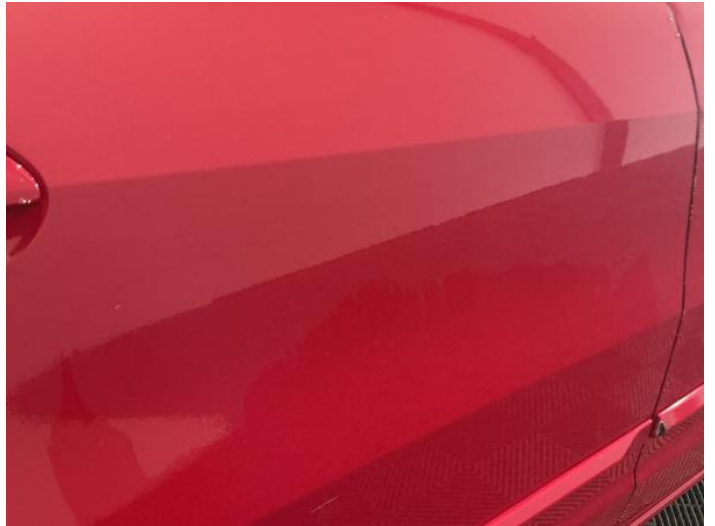
16: Door osr
Dented
With Paint Damage

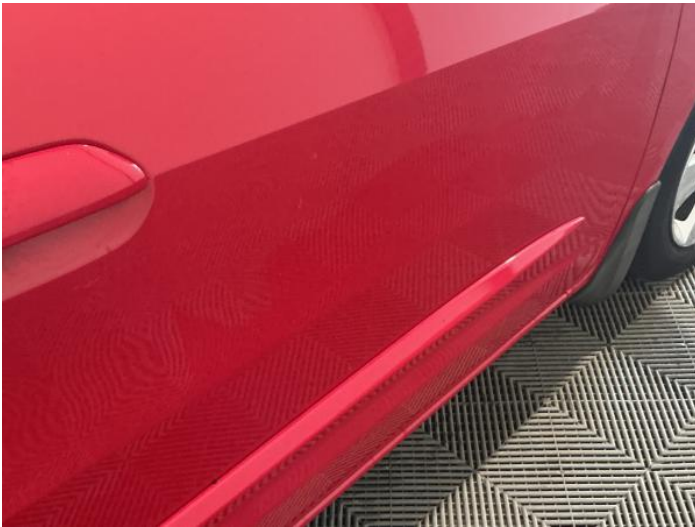
17: Door osf
Chipped
1 To 5

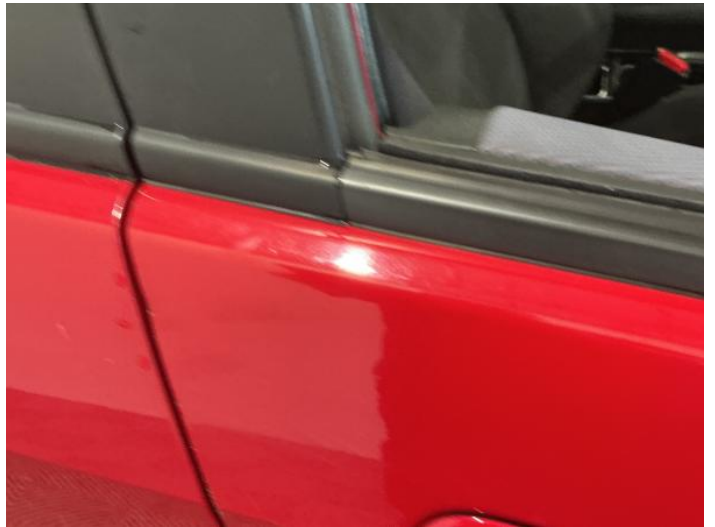
18: Door osf
Dented
Over 2 UpTo 10mm

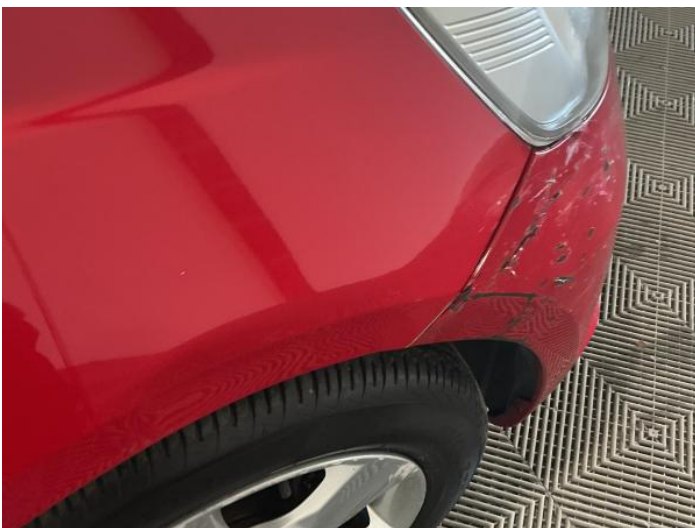
19: Wing osf
Dented
Over 30mm

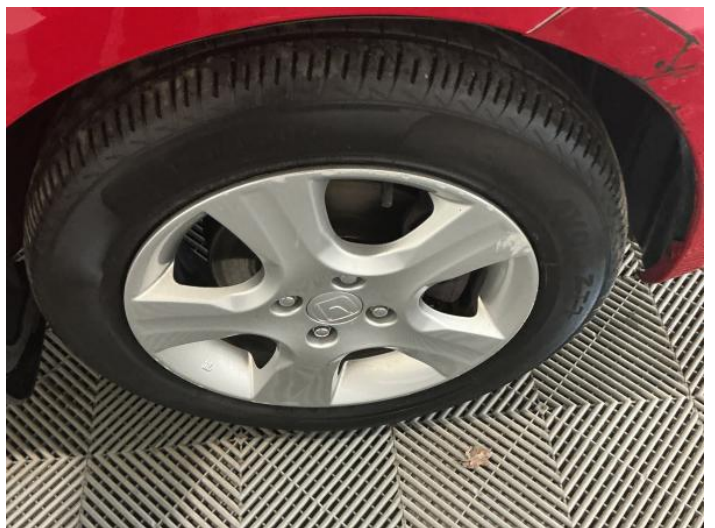
20: Wheel osf
Scratched
Over 50mm

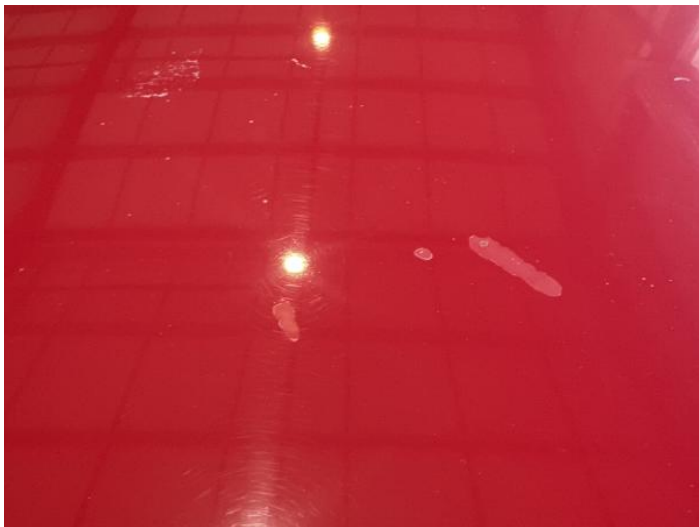
21: Roof
Poor Previous Repair
Paint Flake
