VEHICLE INSPECTION REPORT

LB15FGP

Kia Rio 1.25 SR7 5dr

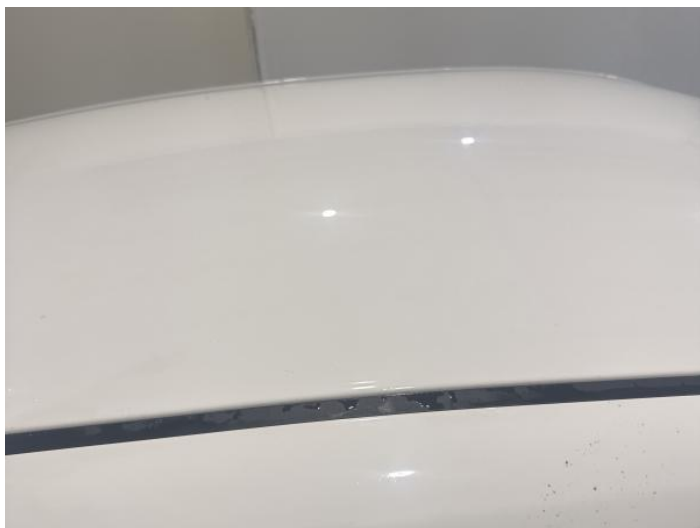
1: Roof
Dented
Hail - Moderate

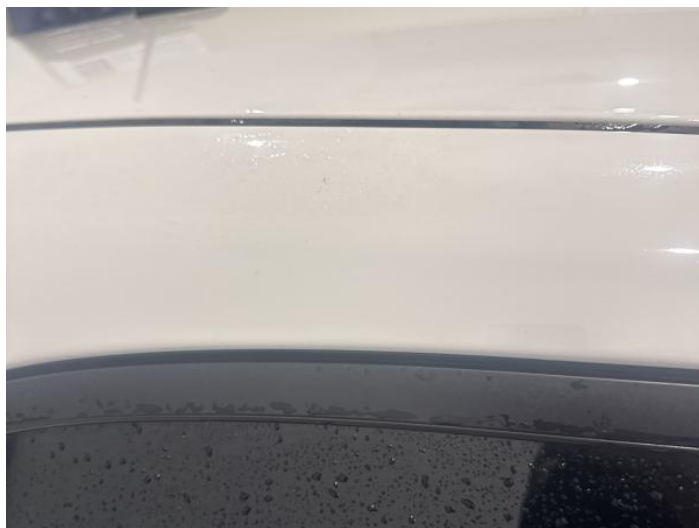
2: D Pillars
Dented
2 Or Less Up To 10mm

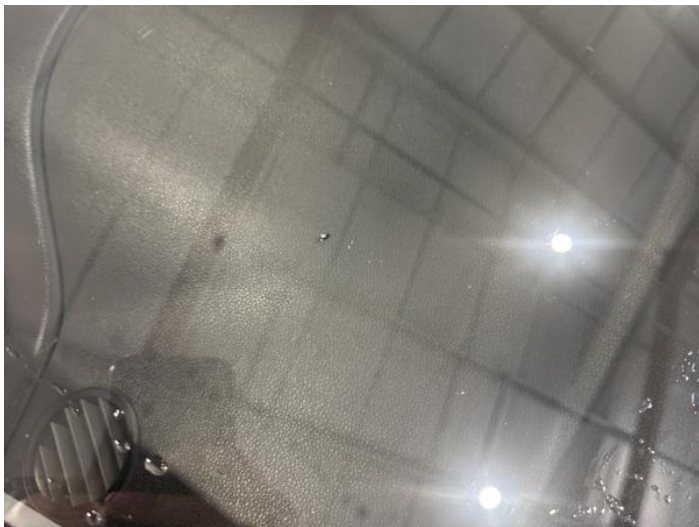
3: Screen Front
Chipped
UpTo 10mm

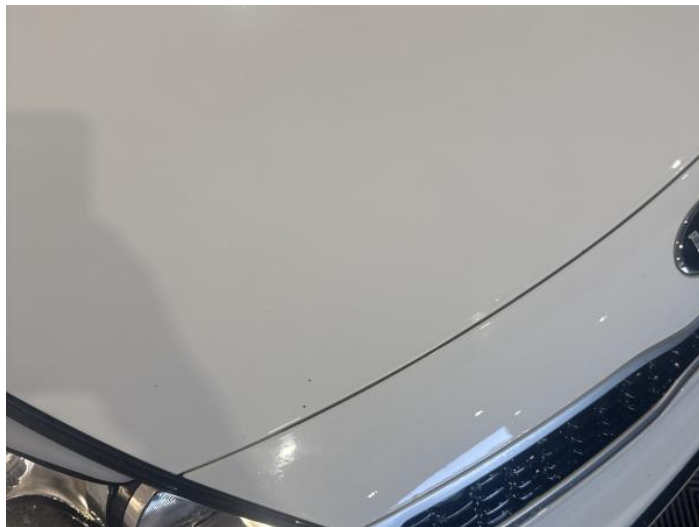
4: Bonnet
Chipped
1 To 5

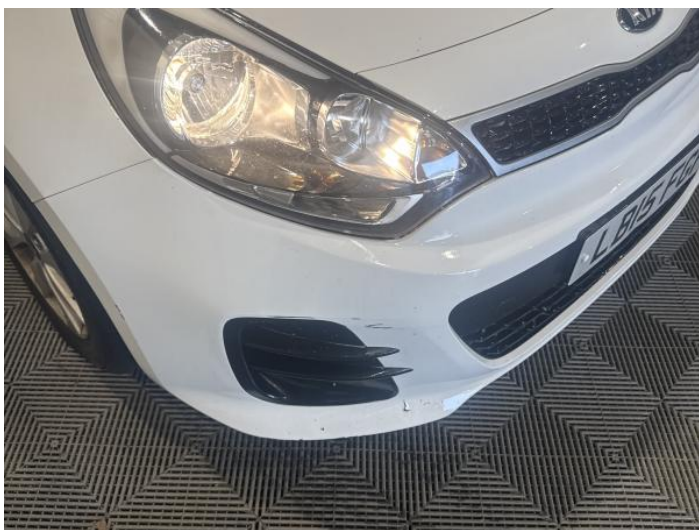
5: Bumper Front
Cracked
UpTo 25mm

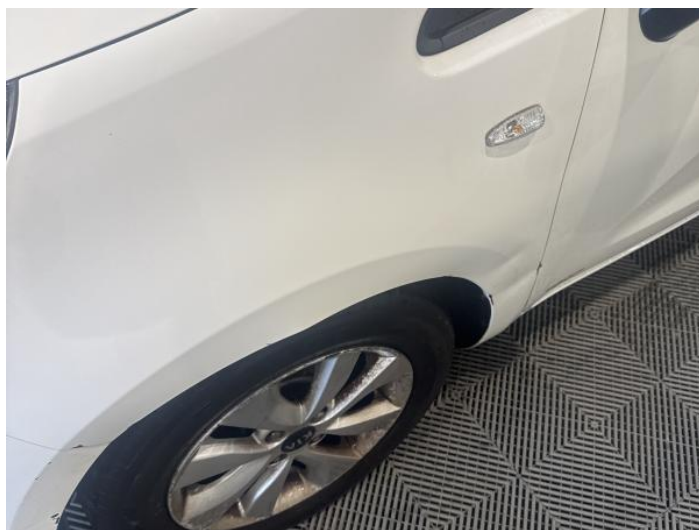
6: Wing nsf
Dented
With Paint Damage

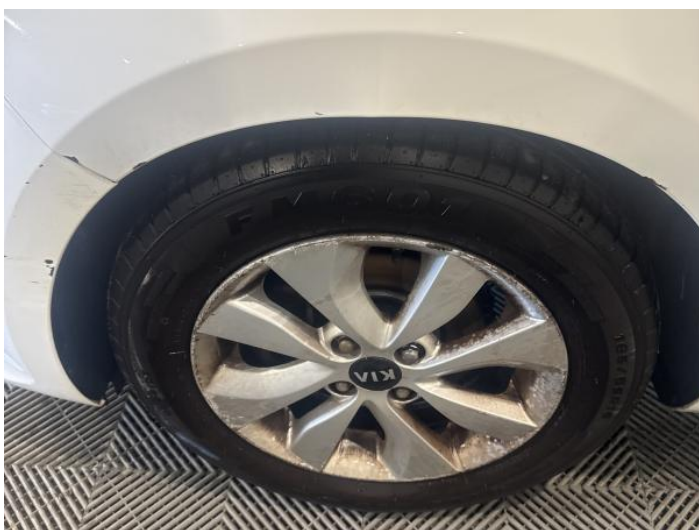
7: Wheel nsf
Scratched
Over 50mm

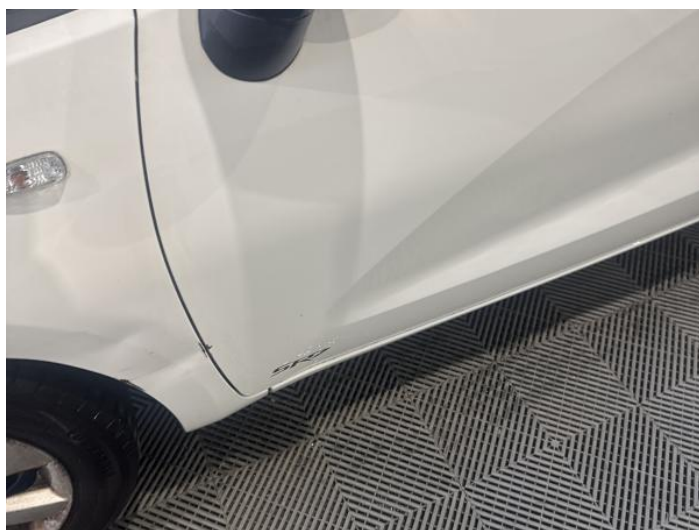
8: Door nsf
Dented
With Paint Damage

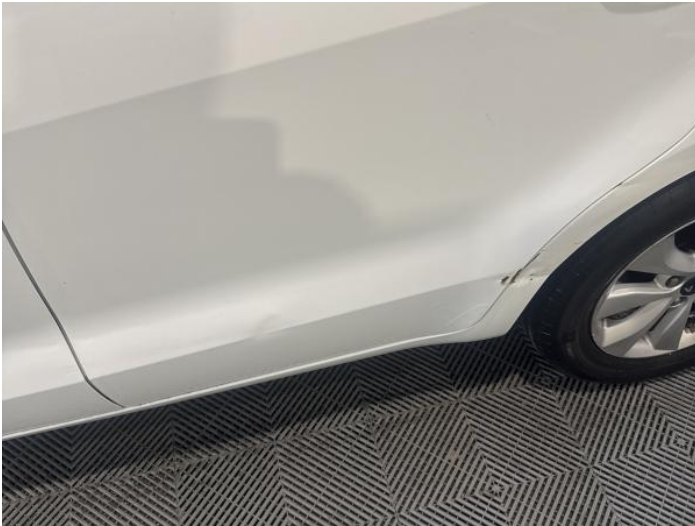
9: Door nsr
Dented
With Paint Damage

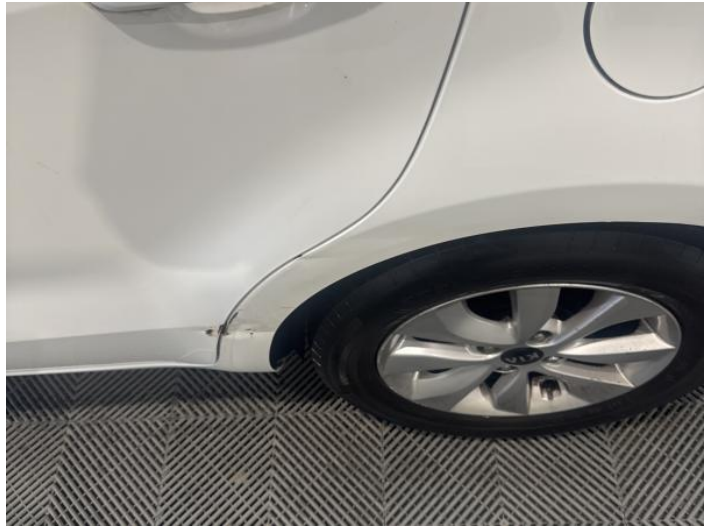
10: Qtr Panel nsr
Dented
With Paint Damage

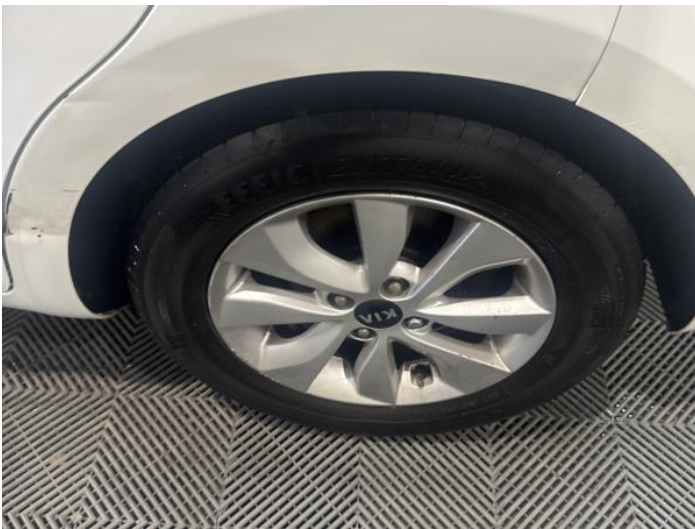
11: Wheel nsr
Scratched
Over 50mm

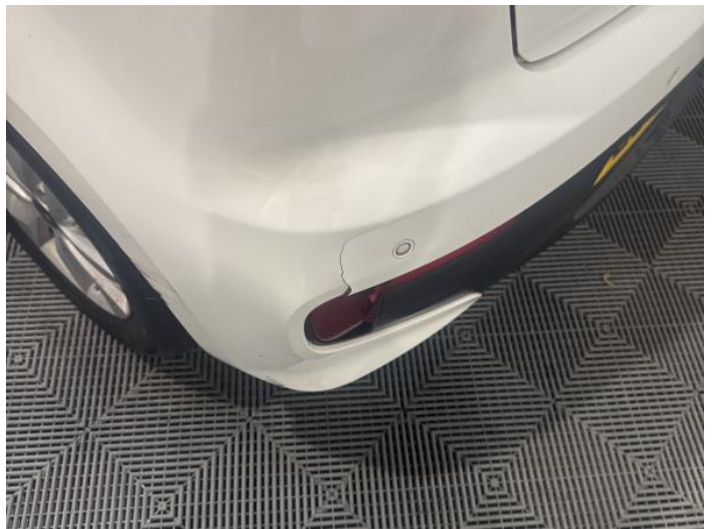
12: Bumper Rear
Cracked
Over 25mm

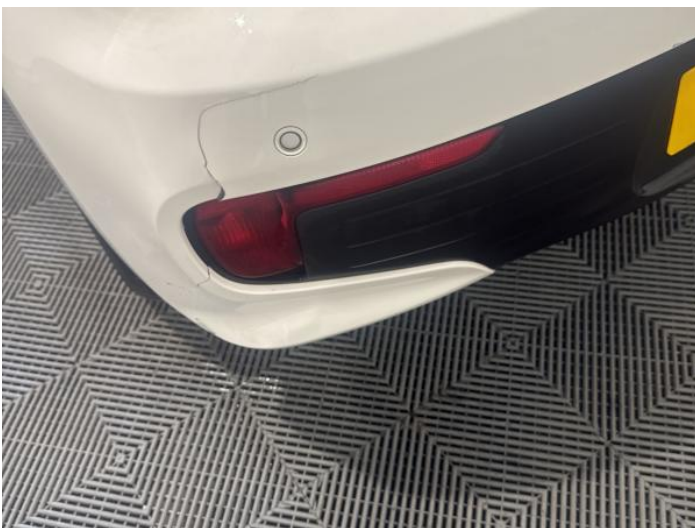
13: Reflector nsr
Broken
Replace

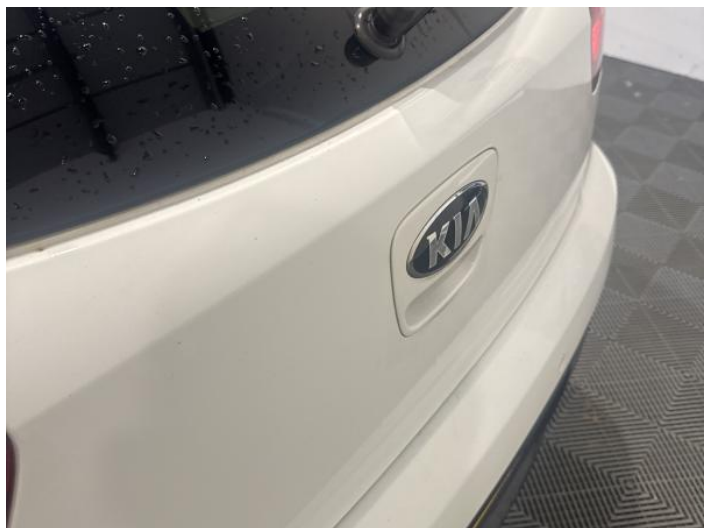
14: Boot Lid
Chipped
1 To 5

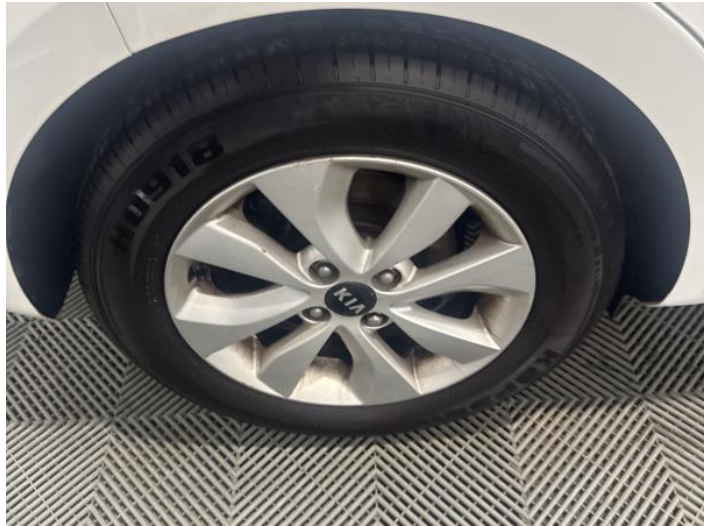
15: Wing osf
Scratched
Over 25mm Not Thru Paint

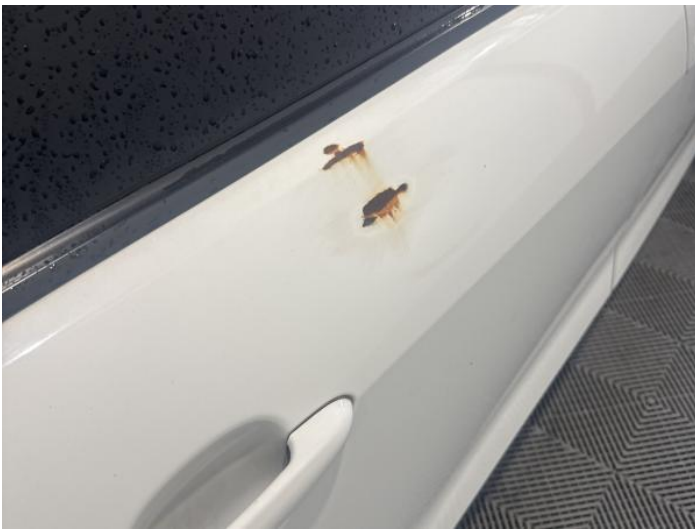
17: Door osr
Rusted
Over 5mm

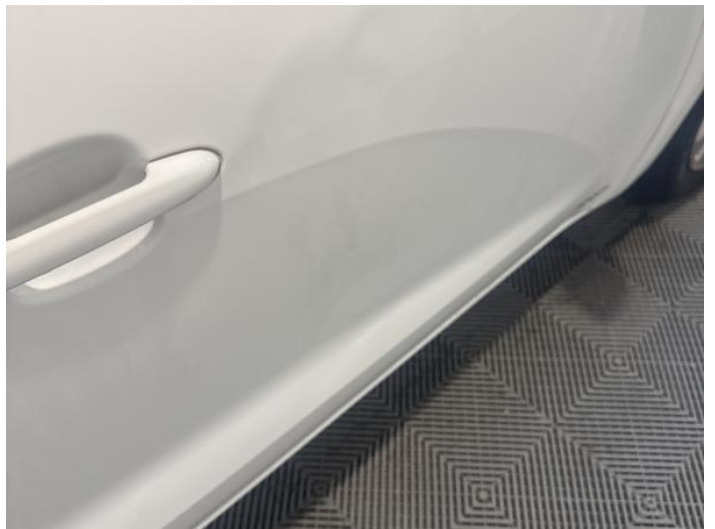
18: Door osf
Dented
Over 30mm

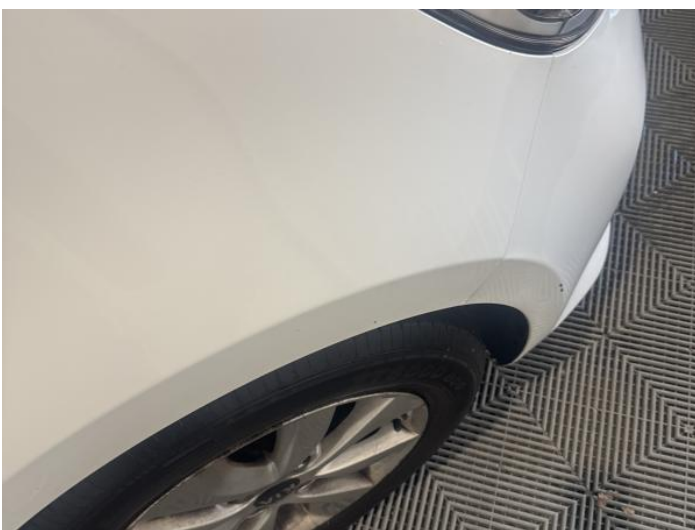
19: Wing osf
Chipped
1 To 5

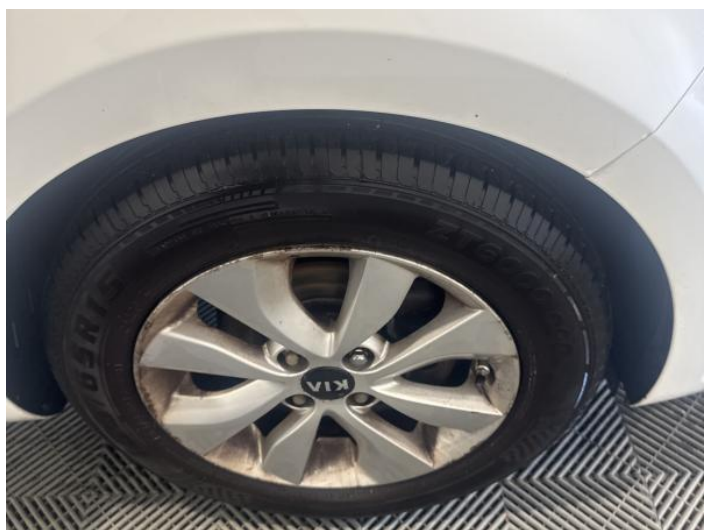
20: Wheel osf
Scratched
Over 50mm

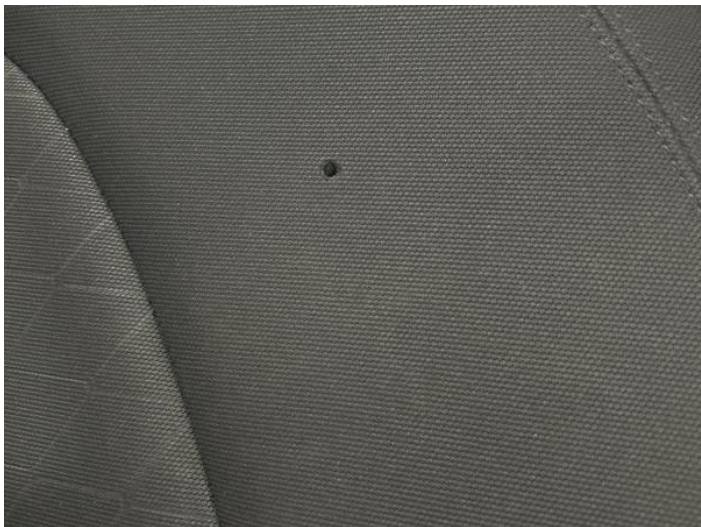
21: Seat Base Cover osf
Holed
UpTo 3mm
