VEHICLE INSPECTION REPORT

LD10SEY

Toyota IQ 1.0 VVT-i 3dr

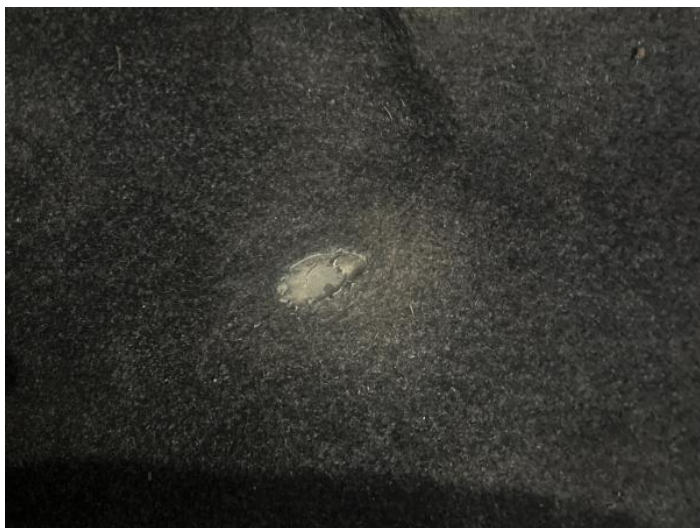
1: Carpets Front
Holed
UpTo 3mm

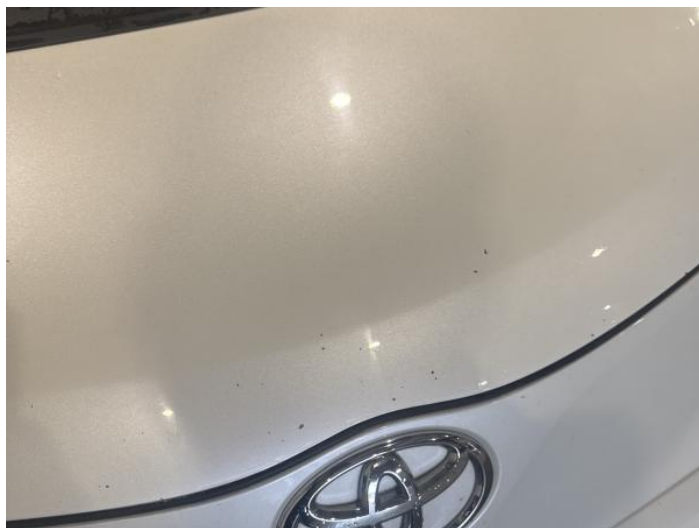
2: Bonnet
Chipped
Multiple Chips

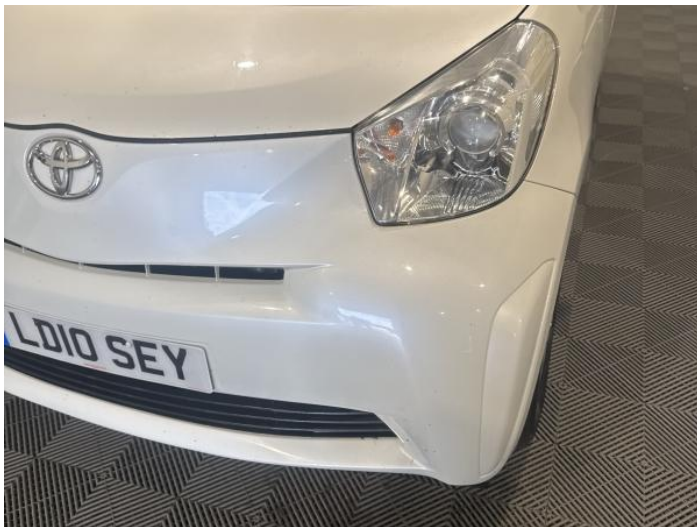
3: Bumper Front
Chipped
Multiple Chips

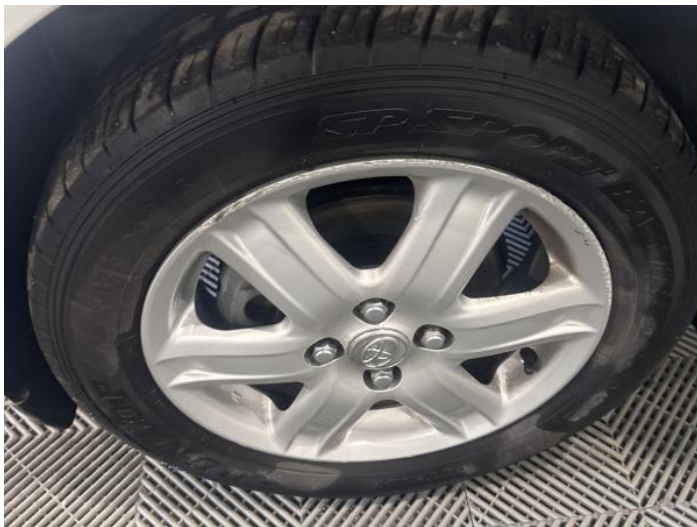
5: Wheel nsf
Corroded
Light

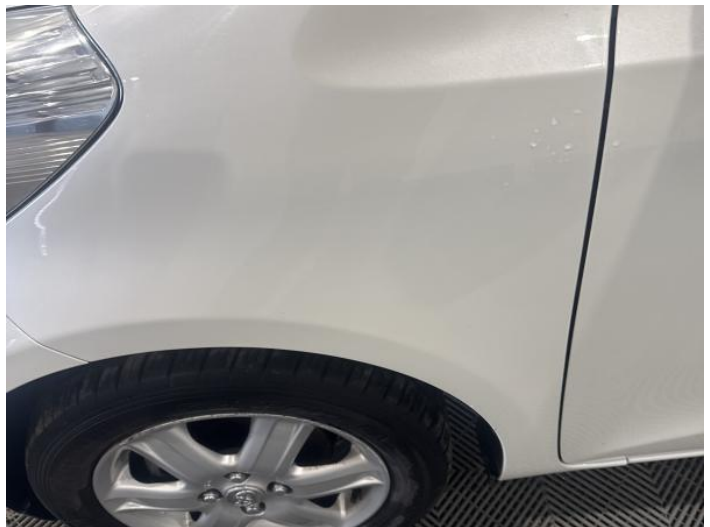
6: Wing nsf
Chipped
1 To 5

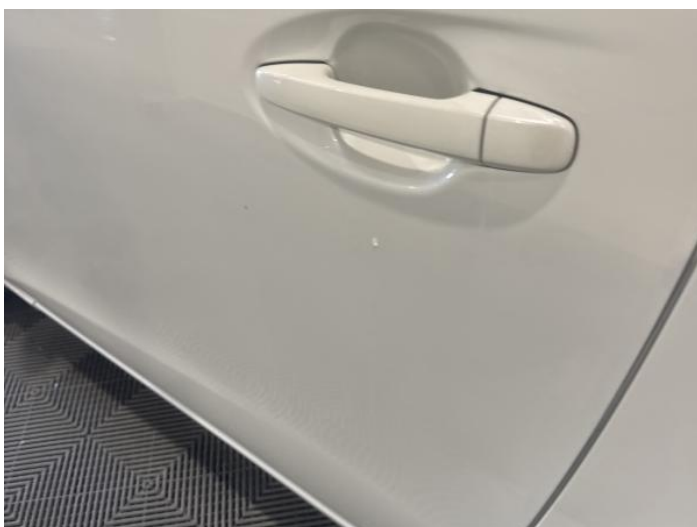
7: Door nsf
Chipped
1 To 5

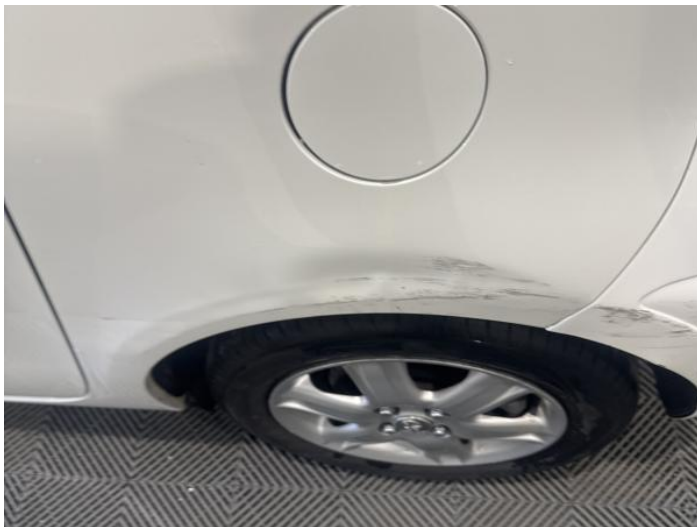
9: Qtr Panel nsr
Dented
With Paint Damage

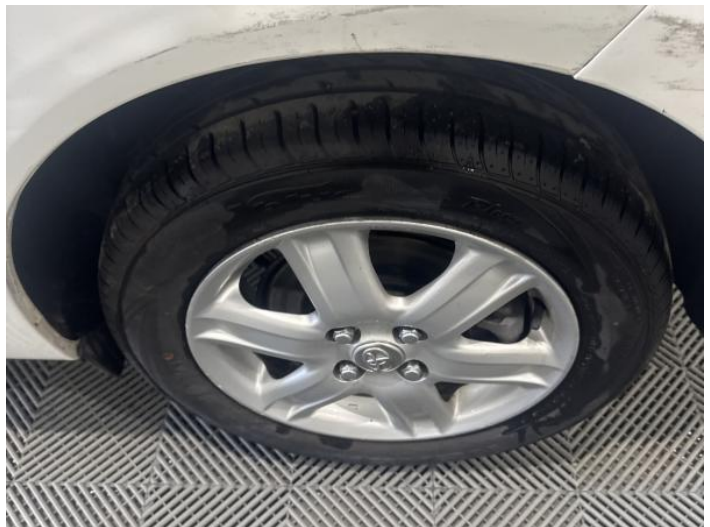
10: Wheel nsr
Scratched
Over 50mm

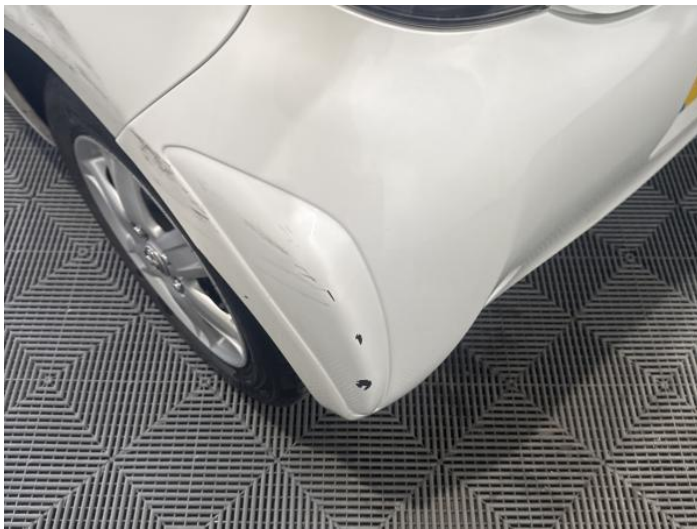
11: Bumper Rear
Scratched
Over 100mm Thru Paint

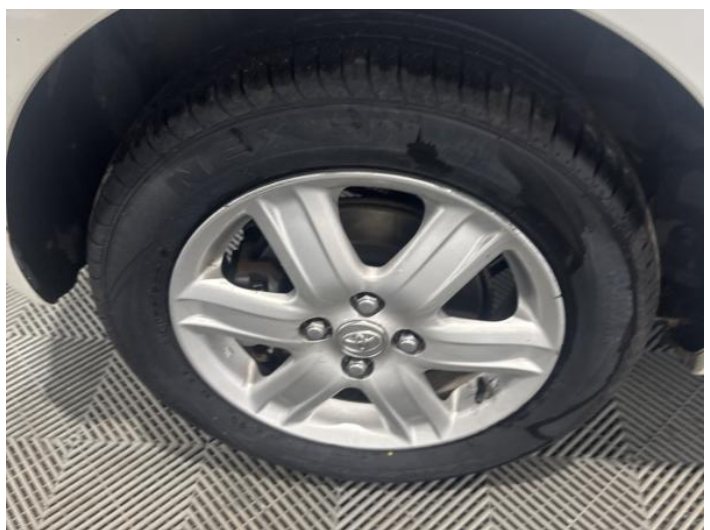
14: Wheel osr
Scratched
Over 50mm

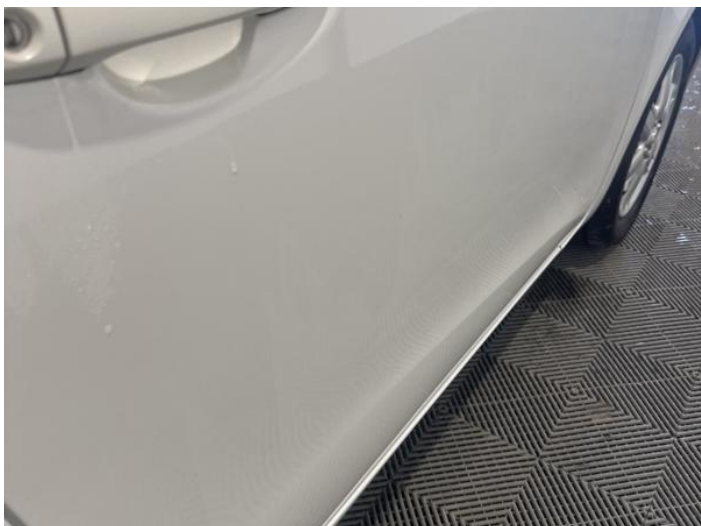
15: Door osf
Dented
Over 2 UpTo 10mm

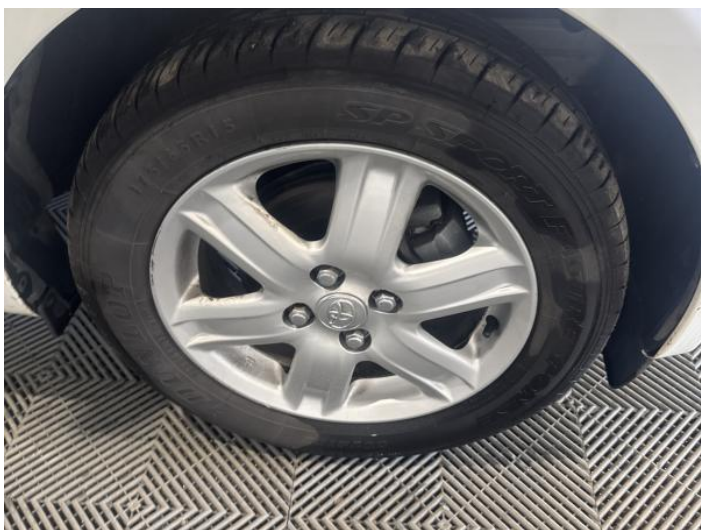
17: Wheel osf
Scratched
Up To 50mm

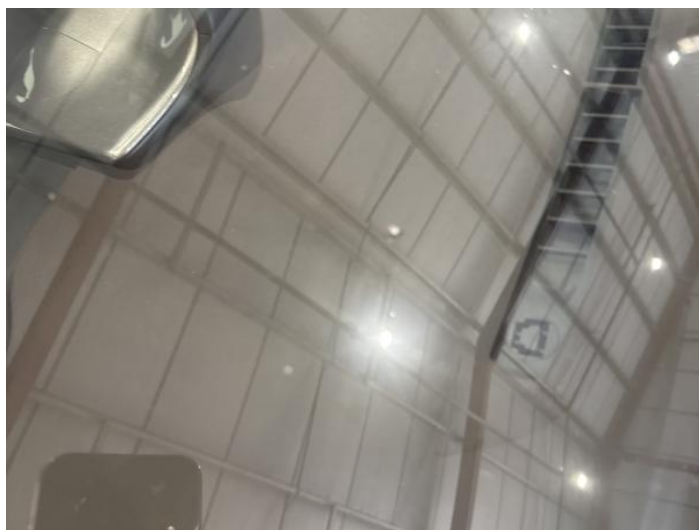
18: Screen Front
Chipped
UpTo 10mm

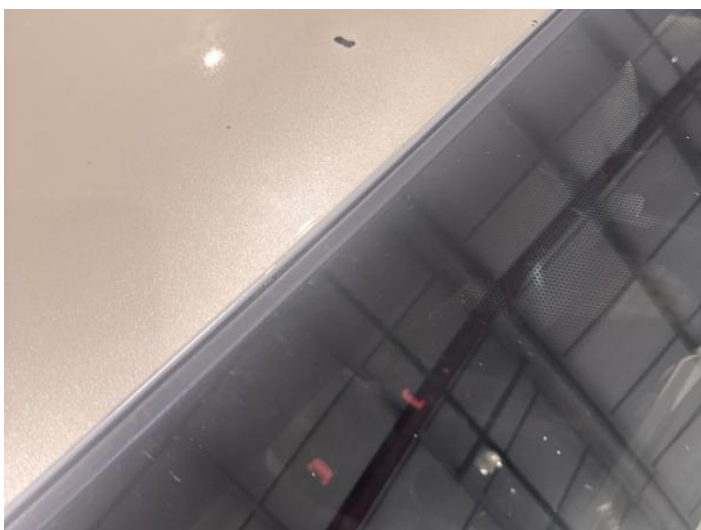
19: Roof
Chipped
Over 5mm
