# VEHICLE INSPECTION REPORT

**GX13UJY**

## Citroen C3 Picasso 1.6 HDi 8V Selection 5dr

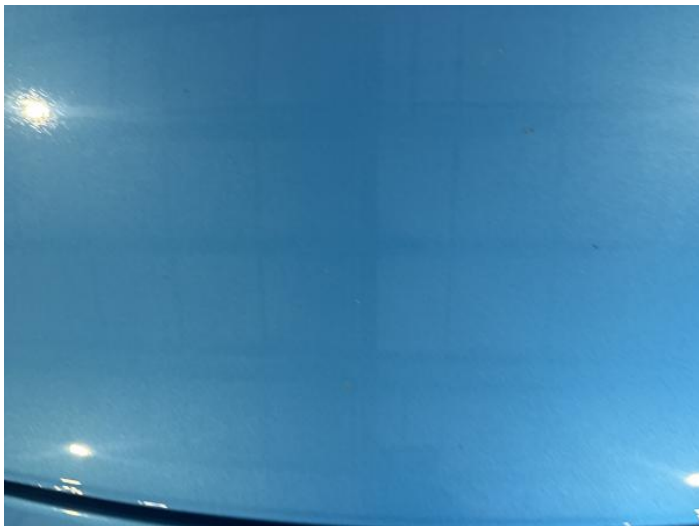
1: Bonnet  
Chipped  
1 To 5

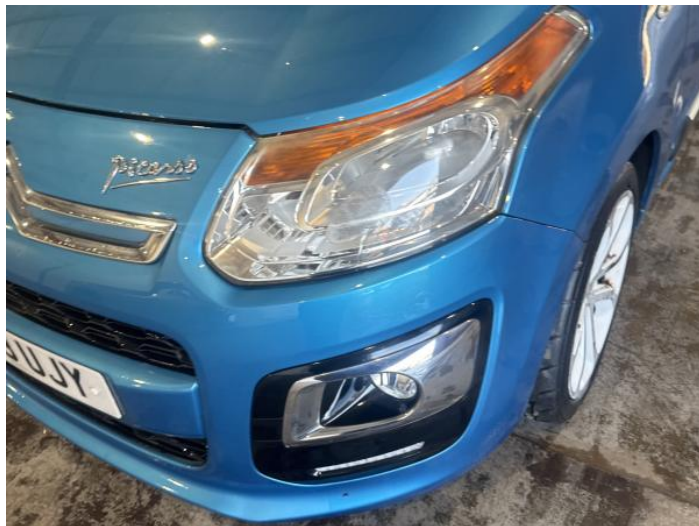
2: Bumper Front  
Chipped  
Multiple Chips

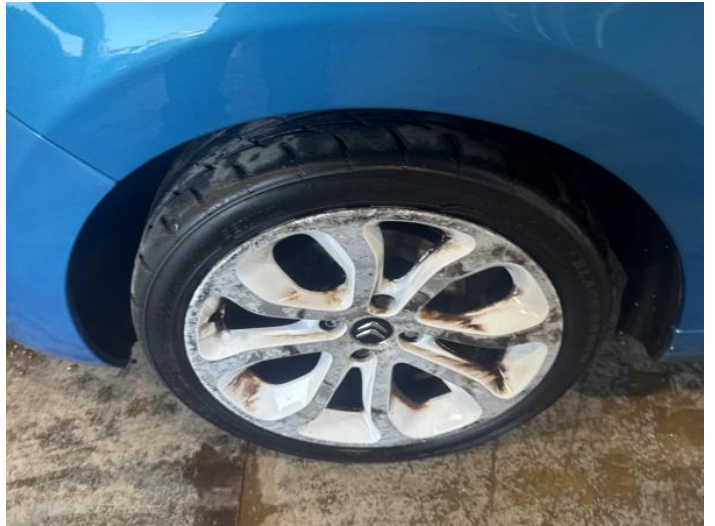
4: Wheel nsf  
Scratched  
Over 50mm

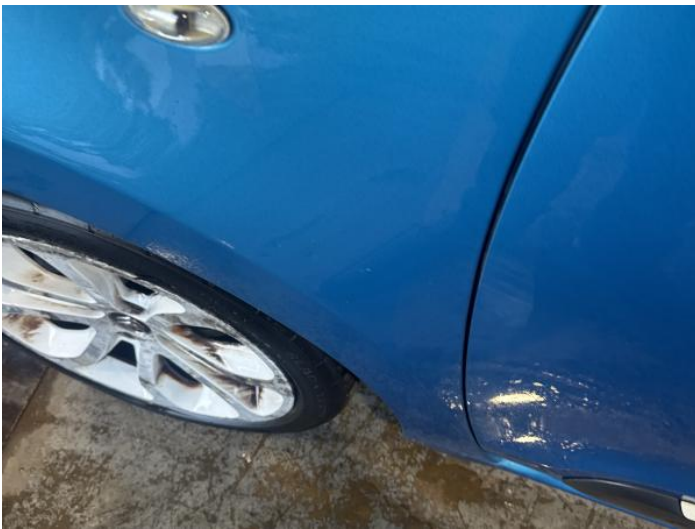
5: Wing nsf  
Chipped  
1 To 5

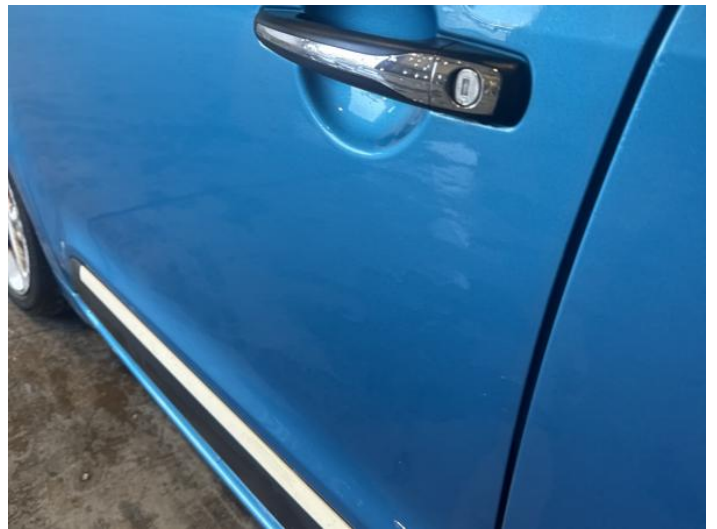
6: Door nsf  
Chipped  
1 To 5

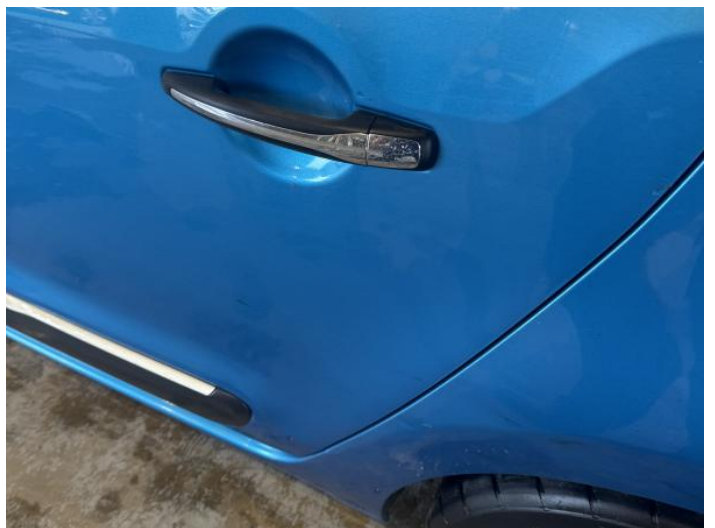
8: Door nsr  
Dented  
With Paint Damage

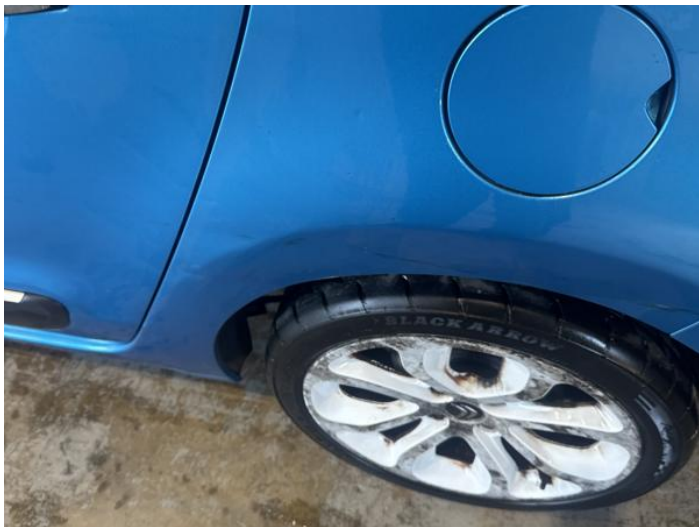
9: Qtr Panel nsr  
Dented  
With Paint Damage

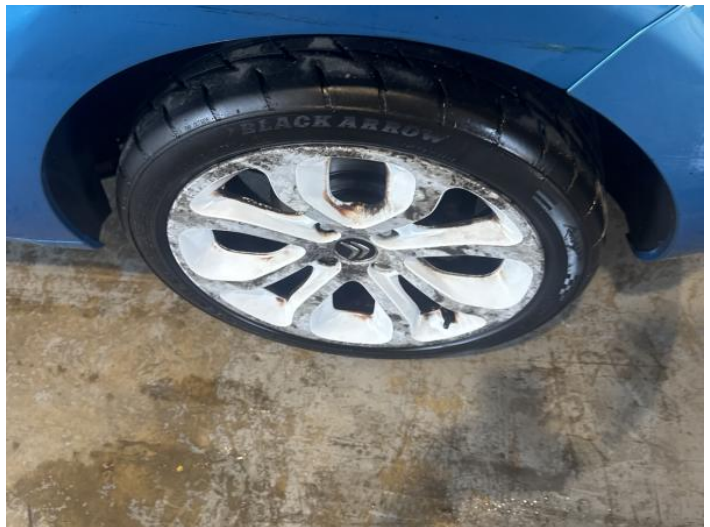
10: Wheel nsr  
Scratched  
Over 50mm

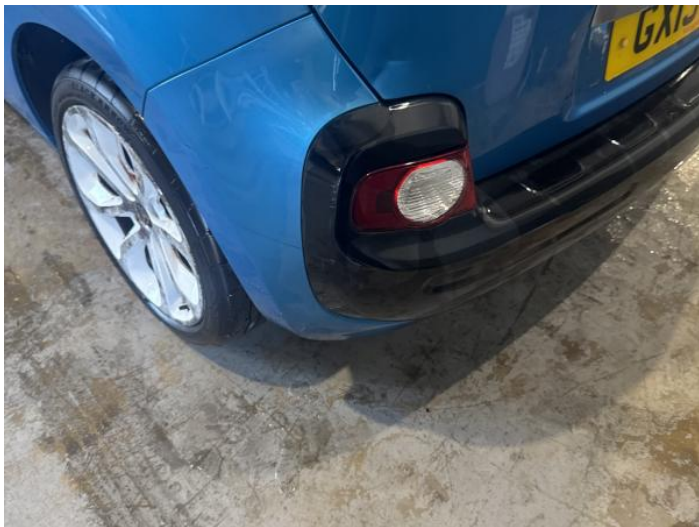
11: Bumper Rear  
Scratched  
25 to 100mm Thru Paint

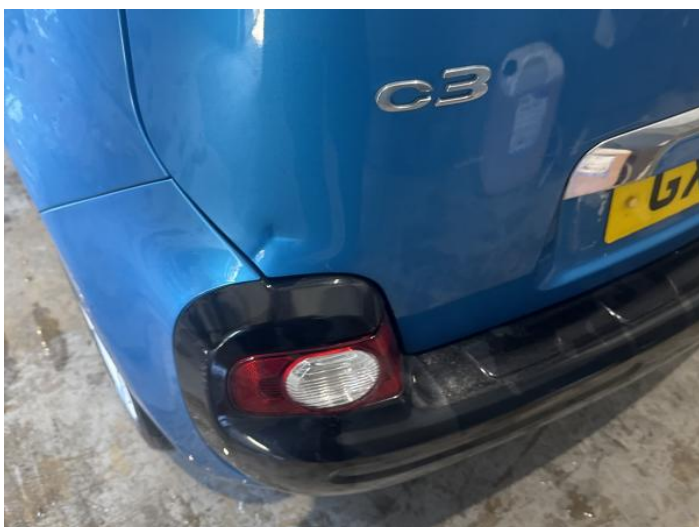
13: Boot Lid  
Dented  
Over 30mm

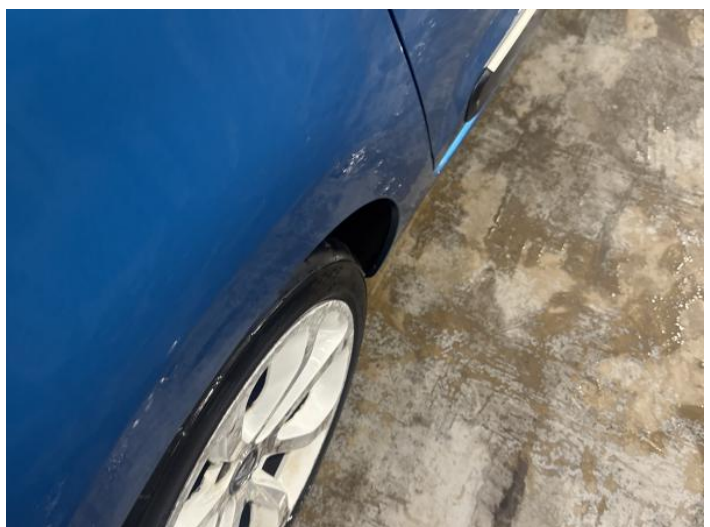
14: Qtr Panel osr  
Dented  
2 Or Less UpTo 10mm

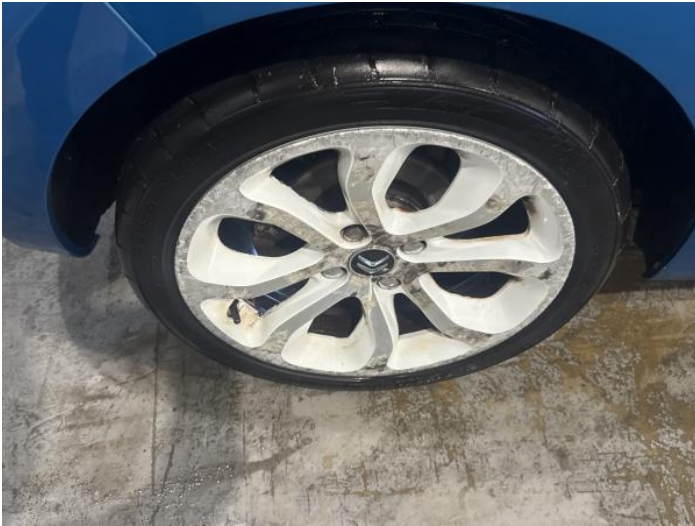
15: Wheel osr  
Scratched  
Over 50mm

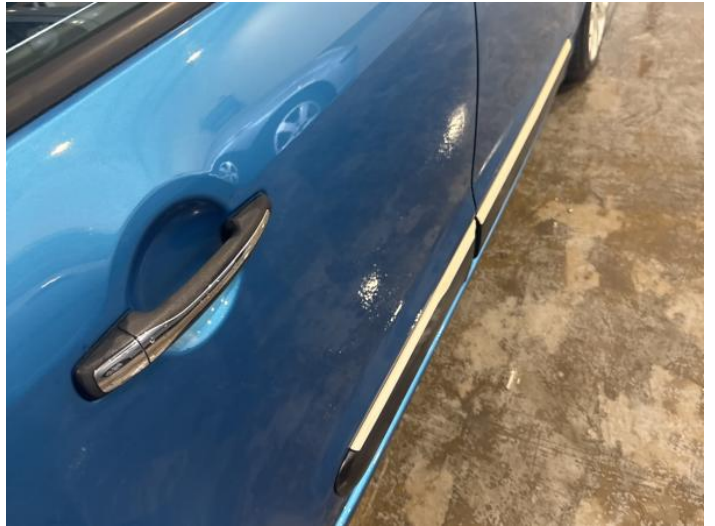
16: Door osr  
Chipped  
1 To 5

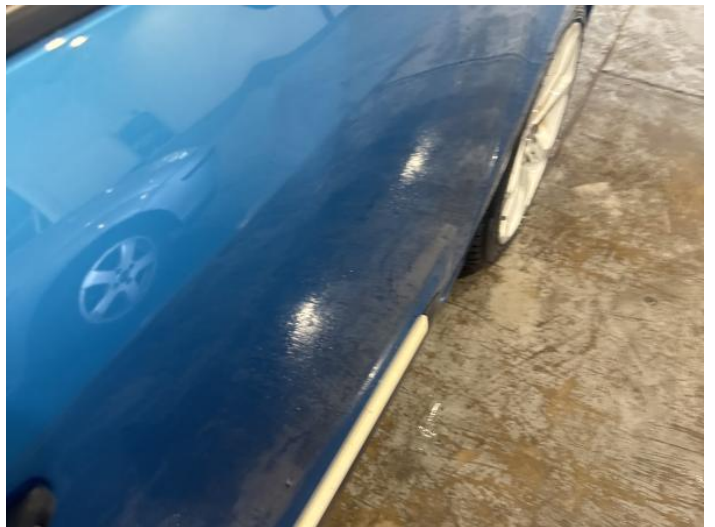
18: Door osf  
Dented  
Over 30mm

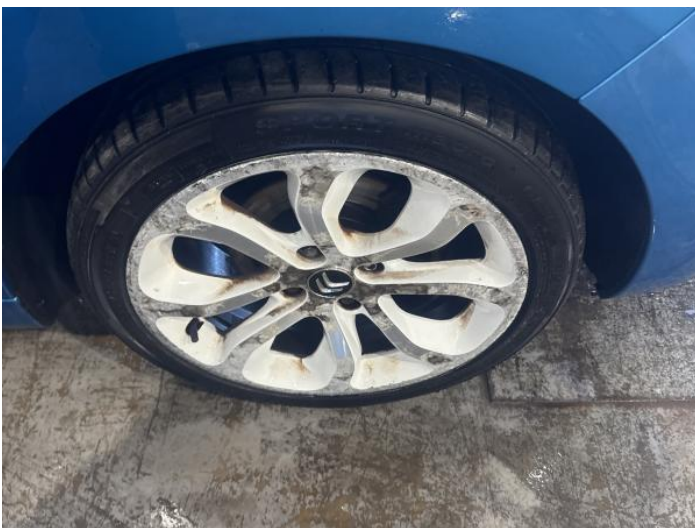
19: Wheel osf  
Scratched  
Over 50mm

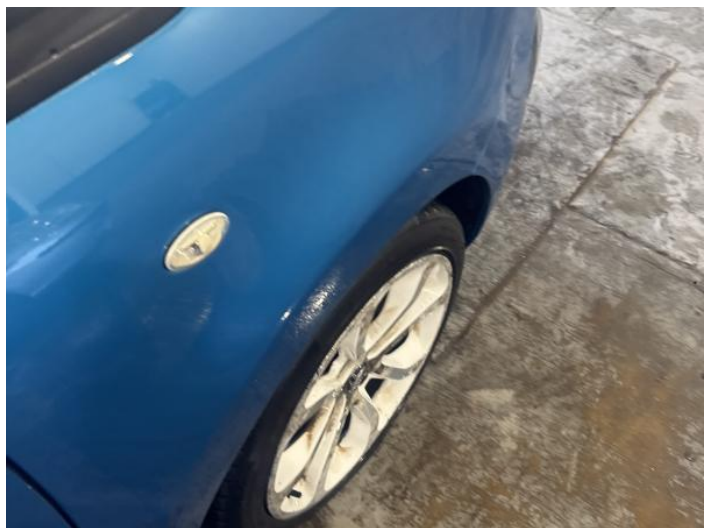
20: Wing osf  
Chipped  
1 To 5
