VEHICLE INSPECTION REPORT

VF64AOP

Nissan Juke 1.5 dCi Tekna 5dr

nama
GRADE
3

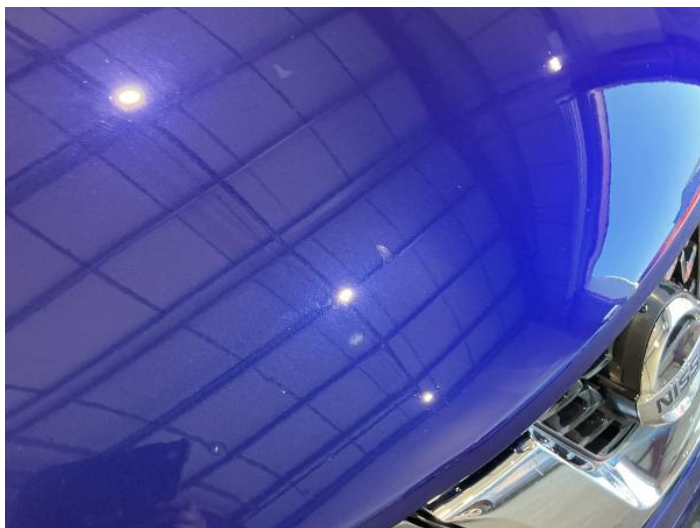
1: Bonnet
Chipped
1 To 5

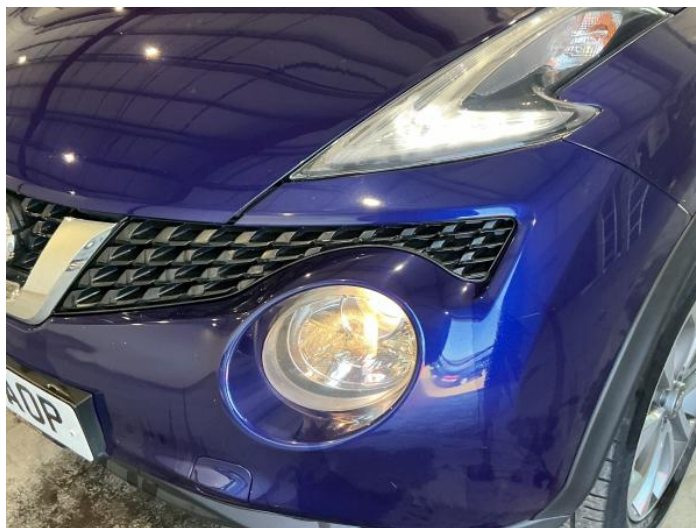
2: Bumper Front
Scratched
25 to 100mm Thru Paint

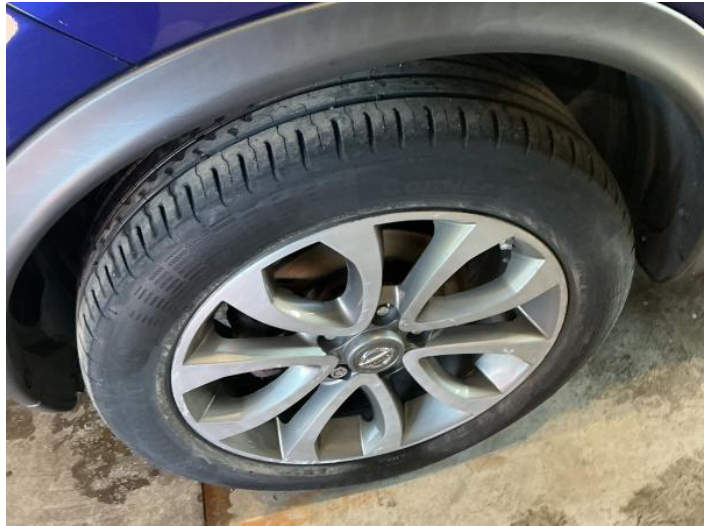
4: Wheel nsf
Scratched
Over 50mm

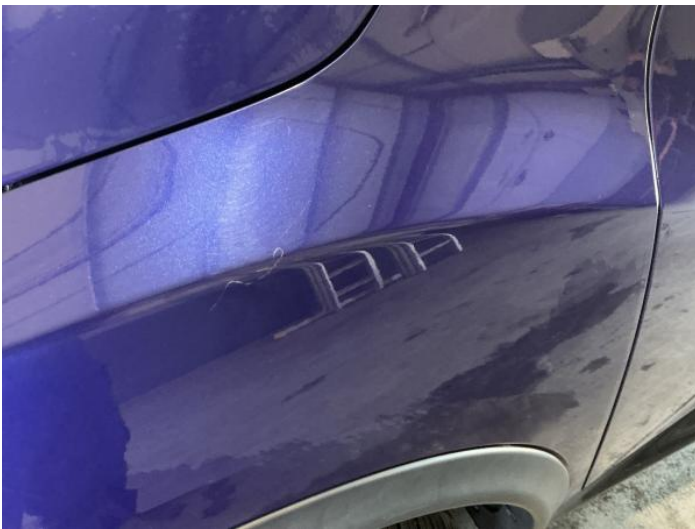
5: Wing nsf
Scratched
Over 25mm Thru Paint

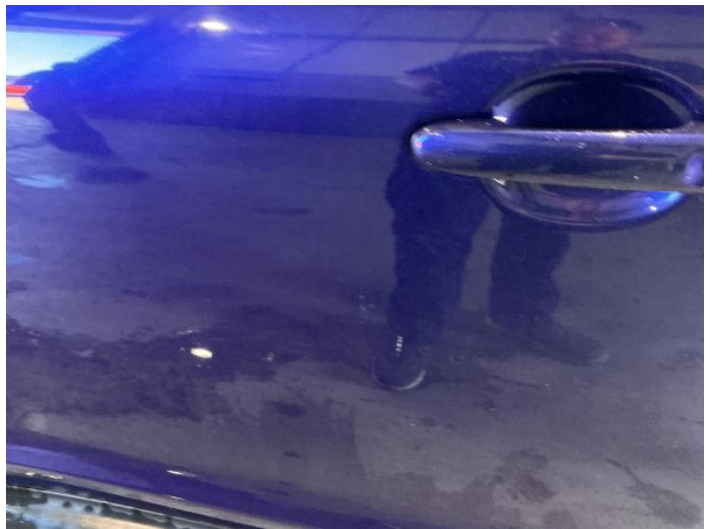
6: Door nsf
Chipped
1 To 5

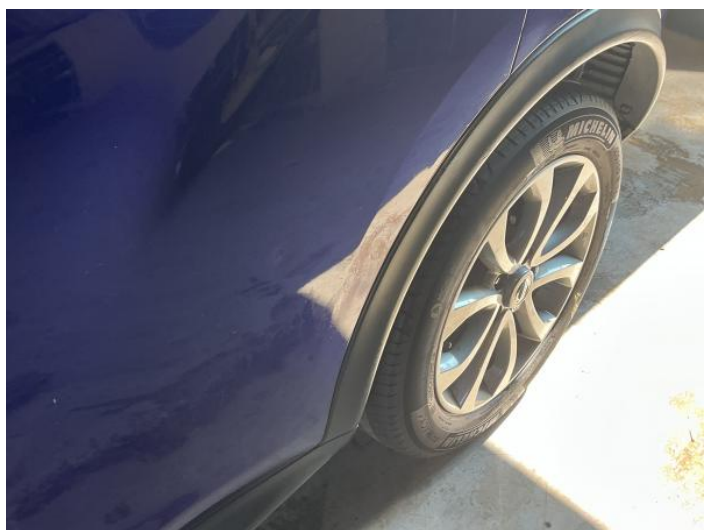
8: Door nsr
Dented
Over 30mm

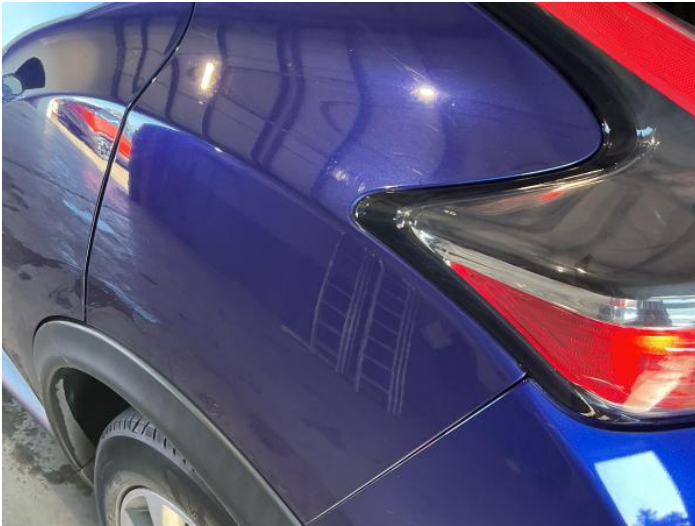
9: Qtr Panel nsr
Dented
Over 2 UpTo 10mm

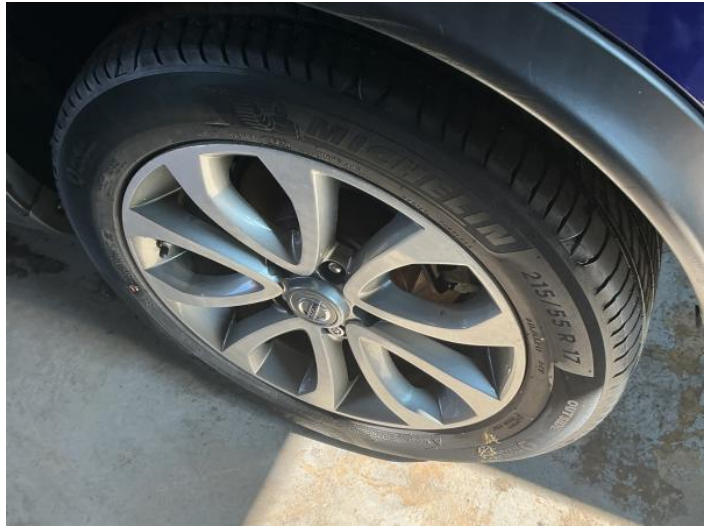
10: Wheel nsr
Scratched
Over 50mm

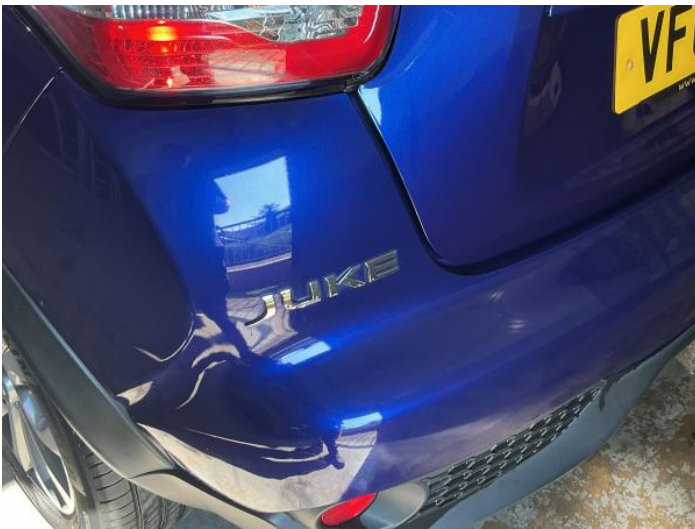
11: Bumper Rear
Scratched
25 to 100mm Thru Paint

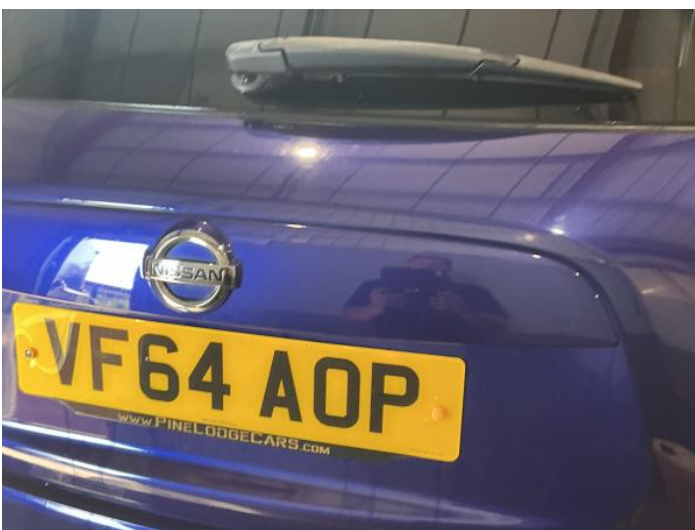
13: Boot Lid
Scratched
Over 25mm Not Thru Paint

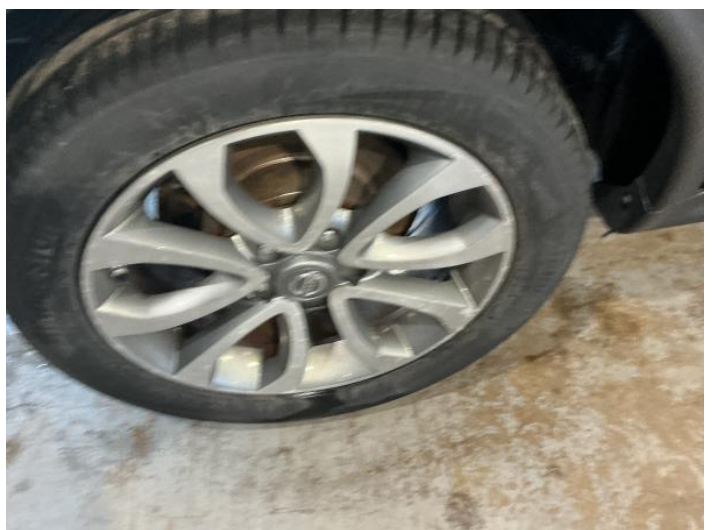
14: Wheel osr
Scratched
Over 50mm

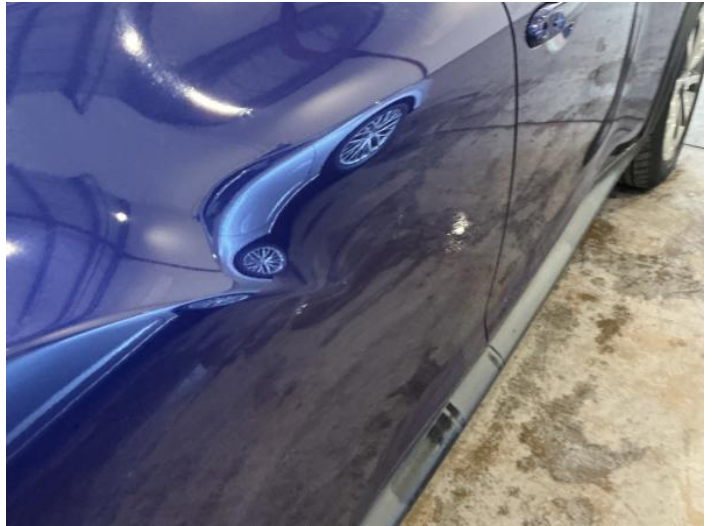
16: Door osr
Chipped
1 To 5

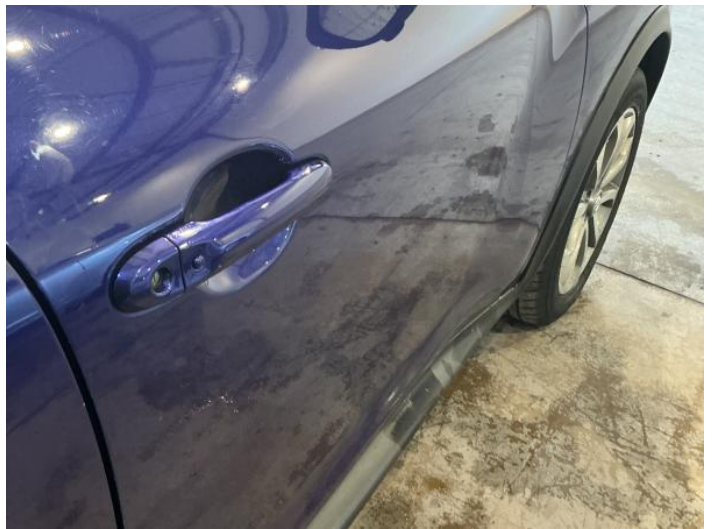
18: Door osf
Chipped
1 To 5

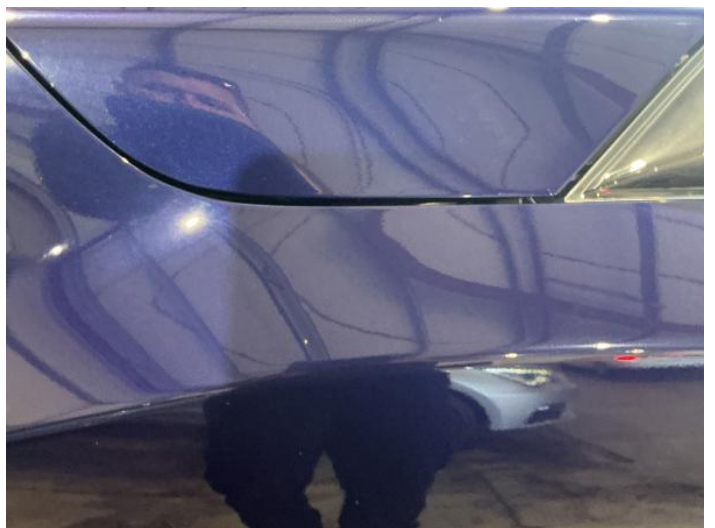
20: Wing osf
Chipped
1 To 5

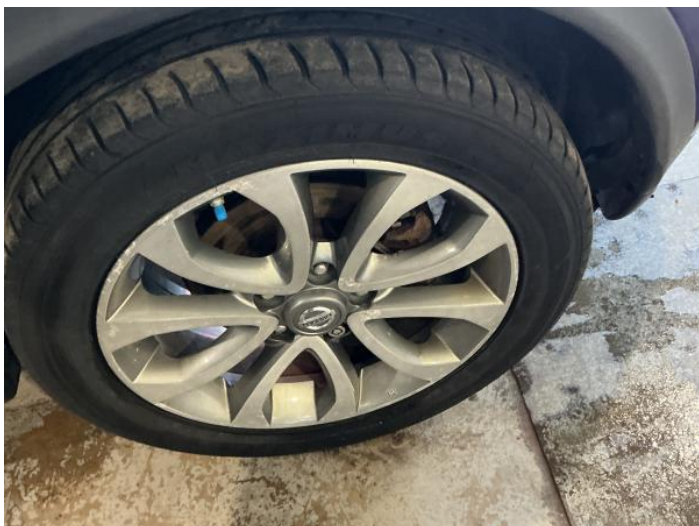
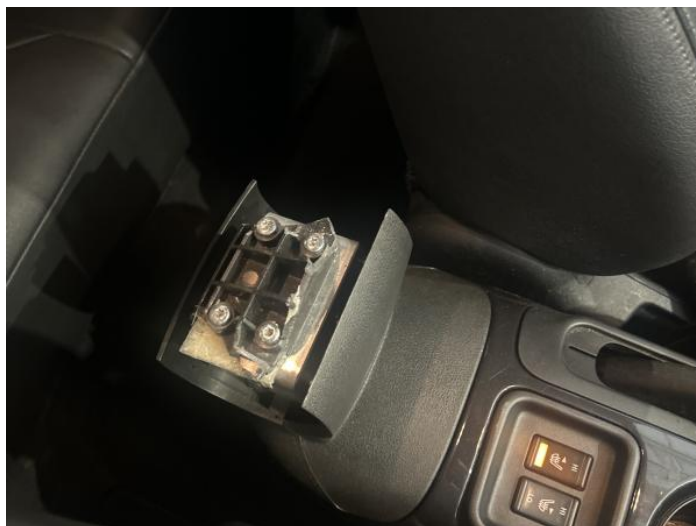
21: Wheel osf
Scratched
Over 50mm
