# VEHICLE INSPECTION REPORT

**GU65AAE**

## Vauxhall Mokka 1.6i SE 5dr

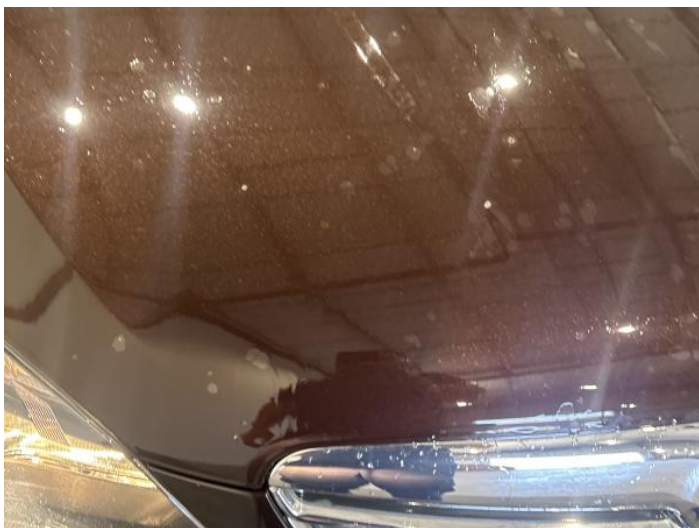
1: Bonnet  
Chipped  
1 To 5

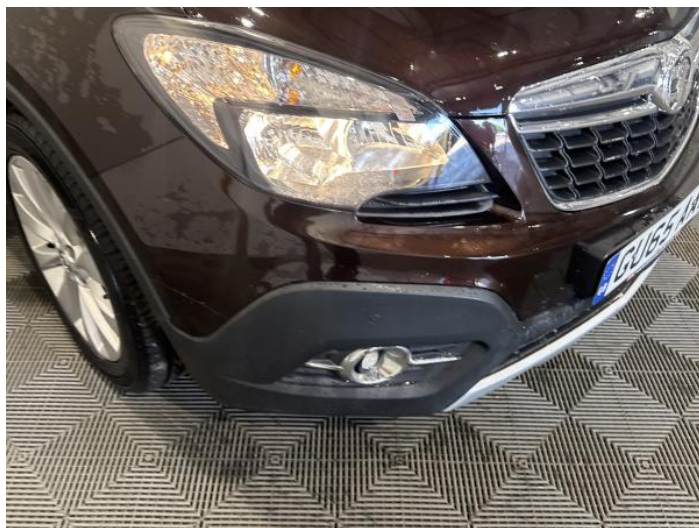
2: Bumper Front  
Scratched  
25 to 100mm Thru Paint

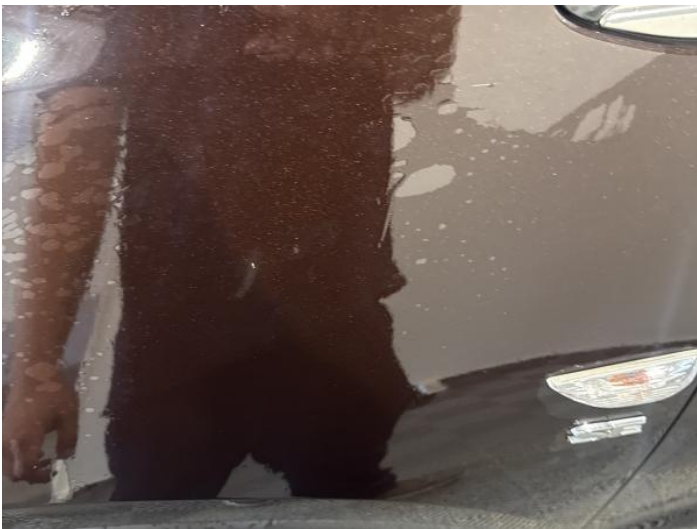
5: Wing nsf  
Chipped  
1 To 5

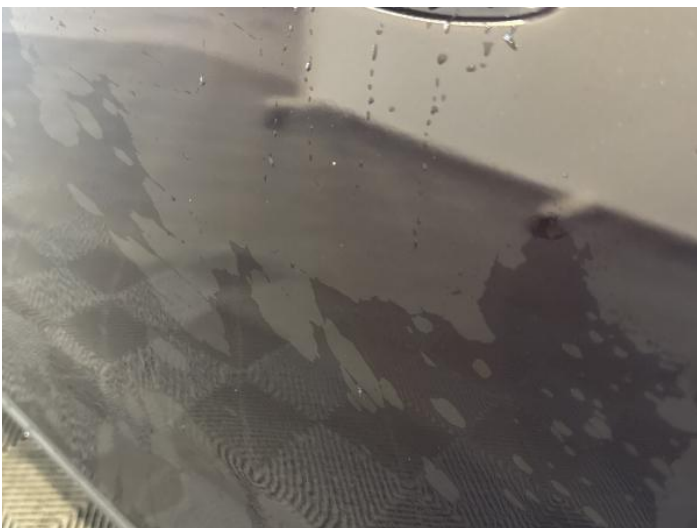
7: Door nsf  
Poor Previous Repair  
Poor Paint

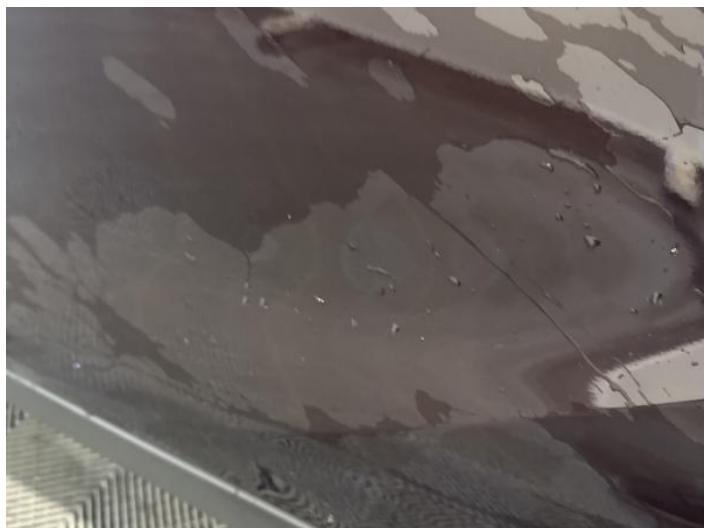
8: Door nsr  
Chipped  
1 To 5

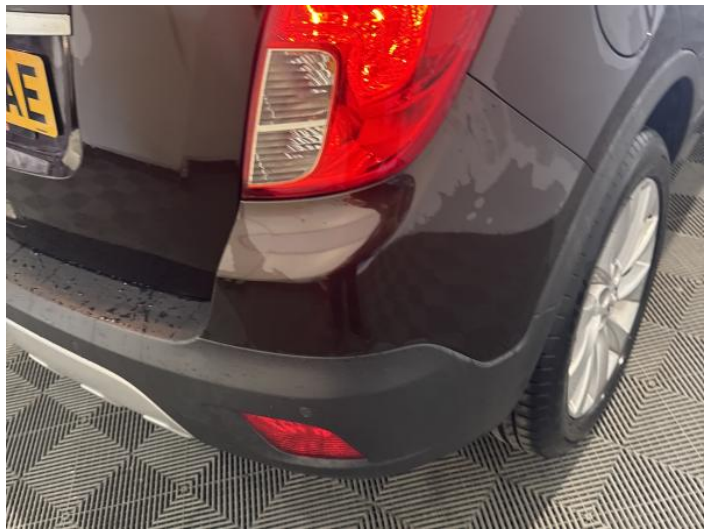
11: Qtr Panel nsr  
Scratched  
Over 25mm Not Thru Paint

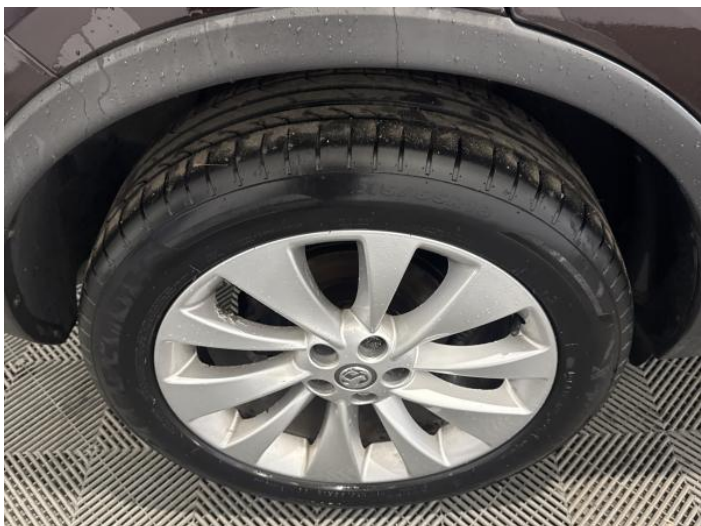
15: Wheel osr  
Scratched  
Up To 50mm

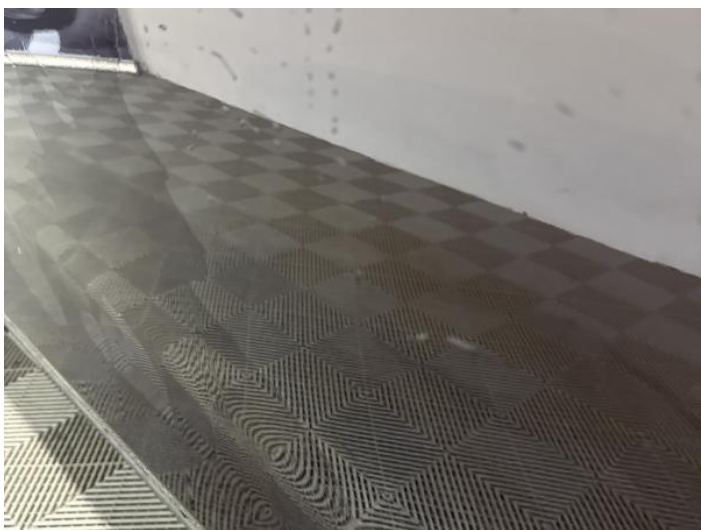
17: Door osf  
Chipped  
1 To 5

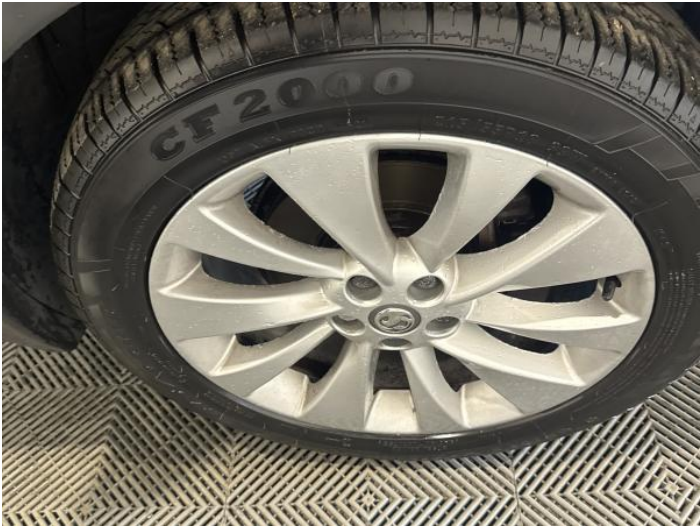
21: Wheel osf  
Scratched  
Up To 50mm

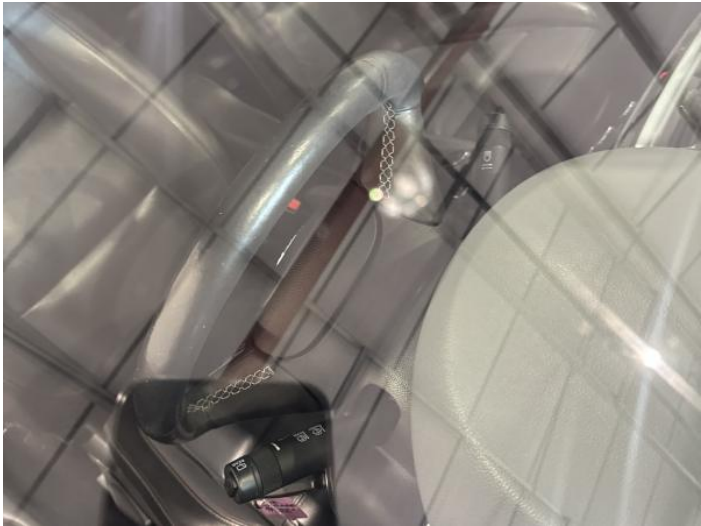
22: Screen Front  
Chipped  
UpTo 10mm
