VEHICLE INSPECTION REPORT

WO18TGF

BMW 2 Series 220d M Sport 2dr [Nav] Step Auto

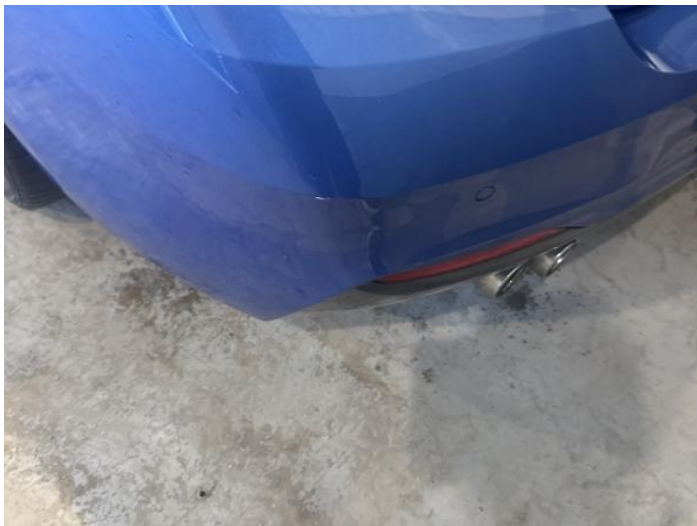
1: Bumper Rear
Scratched
25 to 100mm Thru Paint

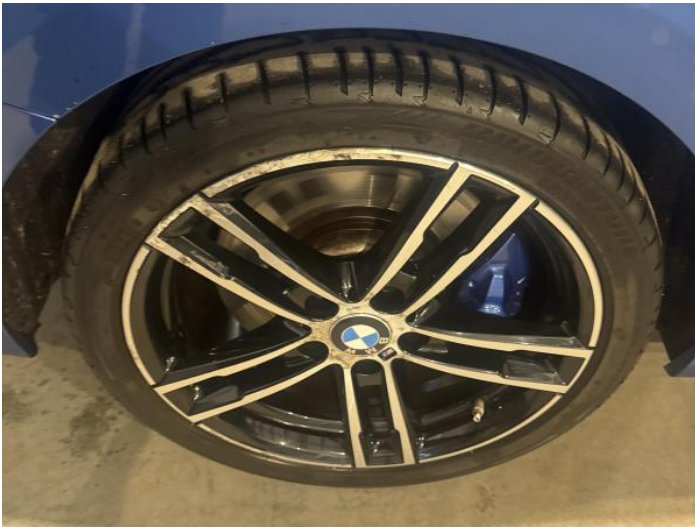
5: Wheel osr
Scratched
Over 50mm

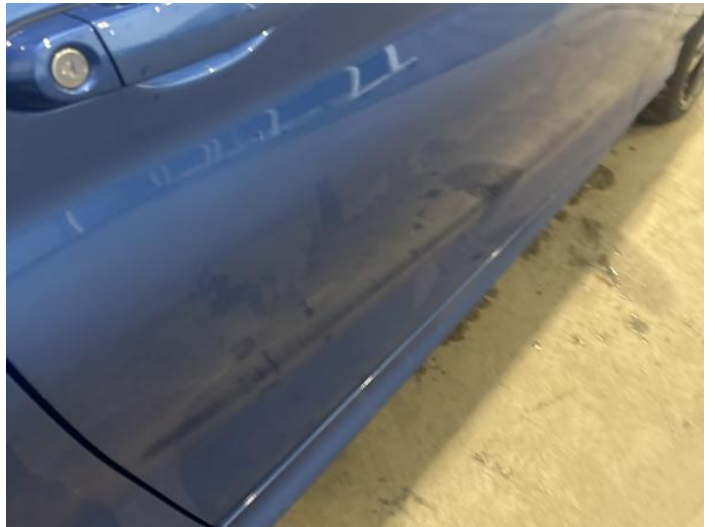
6: Door osf
Dented
Over 2 UpTo 10mm

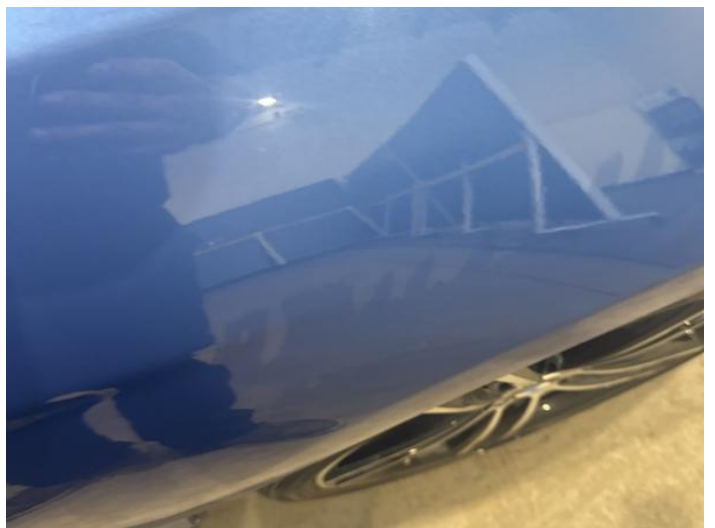
7: Door osf
Scratched
Over 25mm Not Thru Paint

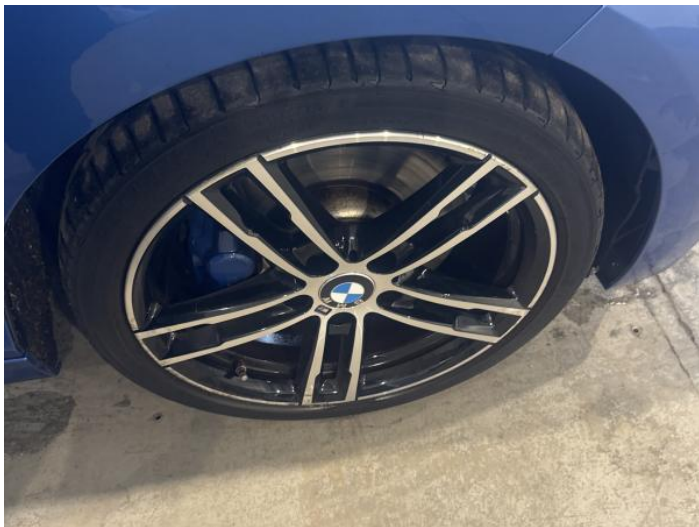
9: Wheel osf
Scratched
Over 50mm

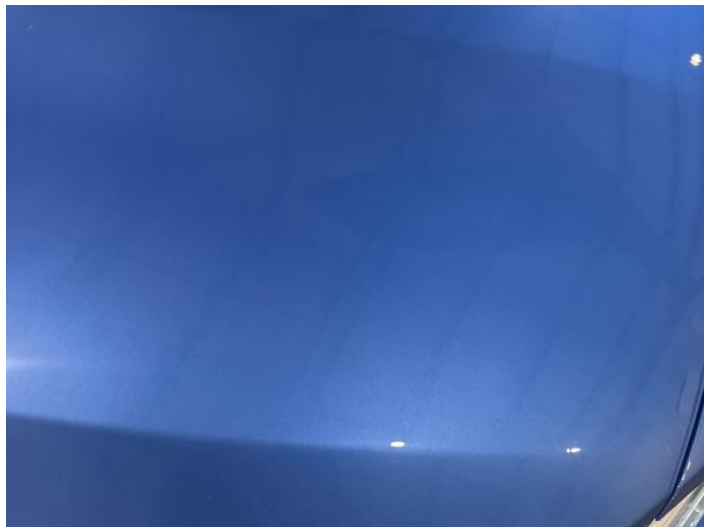
10: Bonnet
Chipped
1 To 5

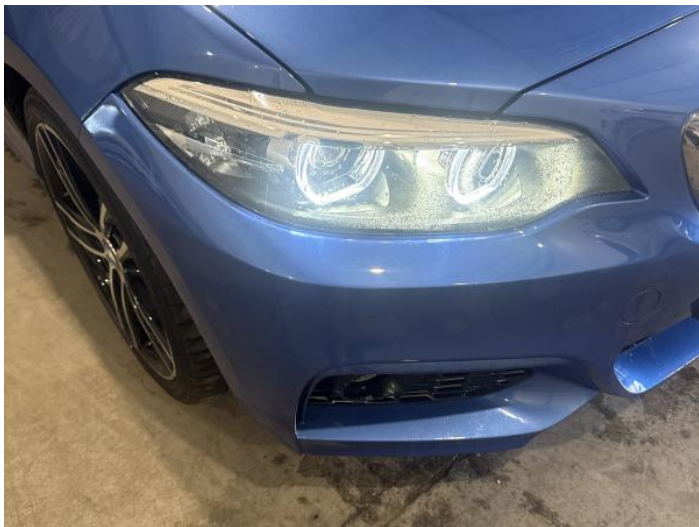
11: Bumper Front
Scratched
Over 100mm Thru Paint

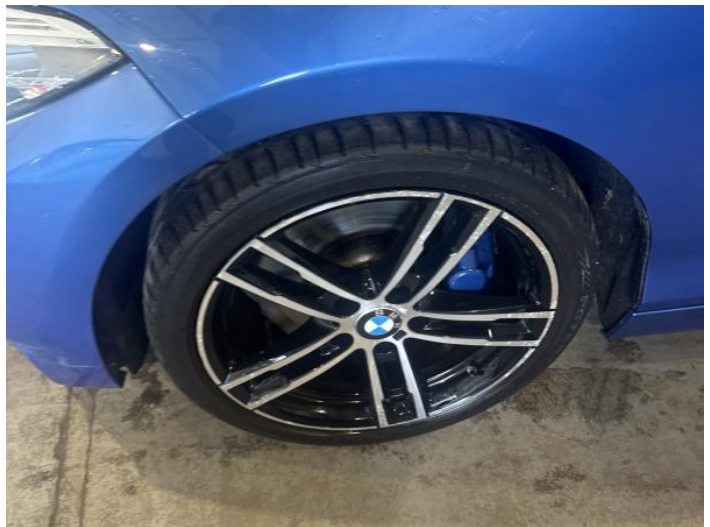
12: Wheel nsf
Scratched
Over 50mm

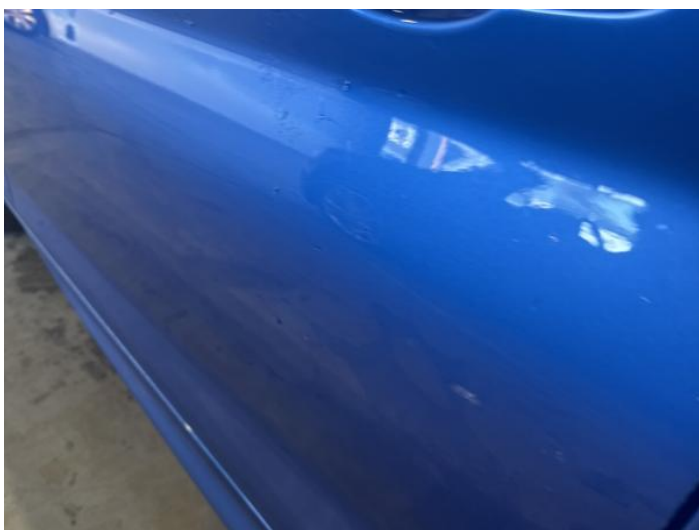
13: Door nsf
Chipped
1 To 5

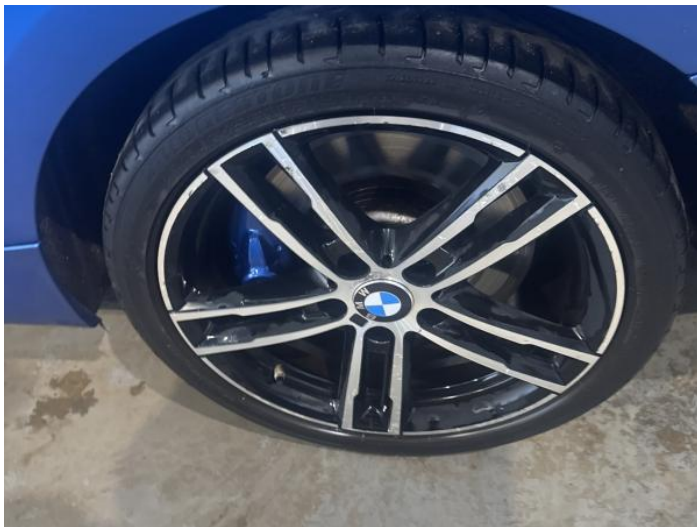
15: Wheel nsr
Scratched
Over 50mm

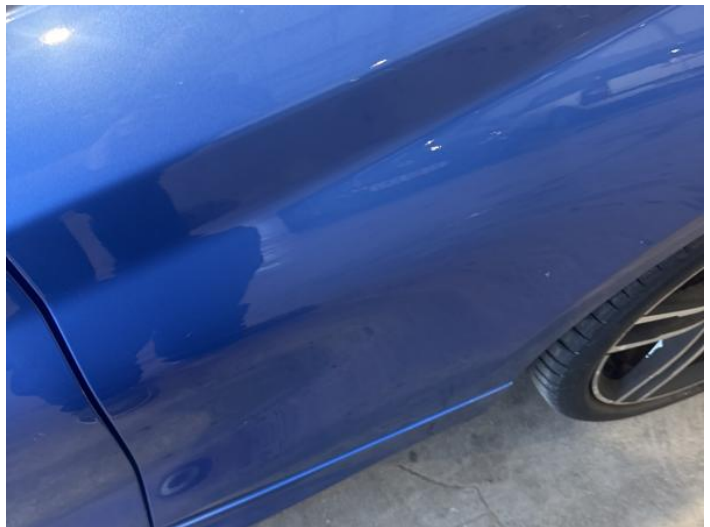
16: Qtr Panel nsr
Dented
Over 2 UpTo 10mm
