VEHICLE INSPECTION REPORT

OY11UTG

Vauxhall Zafira 1.8i Excite 5dr

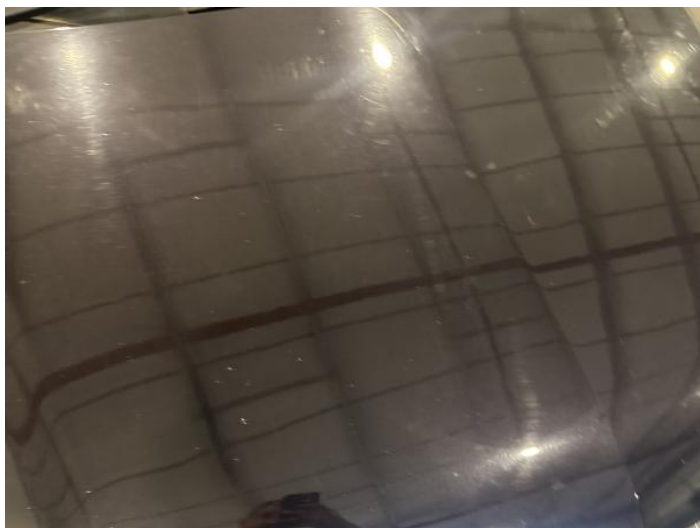
1: Bonnet
Chipped
Multiple Chips

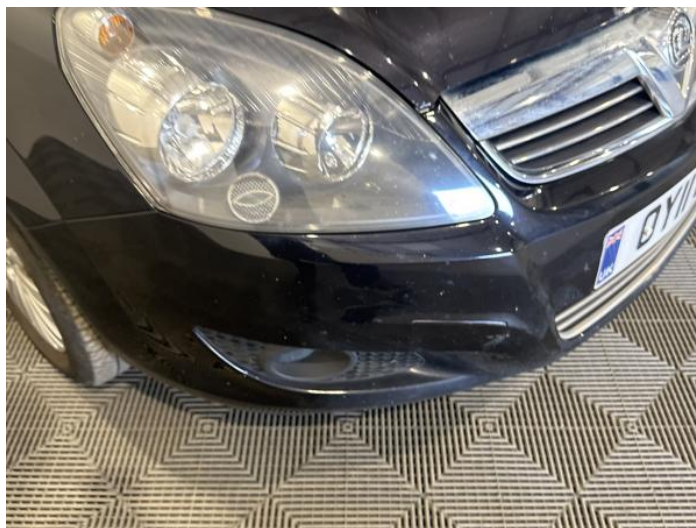
2: Bumper Front
Scratched
25 to 100mm Thru Paint

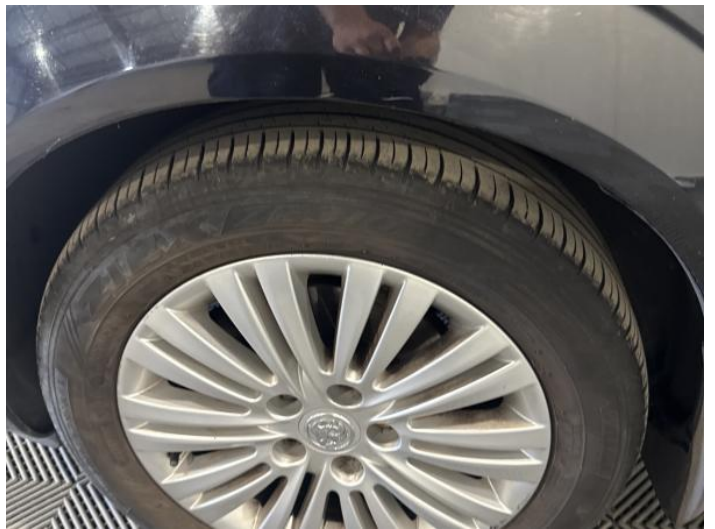
5: Wing nsf
Scratched
Over 25mm Not Thru Paint

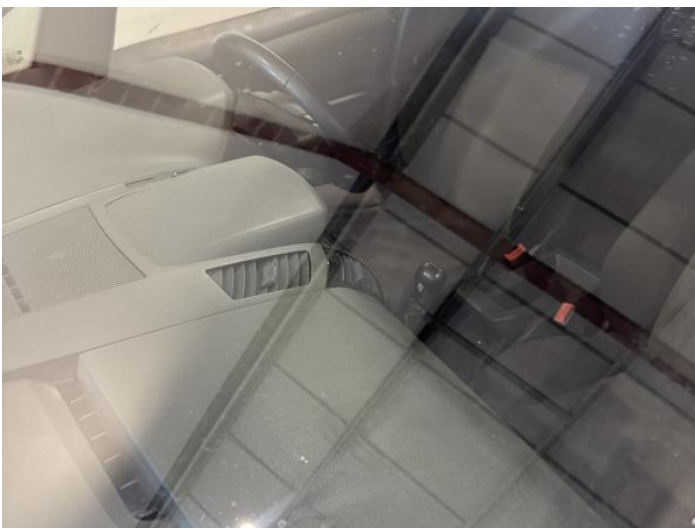
7: Screen Front
Chipped
UpTo 10mm

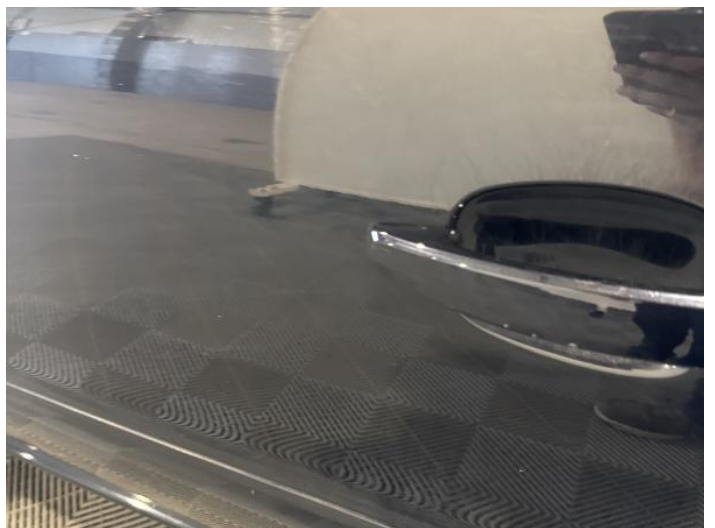
8: Door nsf
Chipped
1 To 5

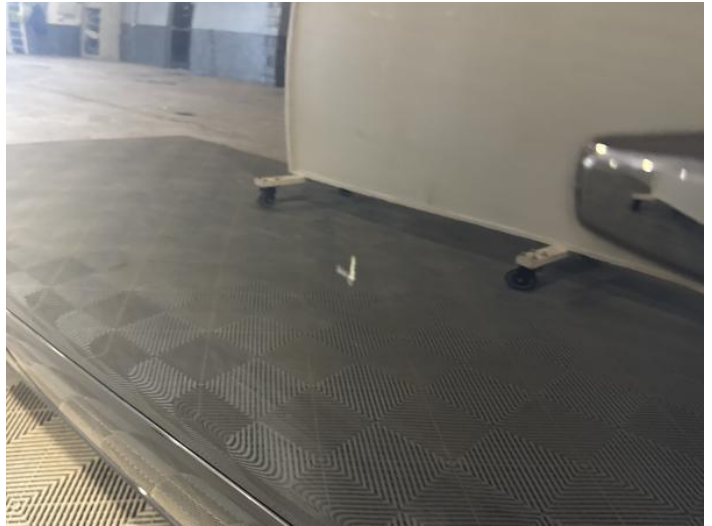
10: Door nsr
Chipped
1 To 5

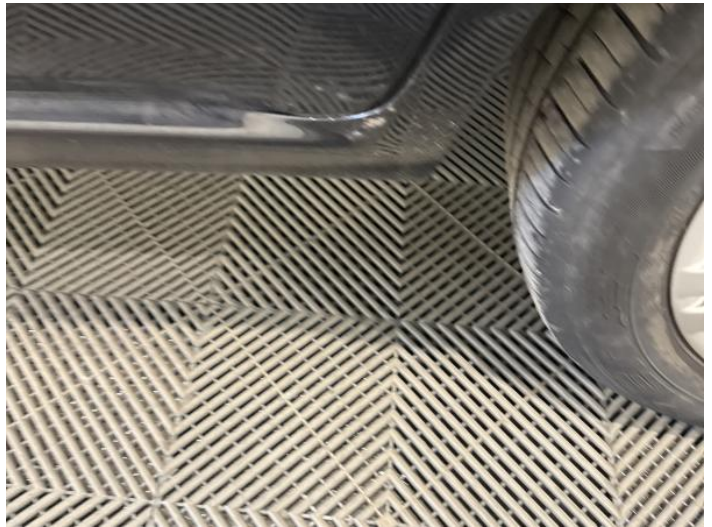
12: Sill os
Rusted
UpTo 5mm

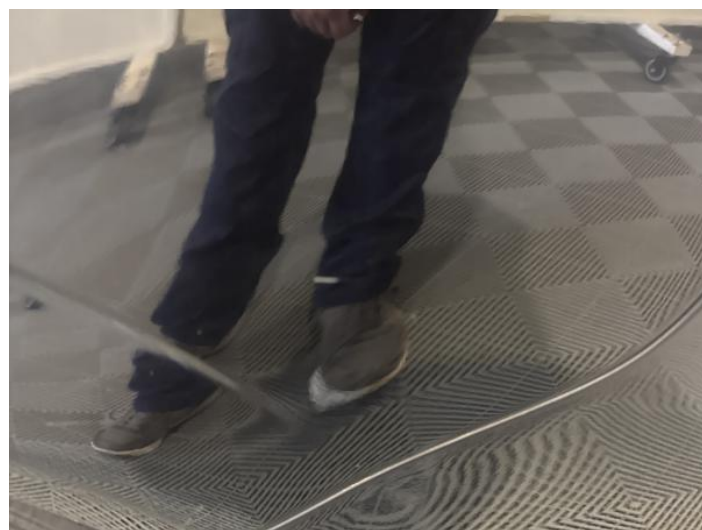
13: Qtr Panel nsr
Scratched
UpTo 25mm Thru Paint

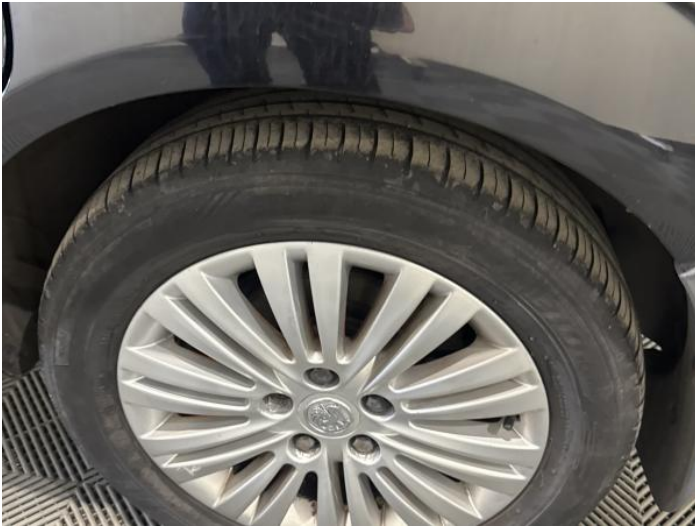
15: Wheel nsr
Scratched
Over 50mm

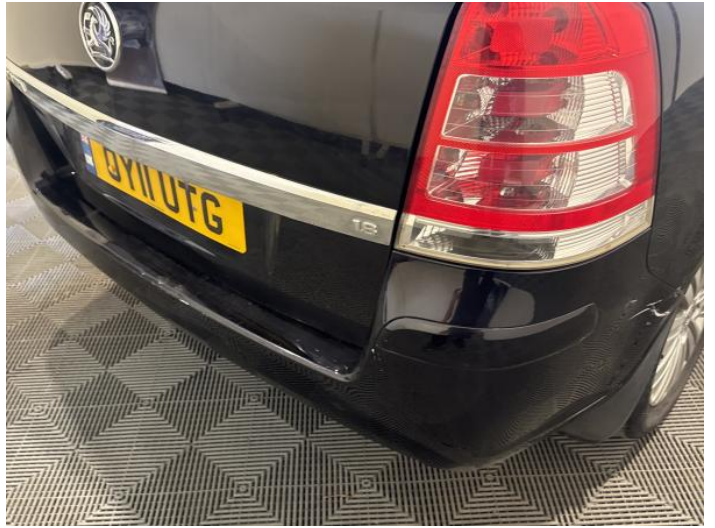
16: Bumper Rear
Scratched
Over 100mm Thru Paint

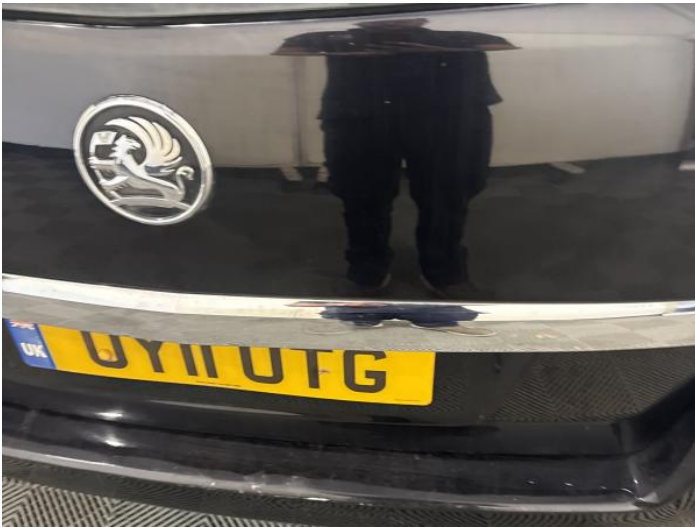
17: Boot Lid
Chipped
1 To 5

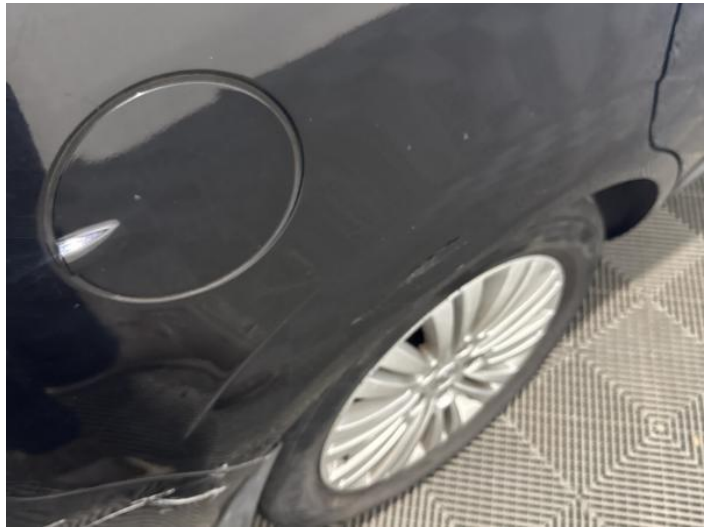
18: Qtr Panel osr
Dented
With Paint Damage

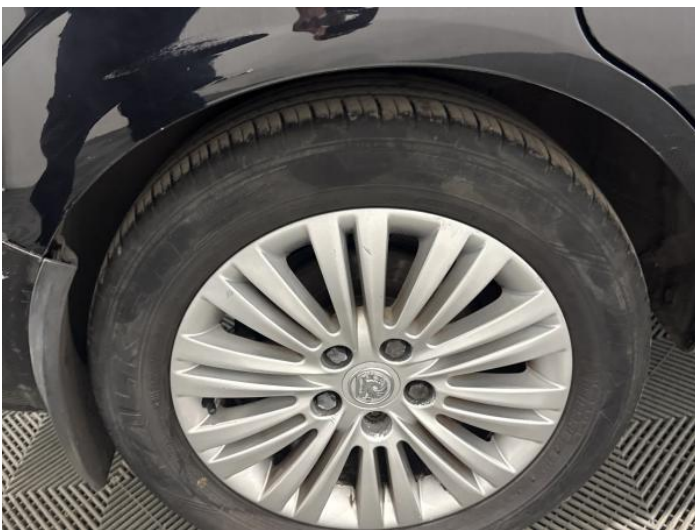
19: Wheel osr
Scratched
Over 50mm

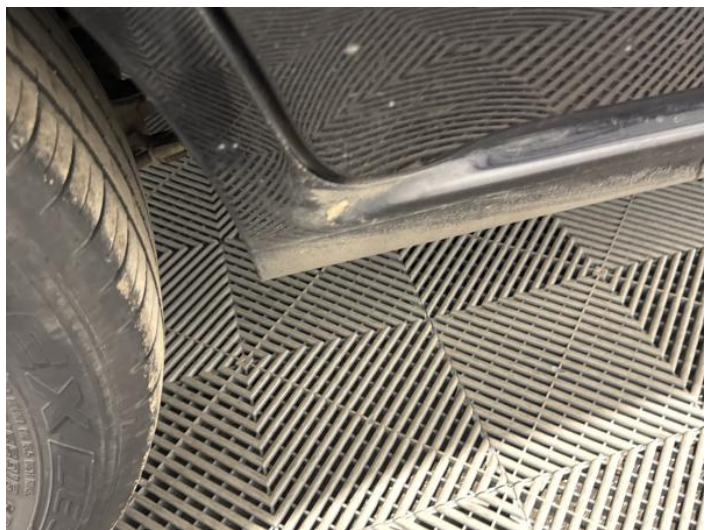
20: Sill os
Chipped
Over 5mm

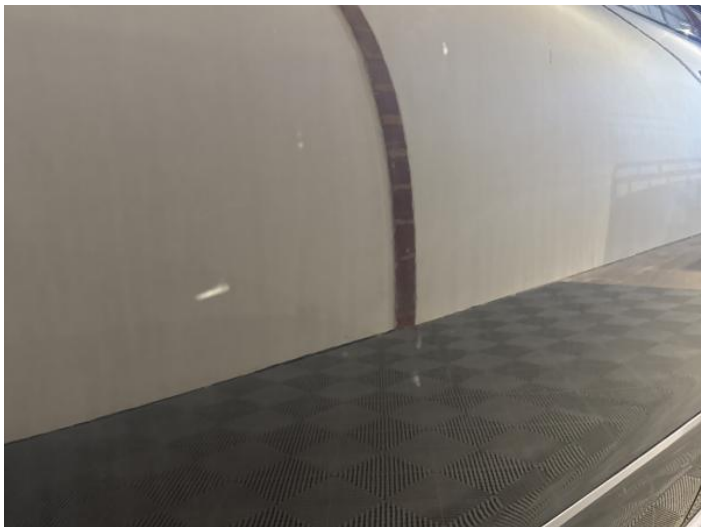
21: Door osr
Chipped
1 To 5

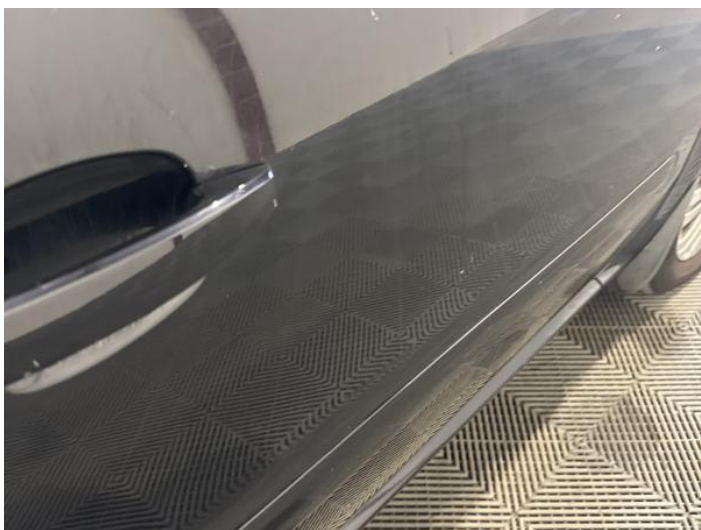
23: Door osf
Chipped
1 To 5

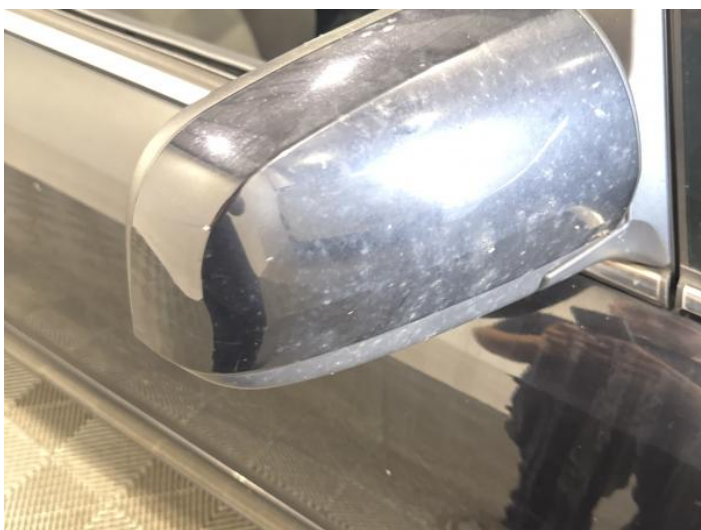
25: Door Mirror Assy osf
Scratched (Painted)
UpTo 25mm Thru Paint

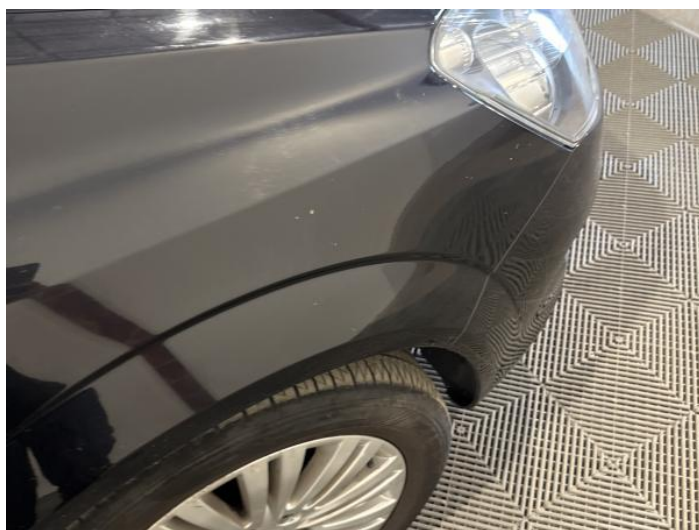
26: Wing osf
Chipped
1 To 5

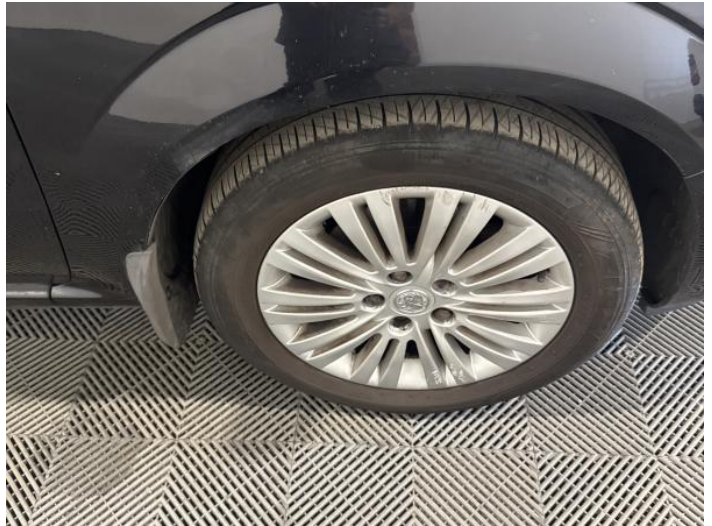
27: Wing osf
Scratched
Over 25mm Not Thru Paint
