VEHICLE INSPECTION REPORT

FY59WKO

BMW 5 Series 520d SE Business Edition 5dr Step Auto [177]

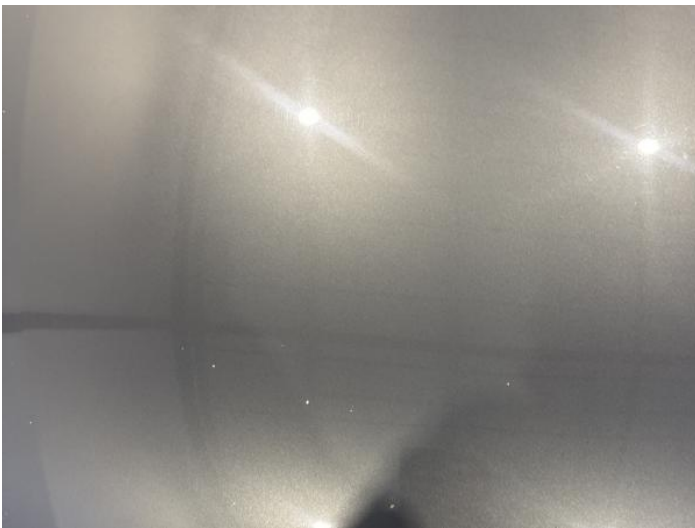
1: Bonnet
Chipped
Multiple Chips

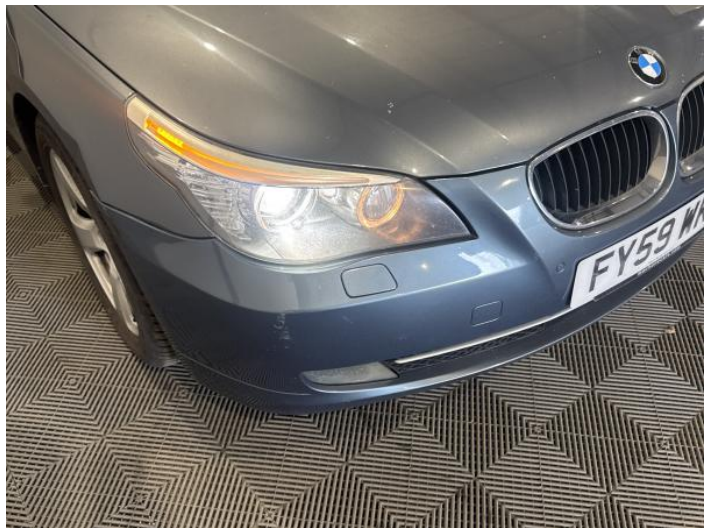
2: Bumper Front
Scratched
Over 100mm Thru Paint

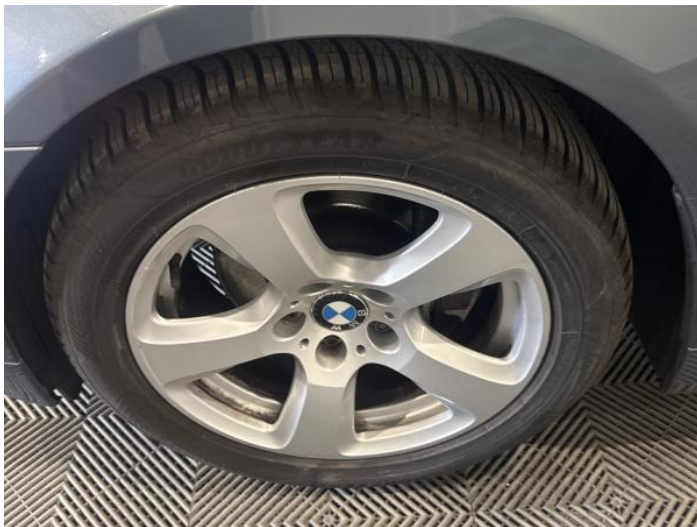
3: Wheel nsf
Scratched
Up To 50mm

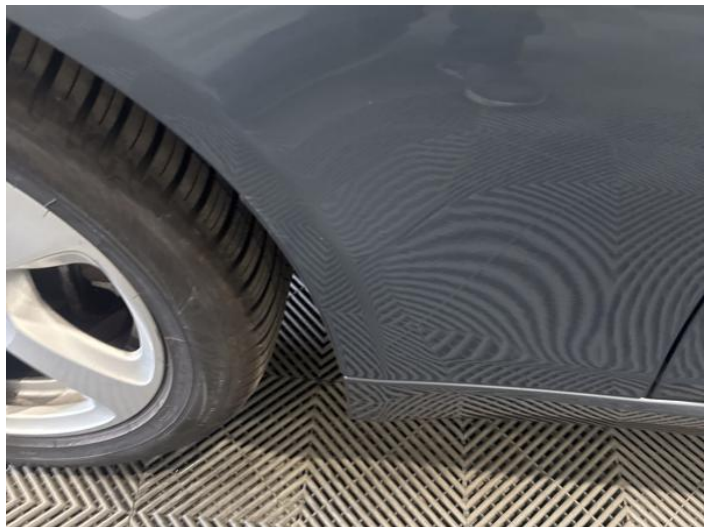
4: Wing nsf
Scratched
UpTo 25mm Thru Paint

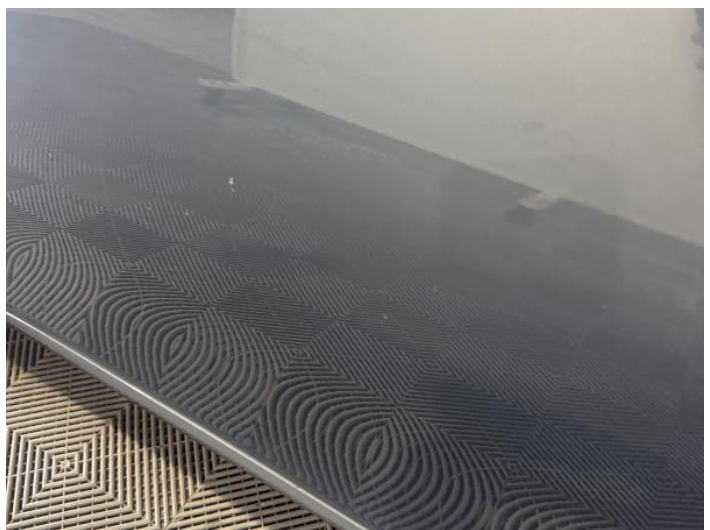
6: Door nsf
Chipped
1 To 5

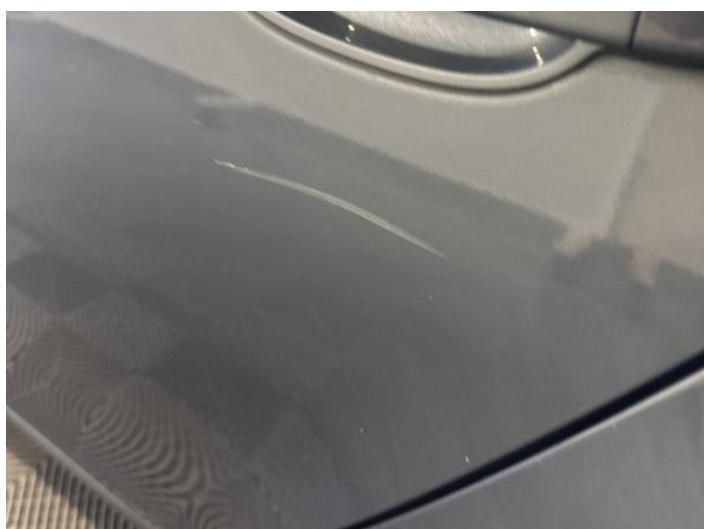
8: Door nsr
Scratched
Over 25mm Thru Paint

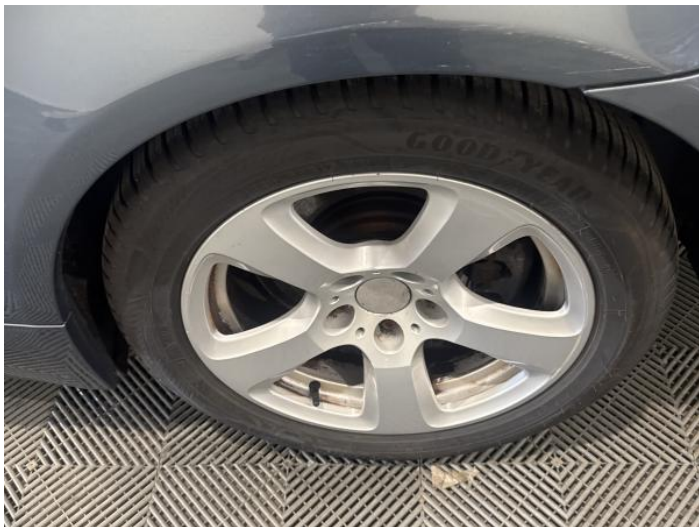
9: Wheel nsr
Scratched
Over 50mm

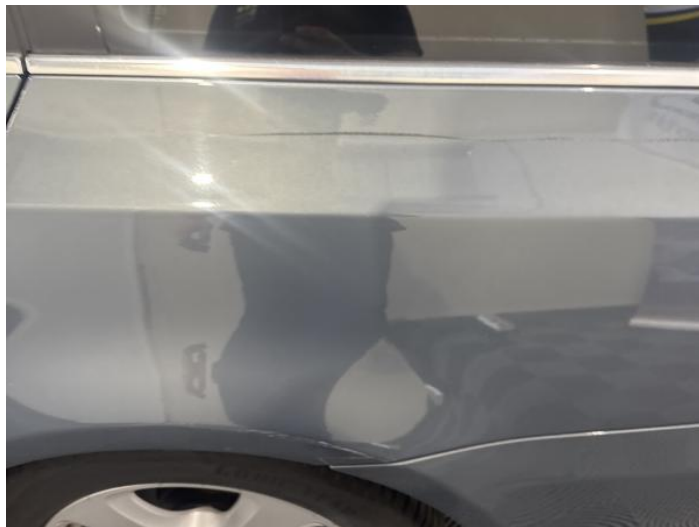
10: Qtr Panel nsr
Scratched
Over 25mm Thru Paint

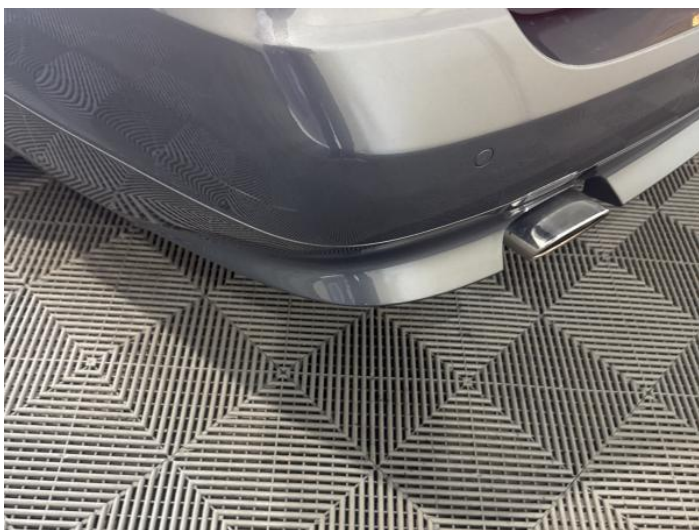
11: Bumper Rear
Scratched
Over 100mm Thru Paint

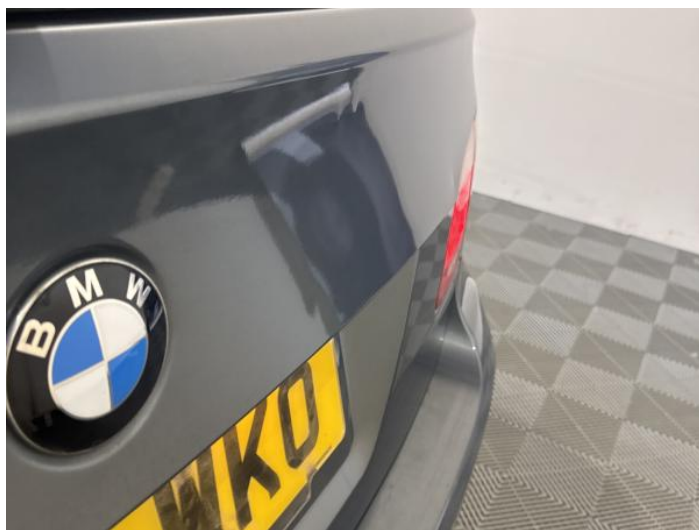
12: Boot Lid
Dented
Over 2 UpTo 10mm

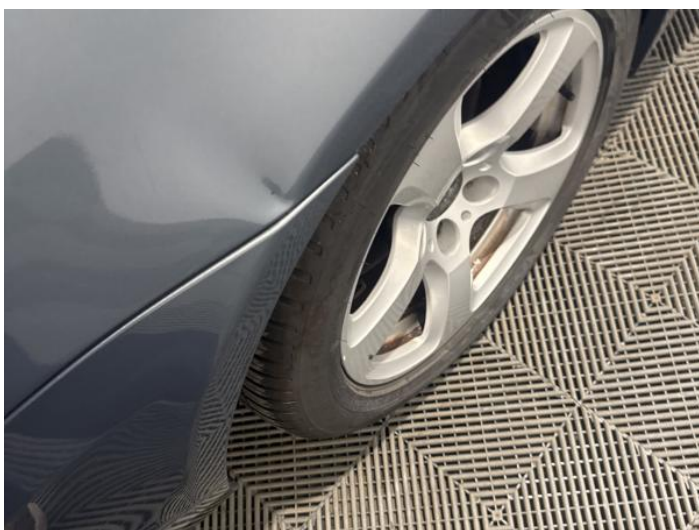
13: Qtr Panel osr
Dented
Over 30mm

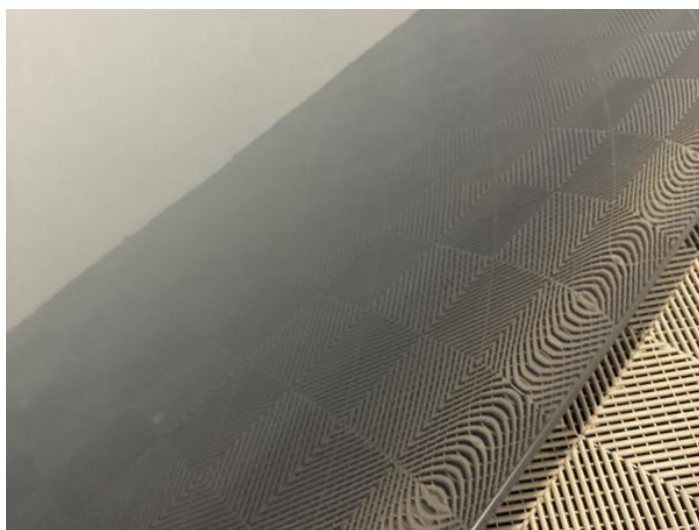
14: Door osr
Chipped
1 To 5

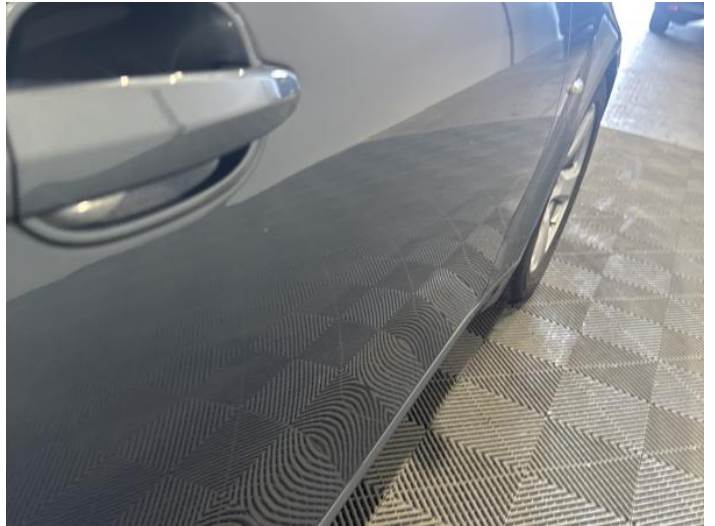
15: Door osr
Scratched
Over 25mm Not Thru Paint

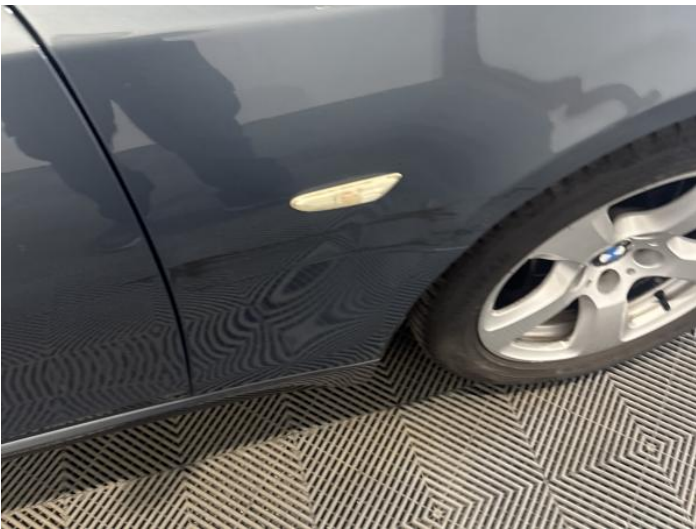
17: Wing osf
Dented
With Paint Damage

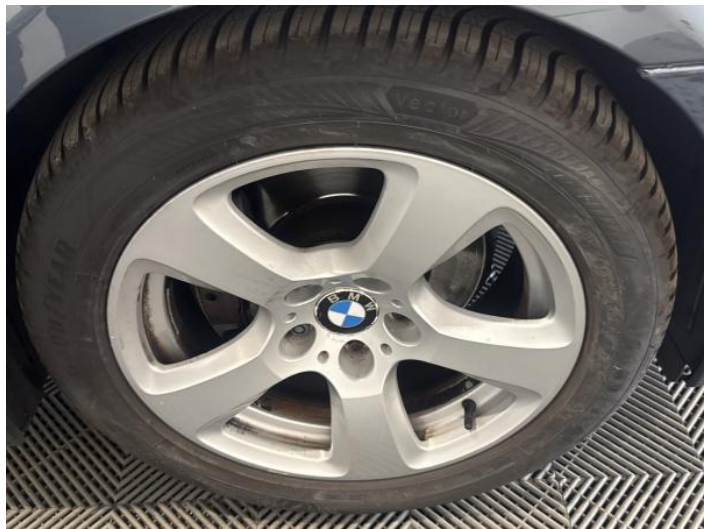
18: Wheel osf
Scratched
Over 50mm

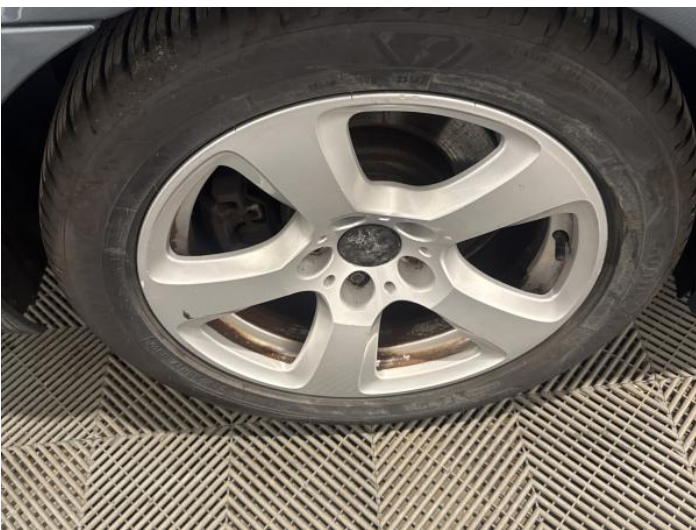
19: Wheel osr
Scratched
Over 50mm

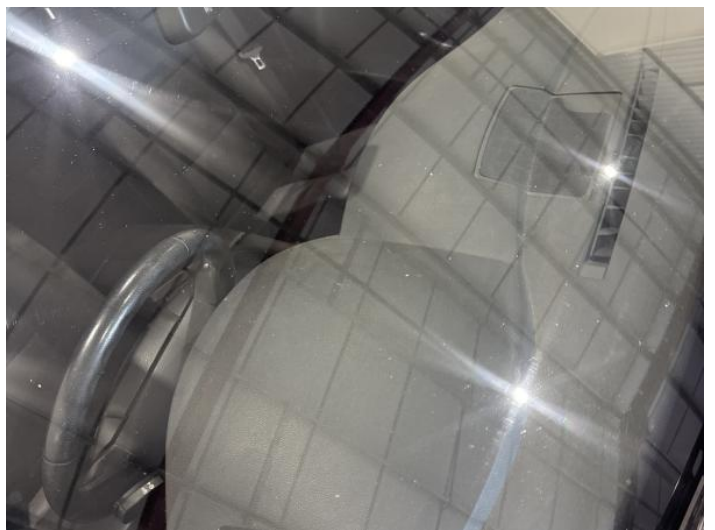
20: Screen Front
Chipped
UpTo 10mm
