VEHICLE INSPECTION REPORT

GV04MVM

Ford Focus 1.6 Edge 5dr

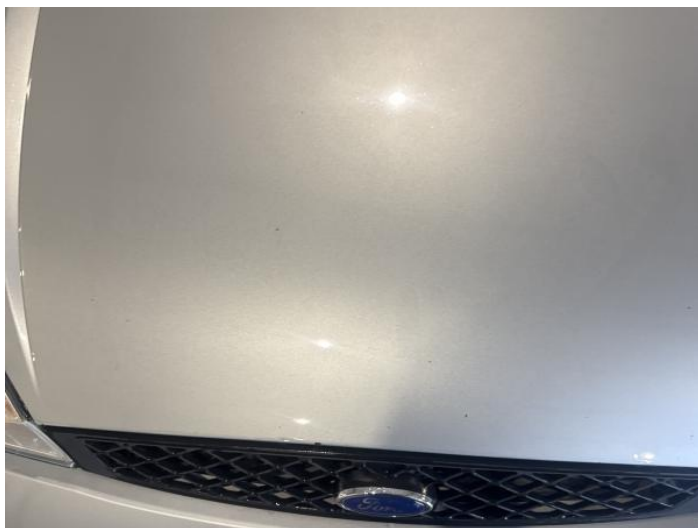
1: Bonnet
Chipped
Multiple Chips

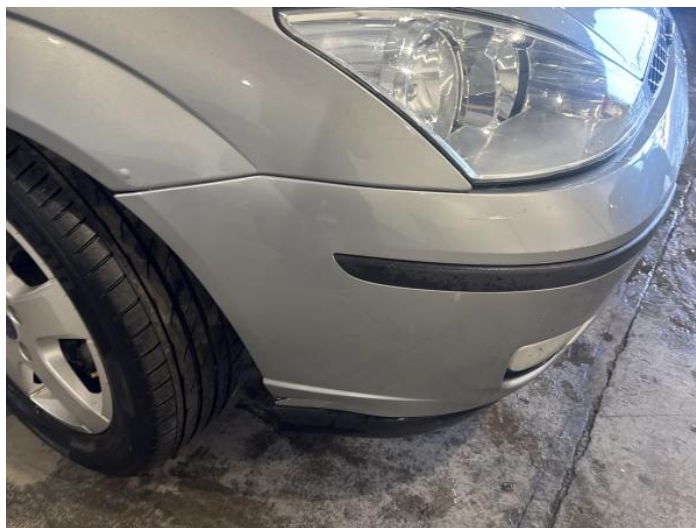
2: Bumper Front
Cracked
UpTo 25mm

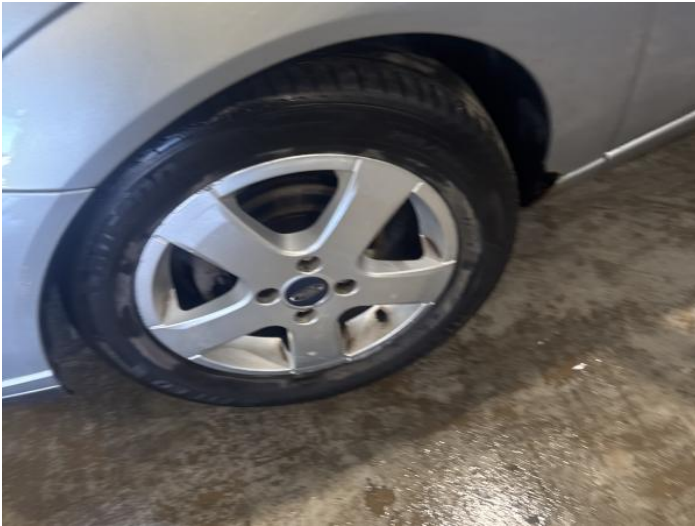
3: Wheel nsf
Scratched
Over 50mm

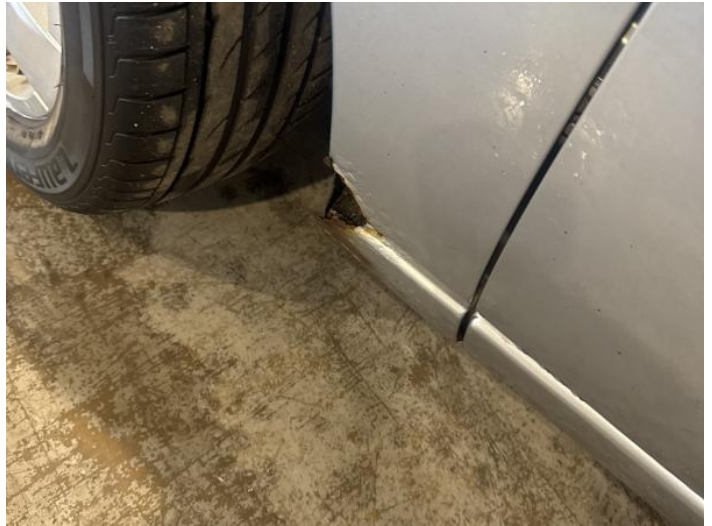
4: Wing nsf
Rusted
Holed

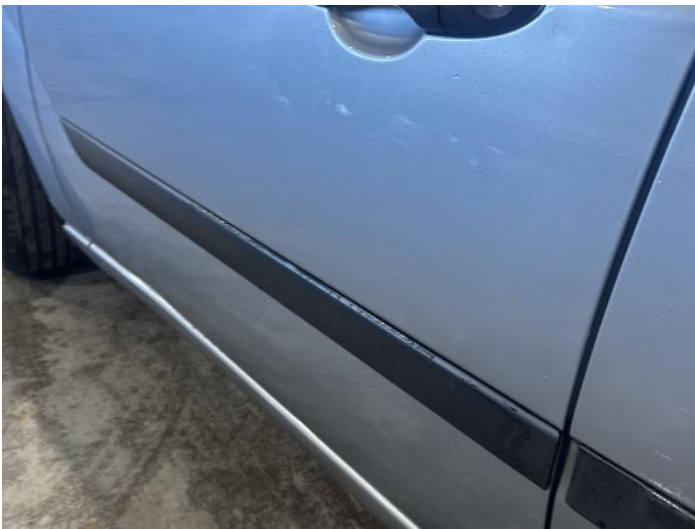
5: Door nsf
Chipped
1 To 5

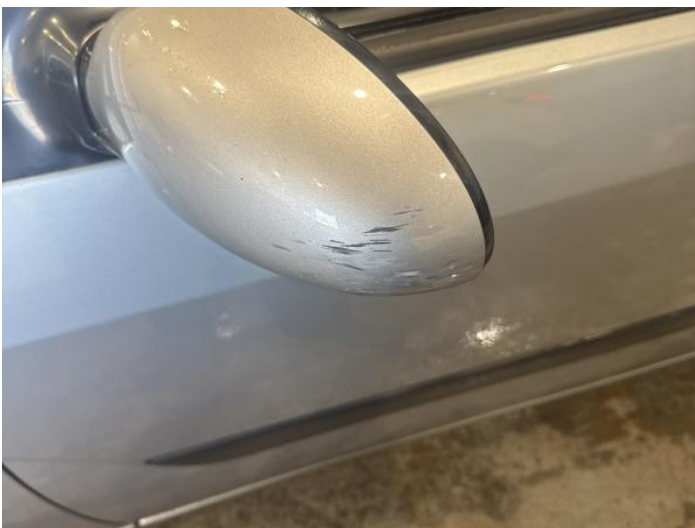
7: Door Mirror Assy nsf
Scratched (Painted)
Over 25mm Thru Paint

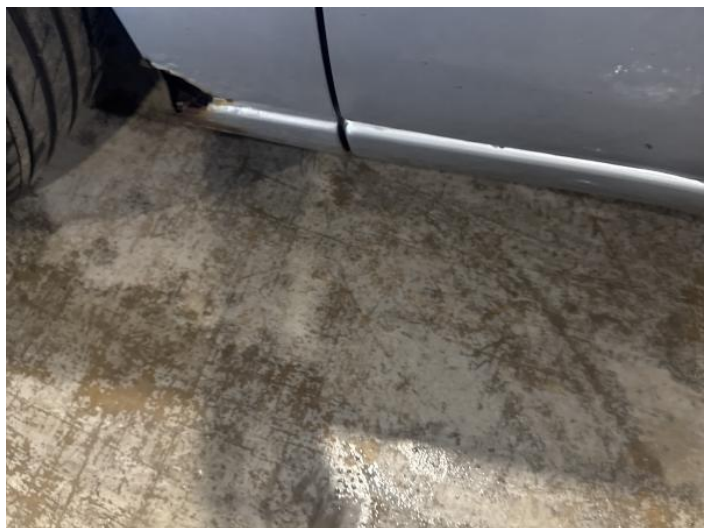
8: Sill ns
Rusted
Holed

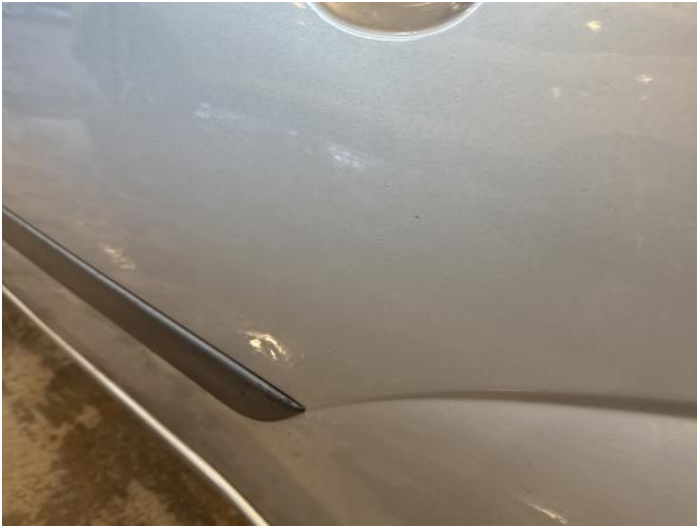
9: Door nsr
Dented
2 Or Less UpTo 10mm

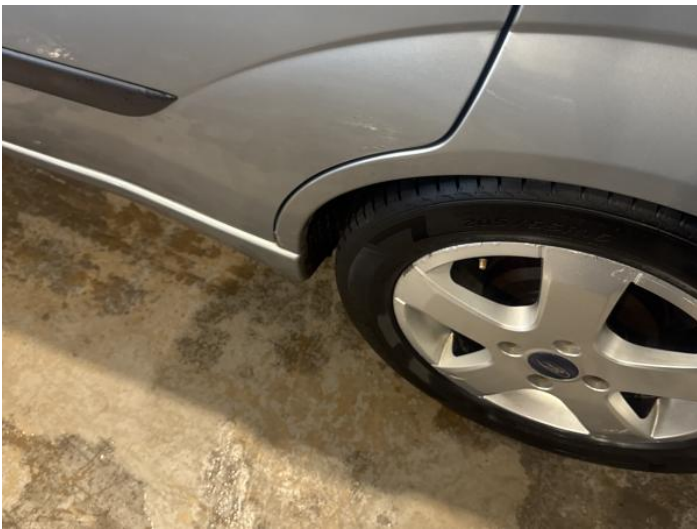
11: Qtr Panel nsr
Rusted
UpTo 5mm

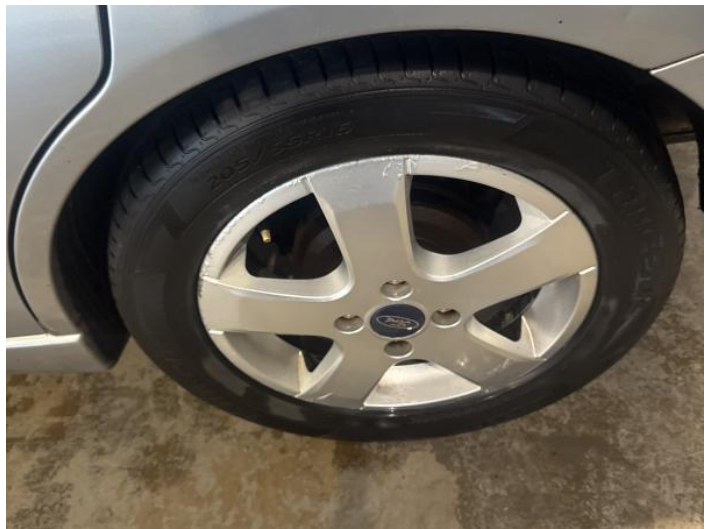
12: Wheel nsr
Scratched
Over 50mm

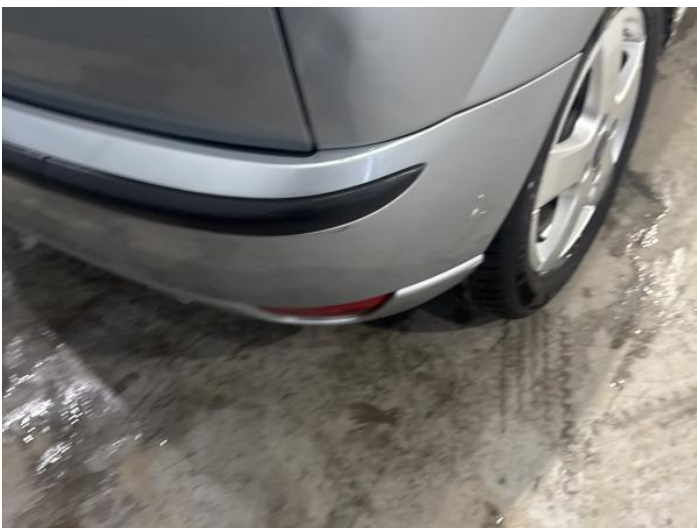
13: Bumper Rear
Scratched
25 to 100mm Thru Paint

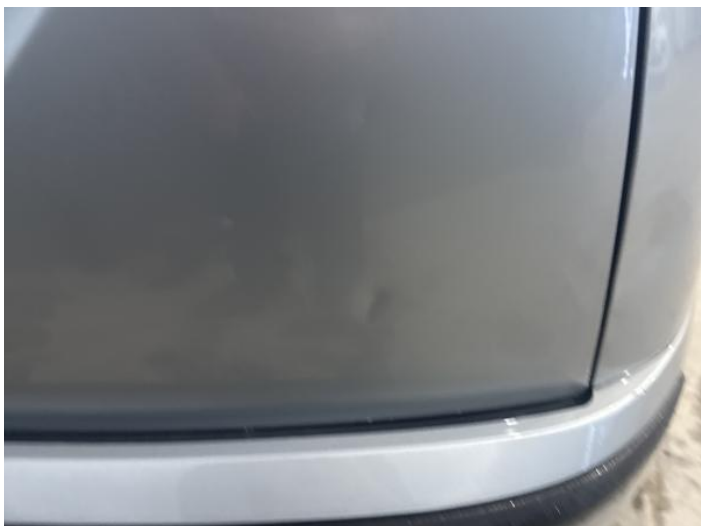
15: Boot Lid
Dented
Over 2 UpTo 10mm

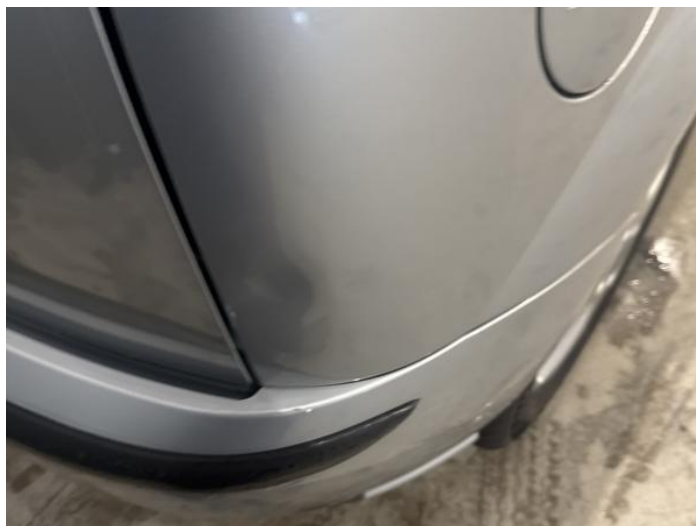
16: Qtr Panel osr
Dented
Over 30mm

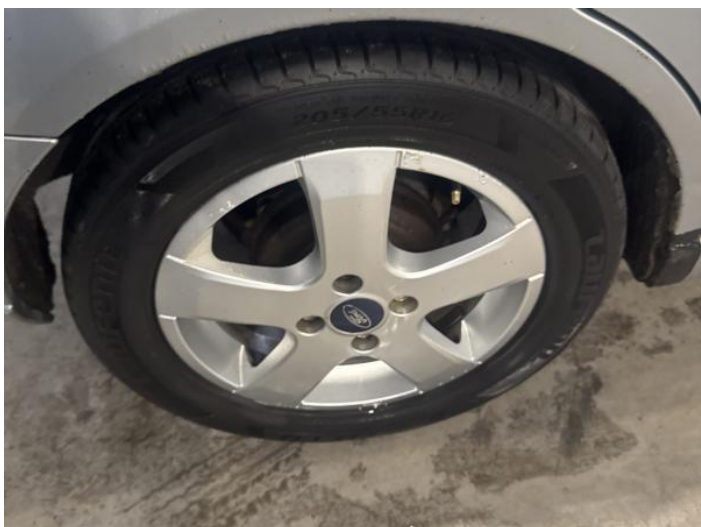
17: Wheel osr
Scratched
Over 50mm

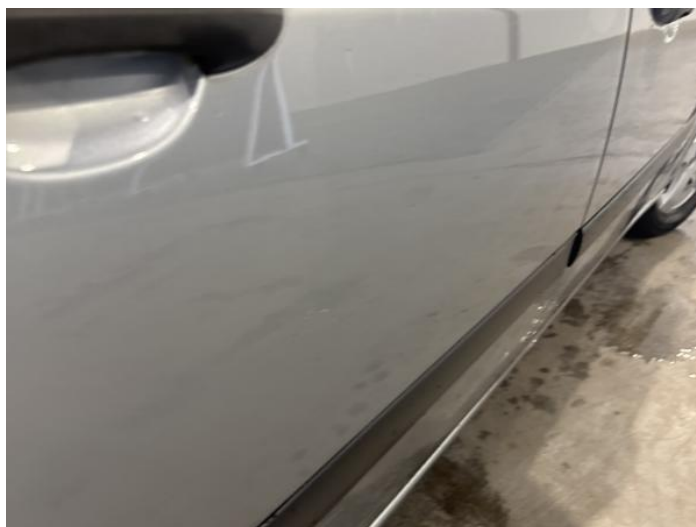
18: Door osr
Dented
Over 2 UpTo 10mm

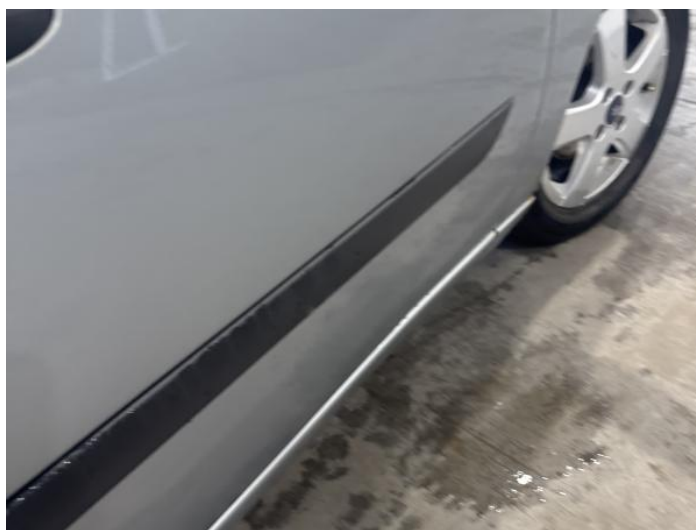
20: Door osf
Dented
2 Or Less UpTo 10mm

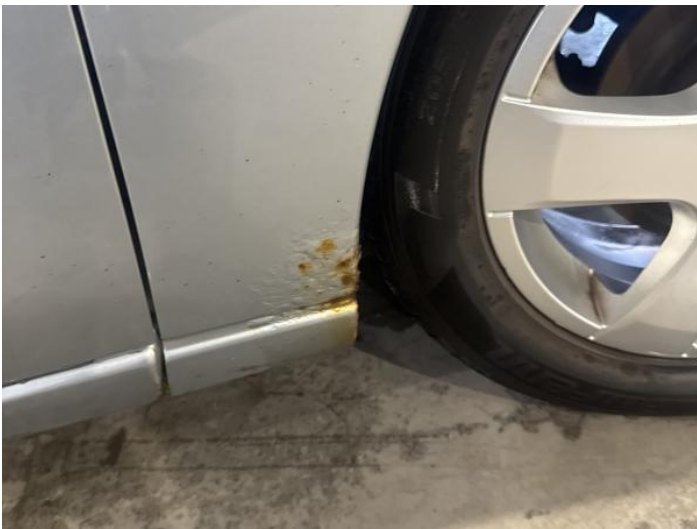
23: Wing osf
Rusted
Over 5mm

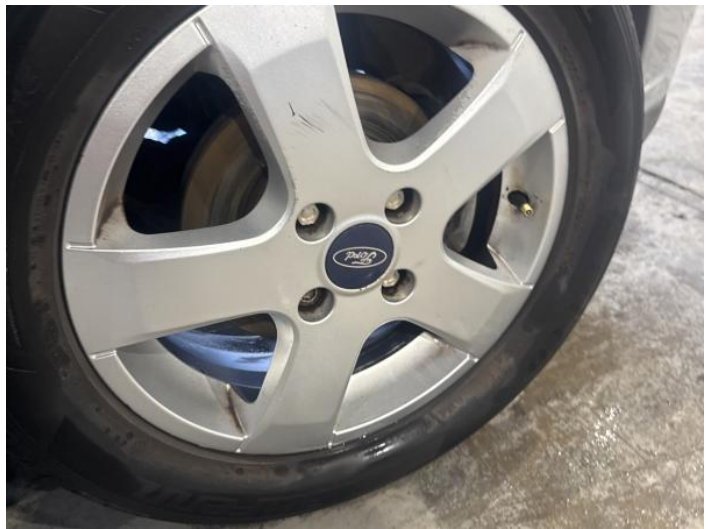
24: Wheel osf
Scratched
Over 50mm
