VEHICLE INSPECTION REPORT

LR57NYS

Nissan Note 1.6 SVE 5dr

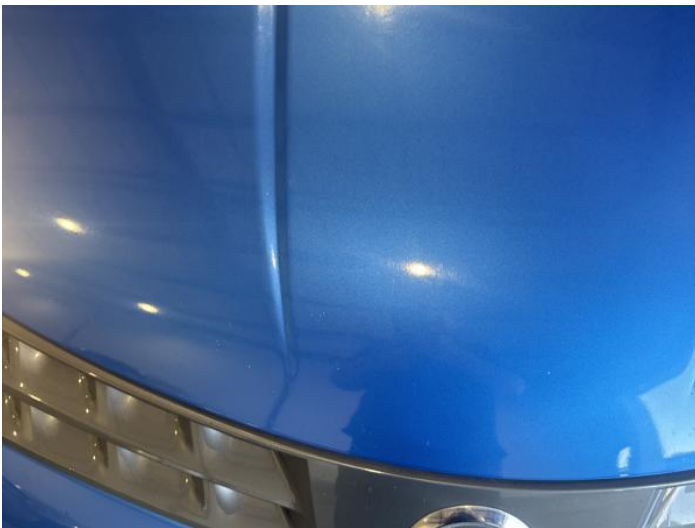
1: Bonnet
Chipped
1 To 5

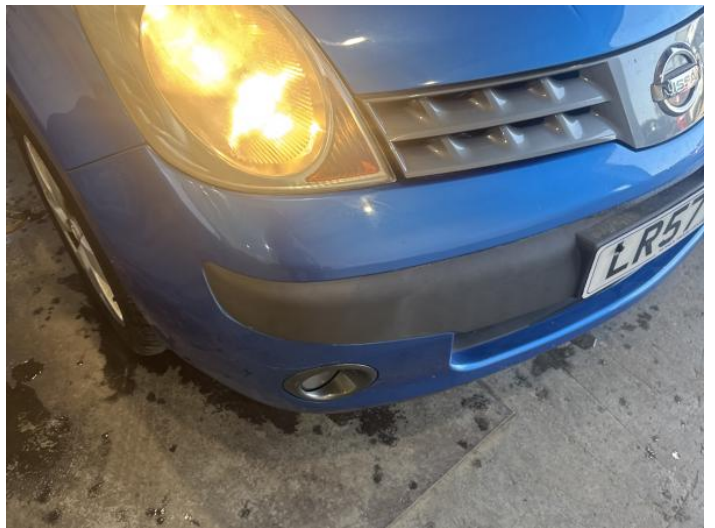
2: Bumper Front
Poor Previous Repair
Poor Paint

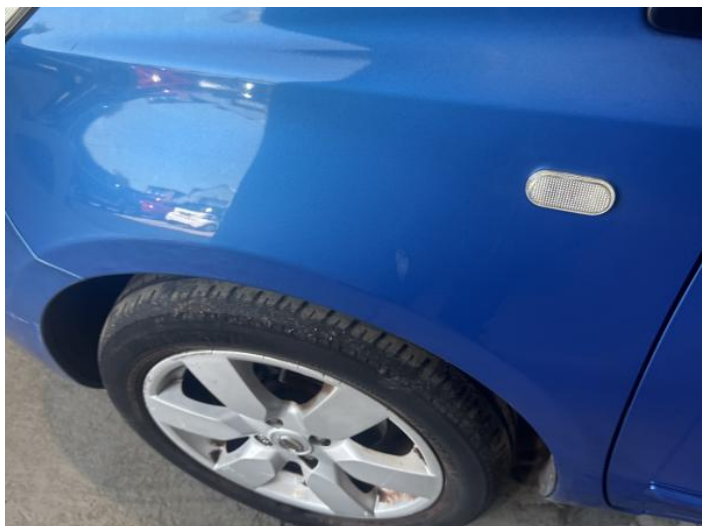
3: Wing nsf
Scratched
Over 25mm Thru Paint

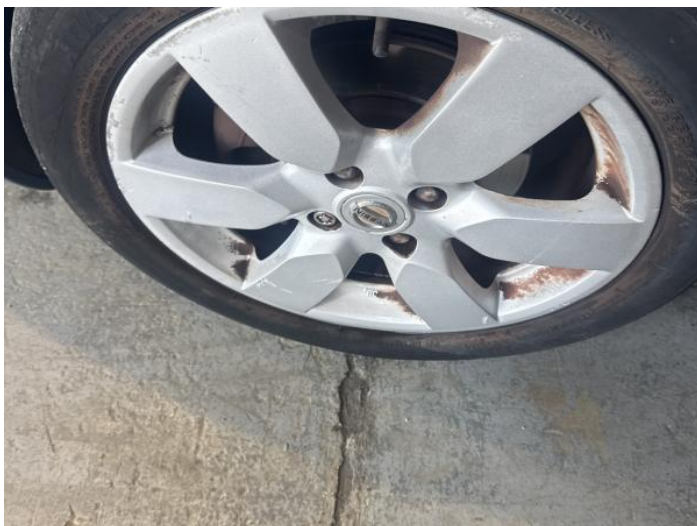
4: Wheel nsf
Scratched
Over 50mm

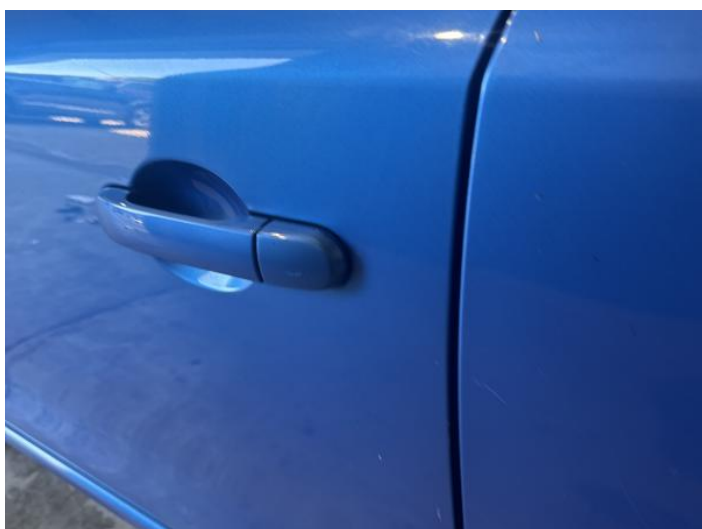
5: Door nsf
Dented
Over 2 UpTo 10mm

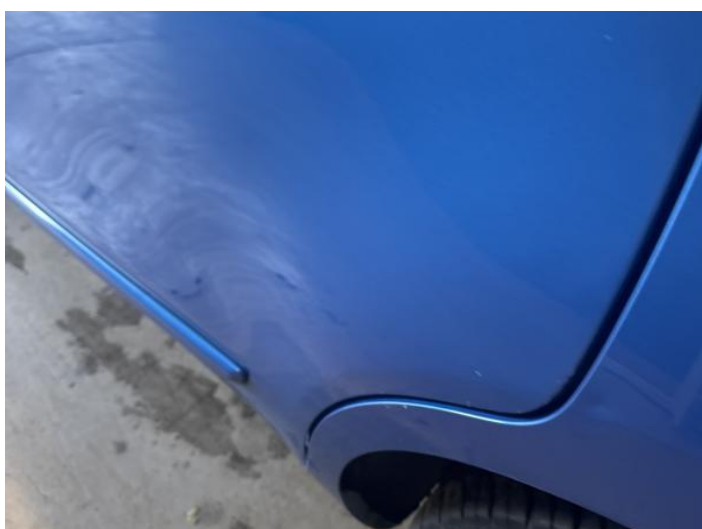
7: Door nsr
Chipped
1 To 5

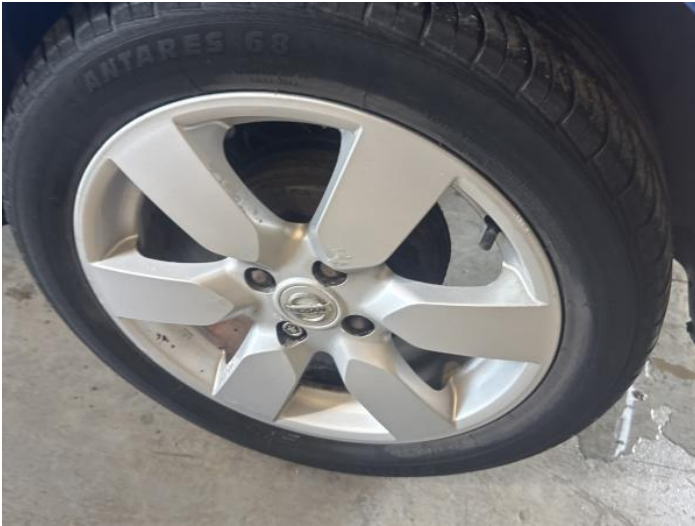
9: Wheel nsr
Scratched
Over 50mm

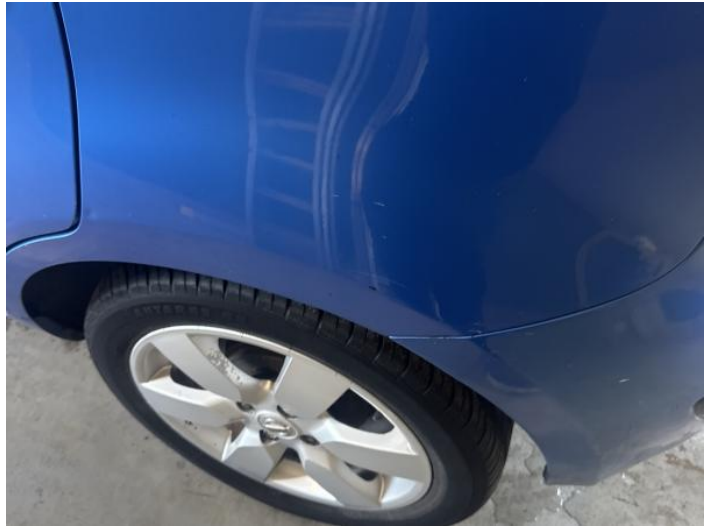
10: Qtr Panel nsr
Scratched
Over 25mm Thru Paint

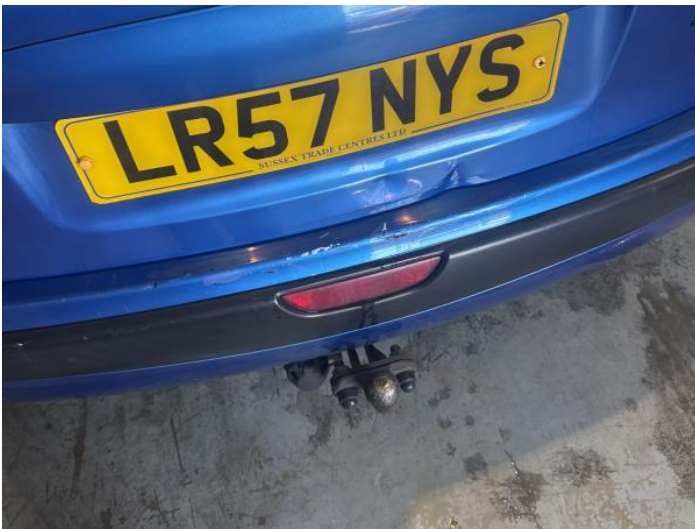
11: Bumper Rear
Poor Previous Repair
Rippled UpTo 30%

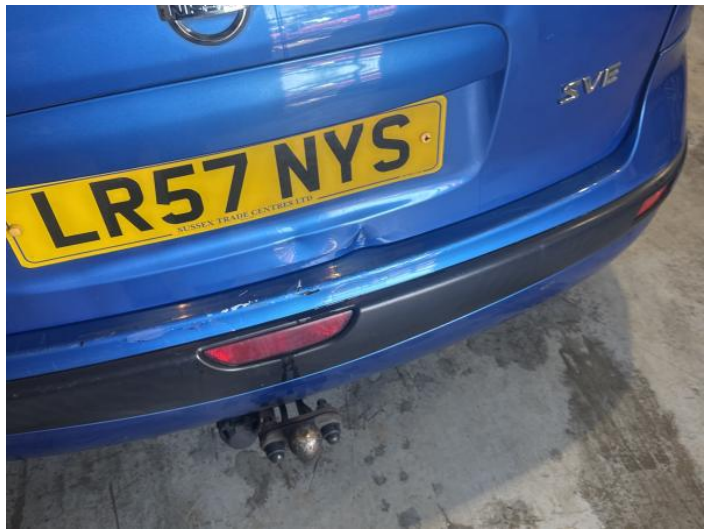
12: Boot Lid
Dented
Over 30mm

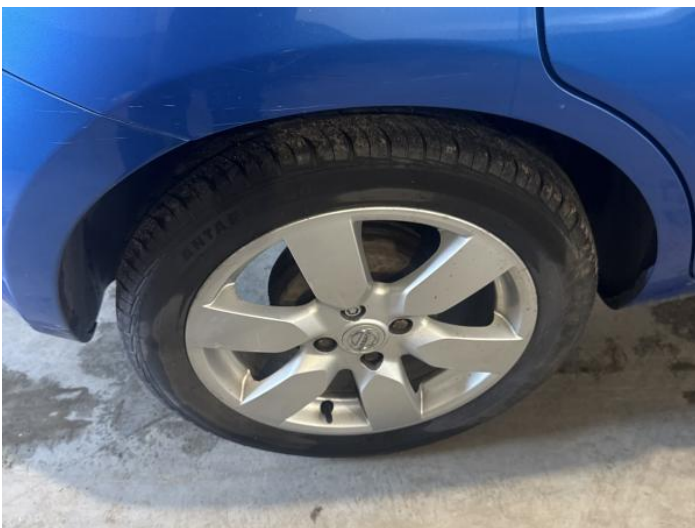
13: Wheel osr
Scratched
Over 50mm

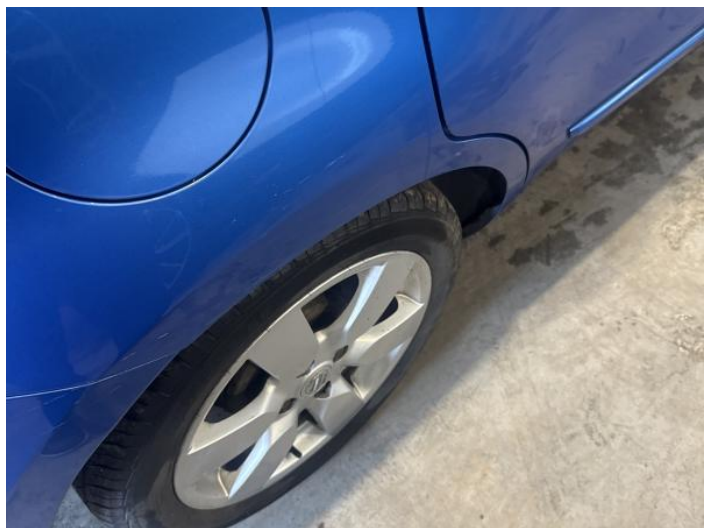
14: Qtr Panel osr
Dented
With Paint Damage

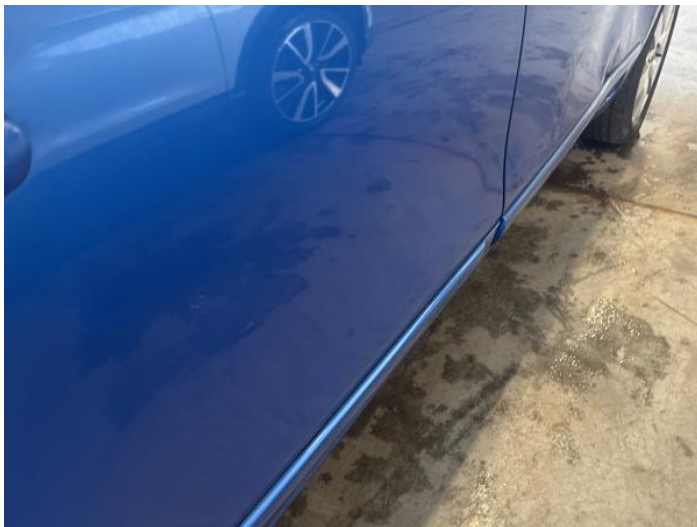
15: Door osr
Dented
Over 2 UpTo 10mm

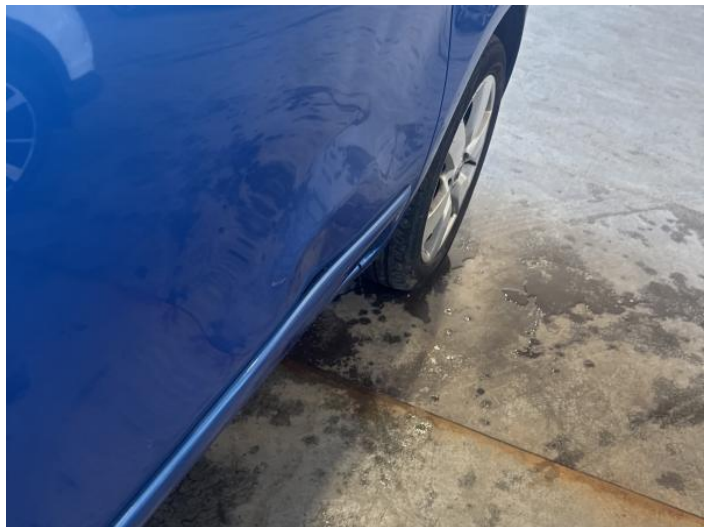
16: Door osf
Dented
Over 30% Of Panel

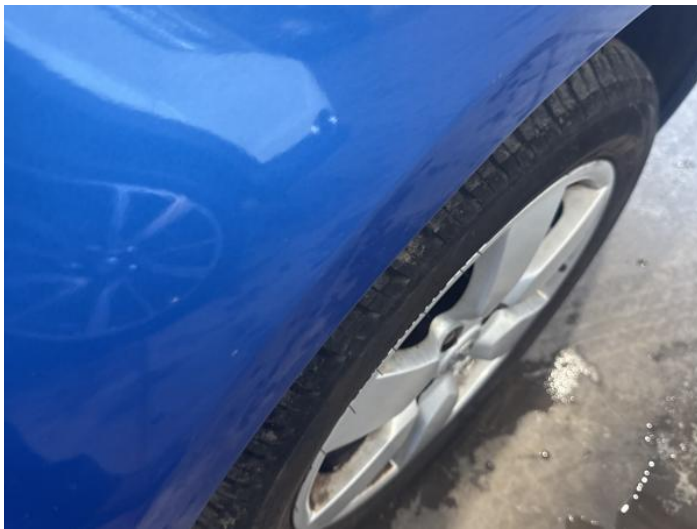
17: Wing osf
Chipped
1 To 5

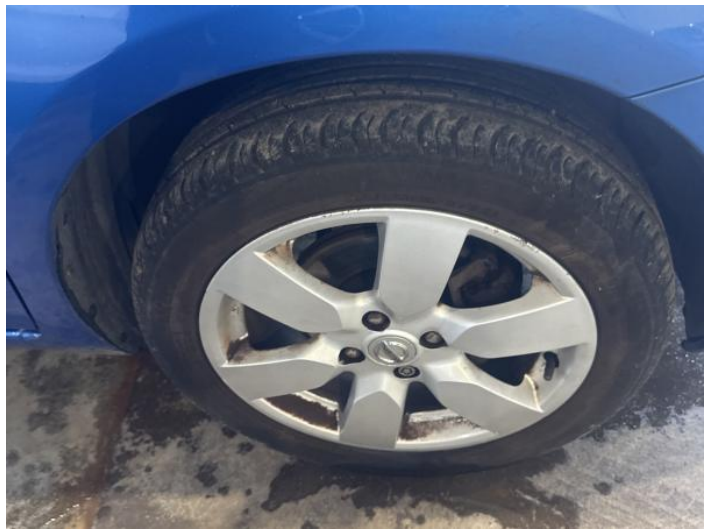
18: Wheel osf
Scratched
Over 50mm
