VEHICLE INSPECTION REPORT

Ford C-Max 1.0 EcoBoost 125 Titanium 5dr

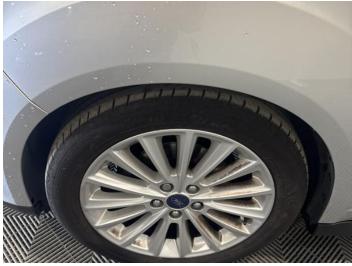
4: Wheel nsf Scratched Over 50mm

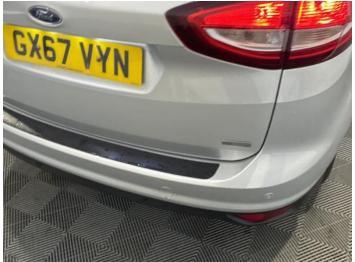
8: Bumper Rear Scratched 25 to 100mm Thru Paint

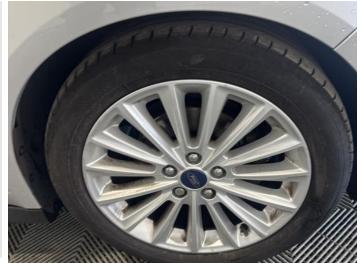
14: Wheel osf Scratched Over 50mm
