VEHICLE INSPECTION REPORT

DV60XCL

Toyota Avensis 2.0 D-4D T4 Nav 5dr

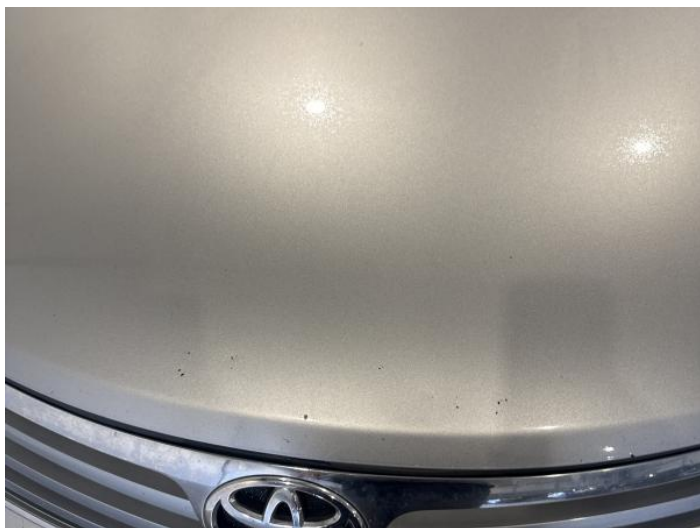
1: Bonnet
Dented
With Paint Damage

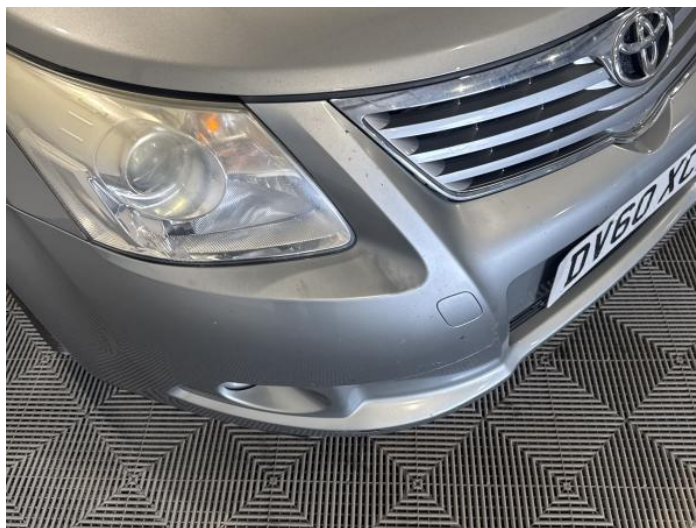
2: Bumper Front
Poor Previous Repair
Poor Paint

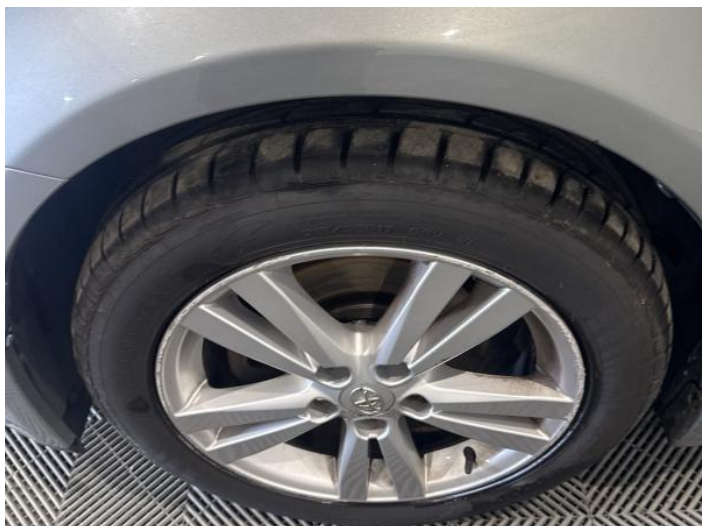
3: Wheel nsf
Scratched
Over 50mm

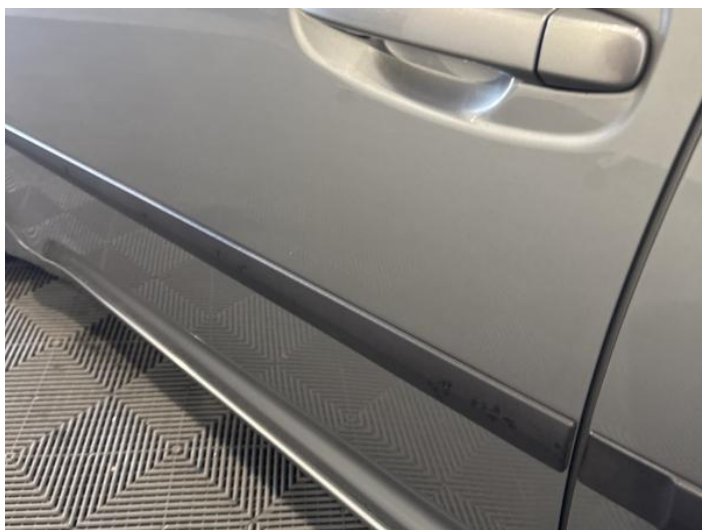
5: Door nsf
Dented
Over 2 UpTo 10mm

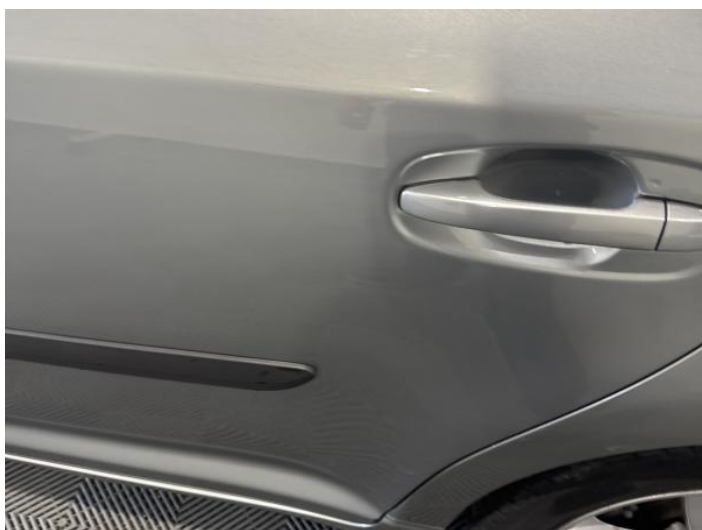
7: Door nsr
Chipped
1 To 5

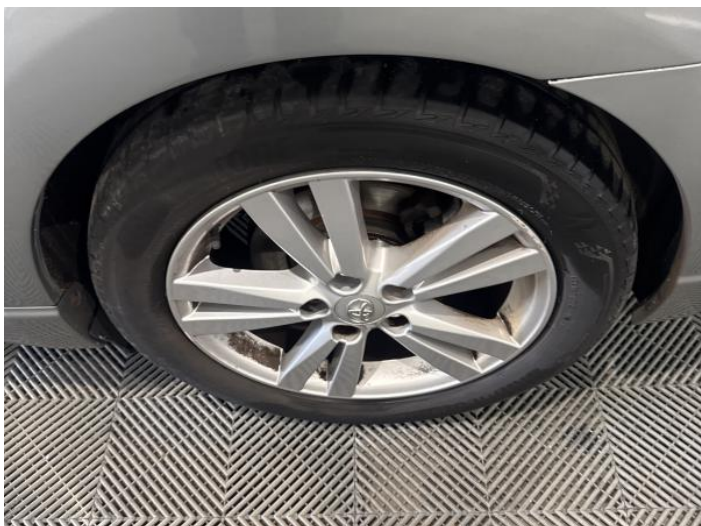
9: Wheel nsr
Scratched
Over 50mm

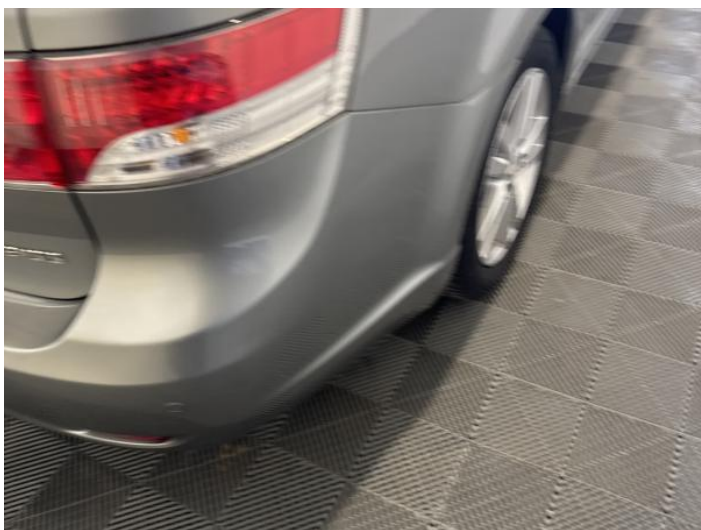
11: Bumper Rear
Scratched
25 to 100mm Thru Paint

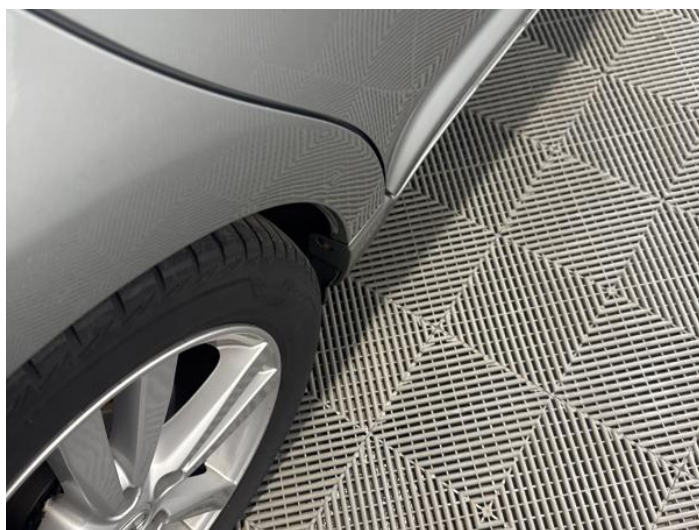
14: Qtr Panel osr
Dented
Between 10mm + 30mm

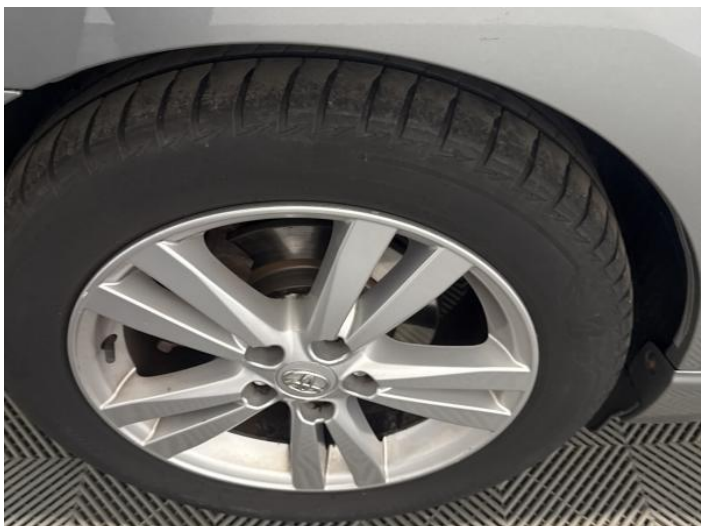
15: Wheel osr
Scratched
Over 50mm

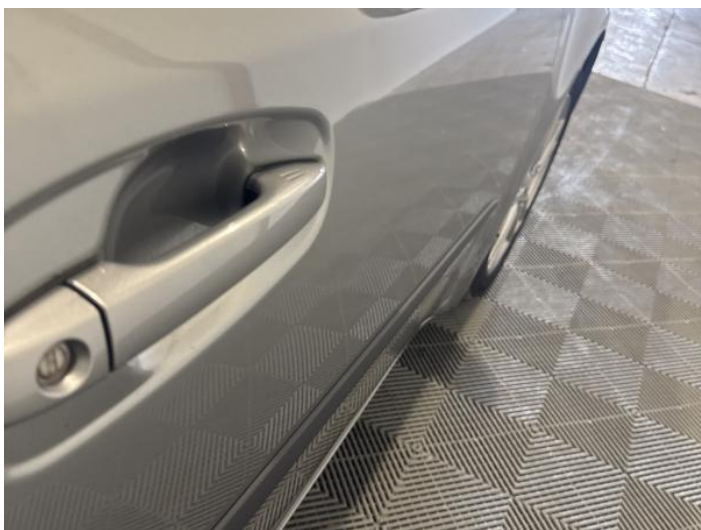
17: Door osf
Dented
Between 10mm + 30mm

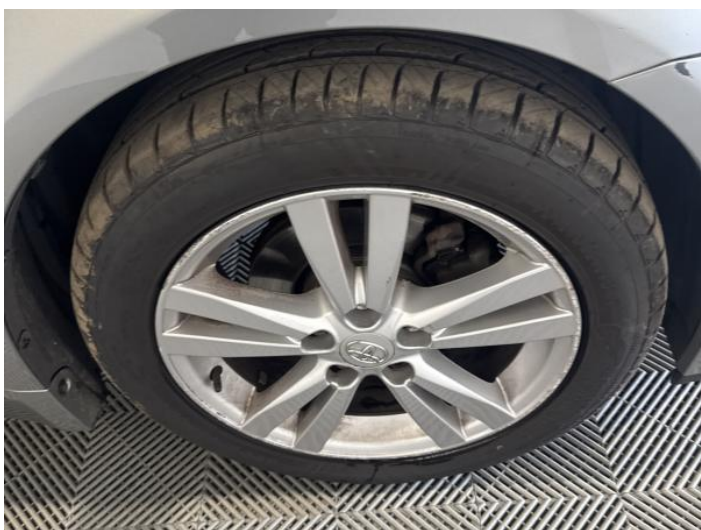
19: Wheel osf
Scratched
Over 50mm
