VEHICLE INSPECTION REPORT

GY69LFO

Nissan Qashqai 1.3 DiG-T 160 Tekna 5dr

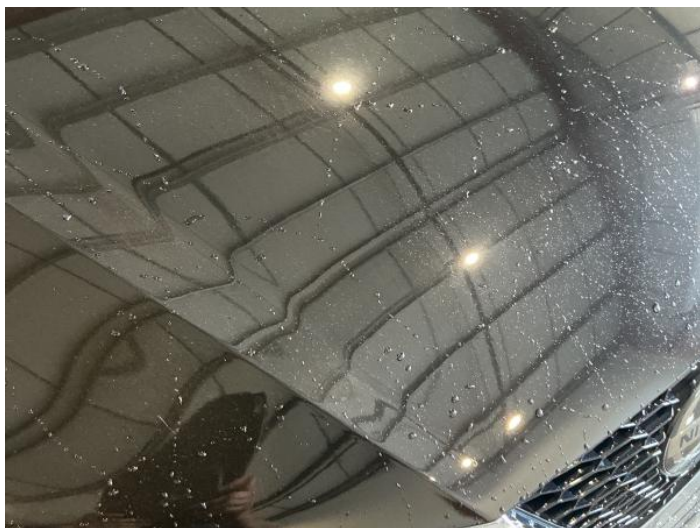
1: Bonnet
Chipped
1 To 5

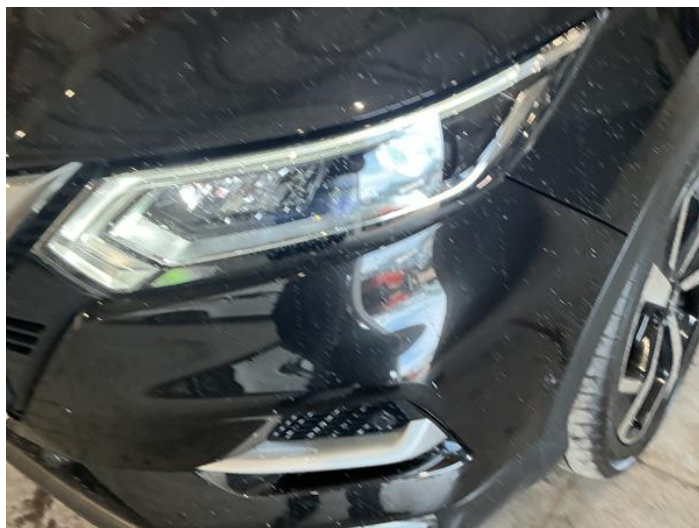
2: Bumper Front
Chipped
Multiple Chips

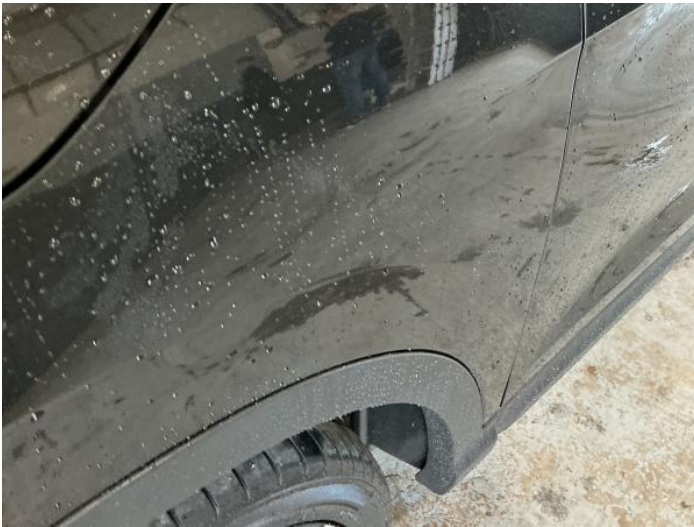
5: Wing nsf
Dented
Between 10mm + 30mm

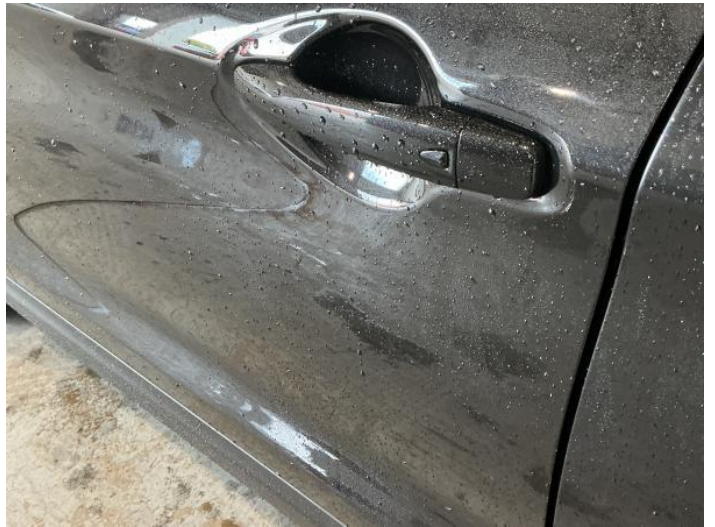
6: Door nsf
Chipped
1 To 5

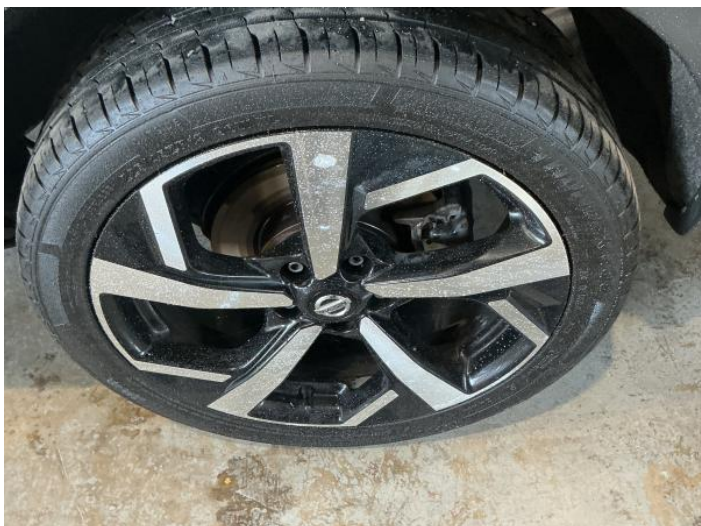
9: Wheel nsr
Scratched
Over 50mm

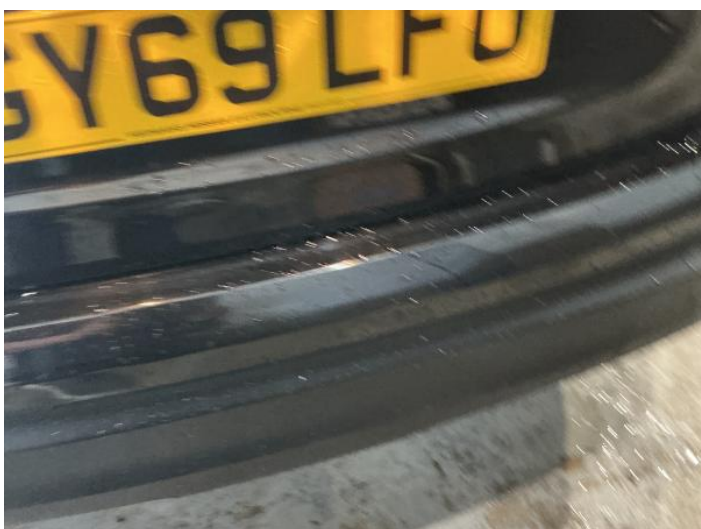
11: Bumper Rear
Chipped
Multiple Chips

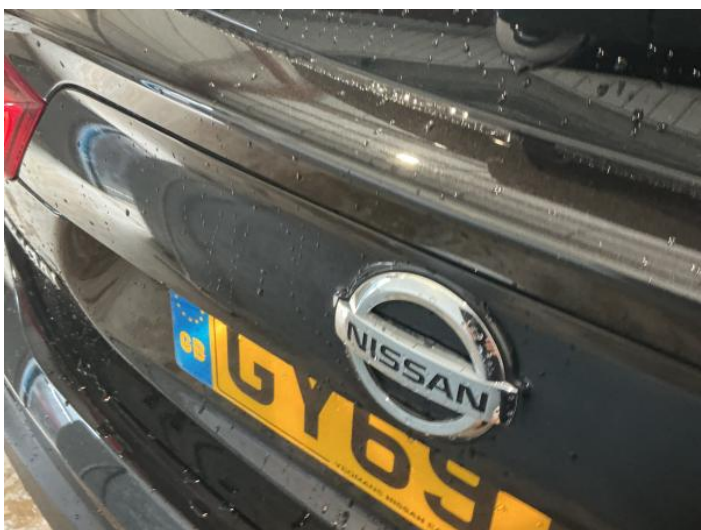
13: Boot Lid
Dented
Over 2 UpTo 10mm

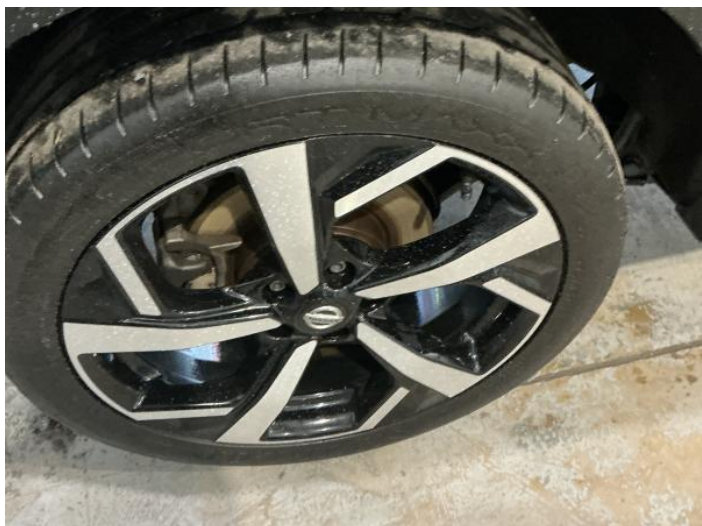
15: Wheel osr
Scratched
Up To 50mm

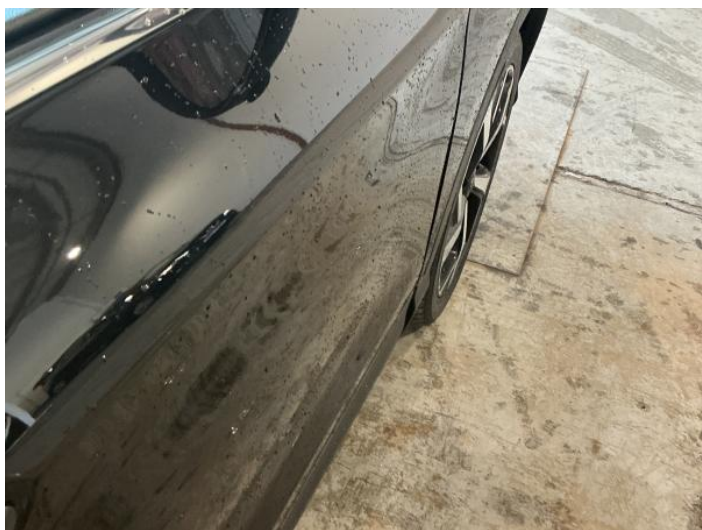
17: Door osf
Dented
Over 30mm

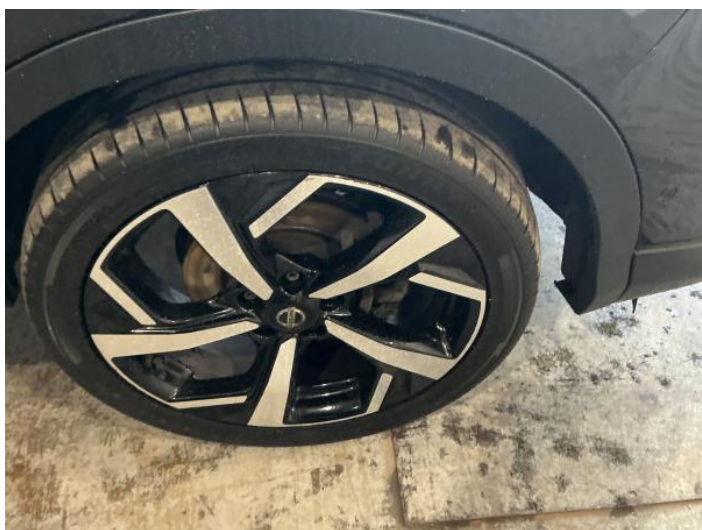
19: Wheel osf
Scratched
Up To 50mm
