VEHICLE INSPECTION REPORT

GU05LCY

Skoda Fabia 1.9 TDI PD Elegance 5dr [AC]

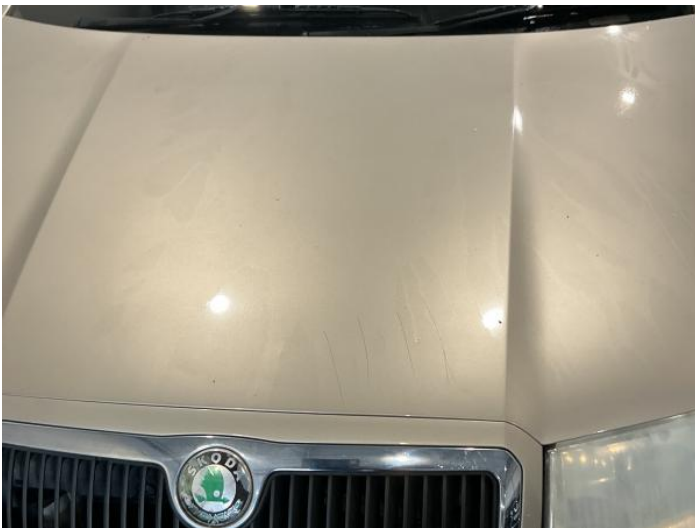
1: Bonnet
Scratched
Over 25mm Thru Paint

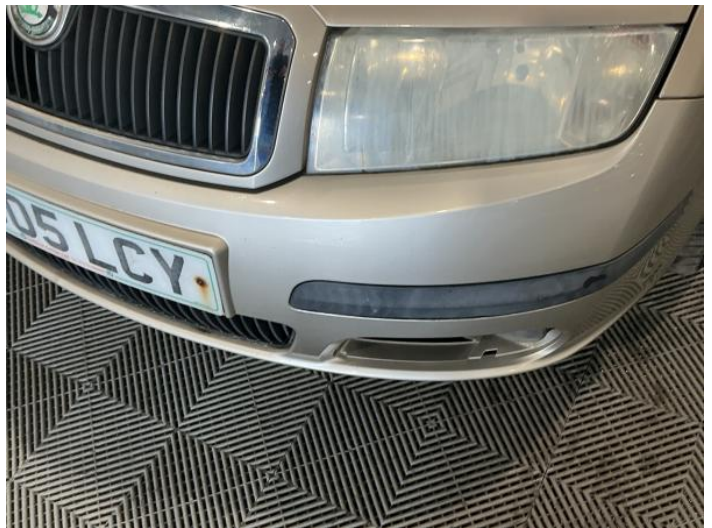
2: Bumper Front
Dented
With Paint Damage

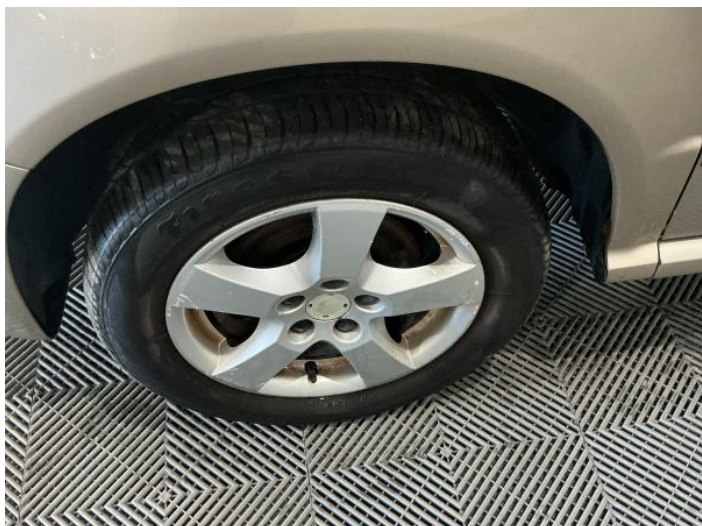
3: Wheel nsf
Scratched
Over 50mm

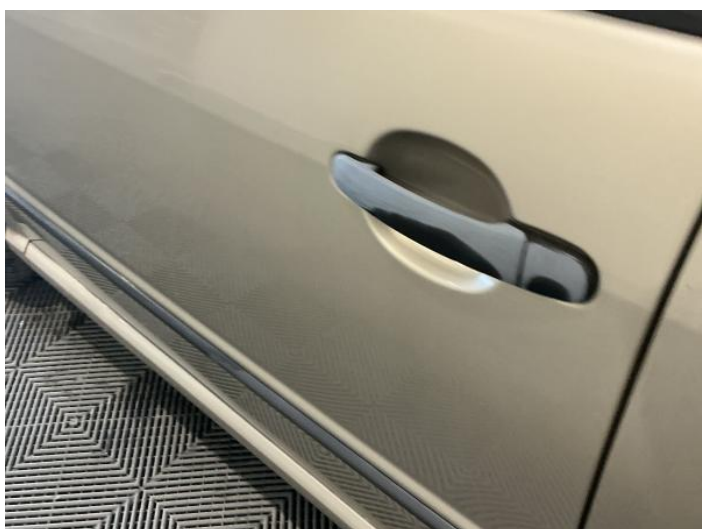
5: Door nsf
Dented
Over 2 UpTo 10mm

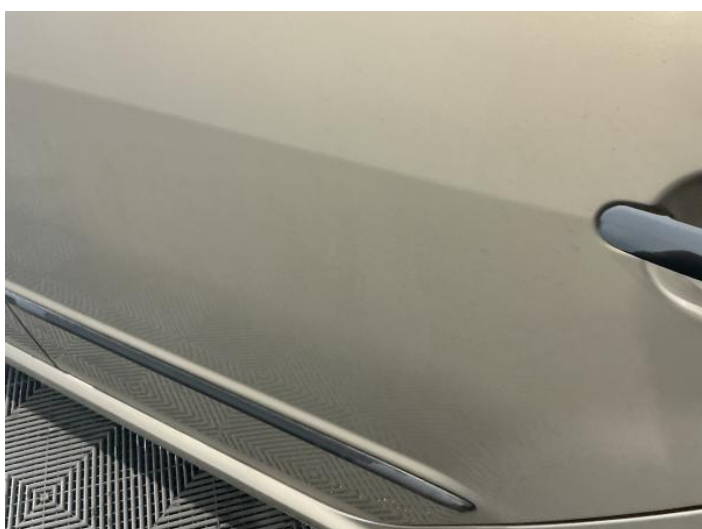
7: Door nsr
Chipped
1 To 5

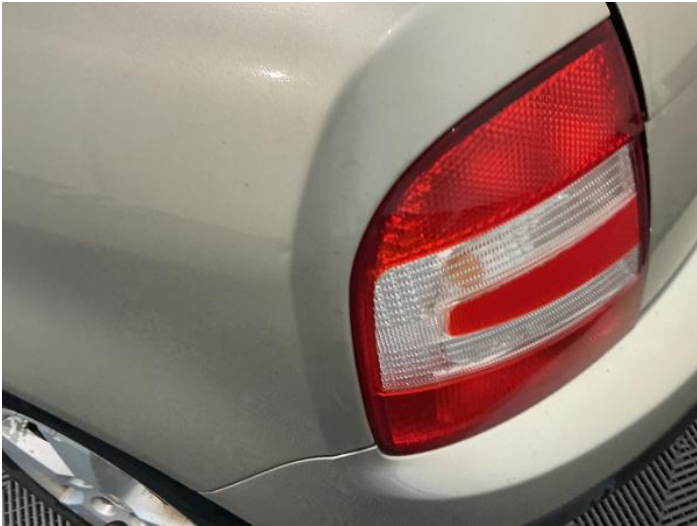
9: Qtr Panel nsr
Dented
Over 2 UpTo 10mm

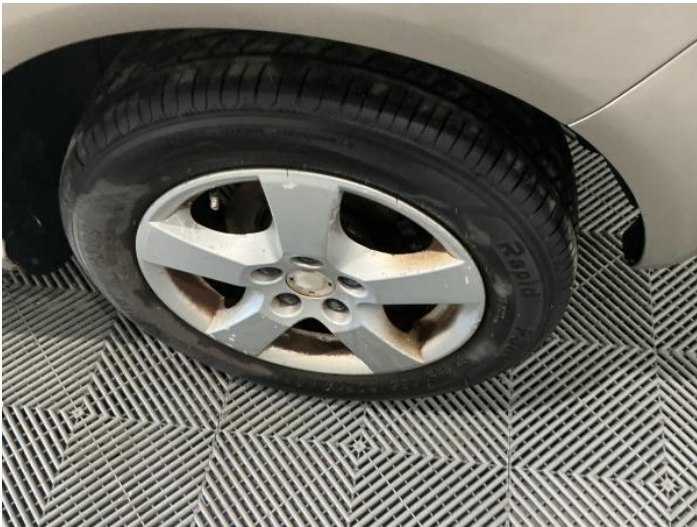
11: Wheel nsr
Scratched
Over 50mm

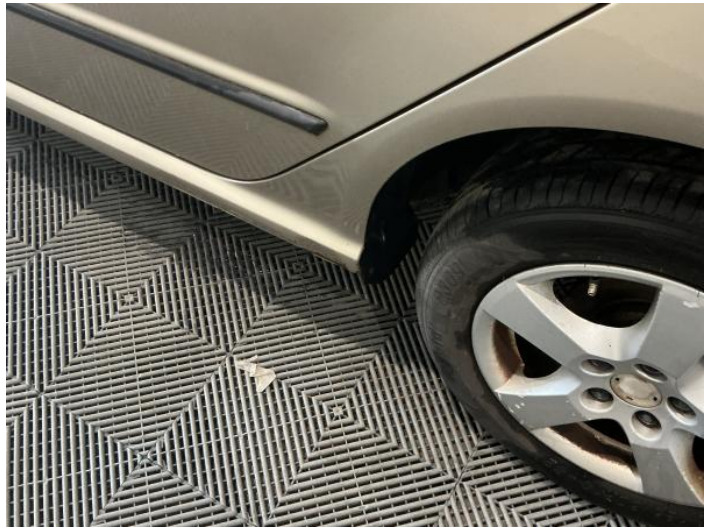
12: Sill ns
Dented
With Paint Damage

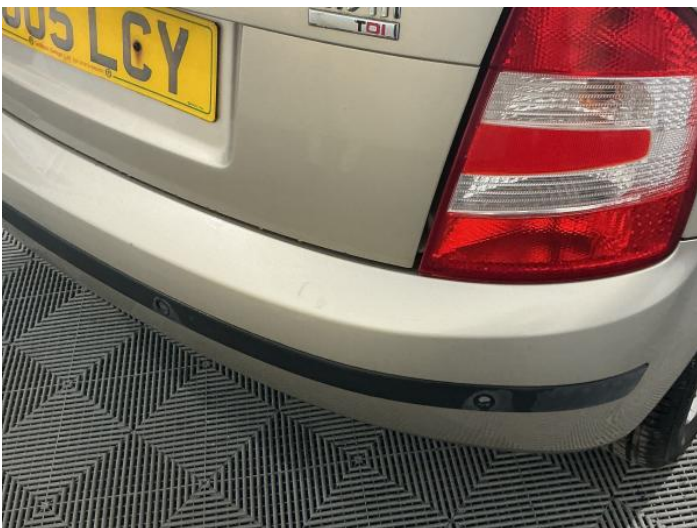
13: Bumper Rear
Chipped
Multiple Chips

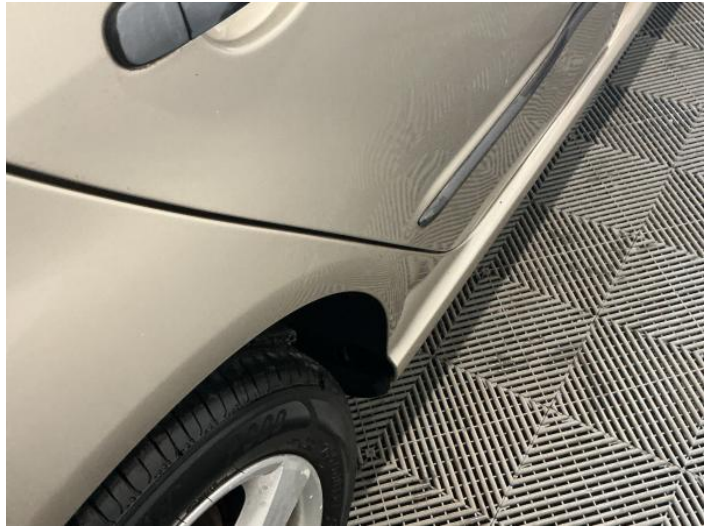
16: Qtr Panel osr
Dented
2 Or Less UpTo 10mm

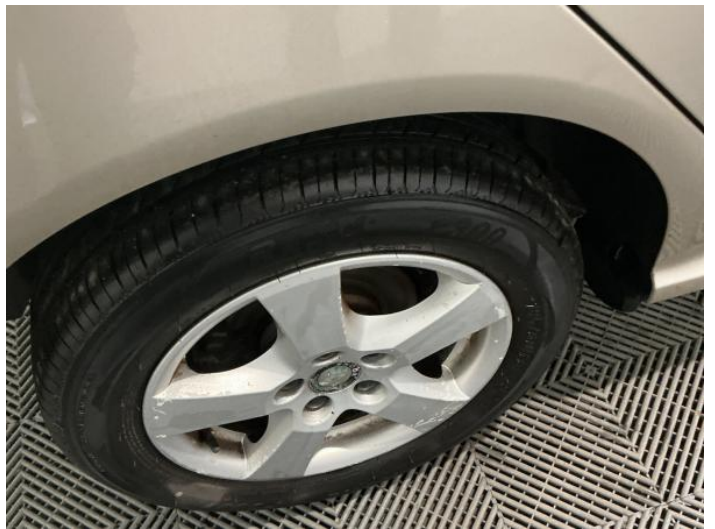
18: Wheel osr
Scratched
Over 50mm

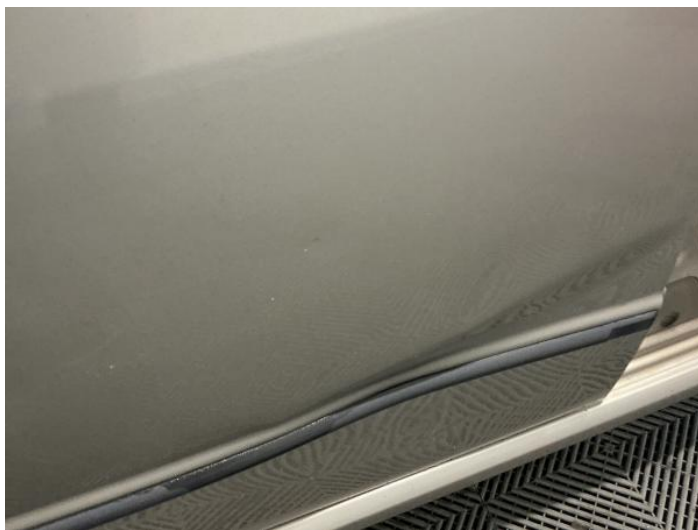
19: Door osr
Dented
Over 30mm

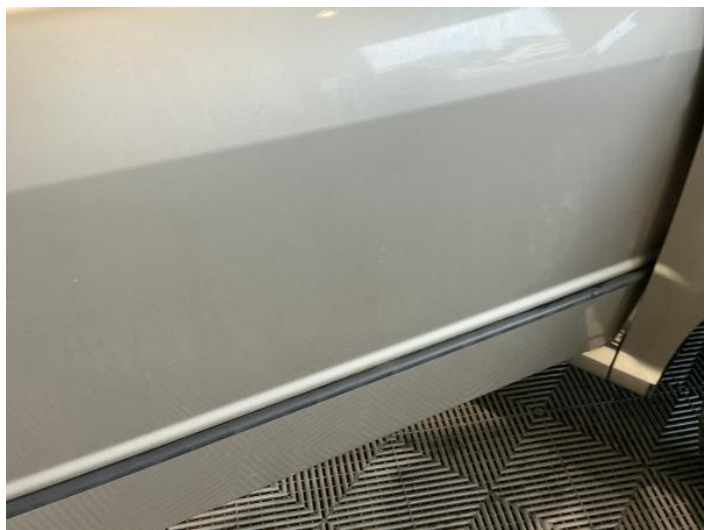
20: Door osf
Dented
Over 2 UpTo 10mm

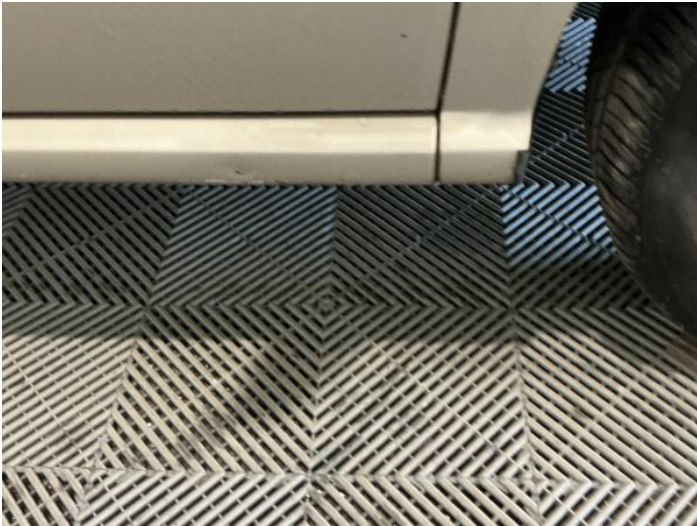
21: Sill os
Rusted
UpTo 5mm

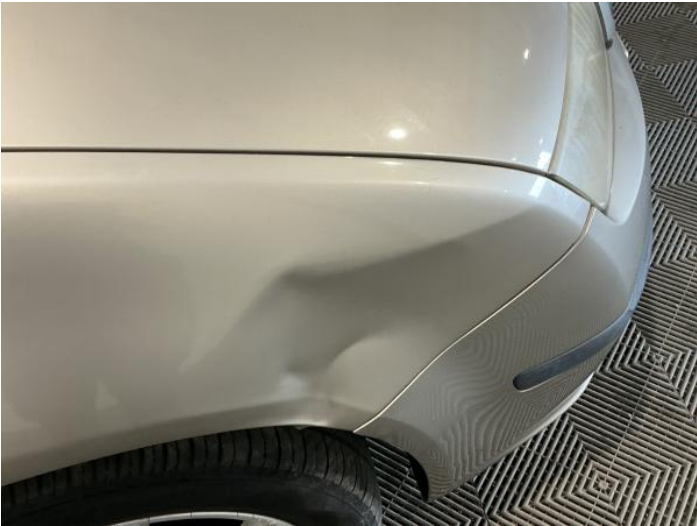
22: Wing osf
Dented
Over 30mm

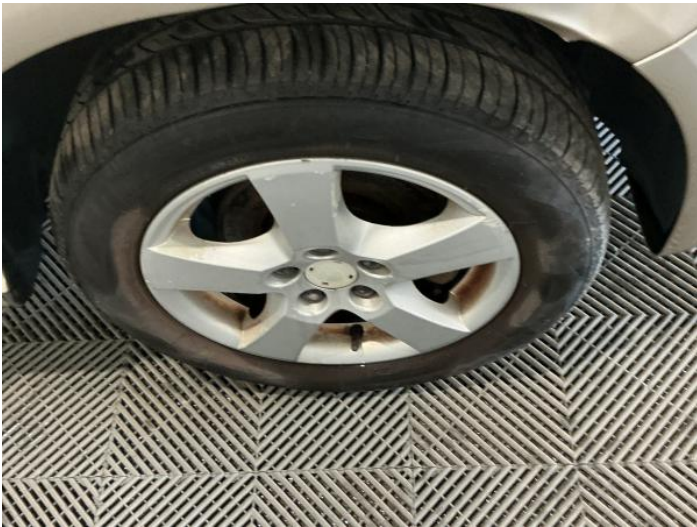
23: Wheel osf
Scratched
Over 50mm
