VEHICLE INSPECTION REPORT

GV22LFP

Volkswagen Id.3 110kW Life Pure Performance 45kWh 5dr Auto

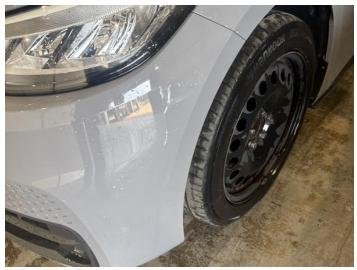
1: Bumper Front Scratched 25 to 100mm Thru Paint No Image

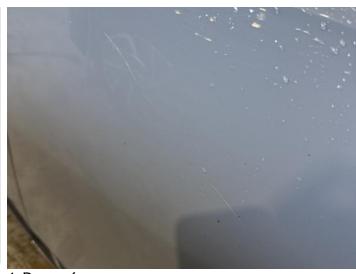
3: Wing nsf Scratched Over 25mm Not Thru Paint
