## **VEHICLE INSPECTION REPORT**

**GY71HRM**

### Ford Kuga 2.5 PHEV ST-Line X Edition 5dr CVT

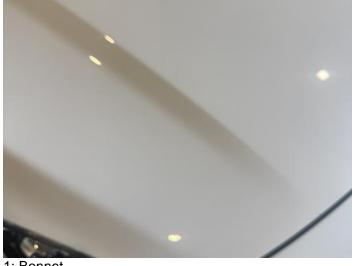
1: Bonnet Chipped 1 To 5

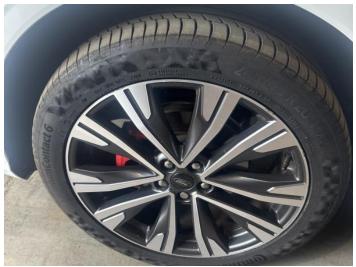
4: Wheel nsf Scratched Up To 50mm

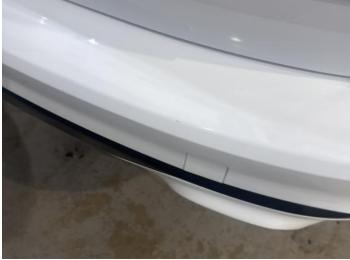
7: Bumper Rear Chipped Multiple Chips

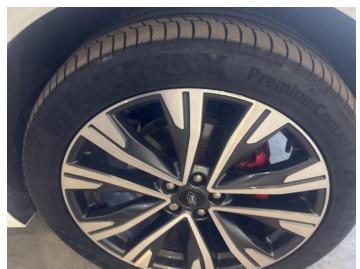
11: Wheel osf Scratched Up To 50mm

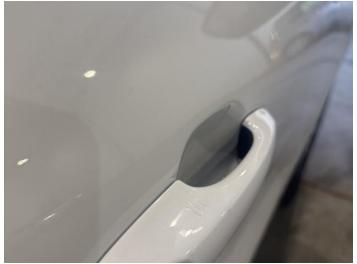
10: Door osf Dented 2 Or Less UpTo 10mm
