# VEHICLE INSPECTION REPORT

**VE21XUX**

Reg. date	11/06/2021	Keys	2	CAP Clean	£17,800.00
Year	2021	Service history	Yes	CAP Average	£16,450.00
Mileage	26,065 Miles Warranted	Service documents	Printout	CAP Below	£15,100.00
Fuel Type	Petrol	Number of stamps	1	Gearbox	SEMI AUTO
Colour	ORANGE	Last service date	09/08/2023	Gears	7
VIN	WVGZZZC1ZMY084106	Last service miles	15,588	Doors	5
Body Style	Hatchback	MOT Due	10/06/2026

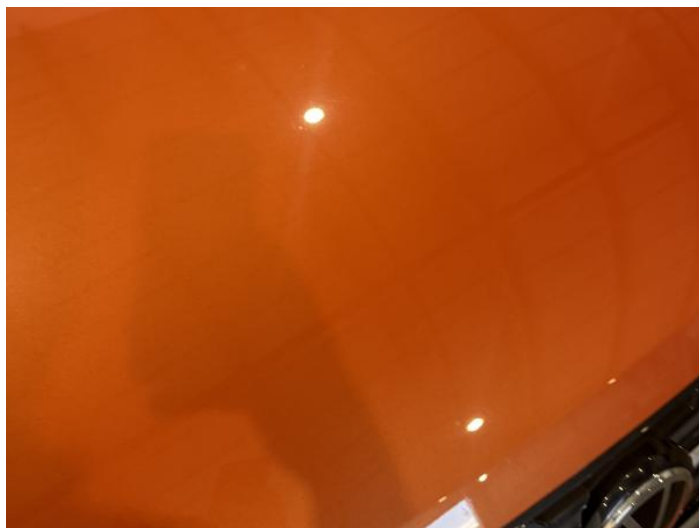
2: Bonnet  
Chipped  
1 To 5

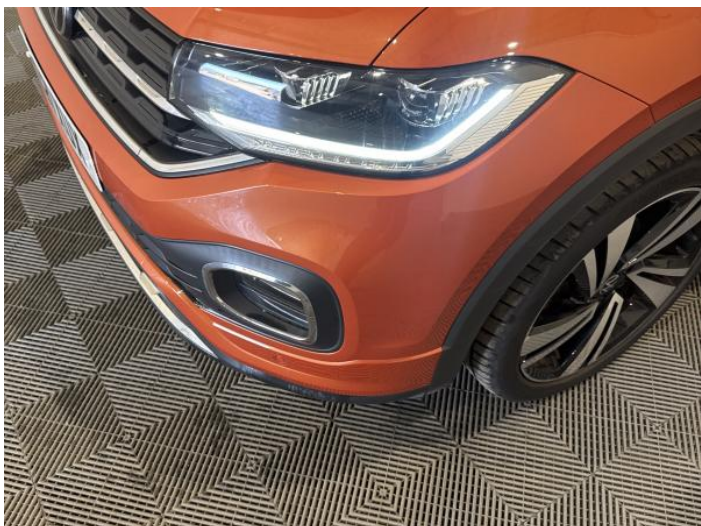
3: Bumper Front  
Chipped  
Multiple Chips

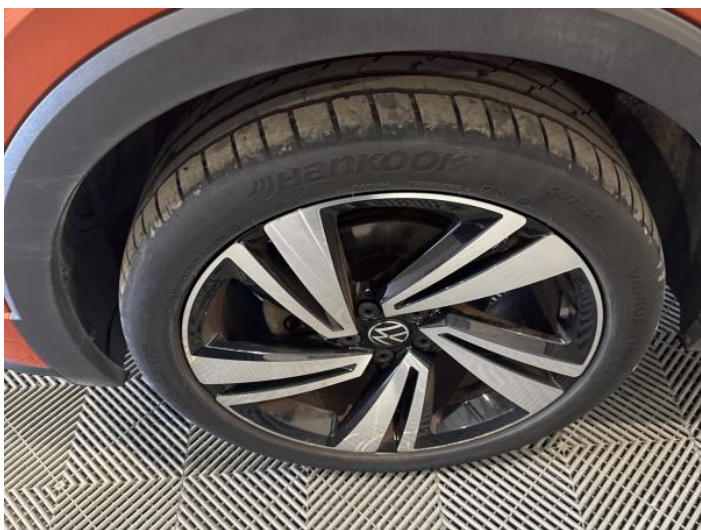
5: Wheel nsf  
Scratched  
Over 50mm

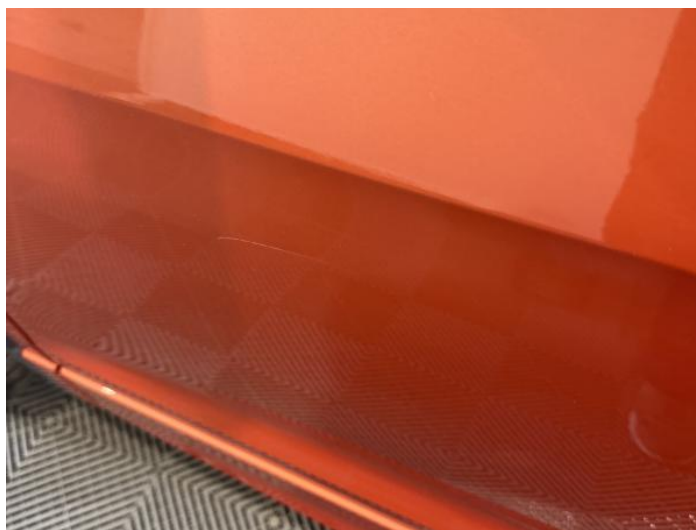
6: Door nsf  
Scratched  
UpTo 25mm Thru Paint

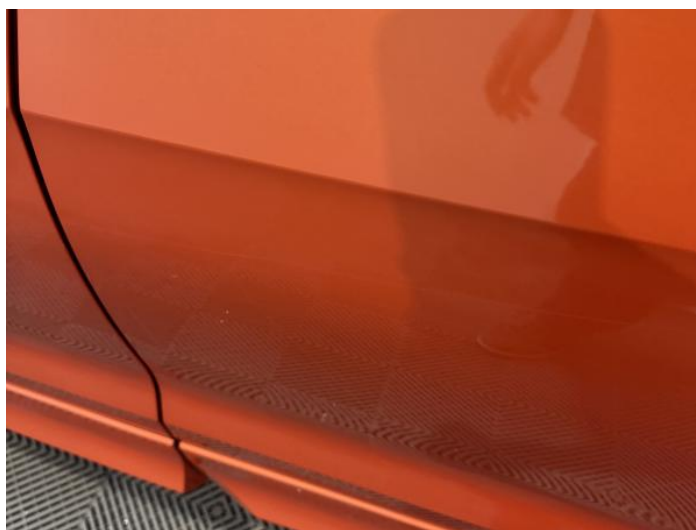
8: Door nsr  
Chipped  
1 To 5

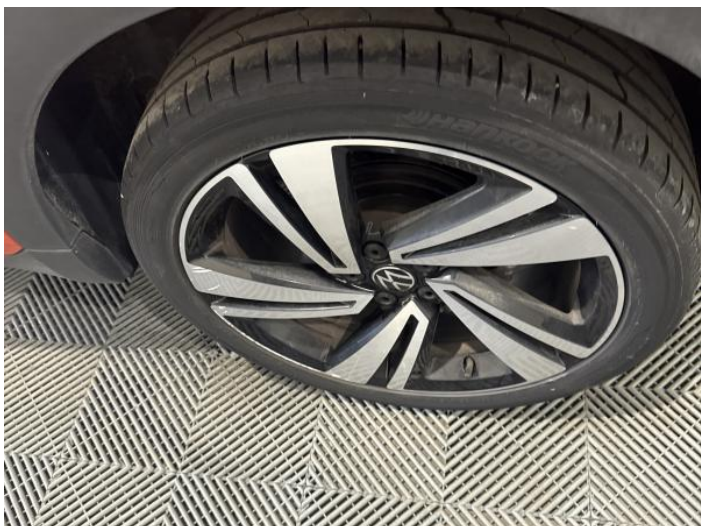
9: Wheel nsr  
Scratched  
Over 50mm

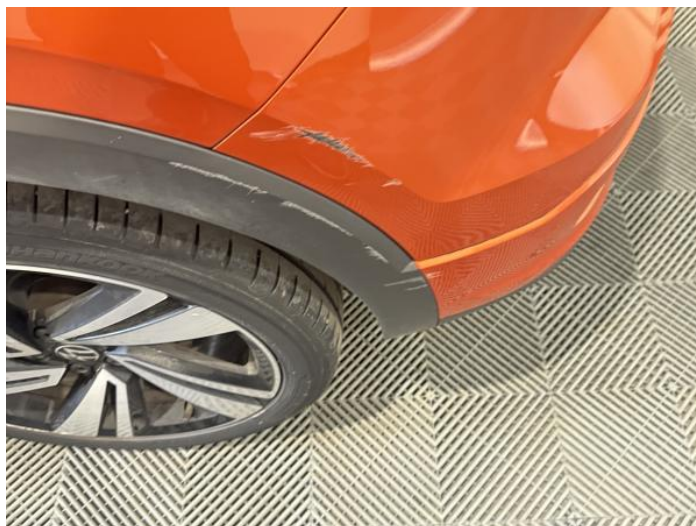
10: Qtr Panel Trim ns  
Scuffed  
Over 25mm

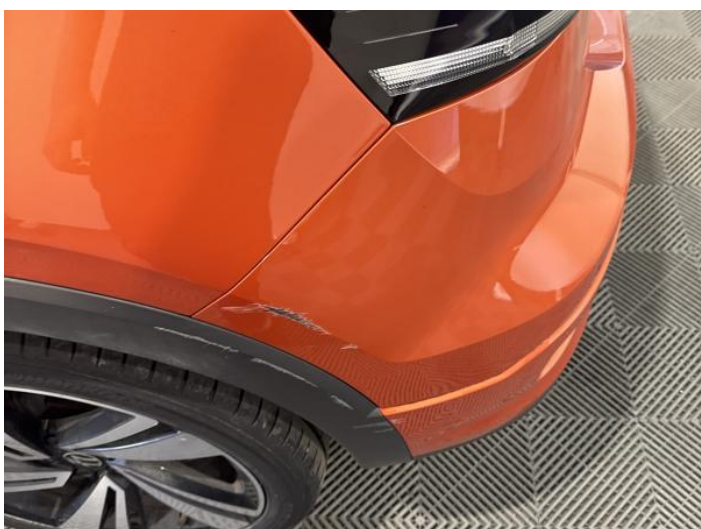
11: Bumper Rear  
Scratched  
25 to 100mm Thru Paint

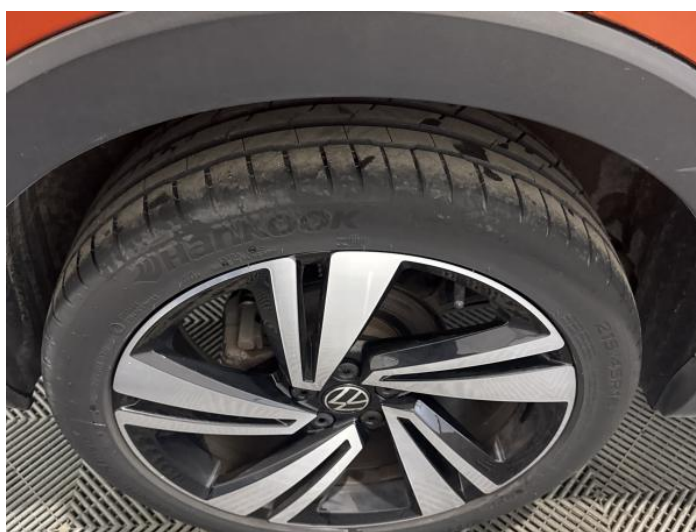
14: Wheel osr  
Scratched  
Up To 50mm

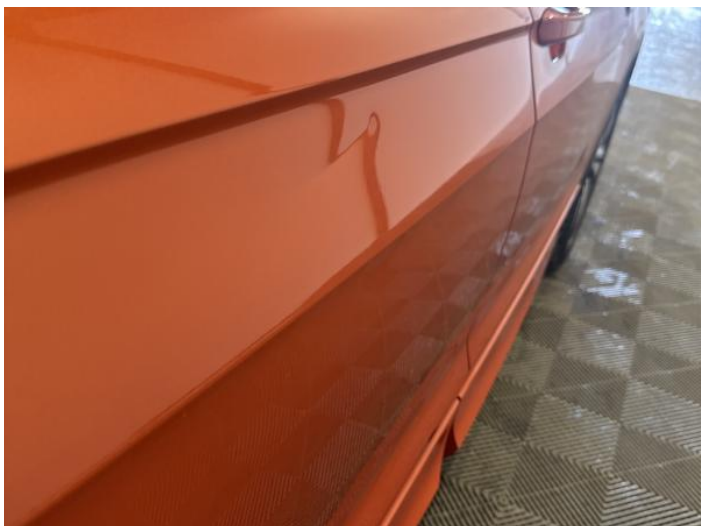
15: Door osr  
Dented  
Over 30mm

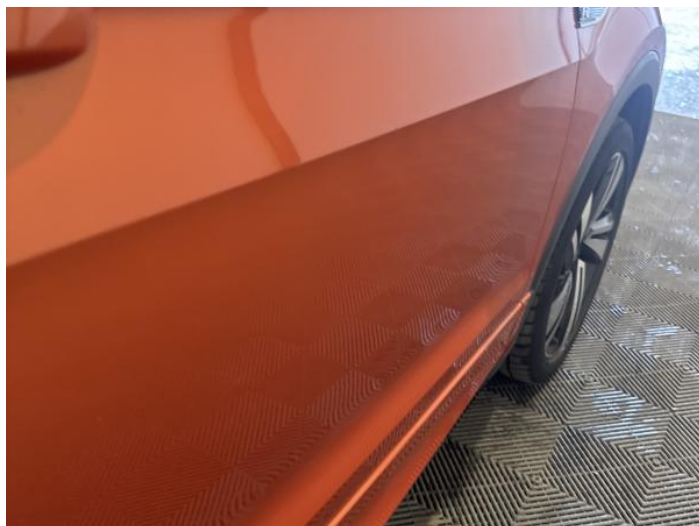
16: Door osf  
Dented  
2 Or Less UpTo 10mm

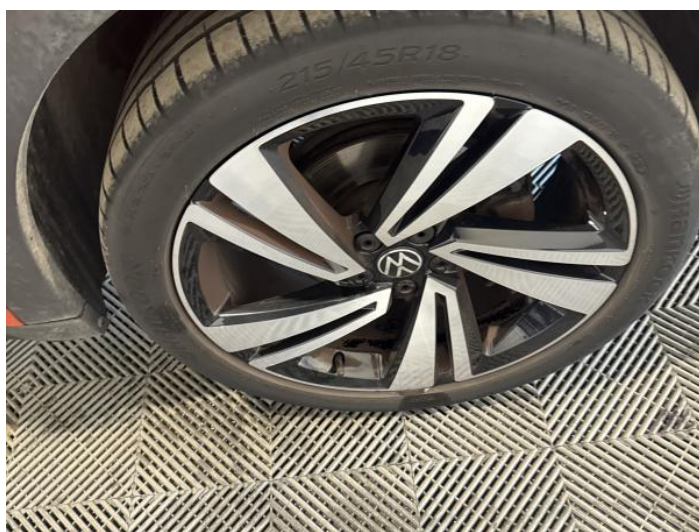
18: Wheel osf  
Scratched  
Up To 50mm
