VEHICLE INSPECTION REPORT

RA18HNP

Nissan Qashqai 1.5 dCi N-Connecta 5dr

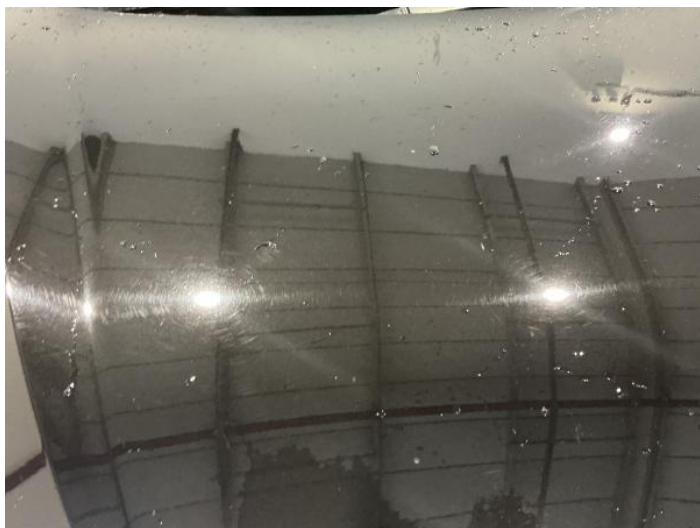
1: Bonnet
Chipped
1 To 5

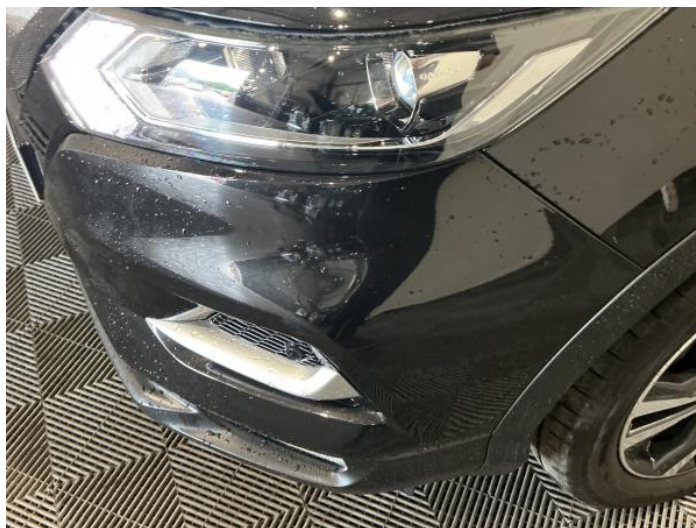
2: Bumper Front
Scratched
25 to 100mm Thru Paint

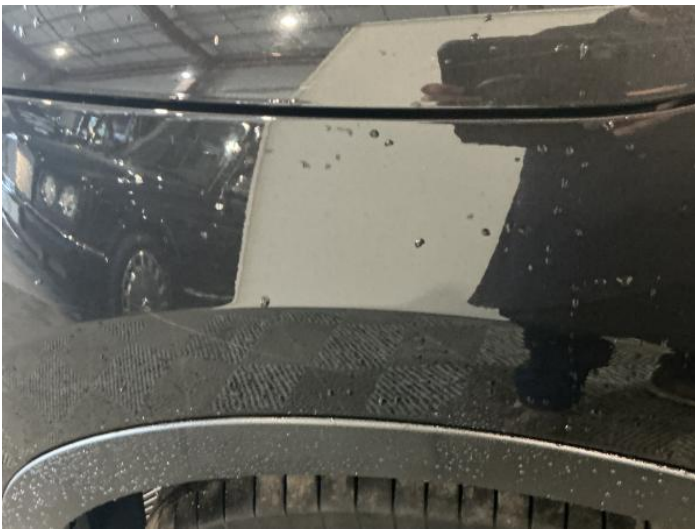
5: Wing nsf
Scratched
Over 25mm Thru Paint

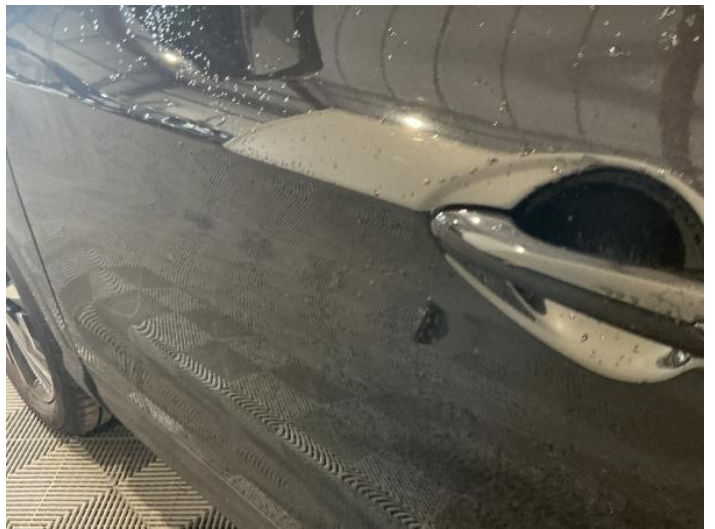
6: Door nsf
Chipped
1 To 5

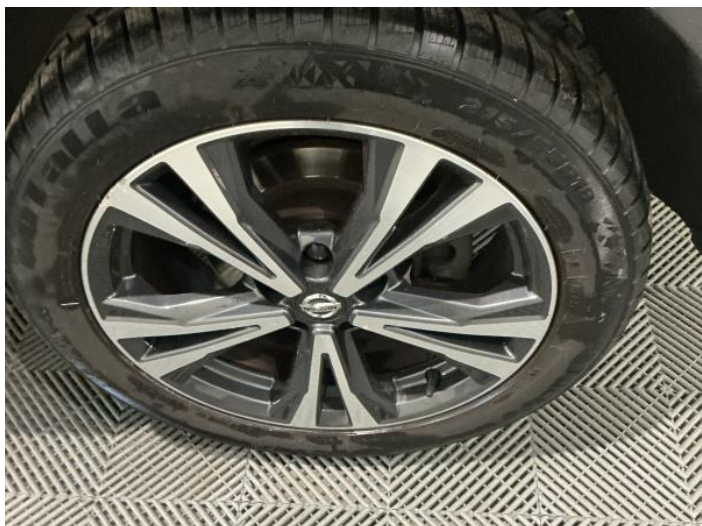
9: Wheel nsr
Scratched
Over 50mm

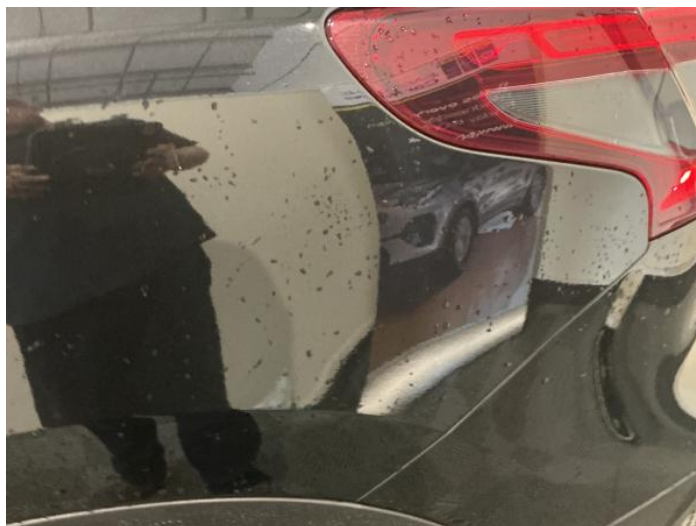
10: Qtr Panel nsr
Poor Previous Repair
Poor Paint

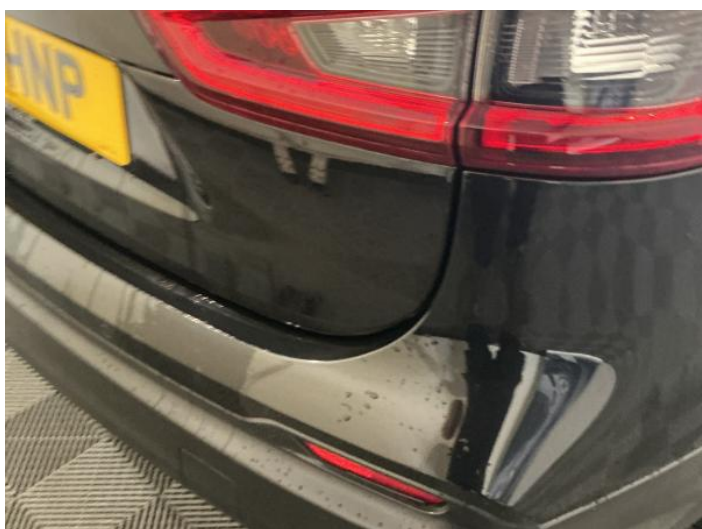
11: Bumper Rear
Chipped
Multiple Chips

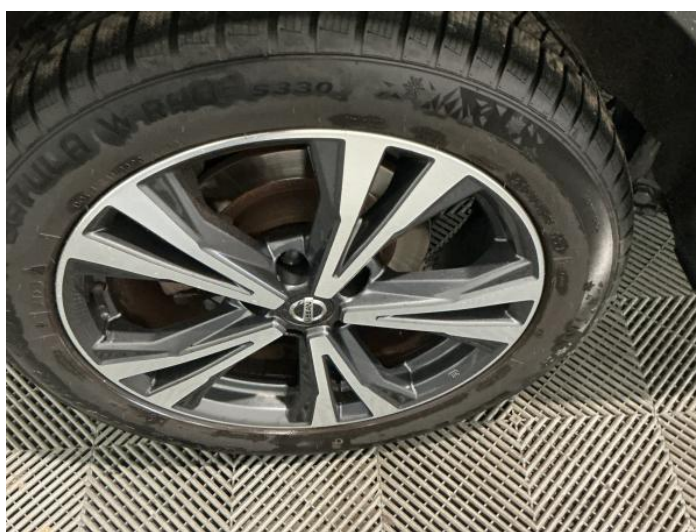
14: Wheel osr
Scratched
Up To 50mm

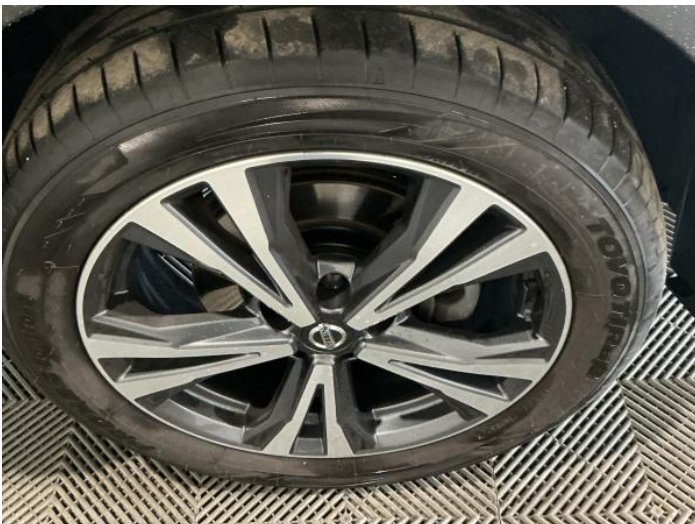
19: Wheel osf
Scratched
Up To 50mm
